Re: Department of Energy Docket No. EO-05-01, Order No. 202-05-03 on the Emergency Petition and Complaint of the Public Service Commission of the District of Columbia Joint Maintenance Status Report of Potomac Electric Power Company and PJM Interconnection, L.L.C.

ATTACHMENT 1
MAINTENANCE ACTIVITIES REPORTS

Maintenance Activities Feeder 23106 Sub. 84 Palmers Corner To Station C

Maintenance Activities Feeder 23107 Sub. 84 Palmers Corner To Station C

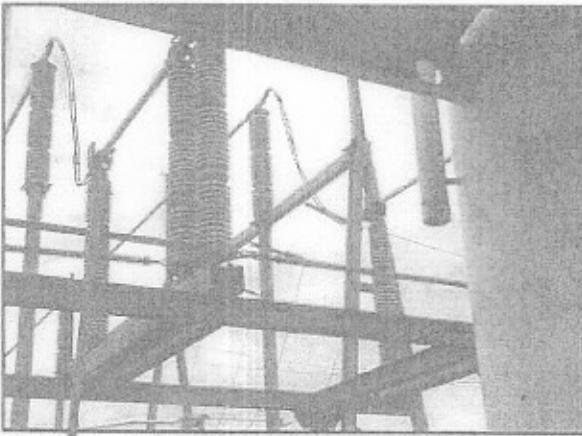
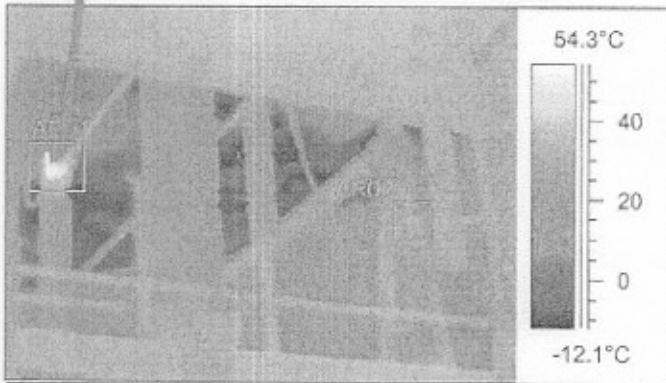
SV Disk No.	1
SV Image No.	28

No. 23016 BUS DISC

TEMP RISE INDICATED ON BUS DISC JAW (B-PHASE)

IR information	Value
Date of creation	6/16/2005
Object parameter	Value
Object distance	10.0 m
Ambient temperature	25.0°C
Label	Temperature
AR01 : max	67.9°C
AR02 : max	34.5°C
Actual Temp Rise	33.40 °C

INSPECT AND REPAIR AS REQUIRED.

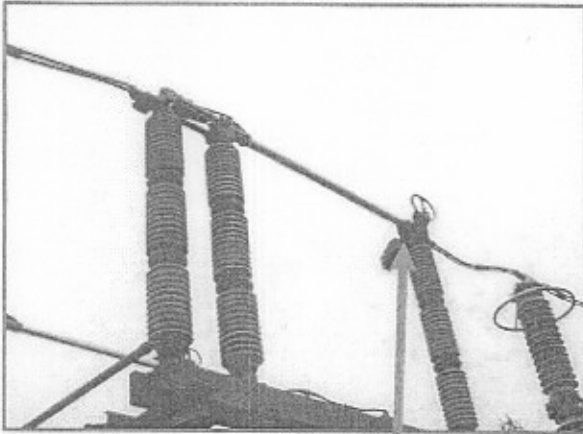
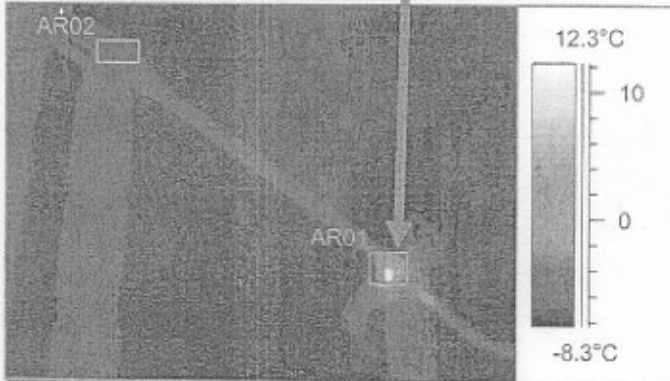
SV Disk No.	1
SV Image No.	30

A predictive maintenance thermography inspection indicated hotspots on the B phase bus and C phase line side disconnects. Hot spots indicate loose connections or corrosion that can lead to equipment failure and sometimes catastrophic failure if left to progressively increase in temperature. The drive mechanism parts were cleaned and lubricated. A follow up thermography inspection was performed on January 30 which indicated that the hot spots had been corrected.

23106 HTF

TEMPERATURE RISE INDICATED ON LINE DISC JAW (A-PHASE)
DS8423

IR information	Value
Date of creation	1/3/2006
Object parameter	Value
Object distance	10.2 m
Ambient temperature	25.0°C
Label	Value
AR01 : max	20.0°C
AR02 : max	-4.1°C
Actual Temp Rise	24.11 °C

INSPECT AND REPAIR AS REQUIRED
