National Nuclear Security Administration

Federal Accident Investigation

**Accident Investigation into Contamination at the
Los Alamos Neutron Science Center on or about
August 21, 2012**

September 2012

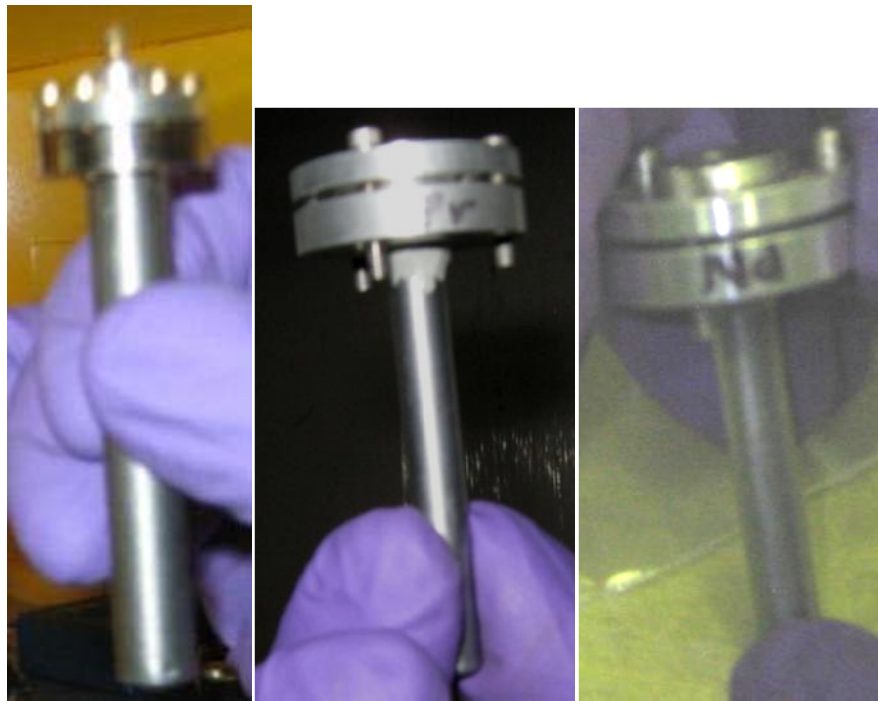
Figure 2.1.1. Typical Assembled Vanadium Sample Canister shown with Praseodymium and Neodymium Technetate Sample Canisters

Figure 2.1.2 shows a photograph of the top of the Neodymium Technetate cap showing the three screw heads used to secure the cap, and the three unused screw holes.

The safety review of the proposed experiments implicitly assumed that robust seals on the canisters would provide containment while at the Lujan Center. The review explicitly assumed that the canisters would not be opened in the facility. Consequently, the hazard level was categorized as Medium. A statement that the canisters would not be opened was written into the *Comments* section of the safety review paperwork. Beyond the previously existing work controls and the statement of this assumption, no additional controls were established or required to ensure the continued validity of these assumptions. At least some of the samples were irradiated in environments that included extreme cold.

The use of only three screws, rather than six, to seal these canisters was inconsistent with the safety review assumption that the canisters were robustly sealed. Simple engineered methods, such as using all six screws and using safety wire to secure the screws in their tightened condition, were not implemented. Such methods could have both increased the confidence that the sample would remain secure while providing a visual indication that the contents were not to be disturbed unintentionally.

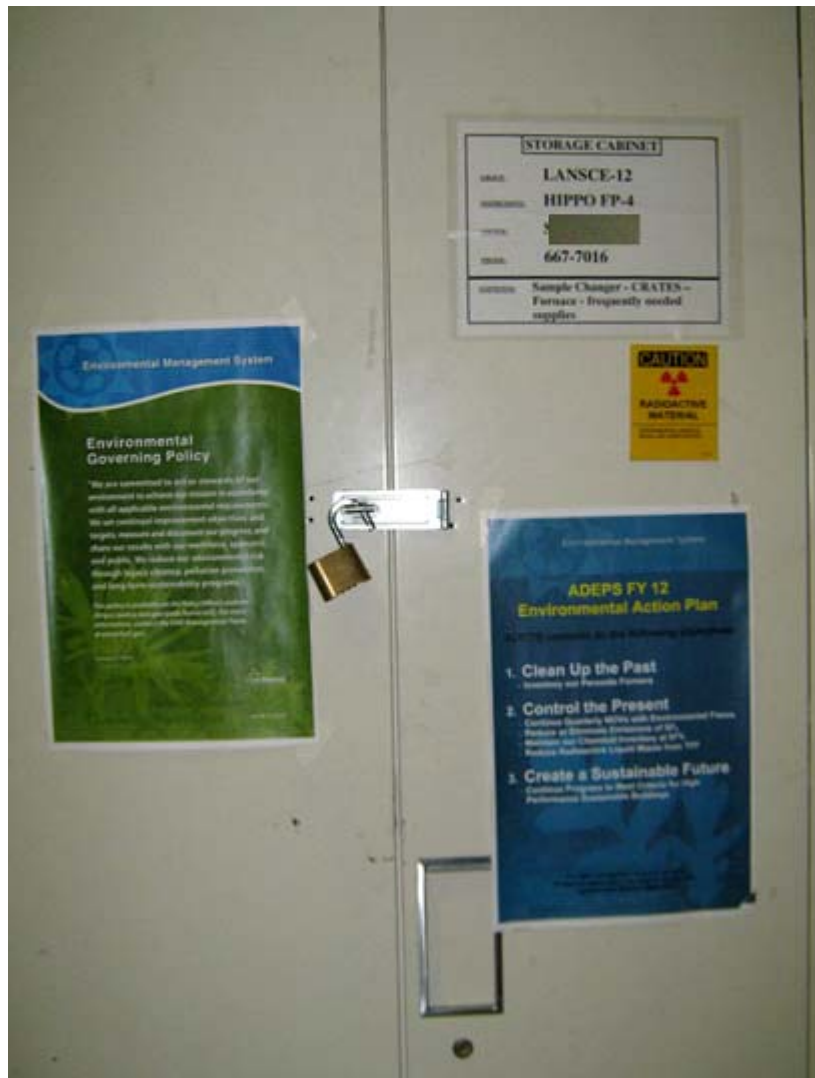
Figure 2.1.3. FP-04 Radioactive Material Storage Cabinet

Photographs of the radiological materials cabinet and its contents after operations were suspended at the end of August 2012 are provided in Figures 2.1.3 and 2.1.4. In Figure 2.1.3, the lock on the cabinet is shown unlocked and hanging from the hasp; however, it was unlocked after the accident to allow inspection and radiological survey. Photographs taken during the first re-entry clearly show that the cabinet was found locked. The owner name has been obscured for this report.

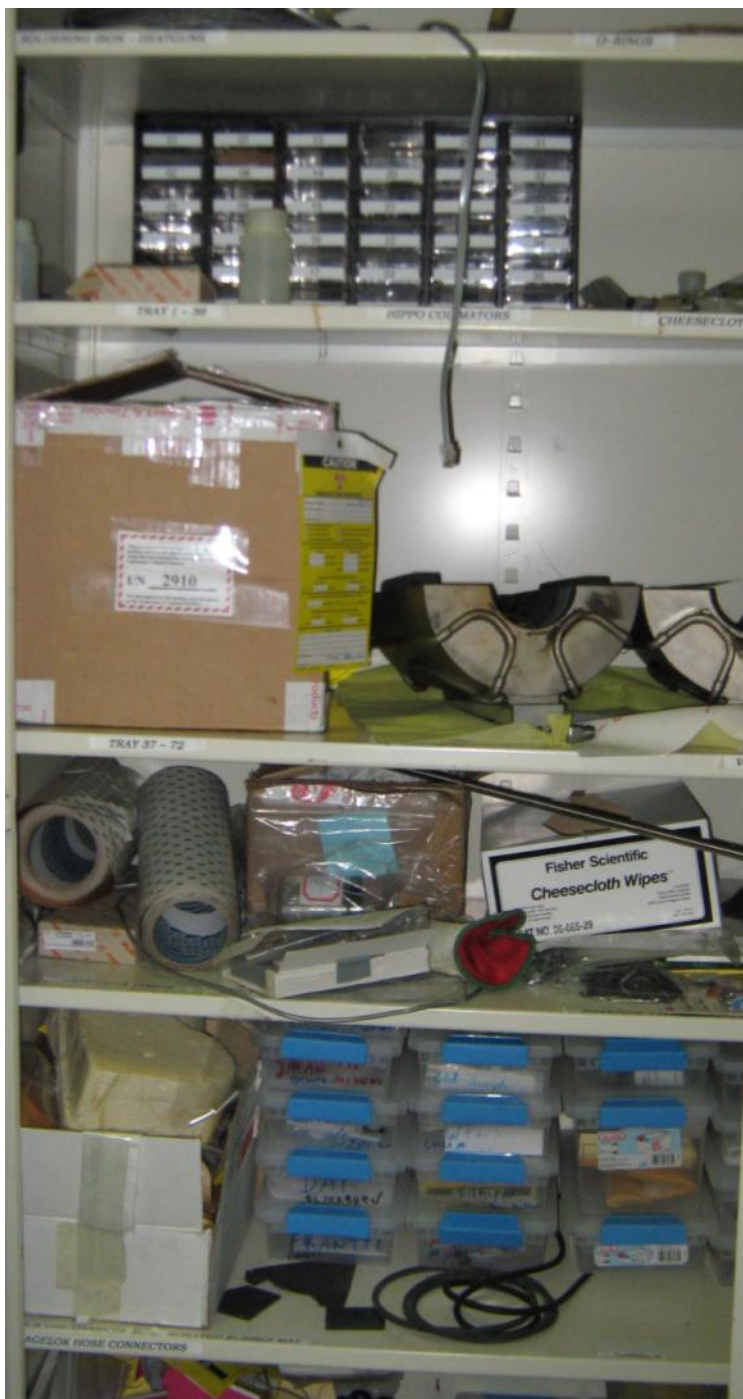
Figure 2.1.4. Inside of FP-04 Radioactive Materials Cabinet

A radioactive material posting is on the outside of the right cabinet door. The Technetate sample canisters were stored in the cardboard box that is visible in Figure 2.1.4 on the left hand side of the cabinet. A radioactive material placard is on the side of the box, facing to the right.

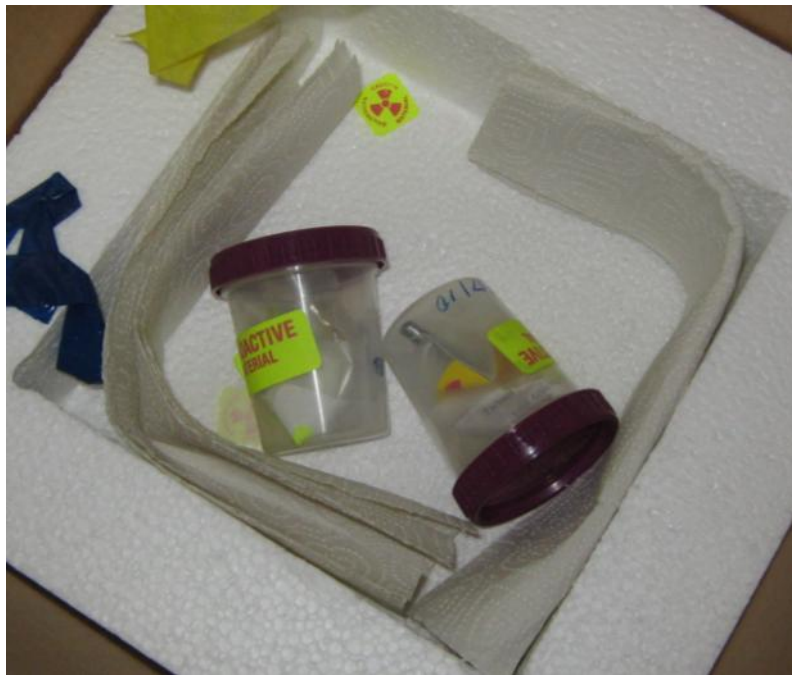
Figure 2.1.5. Pr and Nd Technetate Sample Canisters

Photographs of these two sample canisters in their packaging, as they appeared upon retrieval following the suspension of work in the Lujan Center, are provided in Figure 2.1.5 and 2.1.6.

Following the accident, the containers shown in Figure 2.1.5 were opened and the sample canisters and packaging surveyed. The sample canisters were found sealed (using three of six possible screws), and there was no detectable contamination. Figure 2.1.6 provides a photograph showing the open containers and the zip-lock plastic bags holding the sample canisters. The plastic bags are each tagged with a radioactive material label.

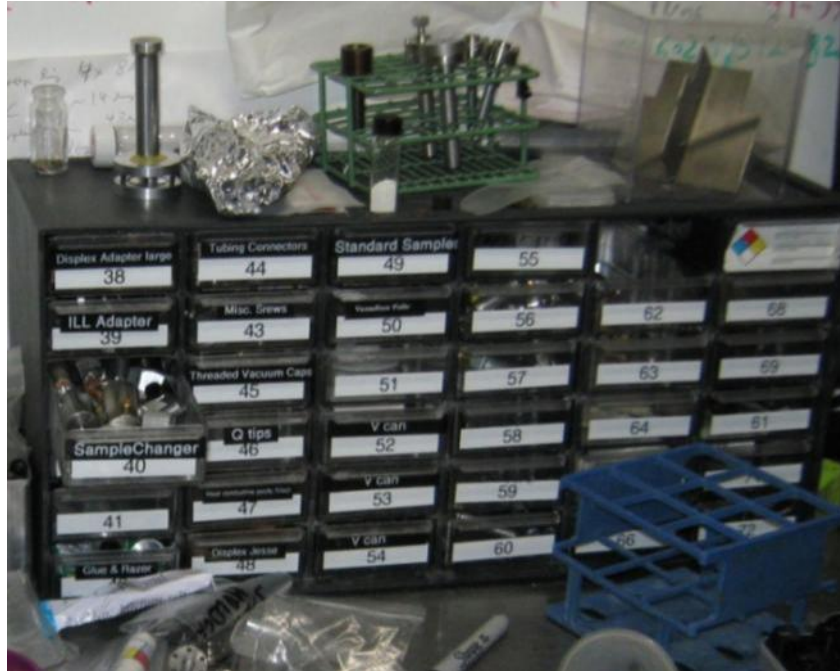
Figure 2.1.8. Supply Cabinet on FP-04 Sample Desk

Per an interview with FP-04 S1, he built this sample canister from parts he took from drawers in the cabinet on the sample desk in FP-04. A photograph of this cabinet is provided in Figure 2.1.8. In the photograph, note that drawers 52-54 are labeled "V Can." Per the testimony of the APIC, new canisters, caps and screws were also available from the APIC, who kept them in a box that he had recently moved to the Lujan Center, Experimental Room-2 (ER-2).

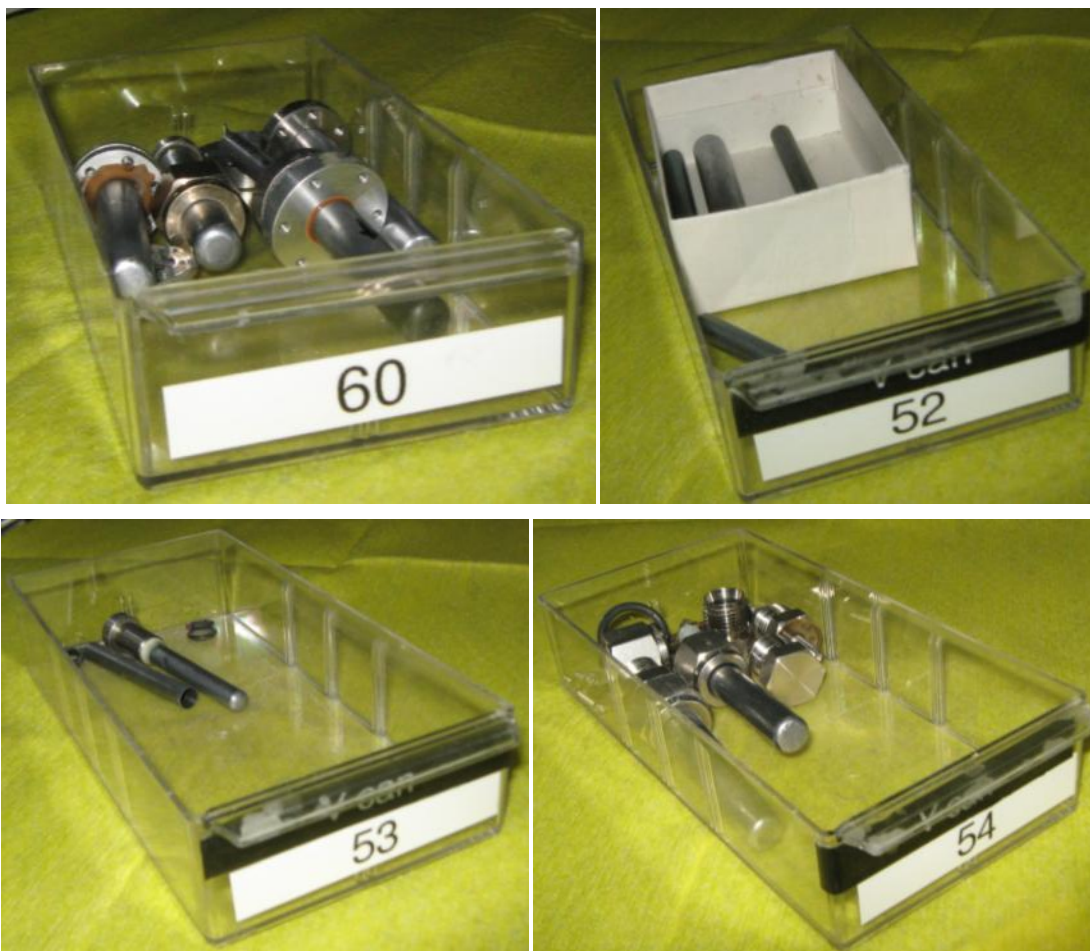
Figure 2.1.9. Drawers from Sample Desk Supply Cabinet

FP-04 S1 said he did not open a used canister for re-use and empty the contents, or ask for a new one from the APIC. He said he probably got the parts from drawers in a supply cabinet on the sample desk. Figures 2.1.9 provides photographs of some of the drawers, removed from the supply cabinet.

The contents of these drawers (and others, not shown) include various components of sample canisters in various stages of assembly, consistent with testimony provided to the AIB. According to multiple interviews, the caps, collars, screws and Vanadium tubes for assembling a canister often were found in multiple drawers.

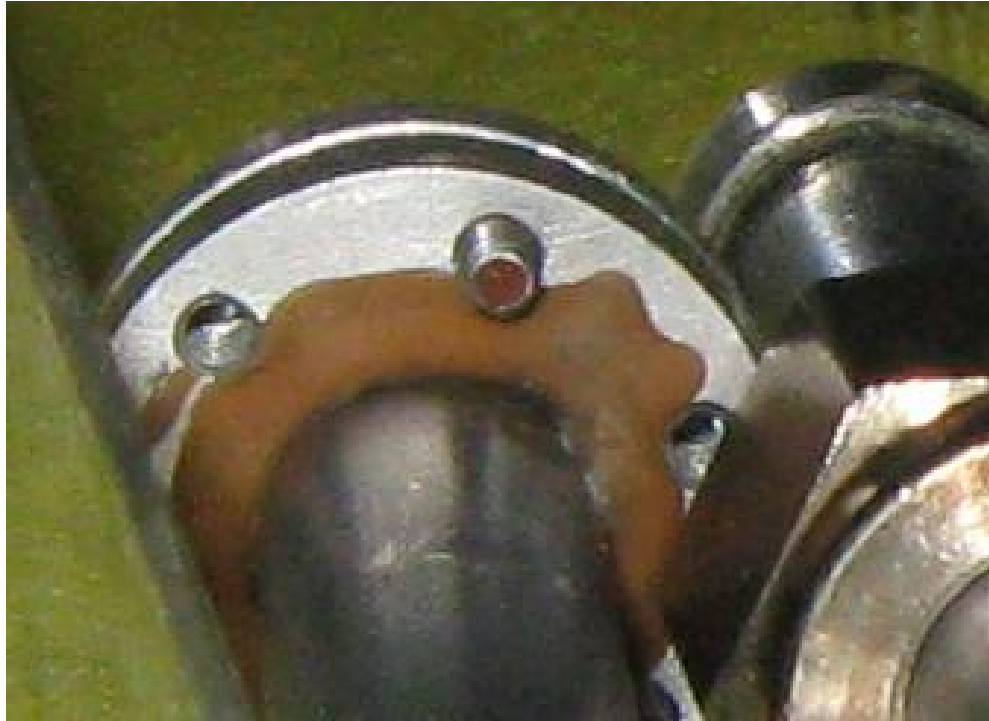
Figure 2.1.10. Blow up of Drawer 60

According to testimony, empty canisters staged for re-use were not usually stored assembled, with cap and collar screwed onto the Vanadium tube. However, at least one drawer, drawer 60, contains what appears to be an assembled sample canister. Figure 2.1.10 provides an enlarged image of the canister in the upper left of drawer 60. As can be seen, the cap is clearly attached; at least one screw is clearly threaded through the cap and collar, with the screw on either side not present.

Had the Lutetium Technetate sample canister been accidentally stored in one of these drawers, someone could have mistaken it for an empty canister, stored with its cap in place for convenience. The use of only a few screws to hold on the cap could have contributed to this impression.

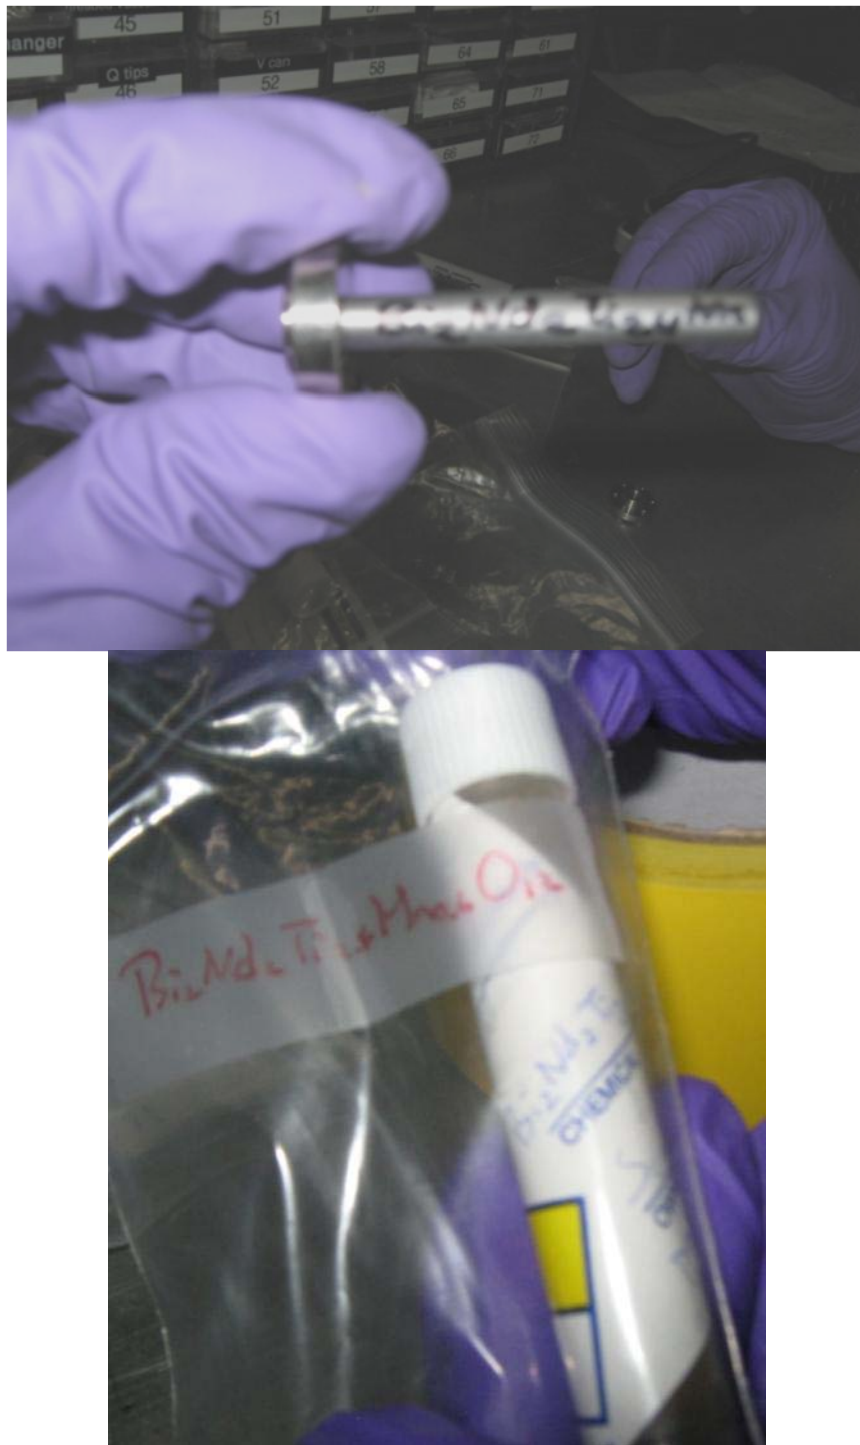
Figure 2.1.11. Empty Vanadium Tube and Collar from Sample Desk with Zip-lock Bag and User Sample Staged for Processing

Given other workloads, the process of preparing a sample canister, putting a sample into it, and sealing it, may not all occur on a single day. For example, Figure 2.1.11 provides a photograph of a Vanadium tube mounted into a collar (but without the cap and screws), apparently empty, that was found in the FP-04 area during a re-entry following work suspension. The figure also includes a photograph of a sample vial that was found on the sample desk, apparently in the process of being prepared for an experiment. It was found in a zip-lock bag that was labeled with a chemical formula similar to that written on the side of the

Vanadium canister: $\text{Bi}_2\text{Nd}_2\text{Ti}_{x,x}\text{Mn}_{x,x}\text{O}_{12}$ (where 'x' denotes a number on the zip-lock bag that is illegible in the photograph).

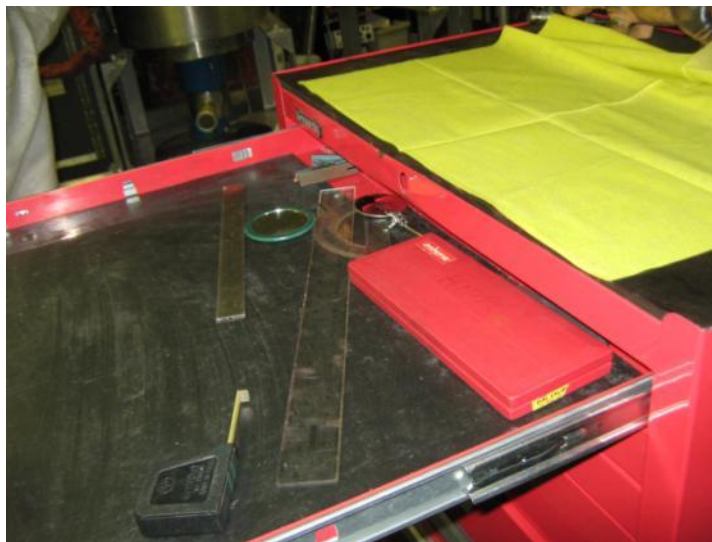
Figure 2.1.12. Top Drawer of FP-04 Tool Box

When this report was written, it was not positively known how, when, where, or by whom the sample canister that contained Lutetium Technetate was opened and emptied, or whether it was opened specifically so that its parts could be used for the displex alignment procedure. In the FP-04 area is a large red tool box, which sits atop the HIPPO door (see Figure 2.1.12). Its top drawer has very few tools in it, and is at a convenient height to be used as an ad-hoc work surface. The highest contamination levels associated with the accident were found on and about this toolbox. The contractor estimated that contamination corresponding to about 0.4 billion dpm (roughly a tenth of the original Lutetium Technetate sample) was removed from the toolbox during recovery. Loss of containment probably occurred when the Lu sample canister was opened at or around the toolbox on top of the FP-04 HIPPO door.

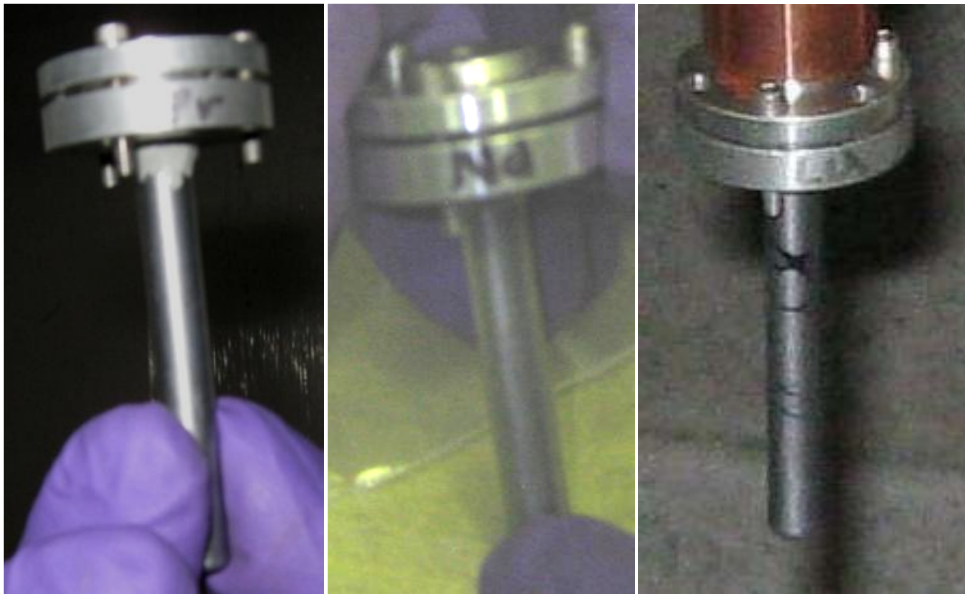
Figure 2.1.13. Comparison of Pr, Nd, and Lu/W Sample Canisters

The use of only three screws to secure the cap to the Lutetium Technetate sample canister, combined with the absence of markings indicating the presence of Technetium, powder, or other hazardous contents, may have contributed to the accident. The un-used screw holes could have provided additional defense in depth; the fact that they were not used could have reinforced the impression that the sample canister did not present a risk if opened.

A photographic comparison of the sample canister used for the Tungsten alignment process to the Praseodymium and Neodymium Technetate sample canisters is provided in Figure 2.1.13.

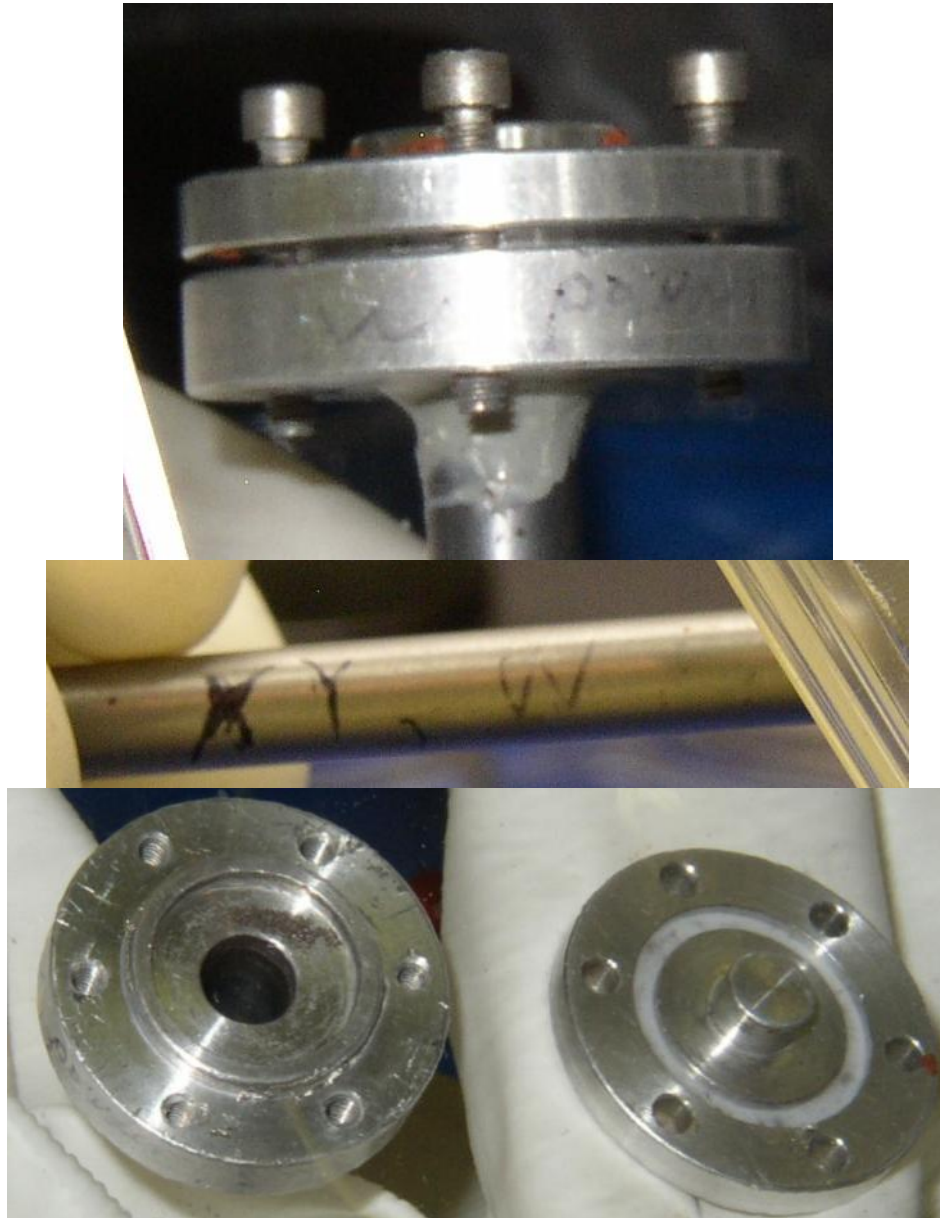
Figure 2.1.14. Lutetium Technetate Canister Re-used for W (Tungsten)

Close up photographs of the Tungsten sample canister, taken after it was removed following the suspension of operations, are presented in Figure 2.1.14. In this photograph, the screws had been loosened to permit radiation surveys of the canister contents, then the cap and screws were removed to permit further evaluation. Markings indicating Tungsten (W) powder are visible on the collar and a marking for Tungsten (W) is visible on the Vanadium tube.

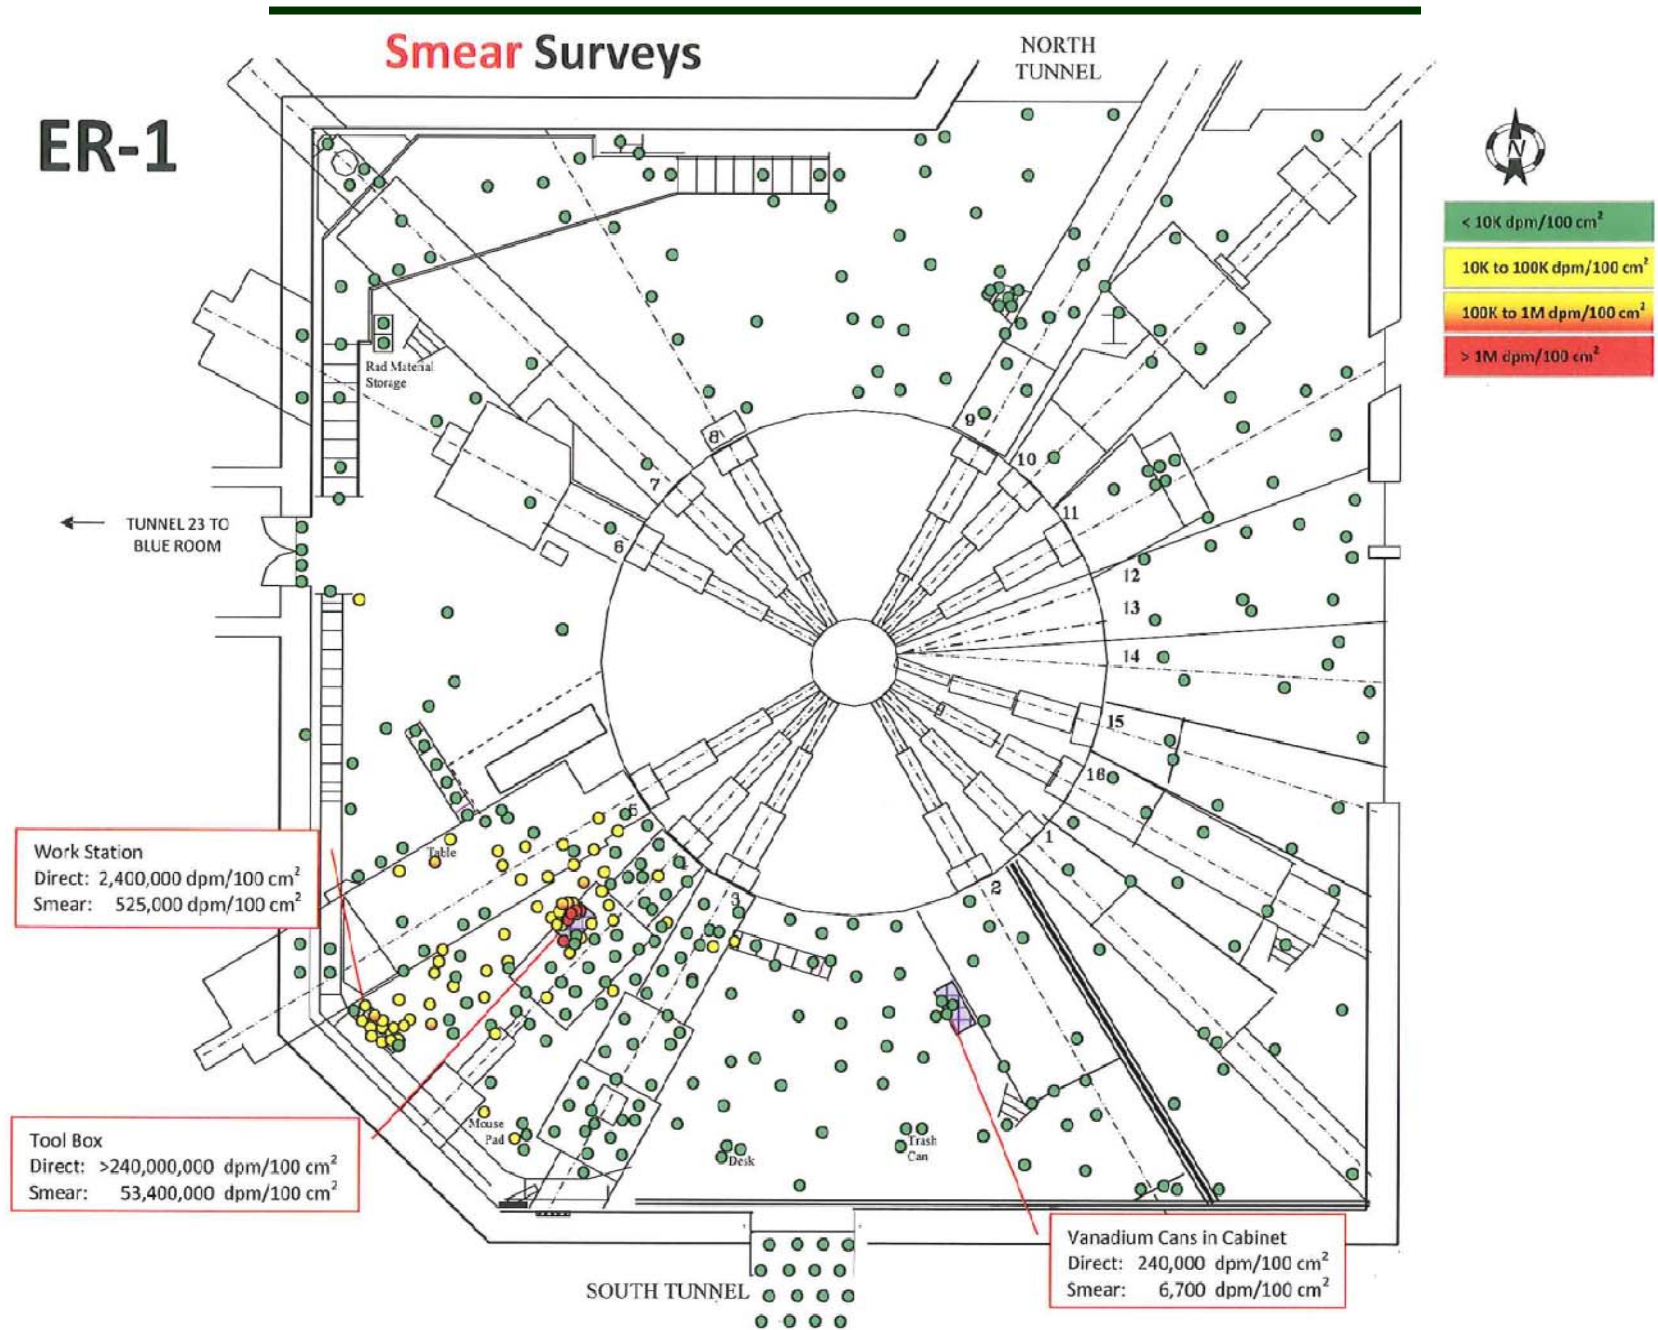
Figure 2.3.1. Results of Smear Surveys of ER-1

The second highest contamination levels were observed on the surface of the FP-04 sample desk (referred to as "Work Station" in the figures).

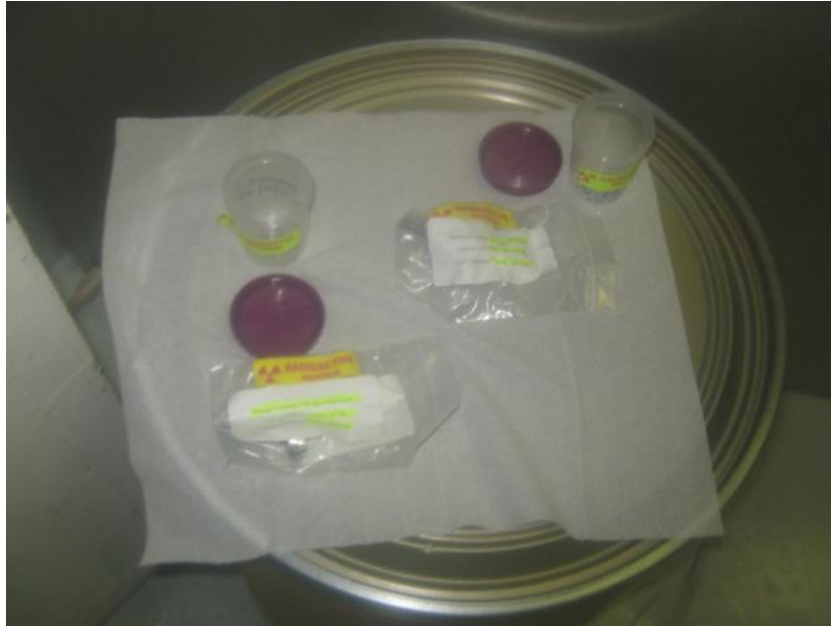
Figure 3.1. Packaging and Labeling used for Tc-99 Samples Shipped from UNLV

the presence of the radioactive material. Information included on the label includes the radiological trefoil indicating the presence of radioactive materials at a minimum. Shipping papers include isotopic information, the activity of the sample, and associated dose rates and contamination levels when applicable. Figure 3.1 provides a photograph of the shipping containers for the Praseodymium and Neodymium Technetate samples shipped from UNLV.

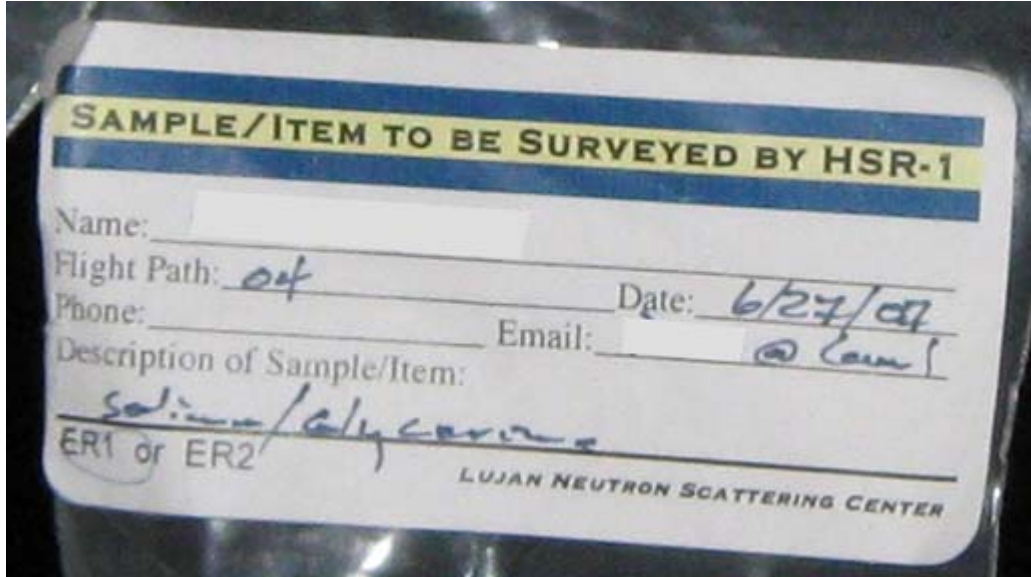
Figure 3.2. Sample to be Surveyed Label

Following irradiation, sample canisters containing samples that are to be released or returned to their user are placed in a plastic zip lock bag with a label on it indicating that a radiological survey is required. The bag is placed in a common RCT in-box pending survey of its contents. Figure 3.2. is a photograph of a typical label used to indicate an item is to be surveyed by an RCT (the name

of the user and their email address has been intentionally obscured for use in this figure). Note that the label does not include any indicator to communicate whether the contents are intrinsically radioactive. Such information would have to be entered into the sample description box to alert the RCT to the presence of internal, intrinsically radioactive materials.
