**Type A Accident
Investigation Board Report
July 11, 1996
Electrical Shock
at
Technical Area 53,
Building MPF-14
Los Alamos National Laboratory**

August 1996

Albuquerque Operations Office

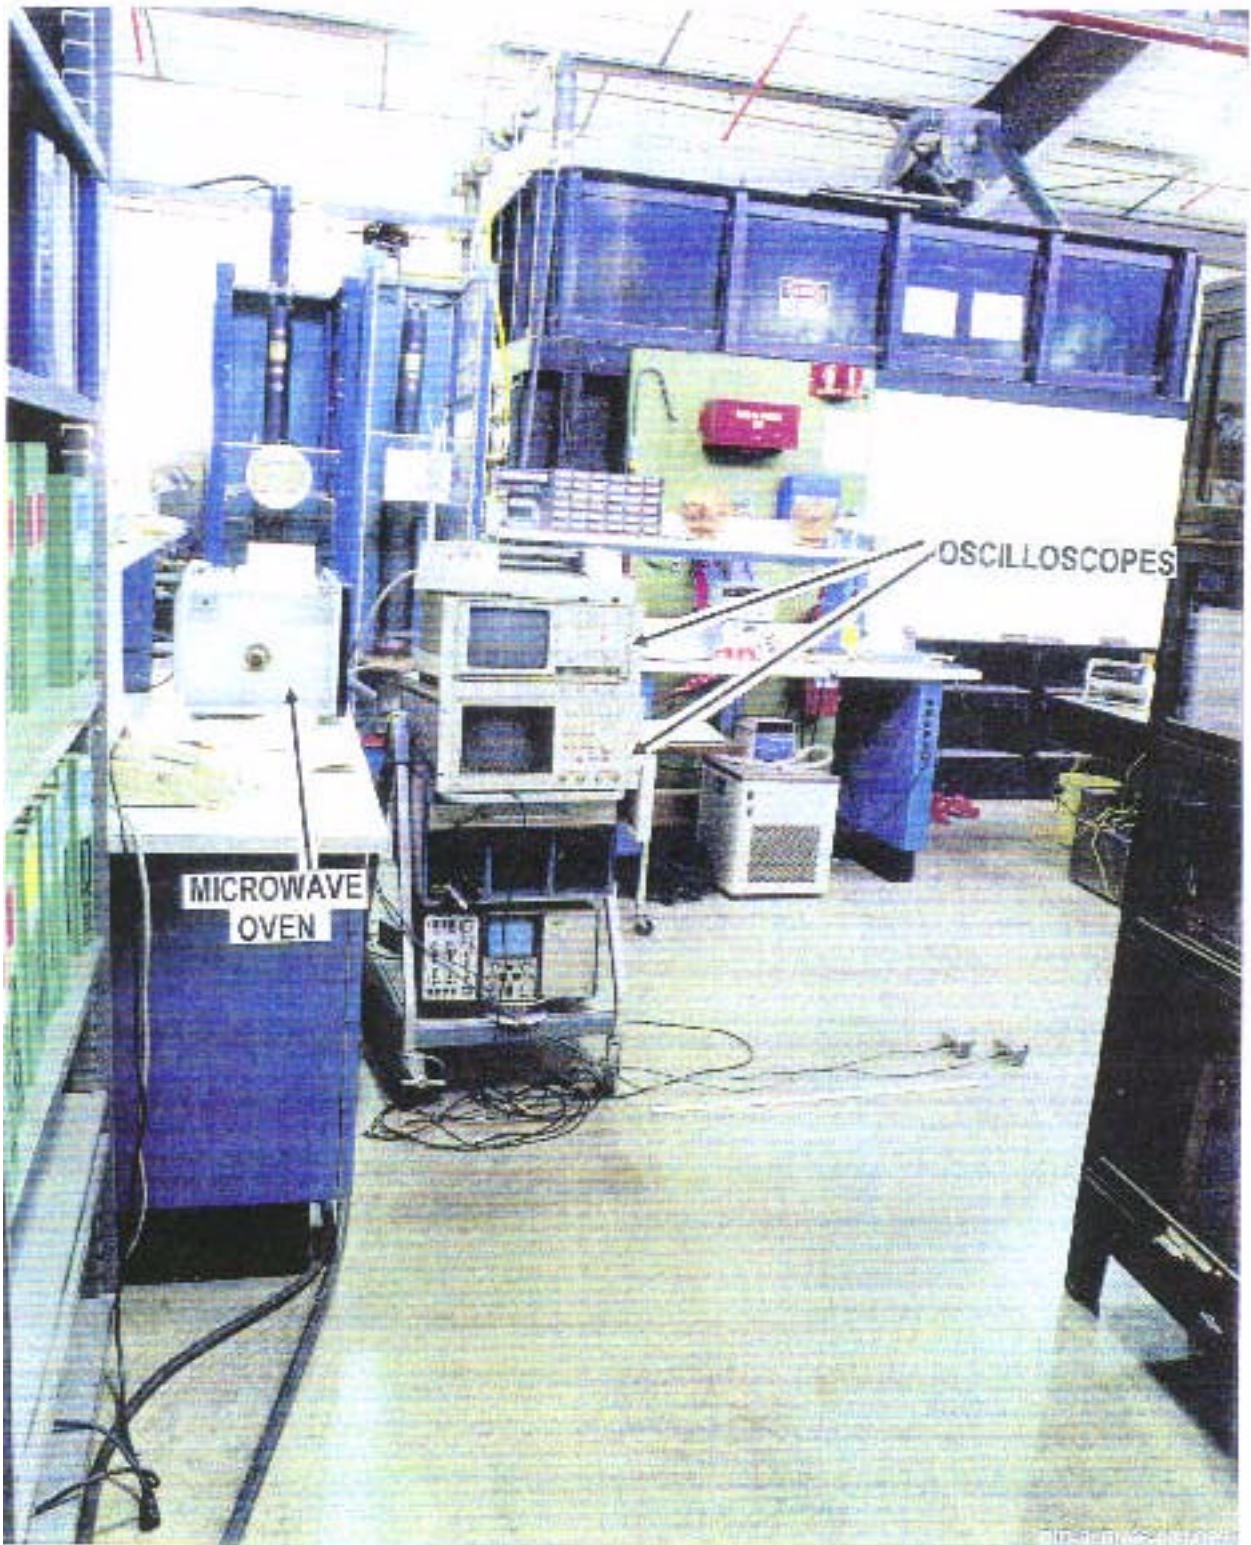
Figure 2-1

Figure 2-1: Overall View of the Accident Scene

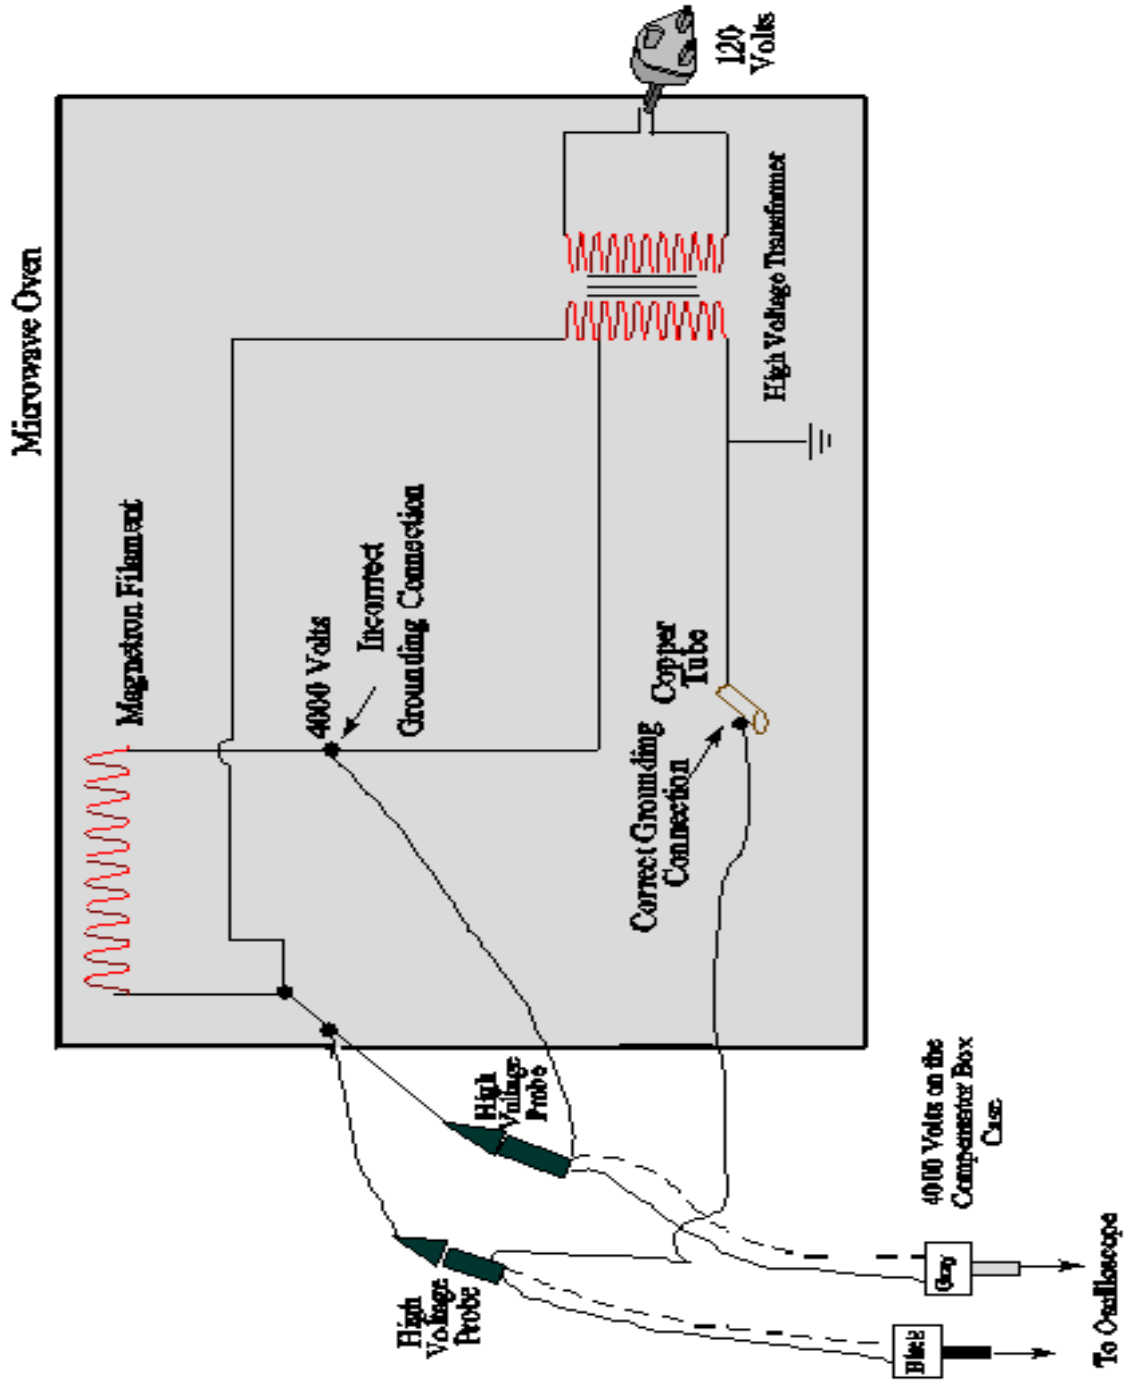
Figure 2-2

Figure 2-2: Test Set-Up at Time of Accident (Simplified)

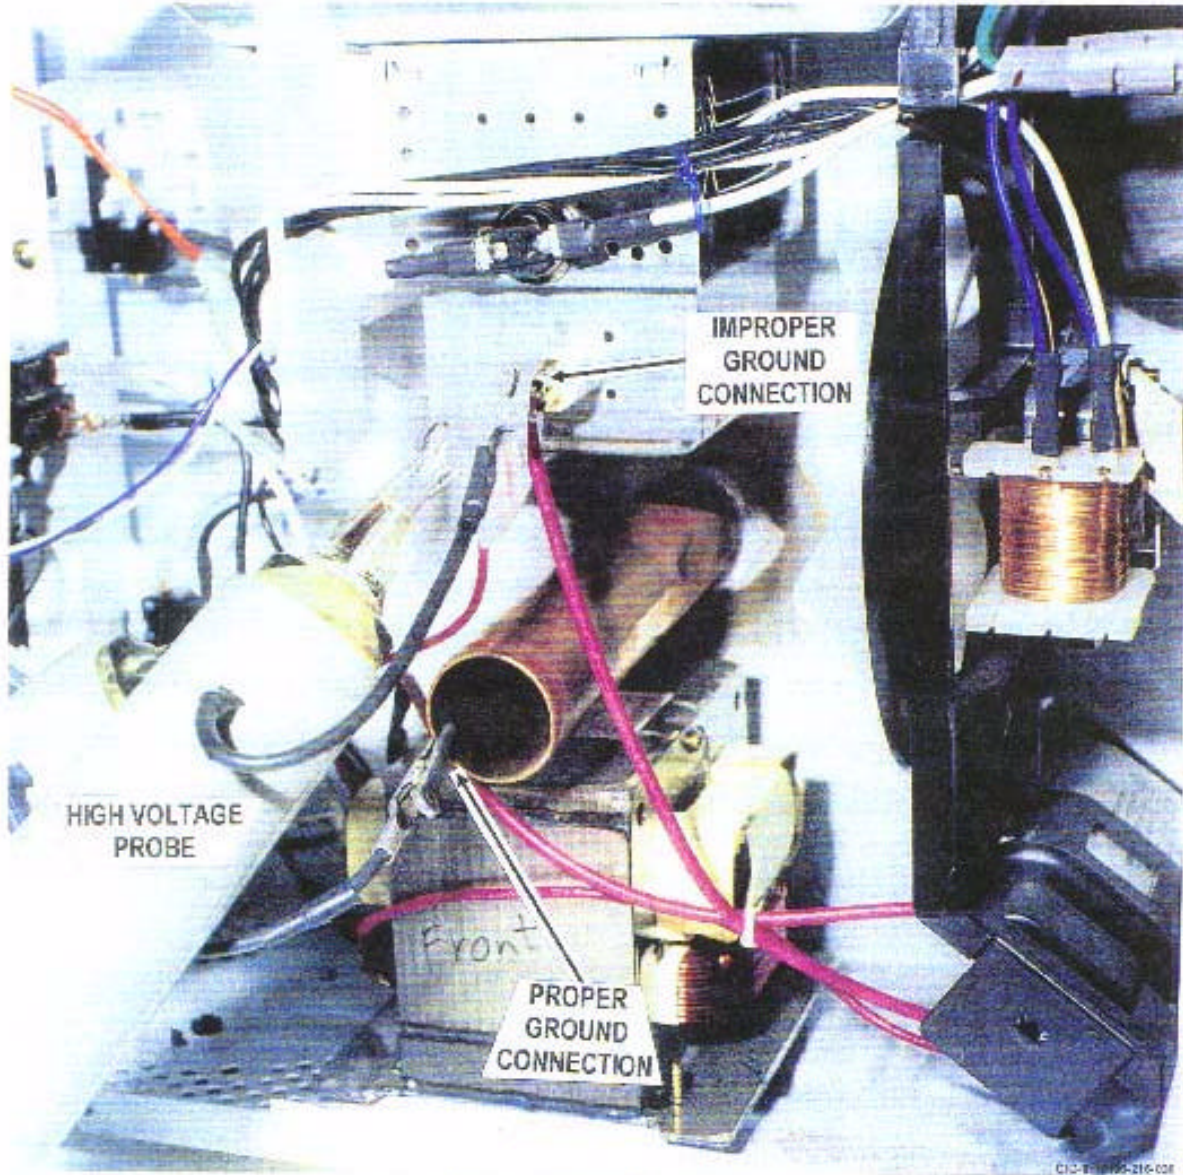
Investigation of the scene after the accident revealed that a grounding clip was incorrectly connected, creating an unexpected 4000 volt electrical shock hazard.

Figure 2-3: High Voltage Probe Connections to the Microwave Oven

Examination of the accident scene revealed that the gray high voltage probe was incorrectly connected to the microwave. The probe tip was connected to one side of the magnetron filament and the grounding wire was clipped to the other side of the filament. A statement from the student employee indicated that he might have been distracted due to being emotionally upset from a personal situation the day before. This distraction may have caused the student employee to improperly connect the gray high voltage probe on the day of the accident. The improper connection resulted in the grounding wire, the compensator box case, and the BNC connector shell and center pin being at approximately 4000 volts. The black probe tip was connected to the gray probe tip and the black grounding wire was properly connected to a microwave oven ground. Figure 2-2 shows a simplified representation of the test configuration at the time of the accident. Figure 2-3 is a photograph of the high voltage probe connections to the microwave oven.

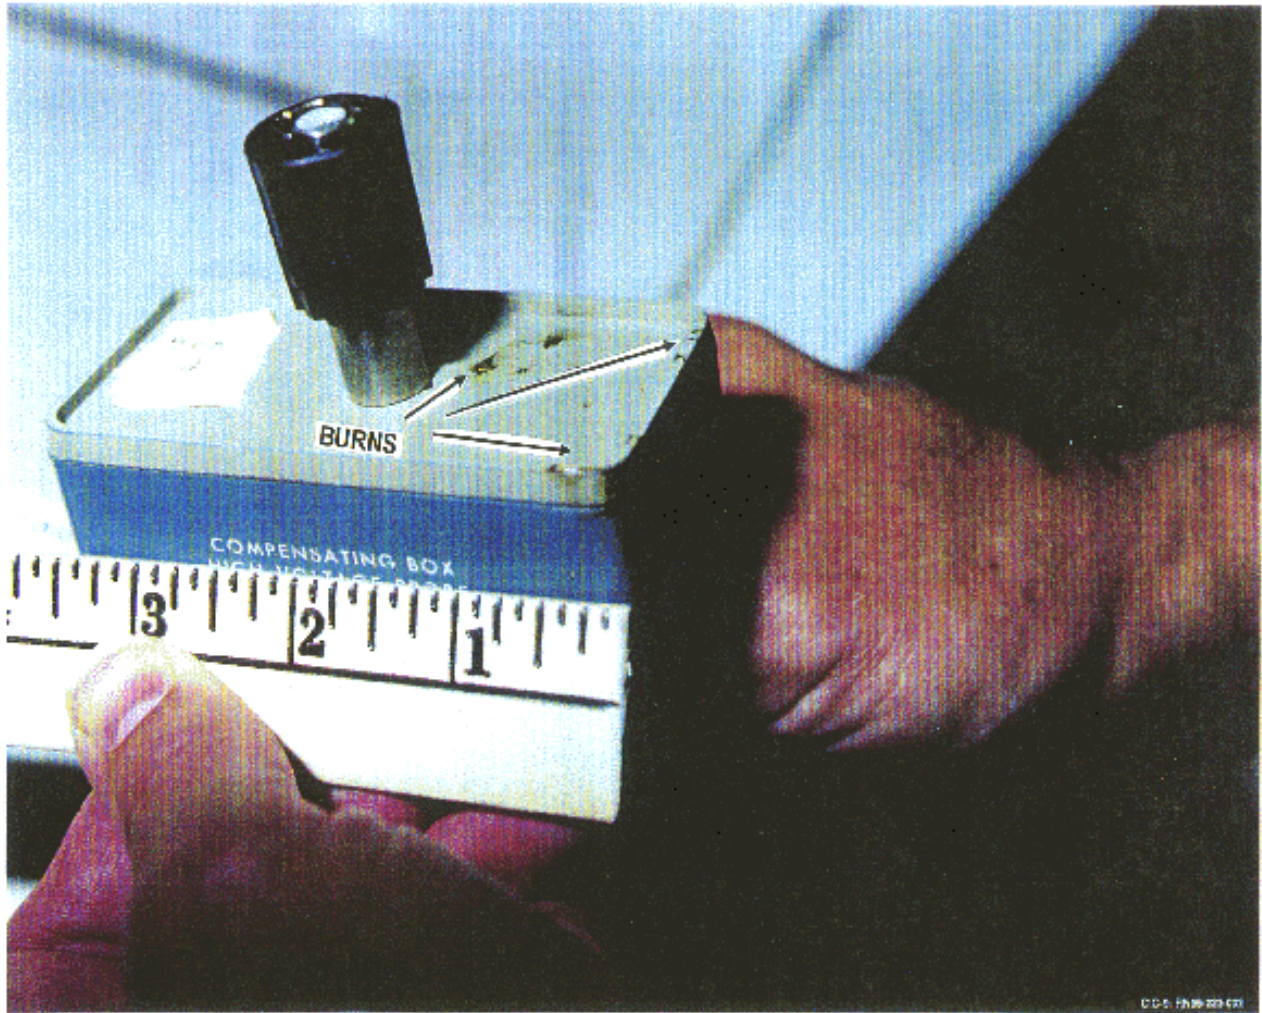
Figure 2-5

Fifteen burn marks were present on the outer case of the black compensator box, including the front face. (See Figure 2-5) Five small burn or scratch marks were present near one corner of the gray compensator box. (See Figure 2-6) Three small burn marks can be seen on the right side

Figure 2-5: Black Compensator Box Showing Burn Marks

the BNC connectors. At this point, it is believed that the student employee attempted to remove the black compensator box with his right hand. From the position of the burn marks on the front face of the black compensator box, it appears that he may have inserted the first two fingers of his right hand between the box and the oscilloscope face to pull the box off. The burn marks on the black compensator box are consistent with the burns to his right hand that would probably have been inflicted if he performed this action.

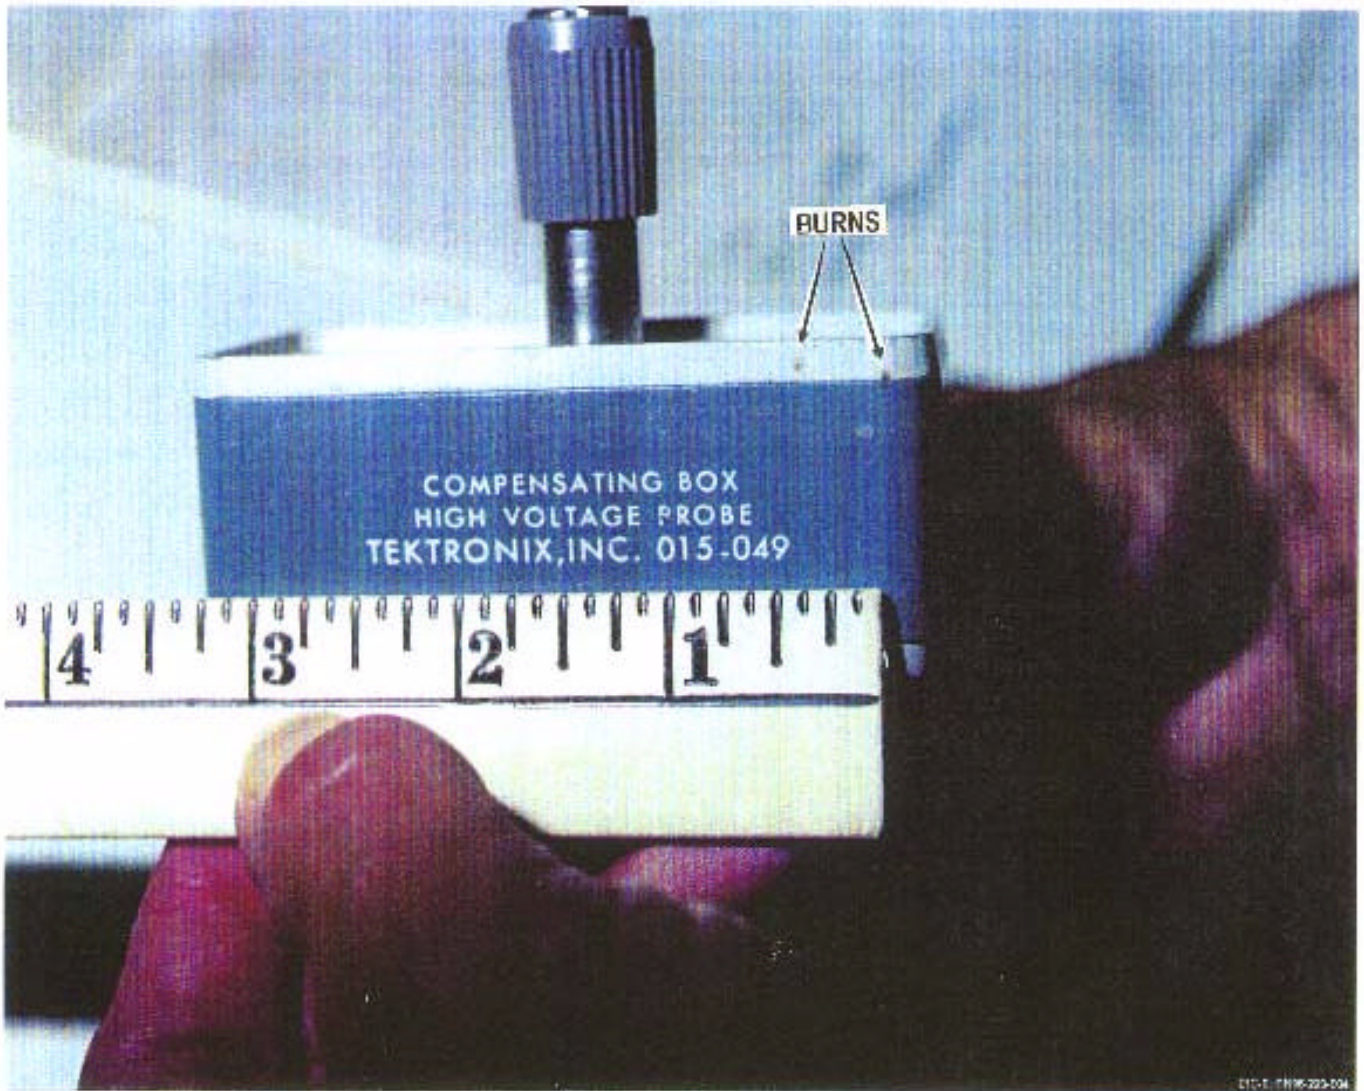
Figure 2-6

Figure 2-6: Gray Compensator Box Showing Burn Marks

The small burns on the gray compensator box are consistent with the rectangular pattern of the small burns on the student employee's left hand, indicating that the student employee disconnected the gray compensator box with his left hand. No shock would occur at this time unless he were grounded at some other point. If he had been grounded at the time he removed the gray compensator box, an arc would be expected between the compensator box and oscilloscope BNC connectors, resulting in burn marks on the connectors. No such marks were observed on any of

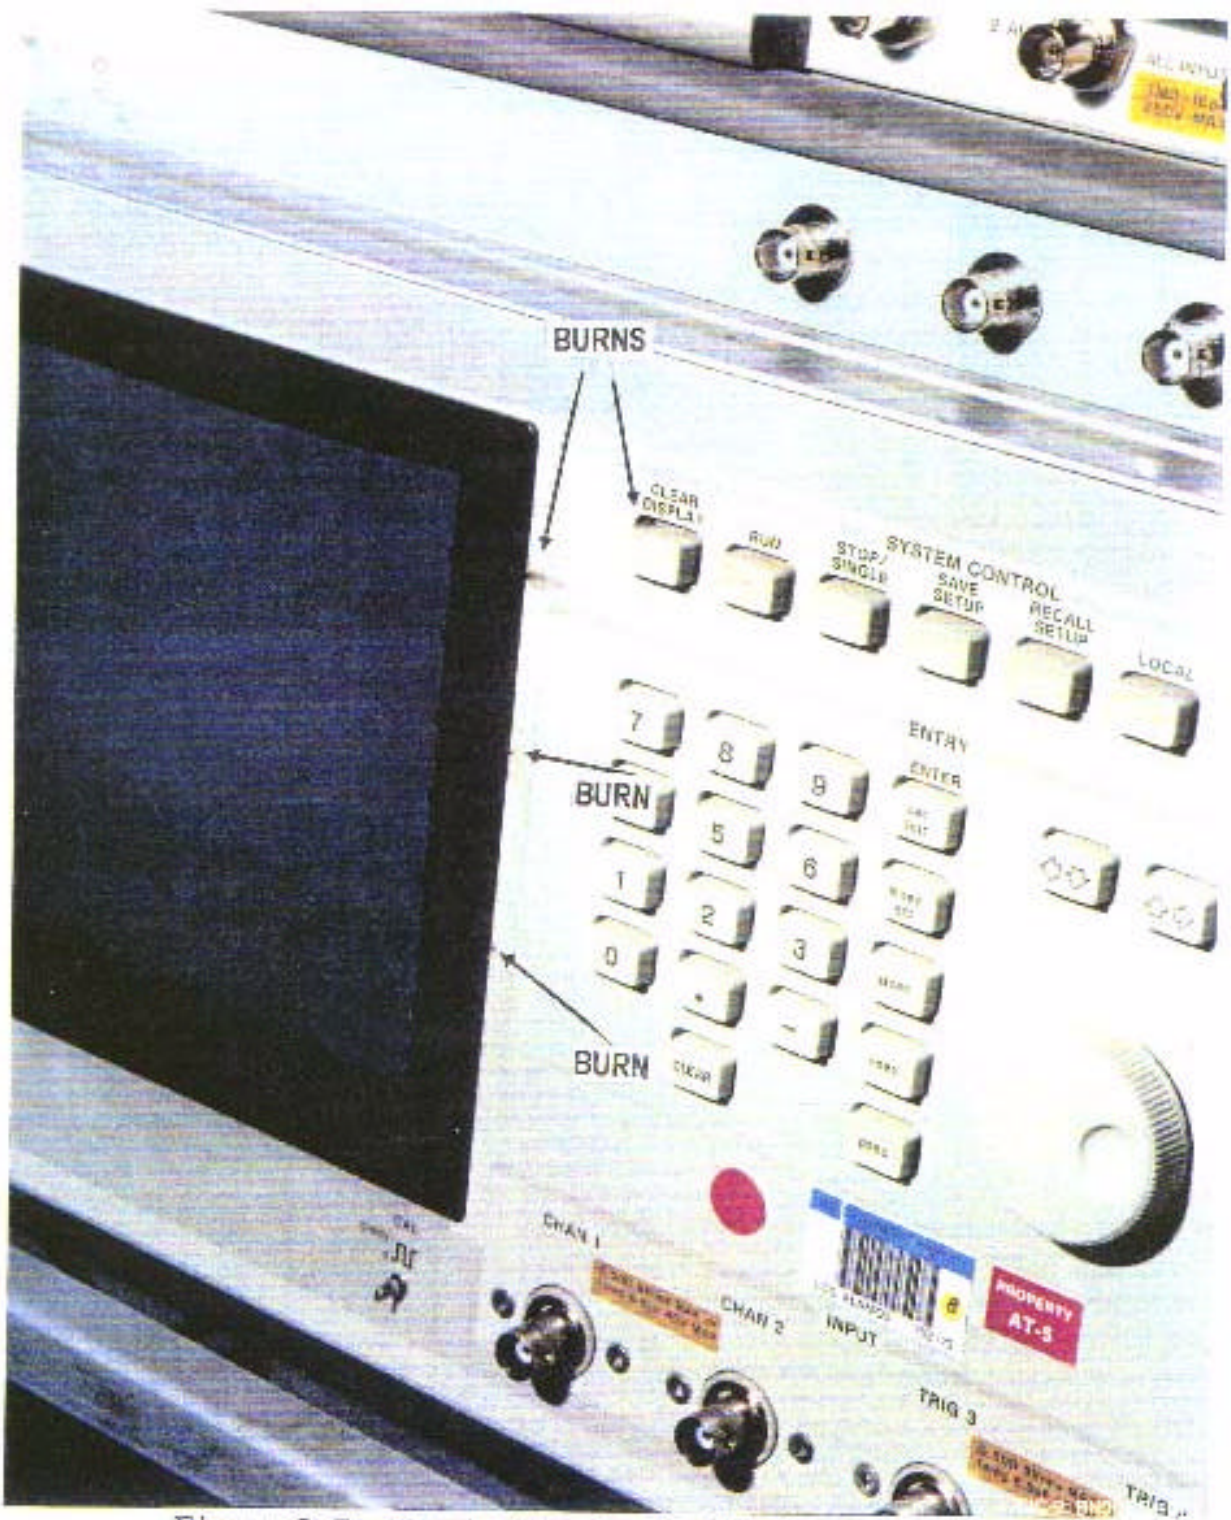
Figure 2-7

of the screen bezel of the Hewlett Packard 54111D oscilloscope and one small burn mark may be seen near the “Clear Display” button. (See Figure 2-7)

Figure 2-7: Hewlett Packard 54111D Oscilloscope Showing Burn Marks
