**Type A Accident
Investigation Board Report
on the February 13, 1997,
Welding/Cutting Fatality
at the
K-33 Building, K-25 Site
Oak Ridge, Tennessee**

**Type A Accident
Investigation Board Report
of the February 13, 1997
Welding/Cutting Fatality
at the
K-33 Building, K-25 Site
Oak Ridge, Tennessee**

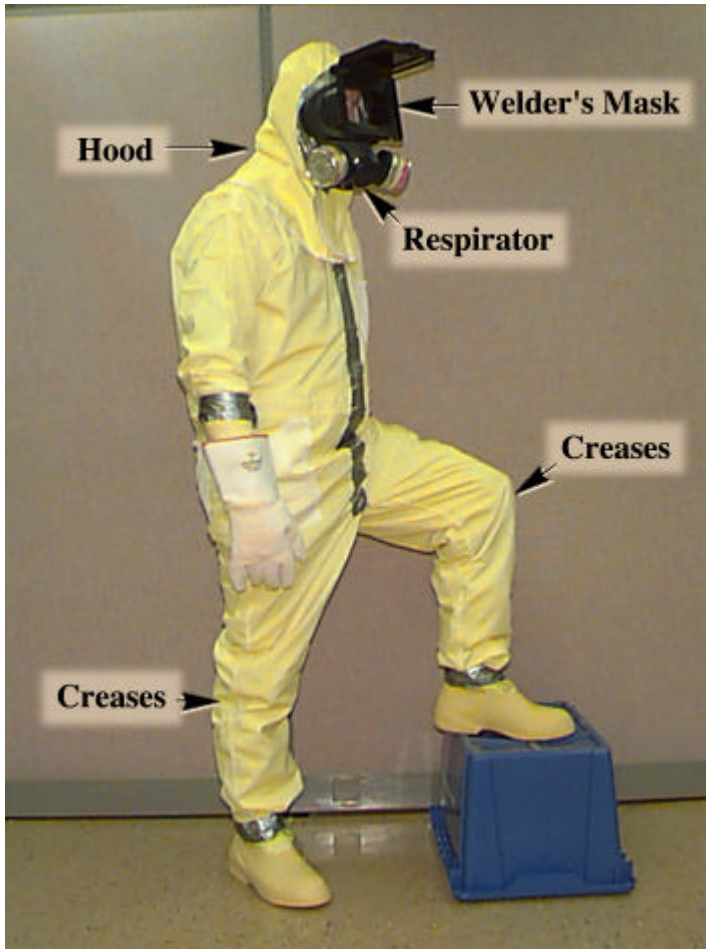
Exhibit 2-1. Similarly Outfitted Welder

At the time of the accident, the Welder was wearing one set of underwear, one set of 100 percent cotton blue general-purpose coveralls, two sets of 100 percent cotton yellow anti-contamination coveralls, one pair of cotton liner gloves, one pair

At the time of the accident, the Welder was wearing three sets of coveralls, three pairs of gloves, four covers over safety shoes, a skull cap and hood, a personal air monitor, and a full-face respirator with an attached welding

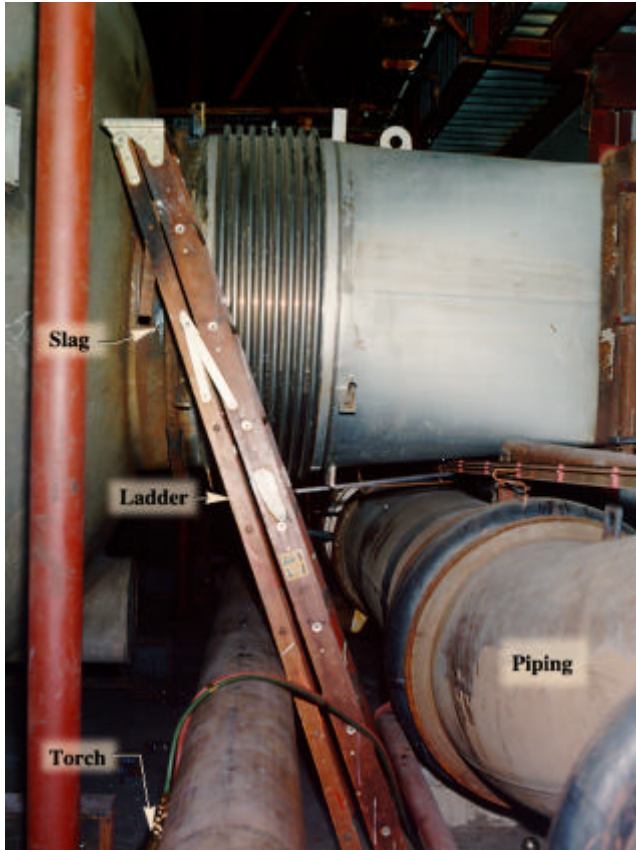
Exhibit 2-2. East End of Converter 4

The Welder was using a cutting torch to remove one of the six remaining process converters and, at the time of the accident, was working on a ladder at the east end of Converter 4 (see Exhibit 2-2).

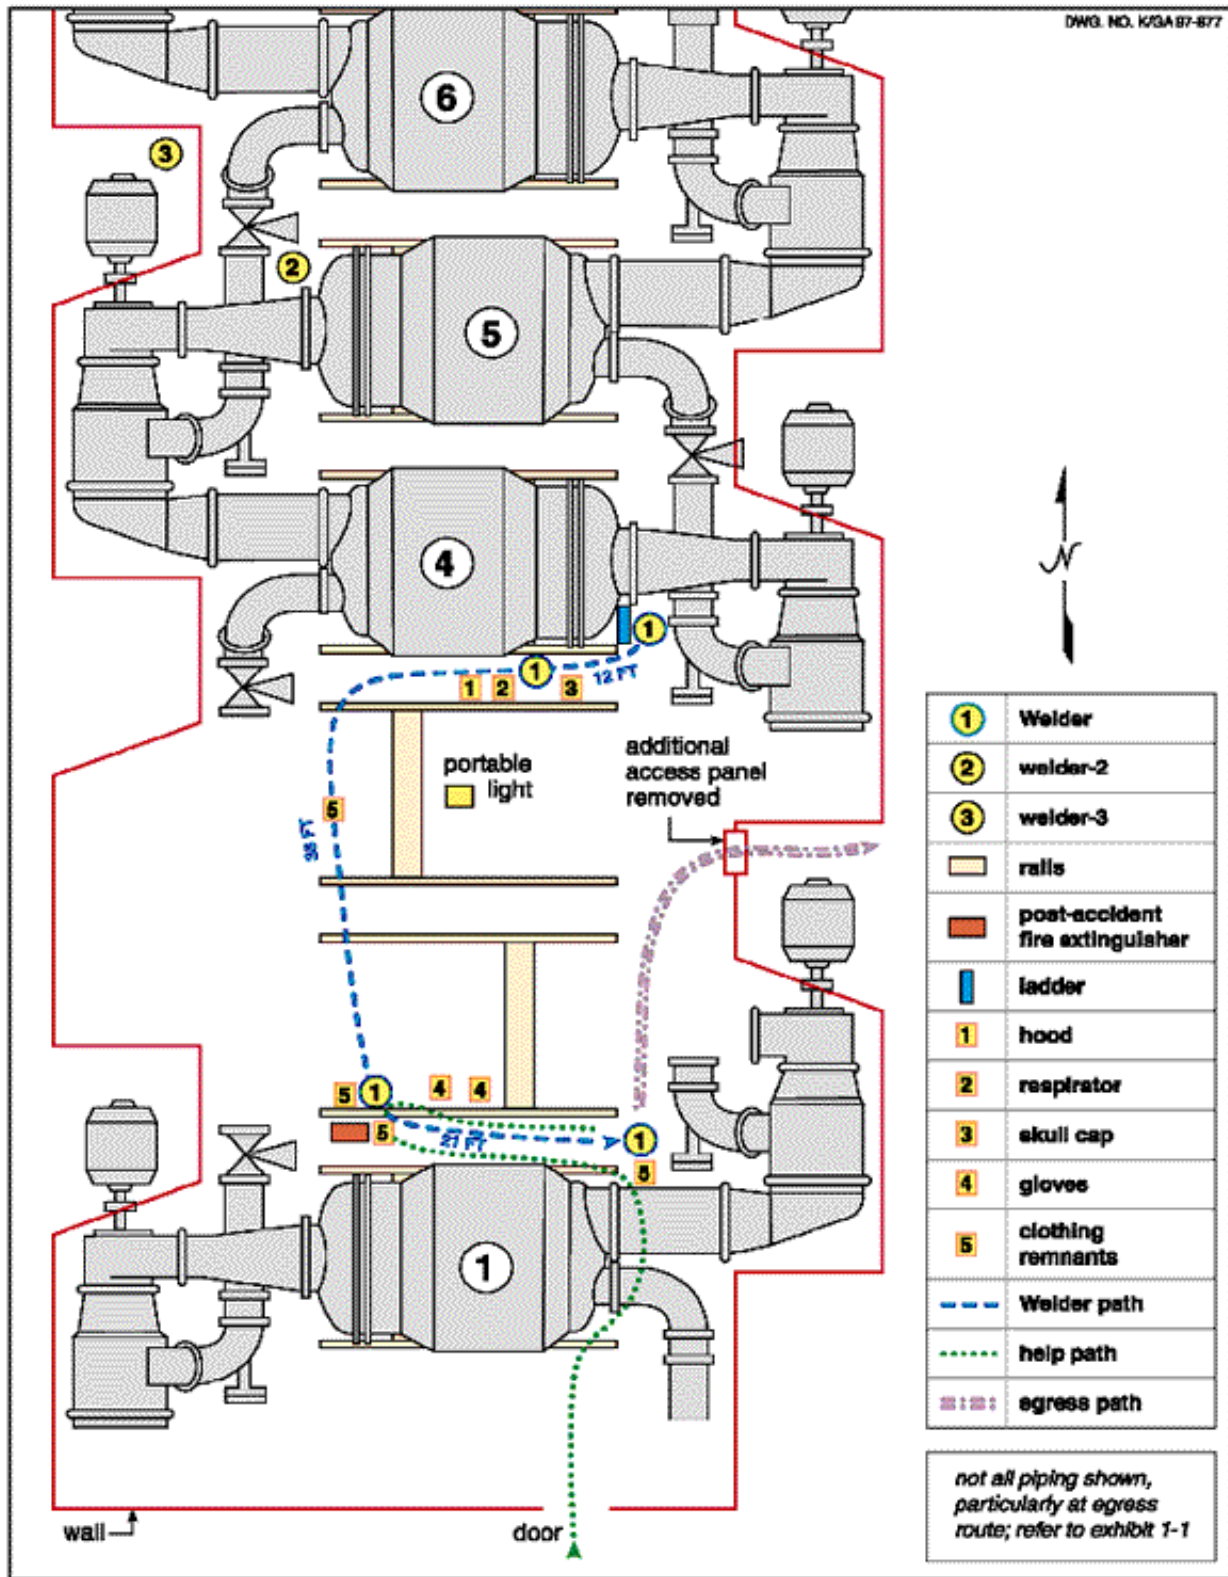
Figure 2-1. The Welder's Location and Movement Within Cell No. 7

eyewitnesses. The Board has reconstructed the most probable sequence of events (through extinguishing the flames by a maintenance mechanic), using the physical evidence, interviews, and results of burn tests. A schematic of the inside of Cell 7, the relative location of personnel, and the path of the Welder after he became engulfed in flames is shown in Figure 2-1. At approximately 11:09 a.m., a piece of hot slag or a spark ignited the Welder's anti-contamination coveralls at or somewhat below his left knee. At approximately 11:10 a.m., the Welder felt heat and noticed that the clothing on his left leg was on fire. The Welder attempted to put out the flames while he was still on the ladder. He came down the ladder, moved to the south side of Converter 4, and screamed for help while still trying to put out the flames. He removed his mask and respirator and screamed for help again. Because the respirator muffled the first scream, only the second scream was recognized as a distress call by one of the four maintenance mechanics outside Cell 7.

Two maintenance mechanics requested permission from a radiological control technician to enter Cell 7. One of them turned off the oxygen and acetylene cylinders of the Welder's torch, located outside Cell 7, while the other entered Cell 7, crawled under the piping, and saw the Welder, who was now standing on the cell floor northwest of Converter 1, totally engulfed in flames. While attempting to help the Welder remove his burning clothes, the maintenance mechanic's gloves caught on fire, so he stepped back and extinguished his own gloves by rubbing them together. At this point, the Welder began to run in a path that took him to the northeast side of Converter 1, where he fell to his knees on the floor of the cell (see Figure 2-1). The maintenance mechanic picked up a dry-chemical fire extinguisher and extinguished the flames at approximately 11:12 a.m.

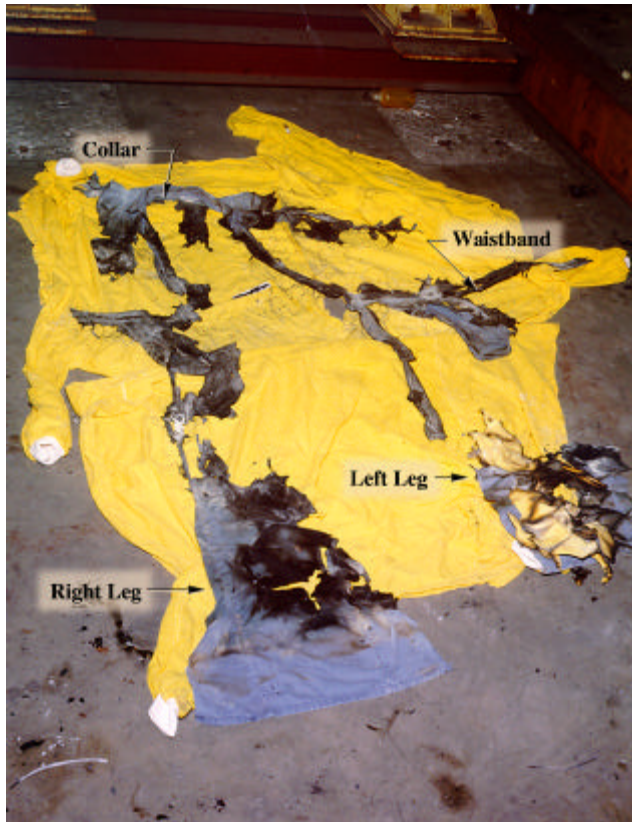
Results of the burn tests revealed that very high temperatures were attained quickly on the outer layers of the anti-contamination clothing, while the temperature at the skin level remained nearly the

The outer anti-contamination coveralls do not provide protection from fire.

same. The multiple layers of clothing effectively insulated the Welder from the heat and seriously impaired early detection of the fire. The burn tests also indicated that the anti-contamination and general-purpose coveralls worn by the Welder and other K-25 LMES welders did not, by themselves, provide any fire protection as personal protective equipment for the hazards of cutting, welding, and other hotwork. The flammability characteristics of the anti-contamination clothing made this clothing inappropriate for the cutting and welding operations being conducted at the time of the accident.
