# **Type B Accident Investigation Board Report**

**May 8, 2004, Exothermic Metal Reaction Event  
During Sodium Transfer Activities  
East Tennessee Technology Park  
Oak Ridge, Tennessee**

**June 2004**

**Oak Ridge Operations Office  
U.S. Department of Energy**

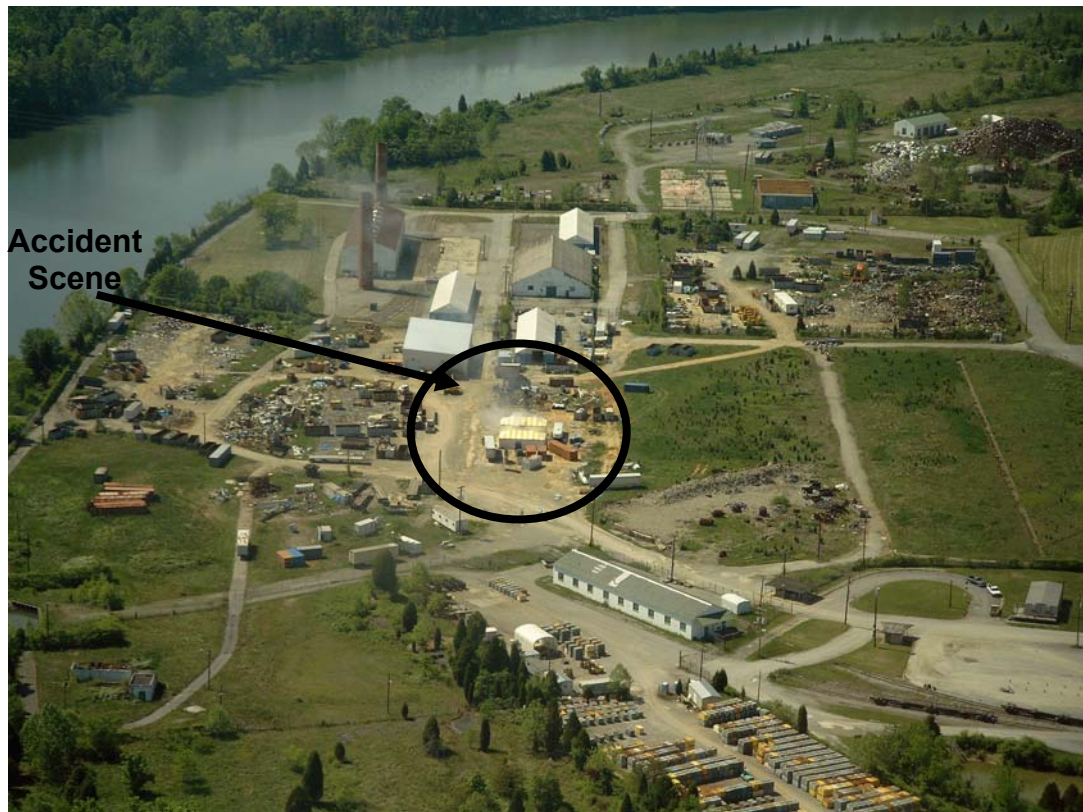
Figure 2-1. Overview of the Accident Scene

Commodore personnel were using the hot box to heat a shield consisting of sodium metal encased in an aluminum shell on May 8, 2004, on the property that Toxco subleased from CROET located at ETTP in Oak Ridge, Tennessee. The shield was being heated to liquefy the sodium for transfer to DOT-approved containers for shipment. The heating process began on May 5, 2004, in a hot box constructed for this purpose and continued through the morning of May 8. At approximately 10:00 am on May 8, as the sodium was being heated, Commodore personnel standing nearby heard a “pop” and a “whoosh” sound. At approximately 11:00 am, this was followed by additional noise and visual observance of material leaking from the hot box near the bottom of the side entrance door. The Commodore operators attempted to build a dam with Class D extinguishing agent to keep the flow of sodium from reaching the standing rainwater on the ground, but their efforts were unsuccessful. The sodium subsequently contacted standing rainwater, and an exothermic reaction occurred. At 11:24 am, Toxco personnel contacted the ETTP Park Shift Superintendent (PSS) and reported that they had a sodium fire at their facility. The ETTP Fire Department, Security, and Health Physics personnel were dispatched to the scene. Figure 2-1 provides an overview of the accident scene.

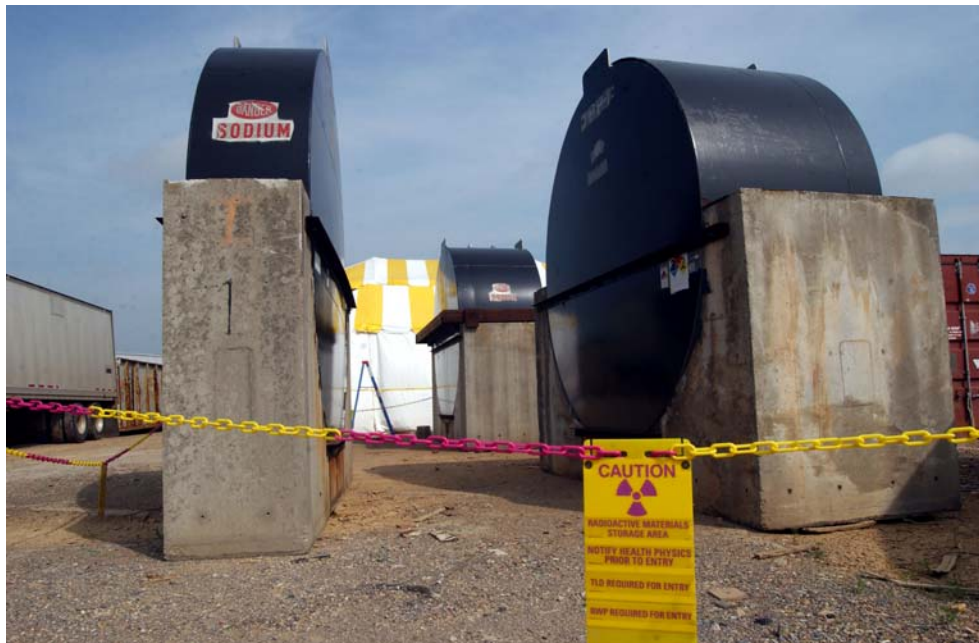
**Figure 2-2. Large Sodium Shields**

long and 2.5 or 5.0 feet thick. The volume of the shield that was being processed (a 2.5-foot-thick shield) is 237 cubic feet, and it contained approximately 14,000 pounds of sodium when the heat transfer process began. The combined shield and cradle were covered with a matching concrete cap that was removed before transport to ETTP and subsequent heating.

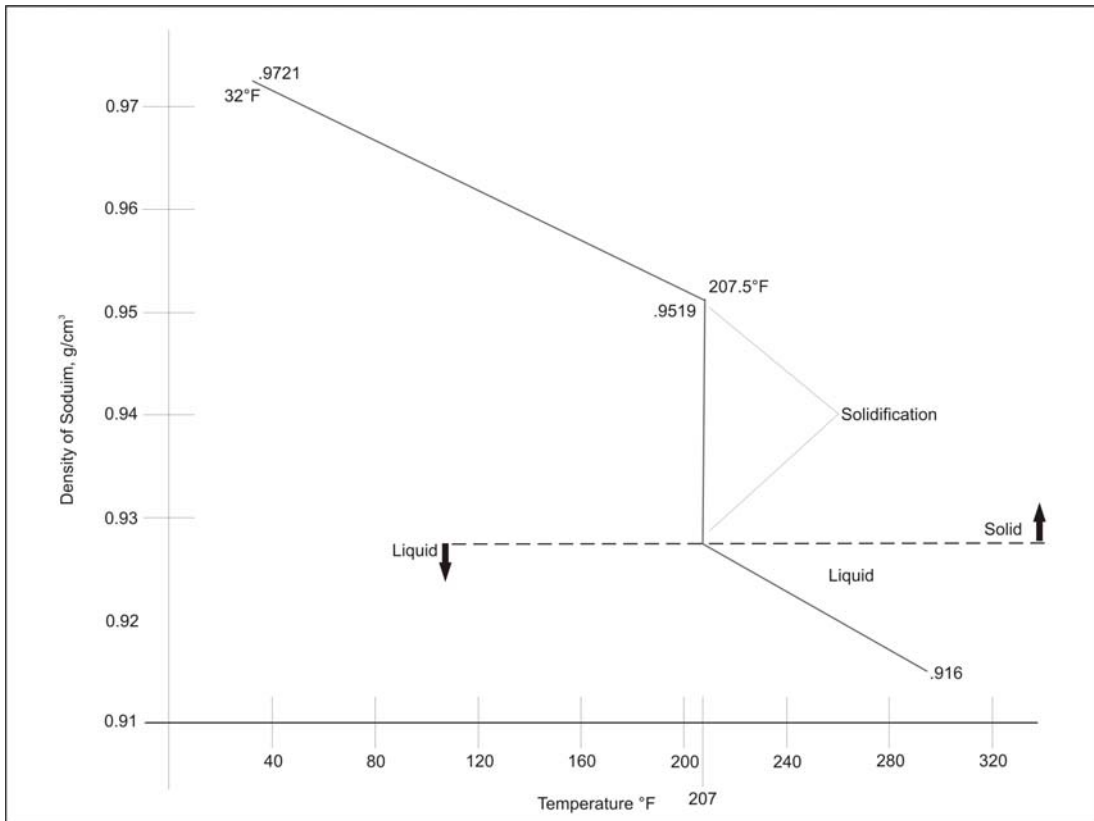
**Figure 2-3. Sodium Density as a Function of Temperature**

The volume change when molten sodium solidifies is 2.43% of the solid volume. Heating the sodium from room temperature to 225°F produces a total volume expansion of 4.39% (see Figure 2-3). With the shield filled with approximately one drum of sodium in excess of the capacity of the shield to hold liquid sodium, pressure was created as the solid sodium was heated and melted. The coefficient of thermal expansion of sodium metal is  $39.4 \times 10^{-6}$  in/in/°F as compared to Type 5083 aluminum alloy, which is  $13.2 \times 10^{-6}$  in/in/°F. The difference in expansion in heating sodium to its melting temperature (208°F) results in a pressure increase. The Board had a structural analysis performed which indicates that the concrete support cradle and iron supports bolted to the face of the concrete cradle restrained the aluminum shield, causing the probable failure point to be the interface between the shield and the concrete. A stress analysis representation of the restrained shield in the concrete cradle is shown in Figure 2-4 on the following page.

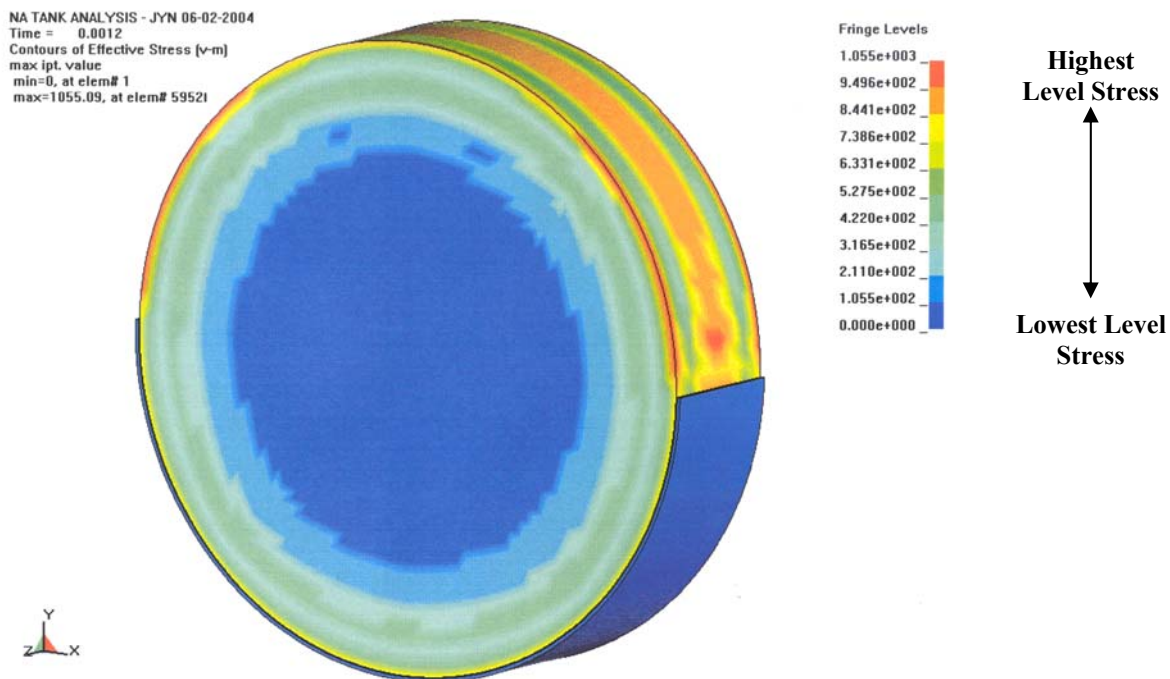
**Figure 2-4. Stress Model of the Failed Sodium Shield**

The unrestrained shield should have contained the sodium, although it would have bulged significantly. The void space in the top of the shield was not adequate to accommodate the

expansion of the melting sodium due to the extra drum of sodium that was added during filling.

*The Board concludes that the rupture of the sodium shield upon heating was caused by the combination of overfilling in 1971 and the stress induced by the concrete cradle.*

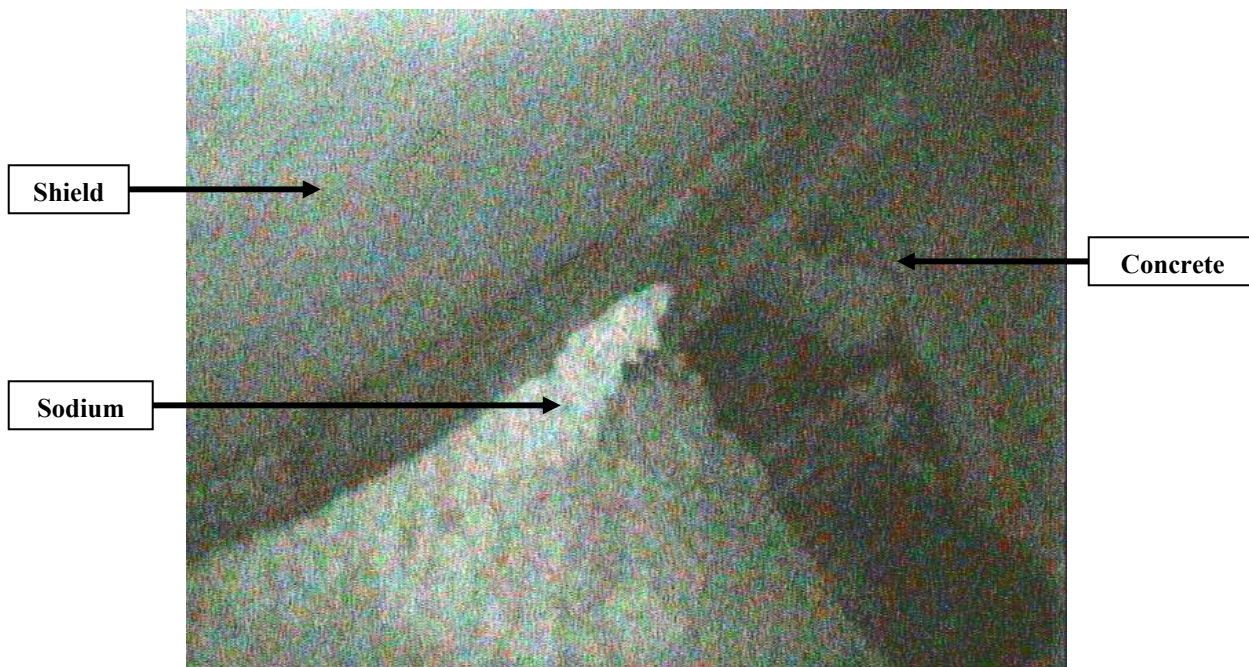
**Figure 2-5. Borescope Photograph of the Failed Shield Area**

Commodore made an initial inspection of the interior of the hot box on May 20, 2004, using a borescope inserted through an existing electrical conduit port in the side of the hot box. Seven inspections were made, with three inspections on each side parallel with the sodium shield faces and one inspection in the end opposite the door. The videotape of the inspections shows sodium on the floor of the hot box, primarily on the east side. The pattern of the flow indicates that the breach probably occurred in the 3 to 4 o'clock position of the

east side of the shield in contact with the concrete support cradle. Figure 2-5 on the following page is a borescope photograph of the probable shield failure area. The quantity of sodium that leaked from the shield was estimated to be about half of the 14,000 pounds loaded into the shield. The exact nature and location of the shield failure can only be determined after recovery has been completed and the vessel can be analyzed.

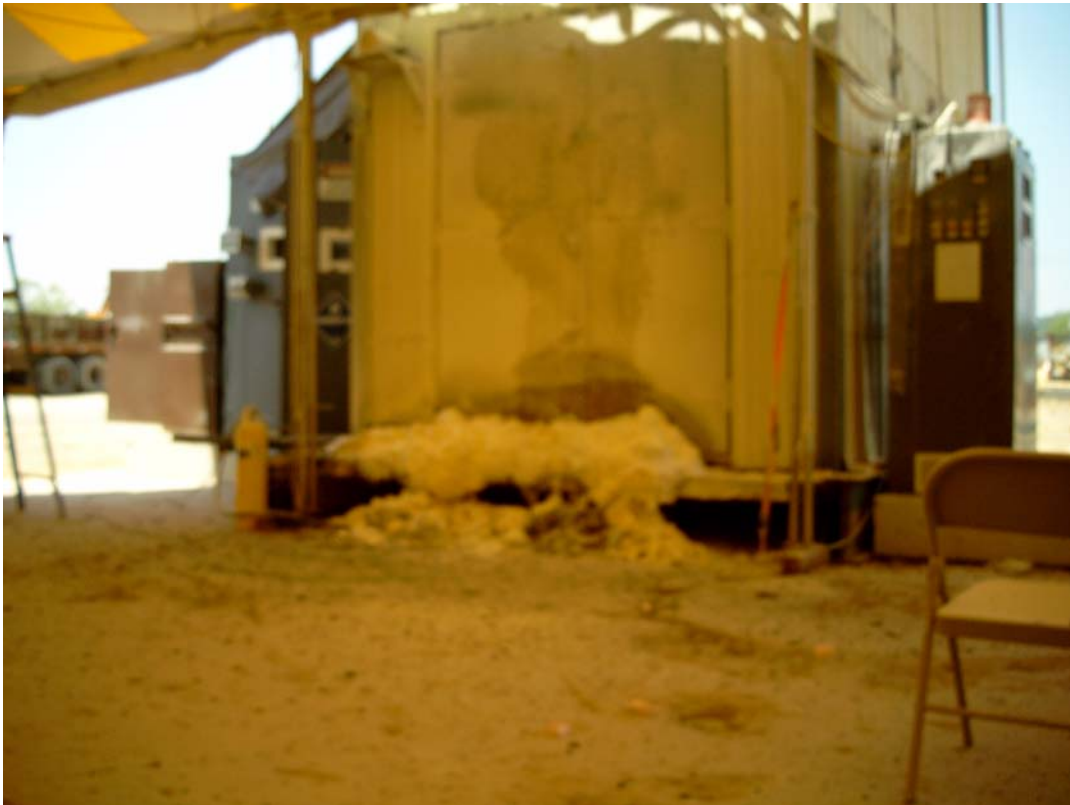
**Figure 2-6. Remnants of the Exothermic Sodium Reaction**

The accident was initiated when liquid sodium seeped under the center of the door. This occurred an estimated hour after the failure of the shield. The door gasket had contained a one-foot-deep pool of liquid sodium before failing. Power to the heaters had been turned off, and the secondary containment appeared to be working properly. Styrofoam insulation boards had been placed around the bottom exterior of the hot box to reduce the increased heat loss created after the hot box was elevated. The Styrofoam in the front of the hot box door was found to be smoldering, which was the first indication that something was amiss. A small flow of molten sodium, approximately one foot wide, flowed slowly under the door and onto the 12-inch-wide steel ledge (the scale) in front of the doors. The operators implemented emergency procedures and attempted to stop the flow of sodium by building a dam using the Class D extinguishing agent. They were aware of the potential for ignition if the sodium flowed off the ledge and onto the damp ground. There was also water on the ledge of the scale that would react with the sodium. The Commodore operators were unable to contain the flow or the subsequent exothermic reaction, so they evacuated the area, and Toxco personnel notified the PSS.

The last smoke from the exothermic reaction was noted at 2:00 am on the morning of the next day. The EOC was disbanded at 1:05 pm on May 9, 2004. During the initial recovery efforts, mineral oil was sprayed on the sodium residue, which promptly ignited and burned. The second recovery effort involved using liquid nitrogen to cool the hot box door and freeze any sodium still reacting.

*The Board concludes that the failure of the secondary containment resulted in the hot box leaking sodium. The nature of this failure cannot be ascertained until the hot box door is opened when recovery operations are resumed.*

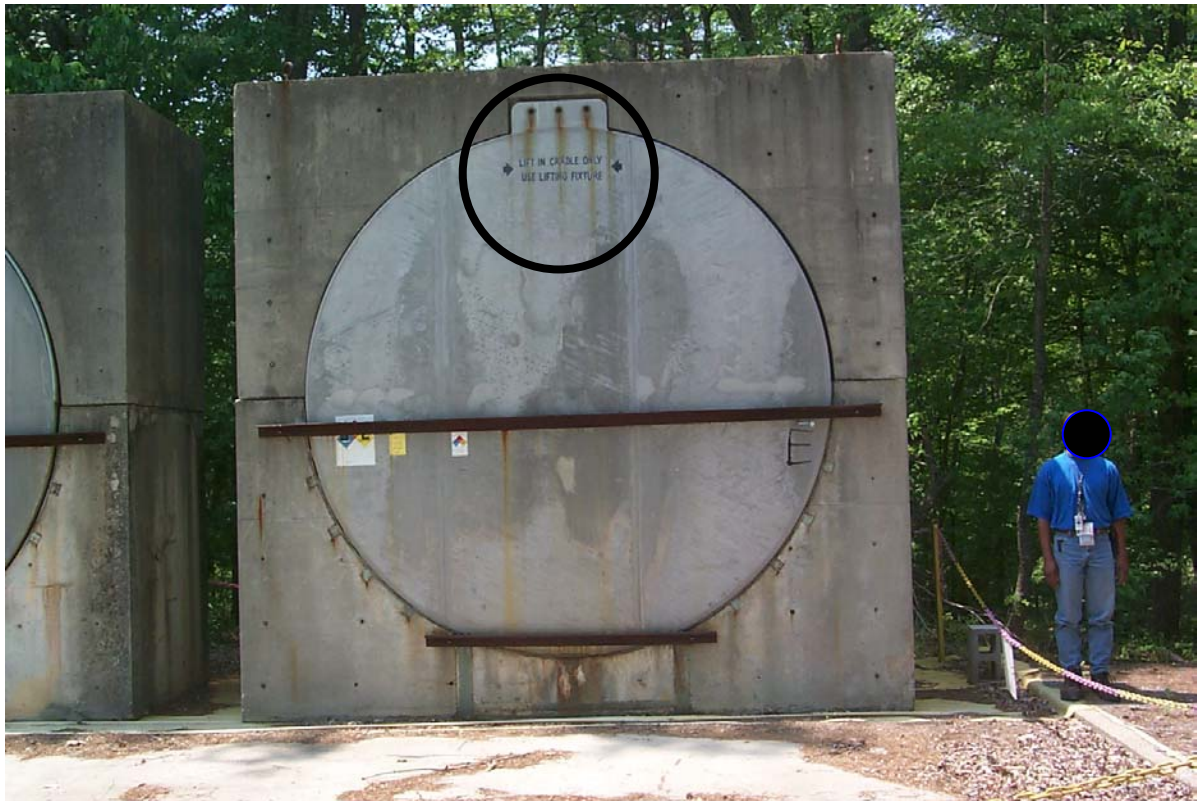
**Figure 3-1. Warning Stenciled on the Large Shields**

The failure to provide important technical information about the shields contributed to an incomplete hazard identification and analysis process. Toxco and Commodore developed procedures and systems to control the sodium hazards, and Toxco had existing radiological control procedures in place to control the shields until they could be determined to be nonradioactive through sampling and analysis. However, since the overpressurization hazard created while heating the shields was not recognized, no controls were identified to address this hazard. The hazard associated with overpressurization was further exacerbated by the presence of the concrete saddle. The large shields are stenciled with the warning “LIFT IN CRADLE ONLY---USE LIFTING FIXTURE” (see Figure 3-1).

Toxco and Commodore adhered to this warning while rigging the shields into the hot box for heating. The concrete saddle was left in the hot box under the shield during heating to stabilize the shield. Commodore and Applied Reactor Technology personnel, unaware that an overpressurization condition would exist in the shield during heating, did not recognize that the saddle would exert a restraining force on the shield as it expanded due to the expansion of the melting sodium, thus causing a stress concentration to occur. A stress analysis of the restrained shield (see Section 2.3) indicates that the concrete saddle caused stress concentrations at the aluminum/concrete interface point that likely led to the failure of the shield.
