Final Report

July 1997

**Type B Accident
Investigation Board Report
of the Plutonium Intake,
Between August 4, 1996–February 10, 1997,
By a Crane Operator
At the Savannah River Site F-Canyon**

Savannah River Operations Office

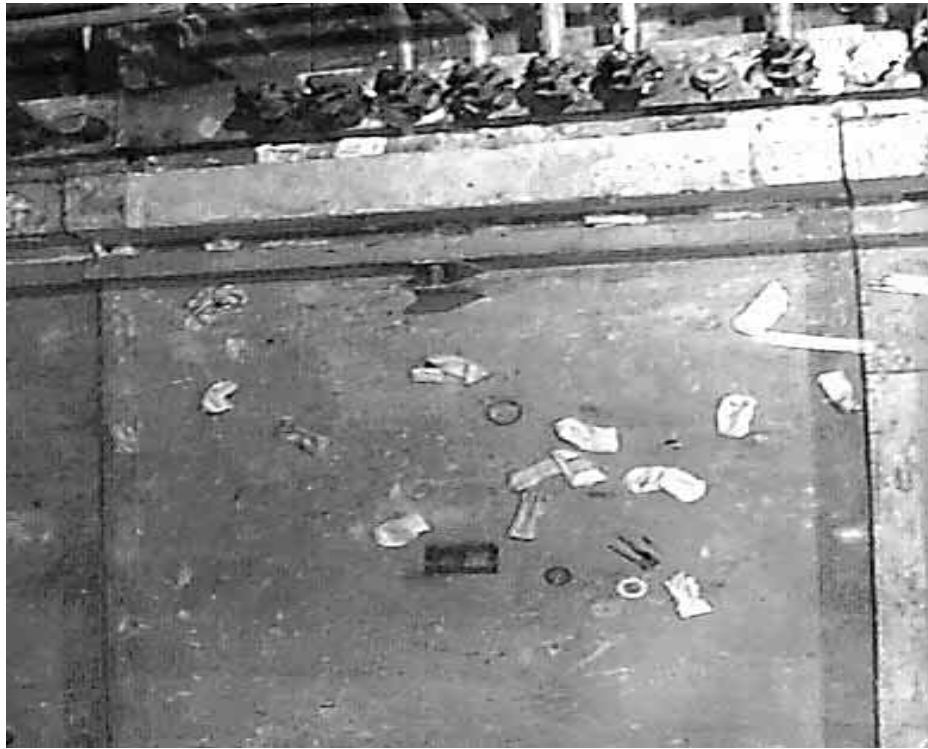
Exhibit 2-1 Protective Clothing and Tools on Cell Covers

On May 22, 1997, the cell covers and the material found on the cell covers were surveyed. Gloves and shoe covers were found in close proximity to tools and equipment, which included a ball peen hammer, thin blade screwdriver, and pliers. Some of the plastic shoes covers were manufactured by FABOHIO Inc., a type not used in F-Canyon prior to April 1996 (Exhibit 2-1). The maximum transferable contamination found on the cell covers was 300,000 dpm/100 cm² alpha and the maximum transferable on any item was 200,000 dpm/100 cm² alpha, which was found on a snap ring, a screw driver and a plastic shoe cover.

The protective clothing found on the platform and landing included rubber gloves, cloth coveralls, plastic shoe covers, cloth hoods, cloth booties, plastic suit bottoms, and giant rubber shoes (Exhibits 2-2 and 2-3). An adapter hook, screwdriver, jumper gaskets and snap rings were also found. The material was surveyed on May 28, 1997. The highest contamination levels were found on the rubber shoes (300,000 dpm/100 cm² alpha and 150 mrad/hour/100 cm² beta-gamma) and the adapter hook (500,000 dpm/100 cm² alpha). On a follow-up survey conducted on June 3, 1997, rubber shoes taken from section 18.8 probed 3,000,000 dpm/100 cm² alpha. An isotopic analysis of the rubber shoes indicated that the contamination came from processing more than a year ago, indicating that the shoe covers were not recently worn or the contamination source was from a source of material not recently processed, such as the section 18 waste tank.

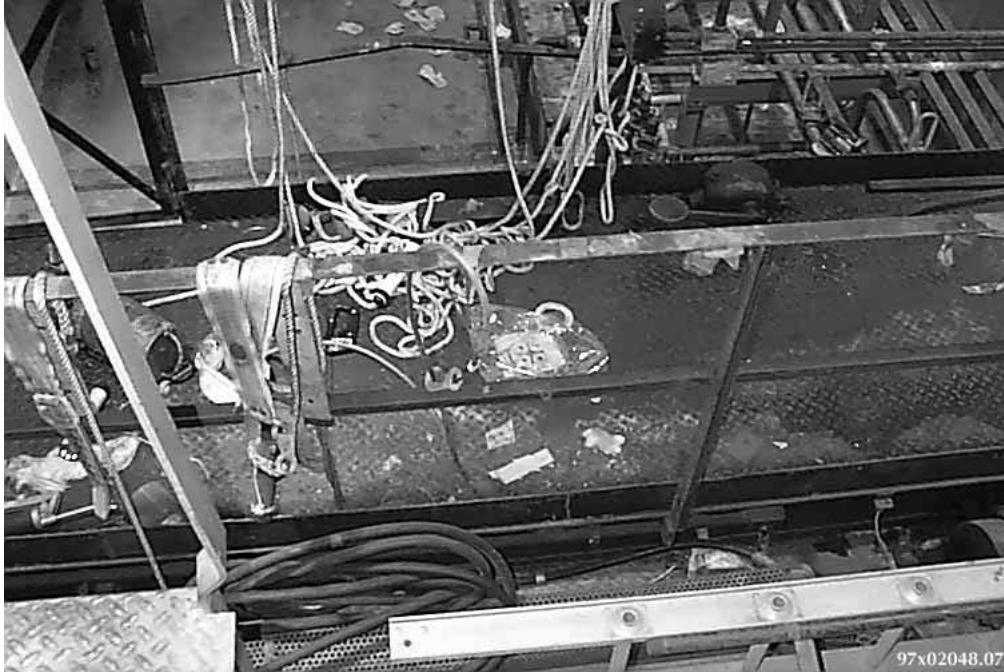
Exhibit 2-4 Material on Bridge

The maintenance bridge was surveyed on May 29, 1997 (Exhibit 2-4). The highest level of alpha contamination found was 40,000 dpm/100 cm². Beta-gamma levels as high as 300,000 dpm/100 cm² were also found. The alpha contamination levels indicate all the material on the cell covers could not be the result of material falling off the maintenance bridge or Warm Canyon Cranes.

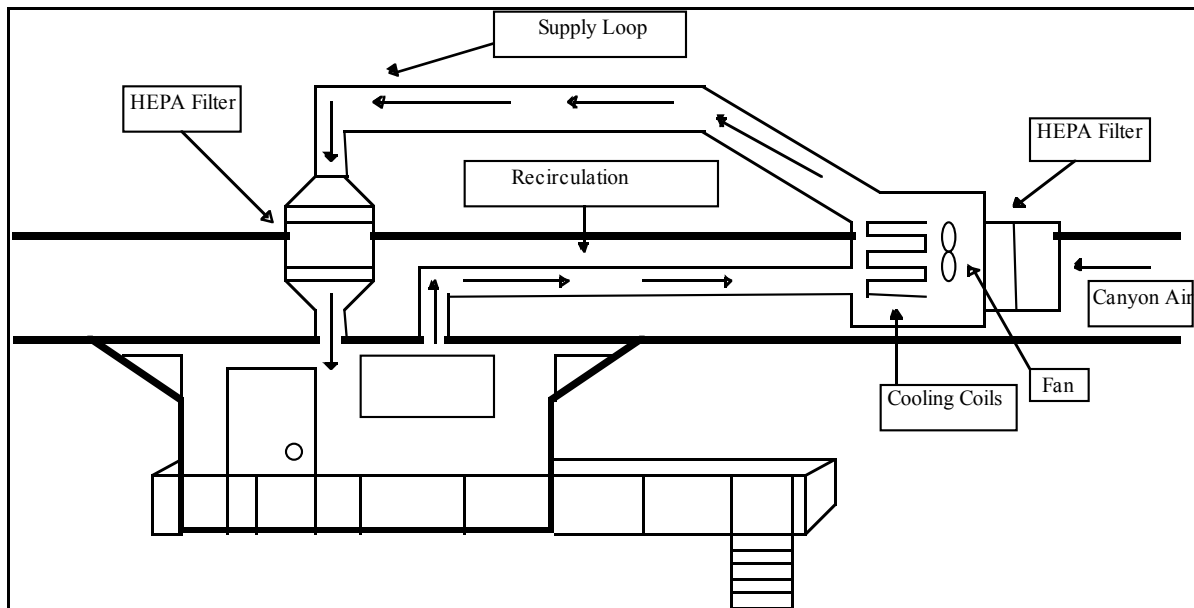
Figure 2-3 Old Warm Crane Cab Ventilation System

A simplified schematic of the Old Warm Crane Cab ventilation system is shown in Figure 2-3. Air from the surrounding canyon environment is pulled by a fan through a single-stage HEPA filter. The air then passes across the air conditioning cooling coils prior to a second-stage HEPA filter. Air is supplied into the cab through a register located in the ceiling near the cab door. The design rate of supply air into the crane cab is 400 cfm. The ventilation system includes a recycle loop from the crane cab which has design flow rate of 200 to 300 cfm. At the request of the Board, WSRC measured the supply and re-circulation flow rates. The measured flow rates roughly correlated with the design flow rates and resulted in a positive pressurization of 0.035 inches water column of the crane cab with respect to the surrounding canyon environment with the cab door closed (0.0004 inches water column with the door open).

In reviewing the procedure and records for filter penetration testing of the Old Warm Crane Cab ventilation system, the Board found the physical arrangement for performing the filter penetration test on the HEPA filters for the ventilation system tested the filters only in combination as a unit. The physical arrangement did not provide for independent testing of each HEPA filter. It was also unclear from the records when the second HEPA filter had been replaced. The first, or inlet HEPA filter, was known to have been replaced after the system failed a filter penetration test on August 21, 1996.

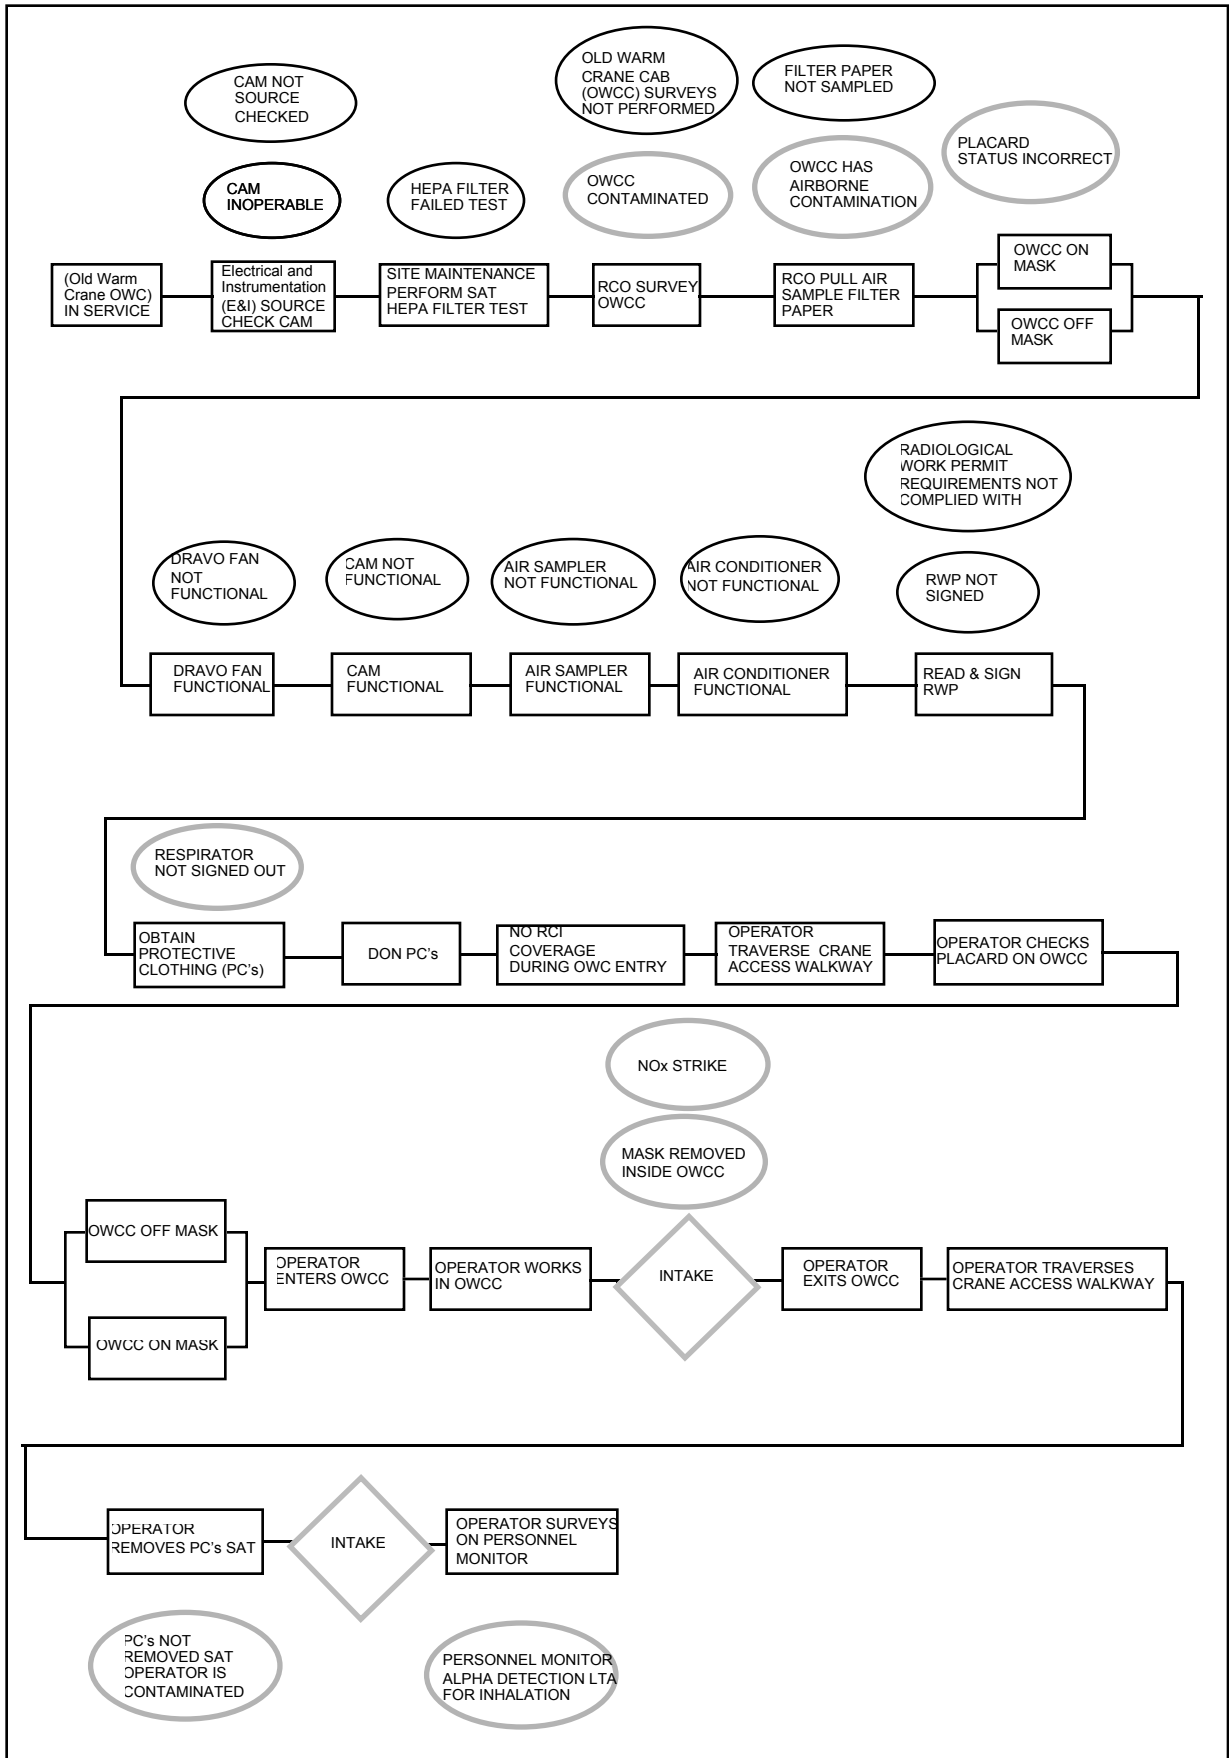
Figure 2-4 Old Warm Crane Cab Events and Causal Factors Chart.

The barrier analysis worksheet is shown in Table 2-3, and a barrier analysis summary is shown in Table 2-4. Physical barriers that may have failed include improper removal of personal contamination clothing, lack of respirator usage, Old Warm Crane Cab safety equipment not functioning, cell covers that had been removed, and a process tank eruption. Administrative barriers that failed were lack of compliance with RWPs, inadequate use operating procedures, and lack of a Job Hazard Analysis for crane operation. Supervisory/management barriers that failed included a lack of worker knowledge related to hazards in the facility, lack of line management oversight to ensure requirements were being met, and lack of RCO coverage during highly contaminated work.

The likelihood of the CRANE OPERATOR's intake from scenario (a) is low. Conversely, the likelihood of his intake from scenario (b) is plausible. In any case, the commonality of findings and associated causal factors of this PERIPHERAL WORK to the other scenarios analyzed again gives credence to the Board's determination of causes and conclusions.

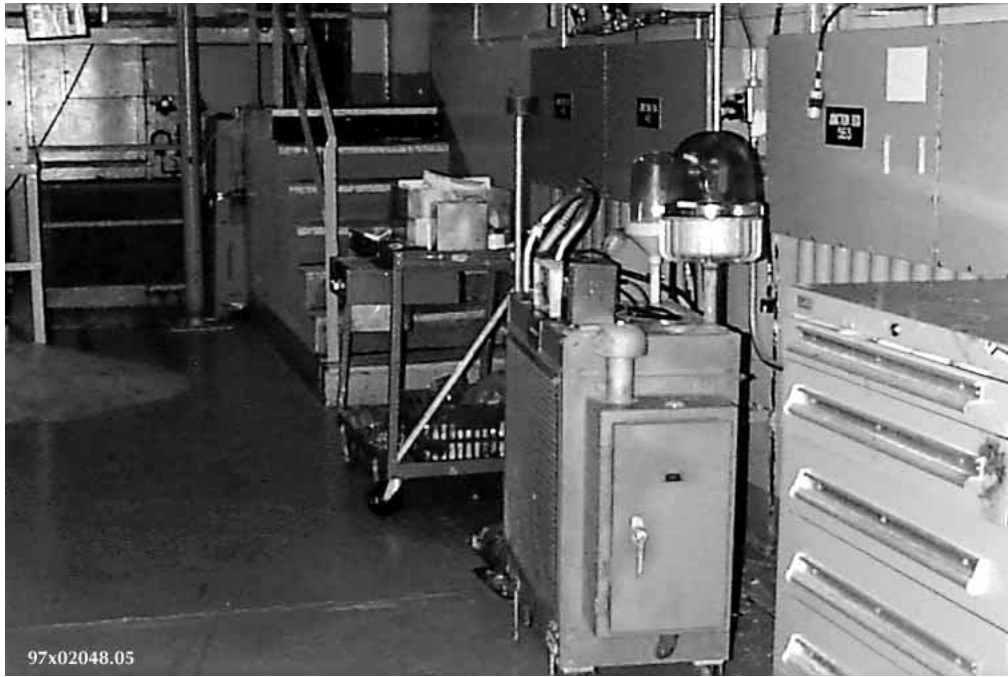
Exhibit 2-5 Warm Gang Valve Corridor Continuous Air Monitor

There is one CAM located in the Warm Gang Valve Corridor in section 5 (Exhibit 2-5). The unit detects alpha emitting airborne radionuclides and displays data output as counts per minute on both a count rate meter and a chart recorder. Alarms are enunciated locally, using an audible device and a large flashing red beacon. The monitor draws ambient air through a device that abruptly changes the direction of the air stream in order to cause airborne particles to impinge on a lightly greased plastic planchet placed in the air stream. Under the thin layer of grease, the planchet is also coated with a thin layer of Zinc-Sulfide (ZnS) crystals. The airborne particles trapped in the layer of grease on the planchet emit alpha radiation from the radioactive material attached to airborne particles. The ZnS crystals scintillate (emit flashes of light) as they are struck by alpha radiation. A light sensitive photomultiplier tube converts the light pulses from the ZnS to current and presents the result as counts on the rate meter and recorder. Should the count rate exceed a predetermined value selected by the attending staff, the alarm circuit activates the audible and visual devices. DOE requirements state such devices shall be sufficiently sensitive to detect airborne radioactivity in the range of 8 DAC-hours under laboratory conditions. Field conditions frequently reduce the practical sensitivity to between 18 and 24 DAC-hours. Although the audible alarm device is designed to be quite loud, ambient noise in the Warm Gang Valve Corridor typically prevents workers more than several sections away hearing the signal. The visual alarm device is a large red beacon that is visible for practically the entire length of the valve corridor. Placement of the CAM at the southern most end (section 5) of the valve corridor is due to the movement of air in the corridor that flows from north at section 18 to south at section 4. In theory, any release of airborne radioactive material in the Warm Gang Valve Corridor would be swept by the air flow pattern toward the CAM. A drawback to keeping a single CAM in this area is the delay in any alarms in the northern sections due to the required time for the contaminant to reach the CAM, and difficulty in alerting the workers in this area.

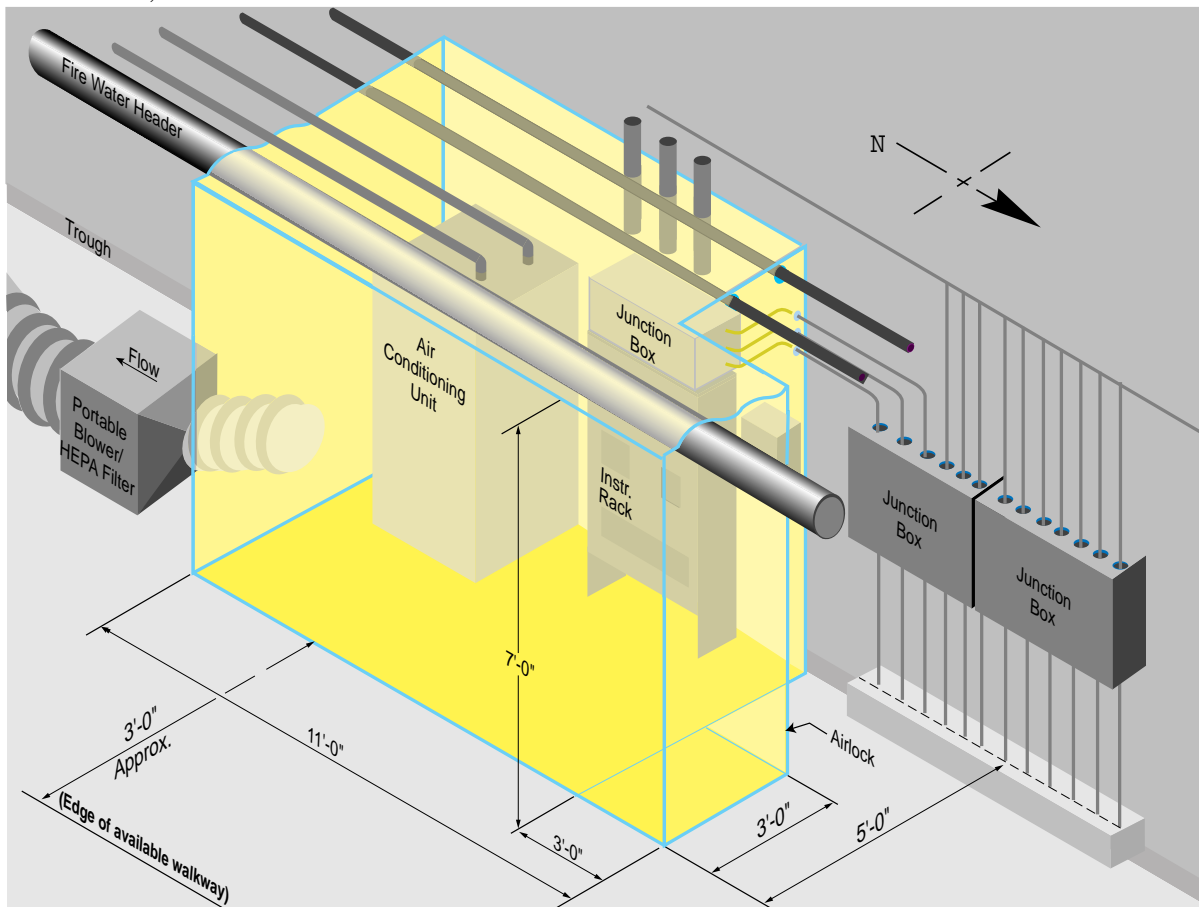
Figure 2-7 Warm Gang Valve Corridor Containment Hut

Construction of a containment hut in section 11 began on October 26, 1996, under RWP 96-FC-267 Rev. 3 (Figure 2-7). A Job Hazard Analysis for constructing and removing plastic huts had not been performed (one was scheduled to be completed June 30, 1997). The hut should have been constructed according to procedure 221-F-55230, a "Use Every Time" procedure entitled "Constructing a Plastic Hut." A complete copy of this procedure for the hut construction in section 11 could not be found. The hut was not constructed according to the procedure requirements. The procedure calls for the ceiling to be continuous with the sides. This was not the case since the ceiling was placed both over and under piping and taped to the piping, making it impossible to bring down the hut in one piece. Personnel involved with the installation stated that the taping to, around, and over the piping required 12 rolls of duct tape. Since surveys of the area had not accurately characterized the contamination area, the hut did not completely enclose the contamination. There was contamination behind the instrument rack which was not enclosed in the hut. Work on the hut continued on October 27, 28 and 29, 1996. The HEPA filter on the hut was filter penetration-tested on October 29, 1996.

On November 25, 1996, RCI surveyed the hut using standing RWP 96-FC-012. The levels were found to be 2,000 dpm/100 cm² alpha and 100,000 dpm/100 cm² beta-gamma at the base of the instrument rack. On November 29, 1996, during routine RCI surveys of the Warm Gang Valve Corridor, it was discovered that the chart paper on the alpha CAM was not advancing. The routine survey on December 1, 1996, had the same notation.

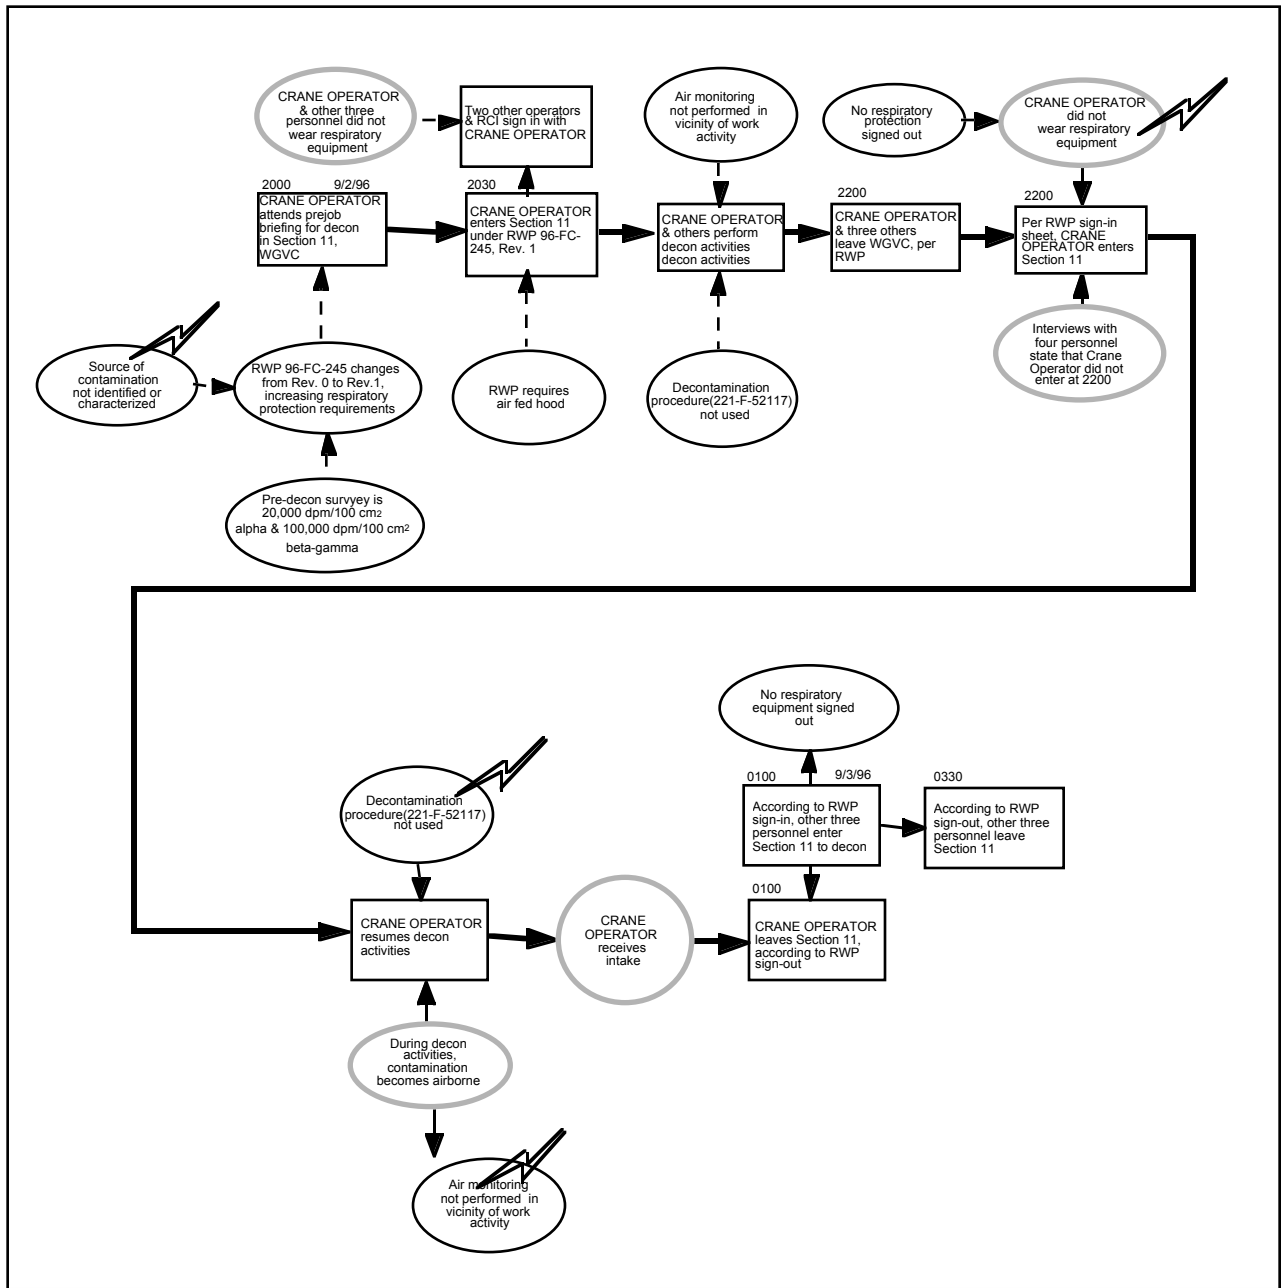
Figure 2-8 Warm Gang Valve Corridor Decontamination Events and Causal Factors Chart.

During the period under investigation, the CRANE OPERATOR is known to have worked in section 11 on two days (September 2 and December 22, 1996) other than the December 21, 1996, hut removal which is covered in Section 2.2.4 of this report. On September 2, 1996, the CRANE OPERATOR entered the Warm Gang Valve Corridor, section 11 area in order to decontaminate the area. The area was posted as an Airborne Radioactivity Area. Contamination levels as high as 100,000 dpm/100 cm² alpha and 400,000 dpm/100 cm² beta-gamma were known to have existed in this area. According to the respirator sign-in sheets, the CRANE OPERATOR did not sign out any respiratory protection equipment for performing the radiological decontamination work. The RWP required fresh air hoods to protect personnel from airborne contamination. According to the times on the RWP, the CRANE OPERATOR worked alone in section 11 for approximately three hours without RCI coverage. Given the levels of contamination found in the area, the potential existed for the CRANE OPERATOR to receive an intake during this work activity if he did not wear the required respiratory equipment (calculations supporting this scenario are shown in Appendix C). An Events and Causal Factors Chart (Figure 2-8) was used to analyze the September 2, 1996, activity in section 11. Four causal factors were identified for this activity:

- The source of contamination was not identified or characterized.
- There was no air monitoring in the vicinity of the decontamination activity (the CAM was located in section 5).
- The CRANE OPERATOR did not wear respiratory equipment (a presumptive causal factor).
- No procedure was used for decontamination activities.

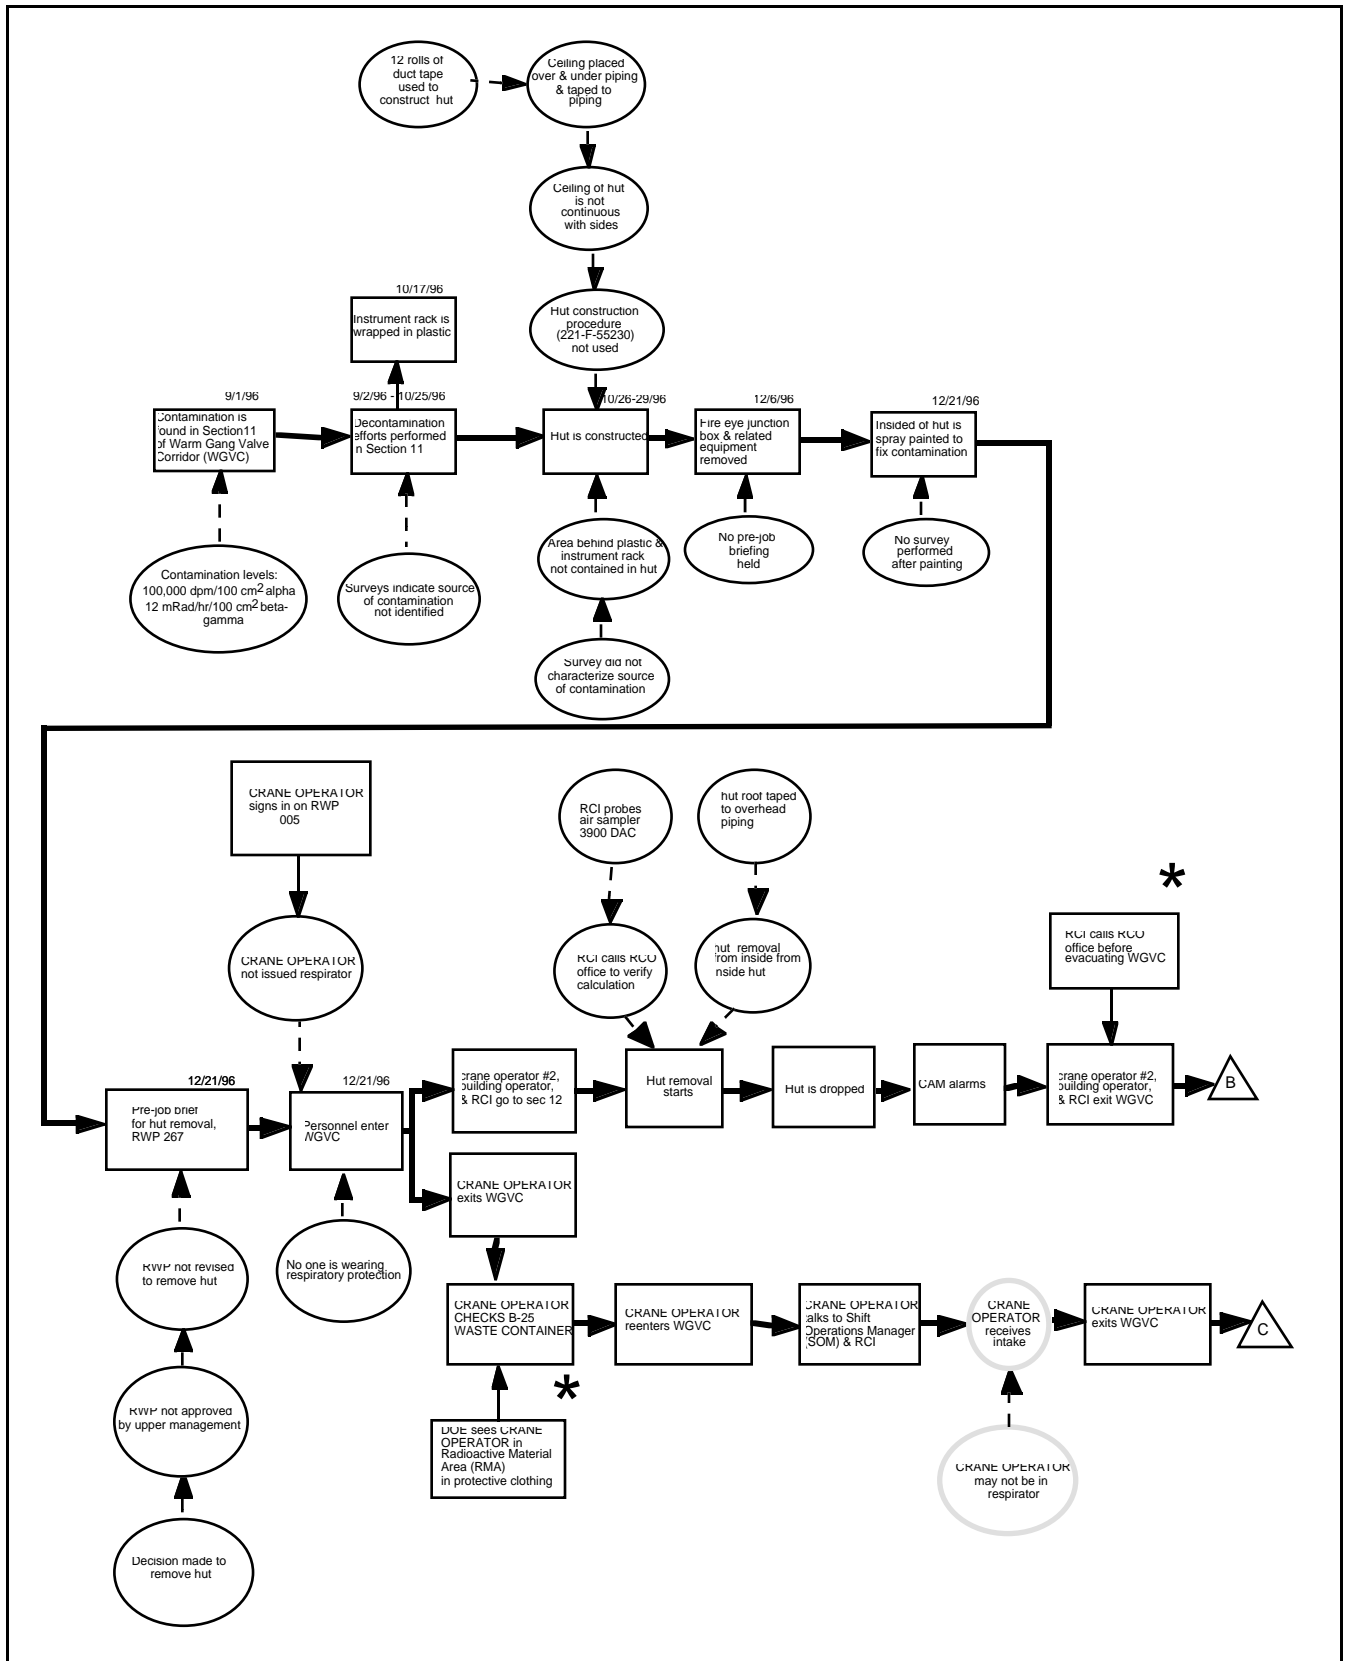
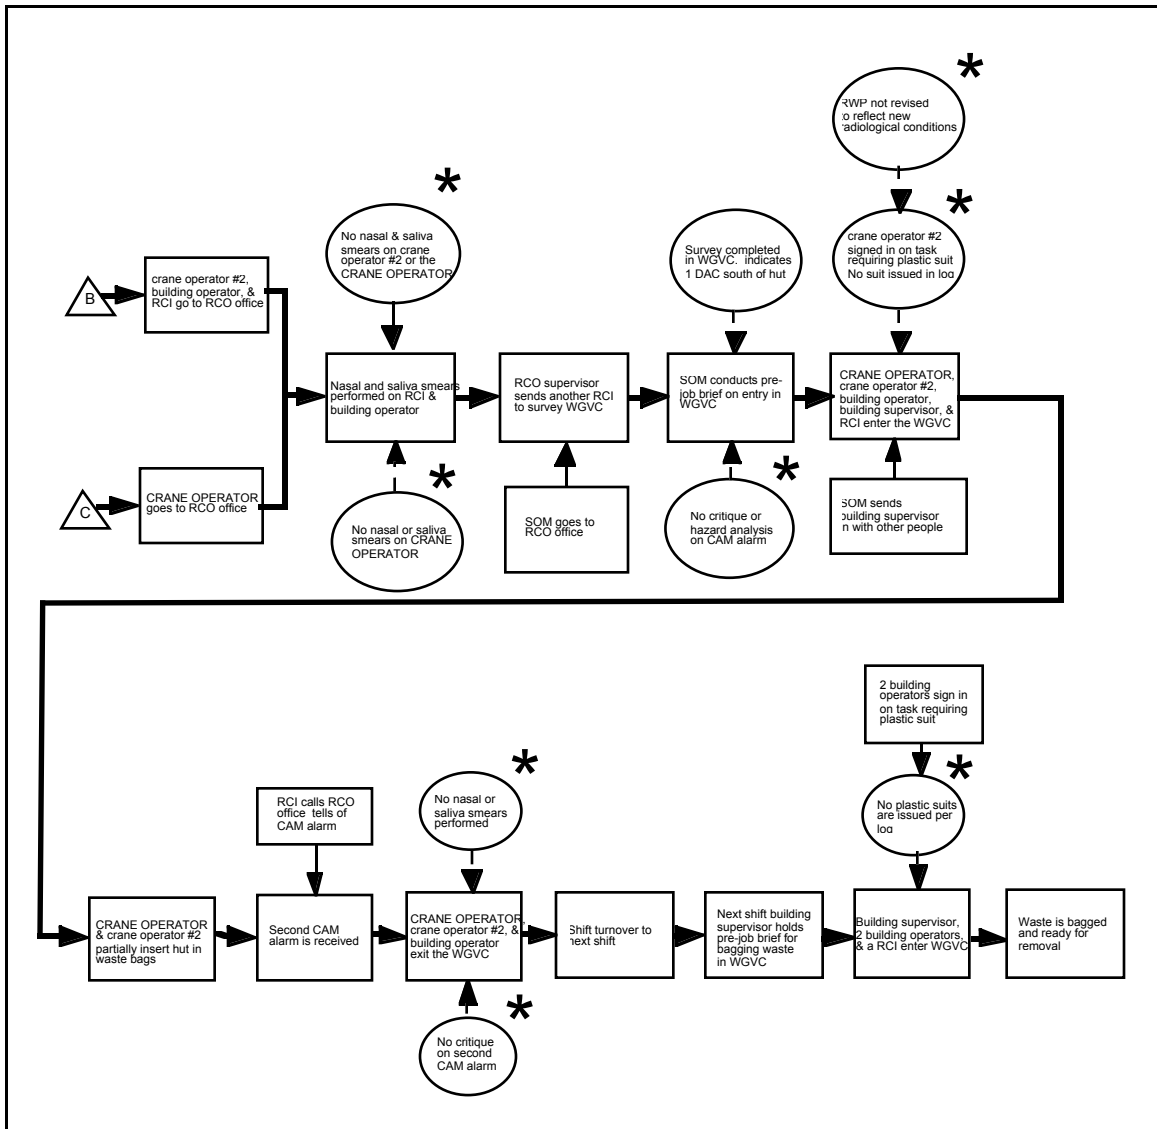
Figure 2-9 Hut Removal Events and Causal Factors Chart (1 of 2)

The RCI stated after entering the Warm Gang Valve Corridor, she performed an initial surface contamination and airborne radioactivity survey, but there is no documented survey sheet for this survey. After this survey, crane operator #2 and the building operator commenced hut removal.

After the CRANE OPERATOR and the RCI talked to the Shift Operations Manager about the B-25 incident, the RCI stated she told the CRANE OPERATOR to put on his respirator and exit the Warm Gang Valve Corridor. The CRANE OPERATOR stated in his interviews he decided to exit the Warm Gang Valve Corridor and talk to the Shift Operations Manager in person. He also stated he thinks he was wearing a respirator when he exited. No one else can definitely remember if the CRANE OPERATOR was wearing a respirator when he exited the Warm Gang Valve Corridor.
