**Type B Accident
Investigation Board Report
on the October 22, 1997,
Electrical Arc Blast
at
Building F-Zero
Fermi National Accelerator Laboratory
Batavia, Illinois**

November 1997

**Chicago Operations Office
U.S. Department of Energy**

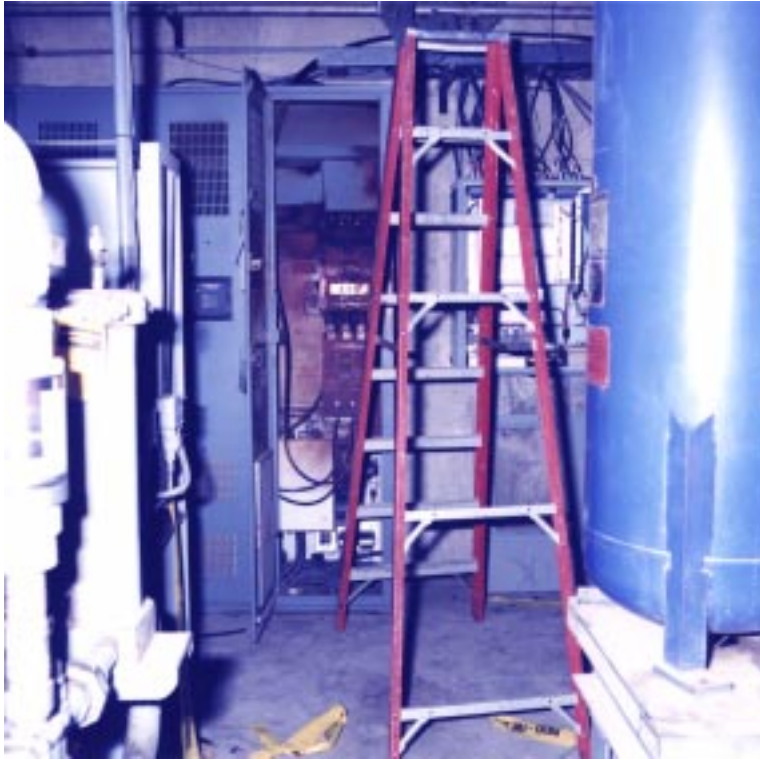
Exhibit 2-1. View of Accident Location

On October 22, 1997, at 10:00 a.m. Electricians A and B arrived at the RF Room of Building F-Zero to connect four cables in DHP-RF1-4. They completed hooking up the cables at DHP-RF1-4 (see Figure 2-1) shortly before 12:00 noon. At

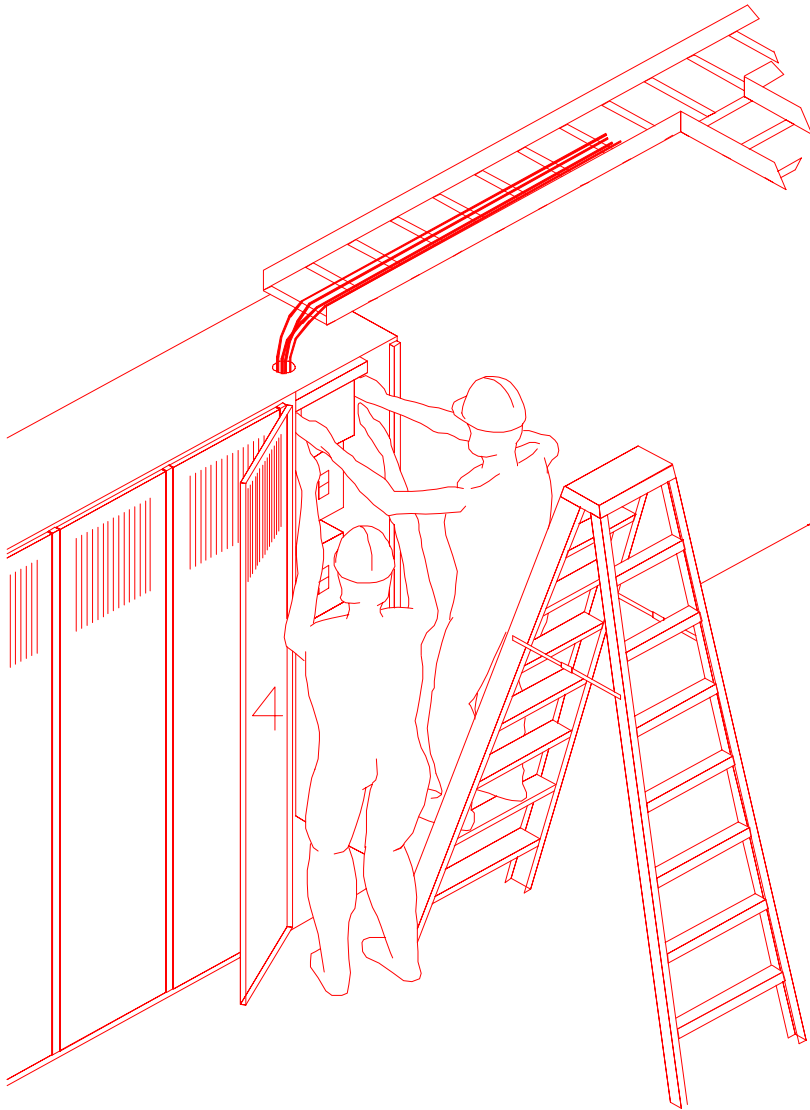
Figure 2-2. Artist Drawing of Work Activity Prior to Accident

case while Electrician B helped him (see Figure 2-2). During this maneuvering the cover contacted the “C” phase of the bus bar causing a short to ground and a subsequent arc blast.

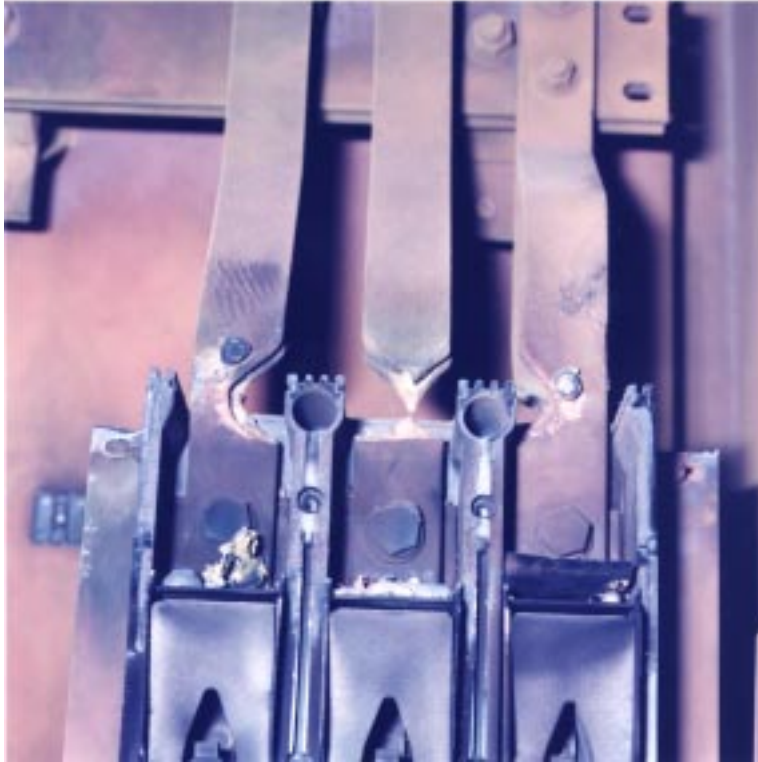
Exhibit 2-2. View of Bus Bar after Electrical Blast

The resulting arc blast vaporized the copper connection (see Exhibit 2-2) and, being deflected by the bus bar cover, was directed downward toward the head and face of Electrician B (see Exhibit 2-3). Electrician B received 2nd and 3rd degree burns to his face and hands while Electrician A, being on the ladder and partially protected by the bus bar cover, received 2nd degree burns to both hands. With the exception of a hard hat (see Exhibit 2-4), no other personal protective equipment was worn by either electrician. Electrician A was knocked off the ladder and both Electrician A and B were temporarily blinded by the arc blast. Electrician B’s coat was smoldering when Electrician A’s sight returned from the bright arc blast.

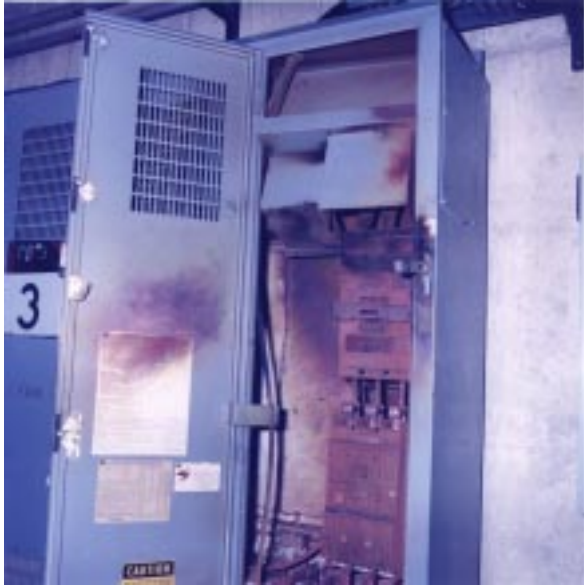
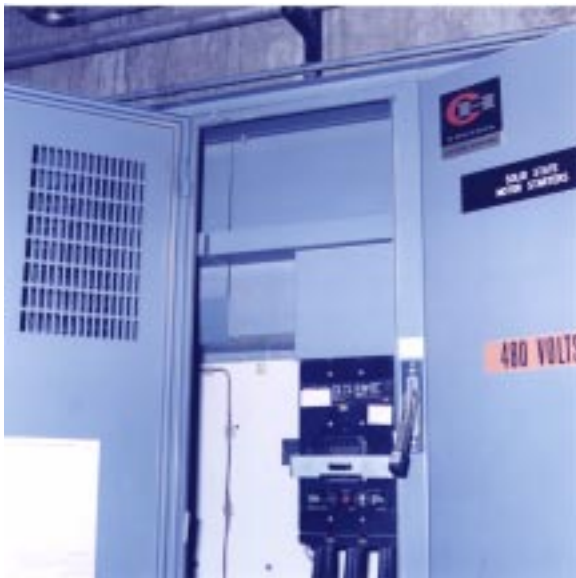
Exhibit 2-3. Comparison of an Intact and the Damaged Bus Bar Cover

The Damaged Bus Bar Cover

Similar Intact Bus Bar Cover

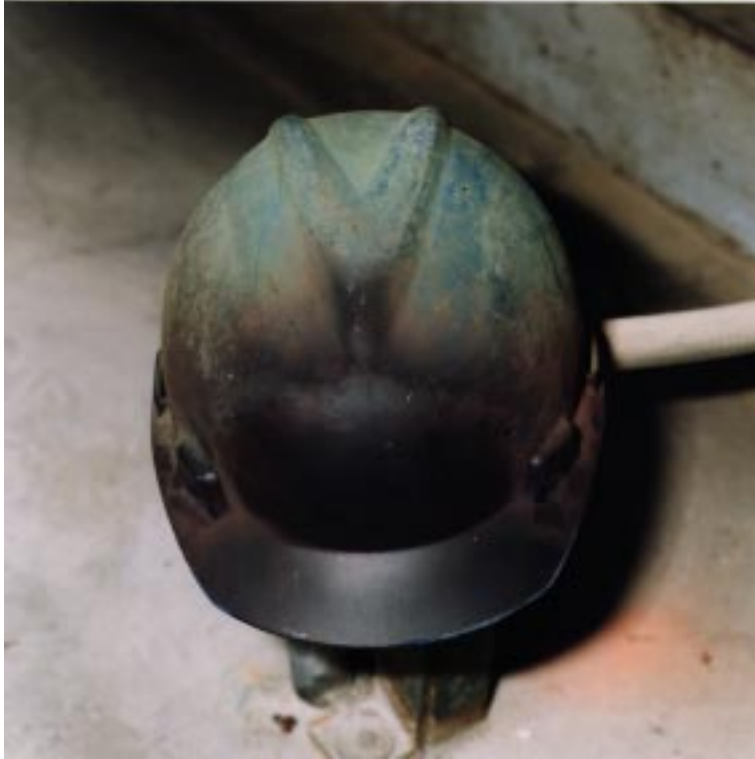
Exhibit 2-4. Electrician B's Hard Hat After Electrical Arc Blast

The resulting arc blast vaporized the copper connection and, being deflected by the bus bar cover, was directed downward toward the head and face of Electrician B. Electrician B received 2nd and 3rd degree burns to his face and hands while Electrician A, being on the ladder and partially protected by the bus bar cover, received 2nd degree burns to both hands.

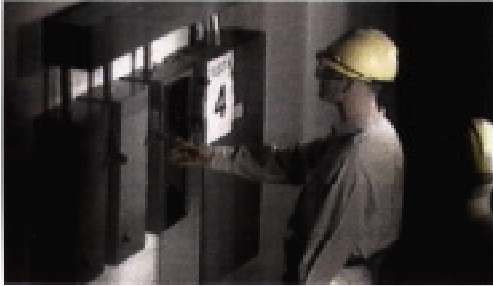
Exhibit 2-5. Electrical Arc Demonstration

Time = 0.00 sec

Time = 0.03 sec

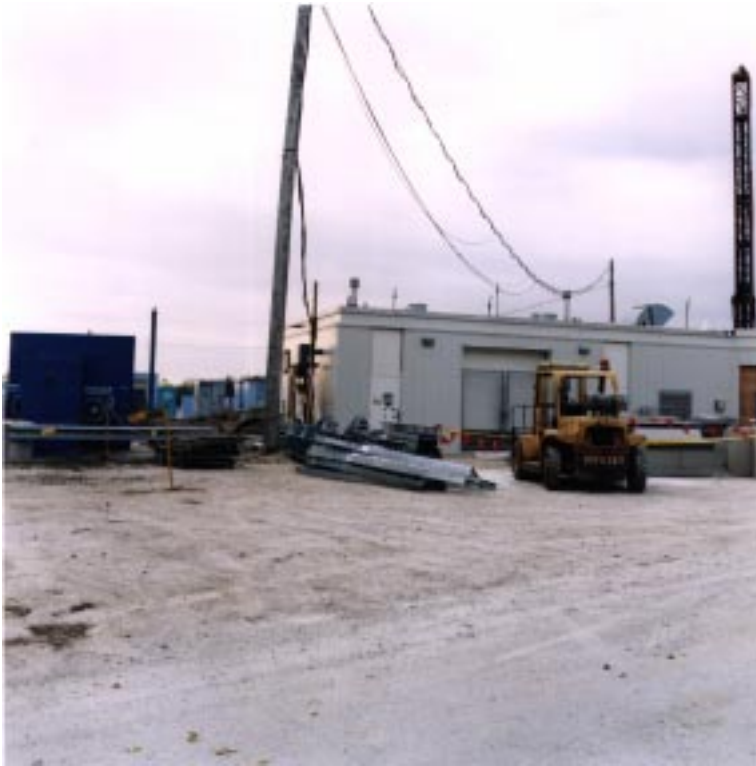
Exhibit 2-6. Feeder 46B and Building F-Zero Compressor Room

On October 21, 1997, two Contractor electricians pulled four cables from the F-Zero Compressor Room to the F-Zero RF Room. This involved installing a 225 A circuit breaker in MCC Cabinet #4. The three load phases were installed in the motor control center, with the neutral remaining to be installed the next day. It took approximately eight hours to complete this part of the job. The Electricians believed that Building F-Zero was deenergized and, hence, they did not use lockout/tagout or voltage verification to install the new 225 A breaker, as required by 29 CFR 1910.333(b)(2),
