## Idaho National Laboratory Plutonium Contamination Investigation Results

*The following article provides an overview of the results from the investigation of the November 2011 Idaho National Laboratory Plutonium contamination event. An Accident Investigation Board was appointed to determine the causes of the accident and to identify corrective actions to prevent recurrence; these corrective actions are reviewed in this article.*

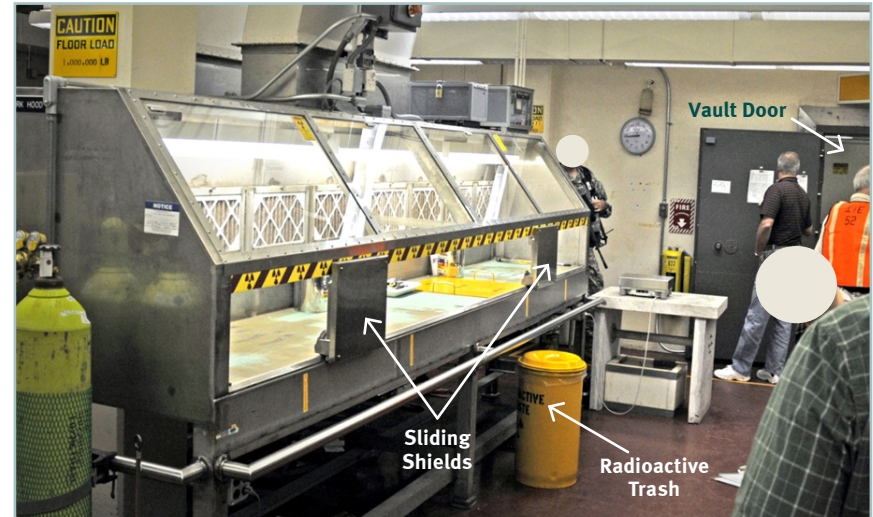
Figure 1-2. ZPPR Work Room South Hood area (circa 2008)

During the planned fuel packaging operation, workers had been instructed to open the Pu clamshells. After removing them from the ZPPR Vault storage, technicians noted that two of the clamshells had atypical notes on them: "Plate dented" and "Swollen upper left corner." One of the two labels further indicated potential abnormalities with the fuel plates inside. The Shift Supervisor called the Nuclear Facilities Manager for consultation, and a decision was made to proceed with the packaging operation. The four clamshells to be processed for shipment were then taken to the ZPPR Work Room and placed in the South Hood (Figure 1-2).

In addition, the Work Room hood where the damaged fuel plates were opened had not been maintained for the safe execution of such work, and it therefore failed to prevent the release of the radioactive material. Opening the damaged plates in a glovebox may have prevented the release, but a glovebox was deemed unnecessary, and so one was not used.

fuel plates as described on the labels. The ZPPR Workroom South Hood, where the fuel plate unpacking work occurred, is not a defense-in-depth SSC, and was not maintained to provide assurance of its performance or operability as an SSC. Going forward, BEA needs to validate the technical basis used to support the safety and design of the ZPPR facility and legacy material, which would include a reassessment of the likelihood, severity, and risk of accidents and the effectiveness of hazard controls.

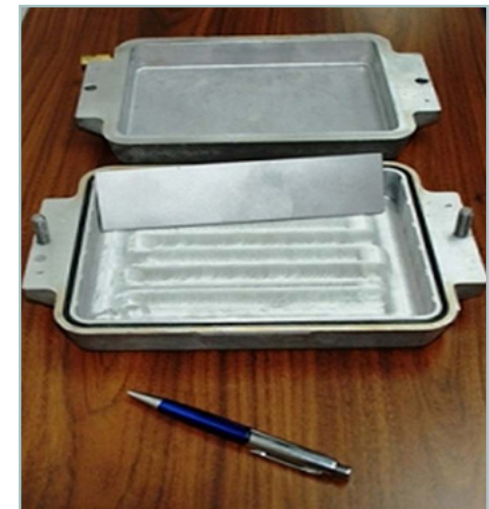
Figure 1-3. Clamshell with fuel plate

When opening the first clamshell, workers discovered that the Pu fuel plate was wrapped in multiple layers of plastic and tape. (An unused clamshell and fuel plate are shown in Figure 1-3.) When workers cut the plastic and tape, they observed powder fall from the wrapping into the clamshell. A smear was taken and the clamshell was closed. The smear pegged a count rate meter on the lowest scale, and through subsequent analysis on December 8, 2001, was found to contain 5.5 million disintegrations per minute [dpm] alpha. Three minutes after the plastic was cut, the CAM alarmed from the uncontrolled release of radioactive contaminants which spread into the ZPPR

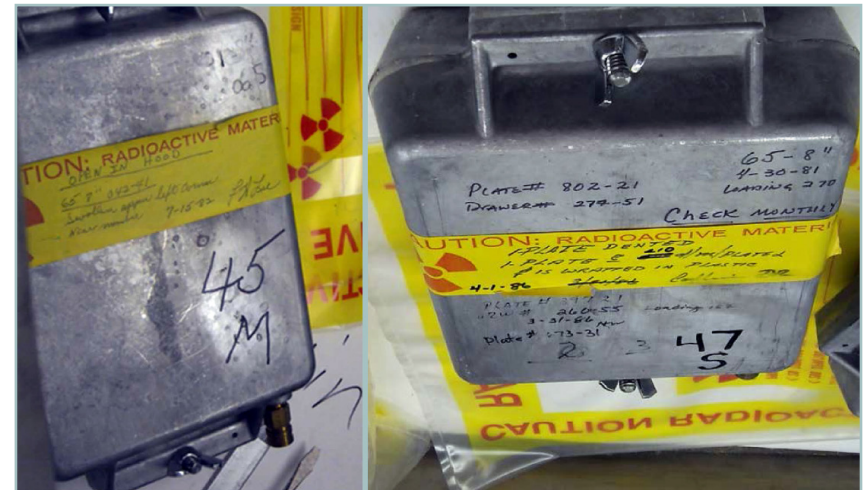
Prior to the ZPPR's 1992 deactivation, day-to-day operations followed specific procedures and practices for handling damaged fuel plates and placing them in a storage vault. Information about the fuel plates was recorded in a handwritten Suspect Fuel Log and some of the fuel containers were labeled according to their condition, as shown in Figure 1-4. The Board determined that fuel plate storage information had not been effectively transitioned into current work planning and operating procedures for work performed on the day of the accident. Although the Suspect Fuel Log was housed in the ZPPR facility, its contents and value were not known by the workers, their immediate supervisors, or the Nuclear Facilities Manager.

**Figure 1-4. Clamshell 45 M (left) with notes that upper left corner of fuel plate is open and to open in hood and Clamshell 47 S (right) with notes that plate is dented and wrapped in plastic and the direction to check monthly**

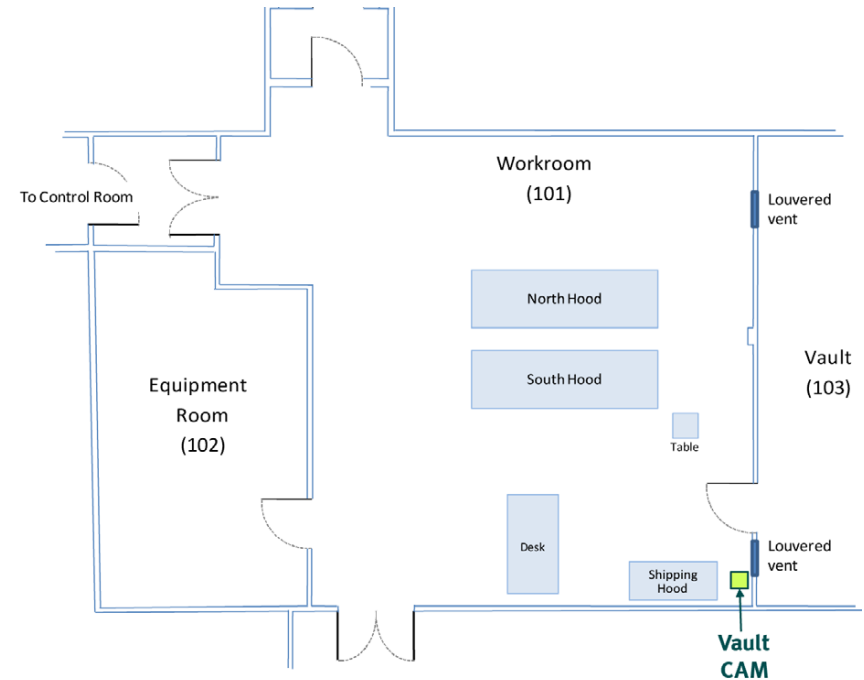
**Figure 1-5. Diagram of ZPPR Work Room**

The Board found that the packaging activity was not consistent with the BEA procedure development process and should have followed appropriately generated procedures rather than process worksheets. The planning effort did not include a thorough review of historical data to aid work planning. Evaluation points and limiting conditions required by the Radiological Work Permit (RWP) were not sufficient to stop work to reevaluate the hazards when unexpected hazards or conditions occurred. Additionally, although the vault CAM alarmed, its location, as determined in engineering evaluations, was not optimal for the work being performed in the workroom hood and should have been placed lower—that is, closer to the workers' breathing zones. (See Figure 1-5, which shows the location of the single CAM.)

- The lack of CAMs in place specific to the work area; appropriately positioned CAMs would have reduced the time to alarm and limited personnel exposure.
- The work in the workroom was performed with the vault door open, thus creating an unknown and unanalyzed air flow.
- The impact of the ISRC Chairman's White Paper regarding the history and safety of the stored fuel plates was not recognized when site management and contract changes occurred at the site.

- Ensure that a thorough review of available historical resources and lessons learned is conducted to determine their effect, if any, on the scope of work.
- Evaluate the placement and positioning of air monitoring equipment to provide workers with early indications of a radiological hazard.
- Reinforce Stop Work expectations.
- Provide facility-specific training for all personnel on the unique hazards of handling plutonium.
- Provide training to Radiological Control personnel on evaluating and effectively communicating facility radiation monitor data.
- Develop and implement training on radiological response, including drills, exercises, and evaluation of radiological consequences of accidents.
- Evaluate processes used to identify radiological source term information for use in evaluating and responding to radiological emergencies.
