# OPERATING EXPERIENCE SUMMARY

**U.S. Department of Energy**  
Office of Environment, Health, Safety and Security  
OE Summary 2016-01  
January 14, 2016

## Arc Flash Accident at Los Alamos National Laboratories Technical Area 53

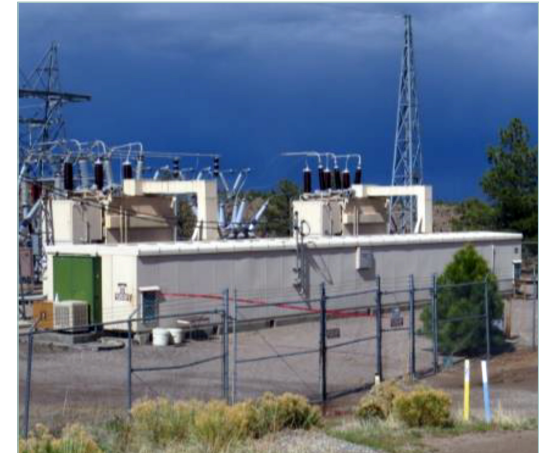
Figure 1-1. The 13.8-kV substation TA-53-0070

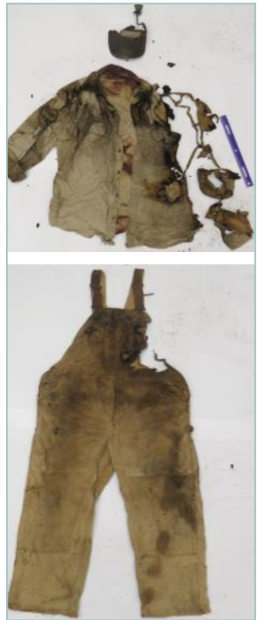
The explosion impacted W1 directly. Investigators assume that, while inside the confined space, W1 placed his hands, forearms, and chest close to the energized components to clean them. The commercially available spray cleaner is intended for use only on non-energized surfaces because it has no established dielectric characteristics – that is, no insulating properties to prevent the conducting of electrical current. W1 received no burns from direct skin-to-electrical component contact; all burns were caused by exposure to the extreme thermal energy of the arc flash. Figure 1-2 shows the energy released from a typical arc flash event, and Figure 1-3 shows W1's burned clothing (recovered after the event). The subsequent pressure wave forced W1 backward and downward onto the floor, where his head struck a piece of micro-ohm testing equipment, resulting in a laceration.

**Figure 1-3. Clothing recovered after the arc flash event**
