# Status Of Integrated Waste Treatment Unit

**Kevin O'Neill**  
Idaho Cleanup Project

**June 22, 2017**

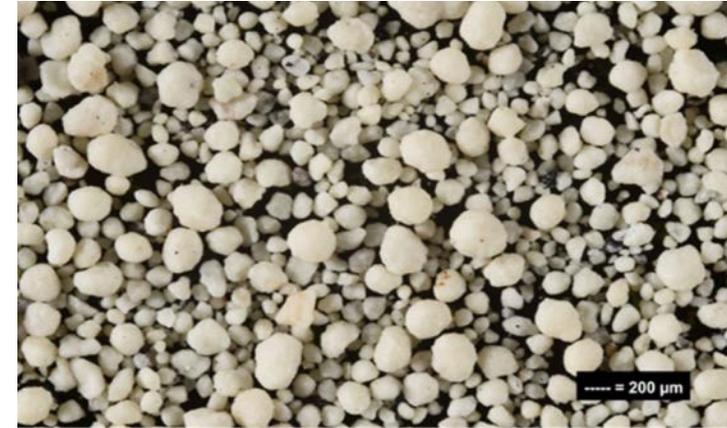
Product generated during most recent simulant run.

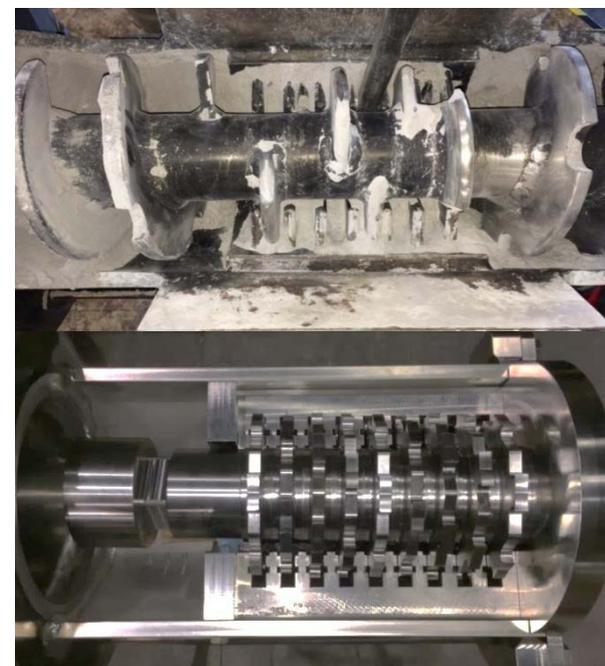
- Issue
  - Auger-grinder is located at the bottom of the DMR and conditions the product for pneumatic transfer to the packaging area.
  - The auger-grinder failed during all previous simulant runs.
- Cause
  - Steam forms a cementitious material that builds up on the auger-grinder, eventually causing it to fail.
- Approach to Resolve
  - Root cause analysis and testing to confirm failure mechanism.
  - Extensive prototype testing.
  - Inputs obtained from industry experts.
  - New design has improved mechanical features.
  - Incorporates purge strategy to minimize presence of steam.
- Status
  - Issue resolved. Successfully tested in IWTU in March 2017.
  - Production unit being fabricated.

Old auger-grinder with cement formations (top) and new auger-grinder (bottom) successfully tested in March 2018

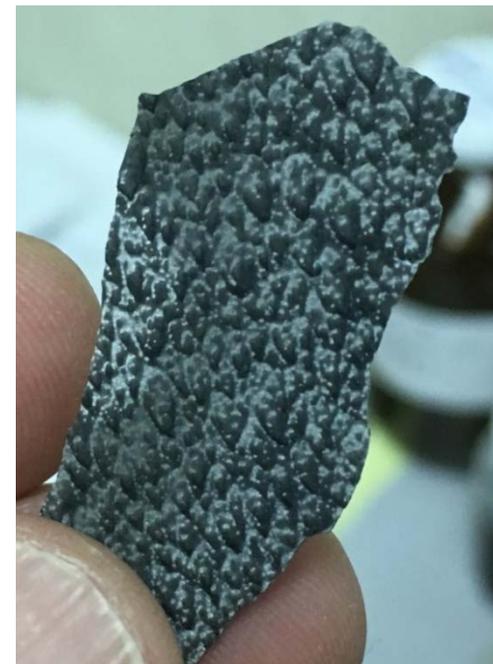
- Scale could accumulate and interfere with stable operations.
- Cause
  - Unreacted feed transfers from bed particles to vessel wall surfaces.
  - Caused by slow reaction kinetics and other reaction by-products.

- Status
  - Progress made in minimizing scale. Scale in IWTU run in March 2017 was about half the thickness as the scale in prior runs.
  - The general trend over the last few IWTU runs is the scale is becoming thinner and chemically less complex with each subsequent run.

Sample of scale from March 2017 test of IWTU.

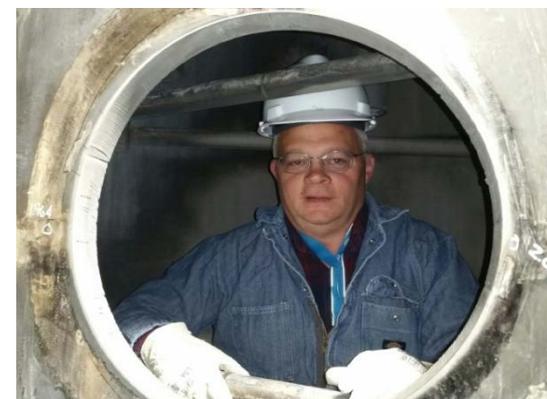
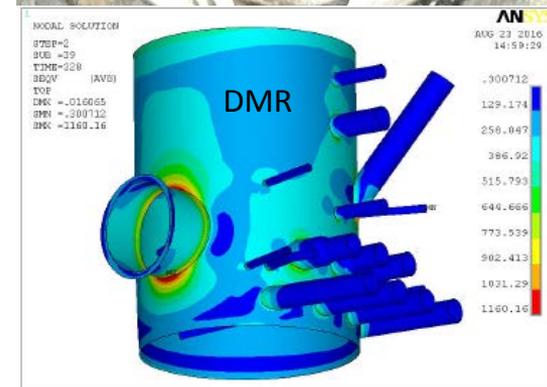
- Damage to ring due to erosion (jet impingement) as a result of sandcastles during 2015 testing.

DMR vessel manway hole (above) with stress analysis output (bottom).

- Manway successfully designed. Vessel opening made in May 2017 with water jet cutting technique. Manway flange currently being welded to the DMR vessel.

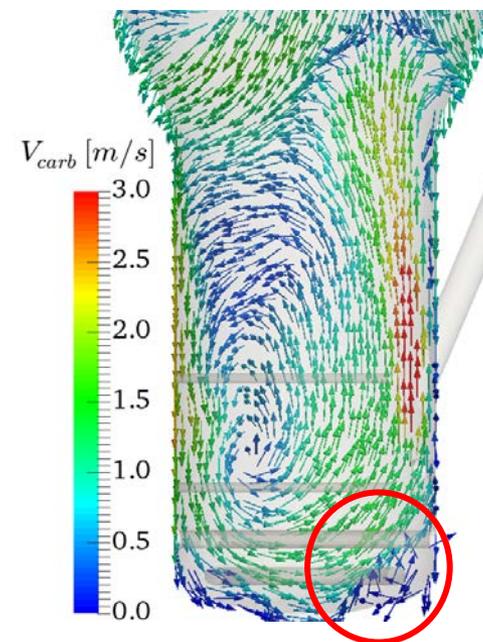
- Insufficient fluidization and mixing.
- Agglomeration of cohesive or sticky particles due to slow or incomplete waste feed conversion reactions.

Modeling showing area of weak fluidization (red circle) where sandcastles form.

- Sandcastle formation mechanisms understood.
- Evaluating physical modifications to lower DMR to increase fluidization.

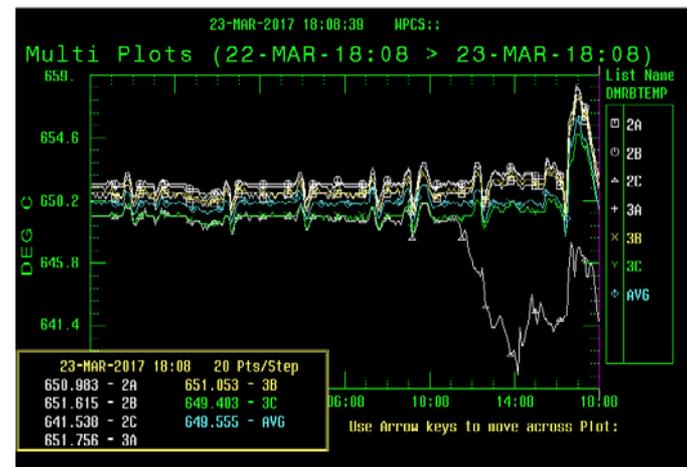
- Instabilities primarily related to sandcastles which disrupt fluidization, causing uneven temperatures.

- Test data and modelling confirm existing DMR design results in inadequate fluidization in DMR lower region.
- Engineering evaluation currently underway on three mechanical options to increase DMR lower region fluidization.

DMR temperature plot showing rapid divergence of temperatures within DMR bed, which is typical of the instabilities.
