OPERATING EXPERIENCE SUMMARY

U.S. Department of Energy
Office of Environment, Health, Safety and Security
OE Summary 2018-03
June 27, 2018

Mishandling Radioactive Sources and Samples

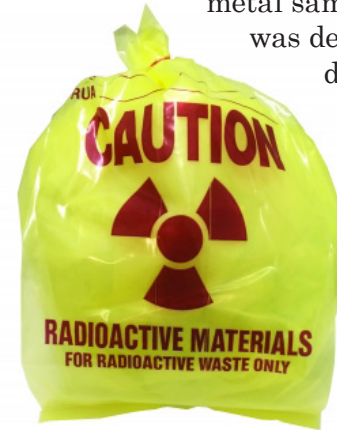
On August 9, 2017, personnel at Lawrence Livermore National Laboratory (LLNL) Donation, Utilization and Sales (DUS) discovered an item in a sealed plastic bag, labeled “Caution Radioactive Material” (see Figure 1 for an example) in a scrap metal bin. A meter survey performed by DUS personnel showed activity above background. The item contained a metal sample in a cylindrical epoxy case, which was determined by a Health Physicist to be depleted uranium. Removable con-

Figure 1. Example of bag labeled “Caution Radioactive Materials,” like that discovered in the waste bin at LLNL

A causal analysis found that the worker requesting pickup of excess equipment did not perform a final check of the materials to ensure that

the items in the box matched the pickup request form inventory, and a delay occurred between filling out the request form and the pickup, during which time additional and inappropriate items were placed in the box, including the sample. The facility stated that employees shipping excess equipment to DUS should do a final check of the contents of shipping containers to ensure that additional or inappropriate items have not been added while the container is pending shipment.

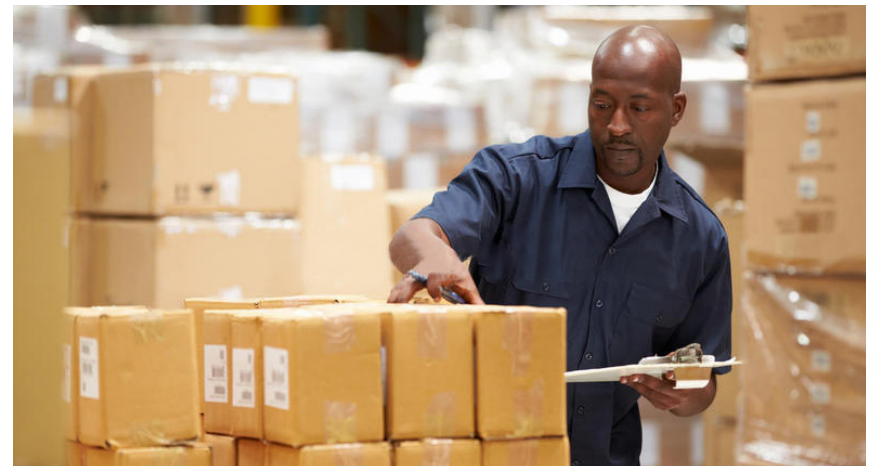
The direct cause of the incidents was the failure of the shipper to select the proper mode of transport. The shipper did not demonstrate knowledge of the applicable regulations governing air transport of radiological materials, or follow site procedures. Lack of management engagement and perceived time pressure were also contributing factors to the event. Perceived time pressure is never an acceptable reason to perform work unsafely.

Figure 2. Using a checklist, with review by peers and managers, can reduce the likelihood of shipping errors.

Corrective actions included a revision to the procedures to mandate a “Use Every Time” checklist for Authorized Shippers, and a daily review of the checklist by a peer and by management (see Figure 2). Training was revised to incorporate

error-likely situations in table-top exercises. Revised training was provided to Authorized Shippers and managers, and a coaching and mentoring program was developed and implemented for all shippers, which included management engagement. Other actions were taken to increase communication between shippers and with managers. In addition, two-person key control methodology was implemented over air-shipment labels.
