**Office of Enterprise Assessments
Assessment of the Pantex Plant
Gravel Gerties Aging Management**

July 2018

**Office of Nuclear Safety and Environmental Assessments
Office of Environment, Safety and Health Assessments
Office of Enterprise Assessments
U.S. Department of Energy**

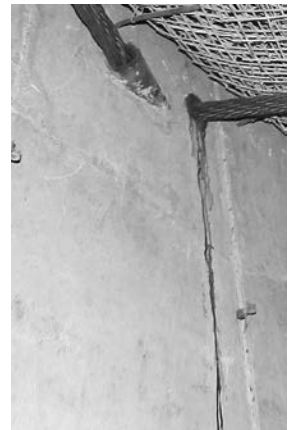
- A drainage system is installed in the Building 12-85 and 12-96 cells, Building 12-98 Cells 1-4, and Building 12-44 Cell 8. The drainage system consists of a copper collection pan below the suspended catenary cable system, connected to a drain line routed down the wall of the round room. The ISI program does not require an inspection to determine whether water is present in the drainage system. There is no recent evidence that CNS or the former M&O contractors have checked the drainage systems in any of cells to determine whether water is present. Maintenance personnel drained approximately 300 gallons of water from this system in Building 12-98 Cell 3 during the early 2000s. Periodically checking the drainage piping for water would provide early indication of water intrusion into the GG.
