# *Groundwater Level Trends on the Idaho Site*

*Nicole Hernandez (DOE-ID)*

*July 11, 2012*

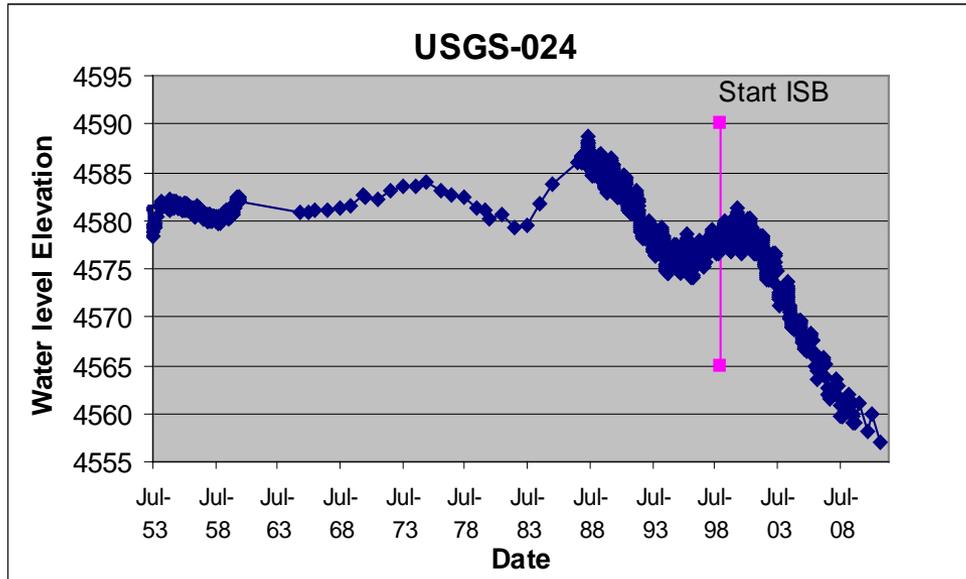
# WAG 1- Test Area North

Water levels at TAN have declined >20 feet since In-Situ Bioremediation (ISB) was initiated to treat the TCE source (Jan 1999).

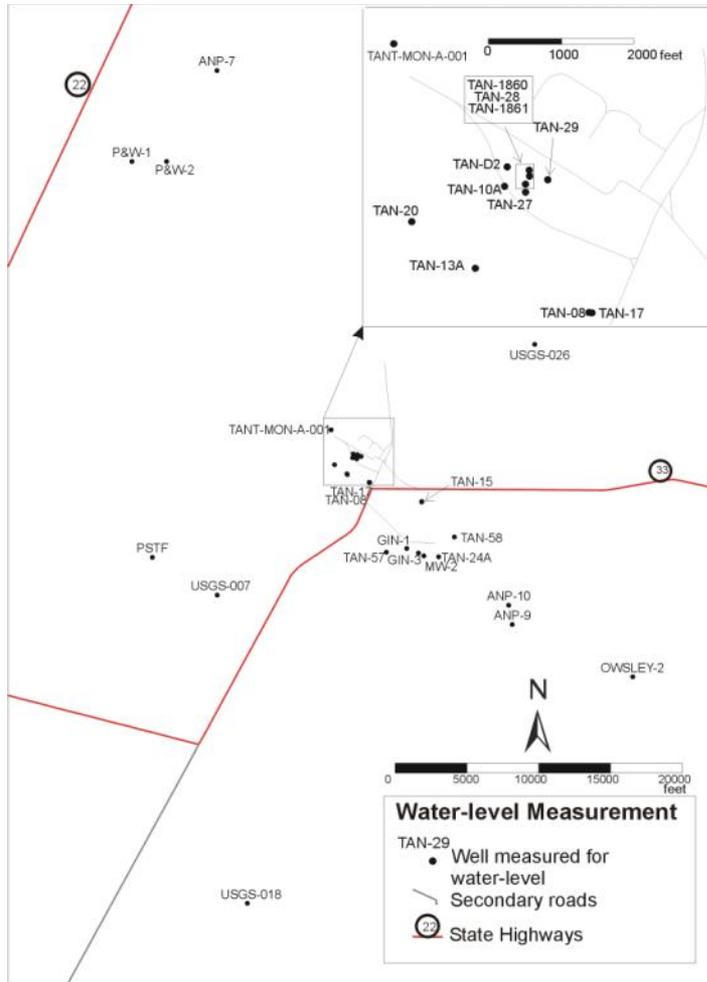
# WAG 1 Wells (Test Area North)

- Map shows wells used for water level map.
- Additional wells are used to support ISB activities.
- None of the required water-level monitoring wells are in immediate danger of going dry.
- The upper sampling interval in one ISB sampling well may go dry, but the well can still be sampled at the lower depth.

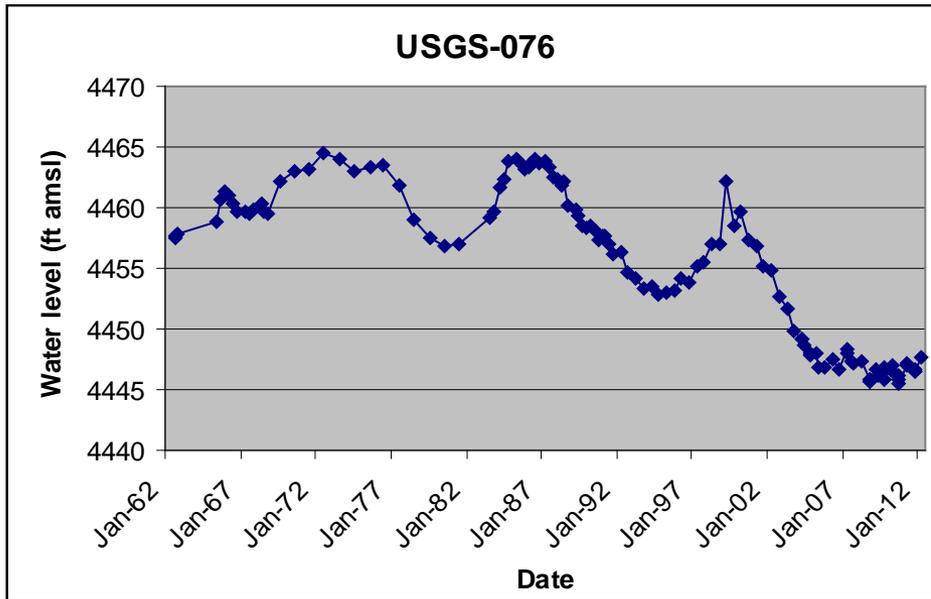
# WAG 2 (ATR Complex)

- Water levels have dropped >11 feet since 2000.
- Most of the decline happened during 2000-2005.
- Water levels have been relatively stable since 2005.

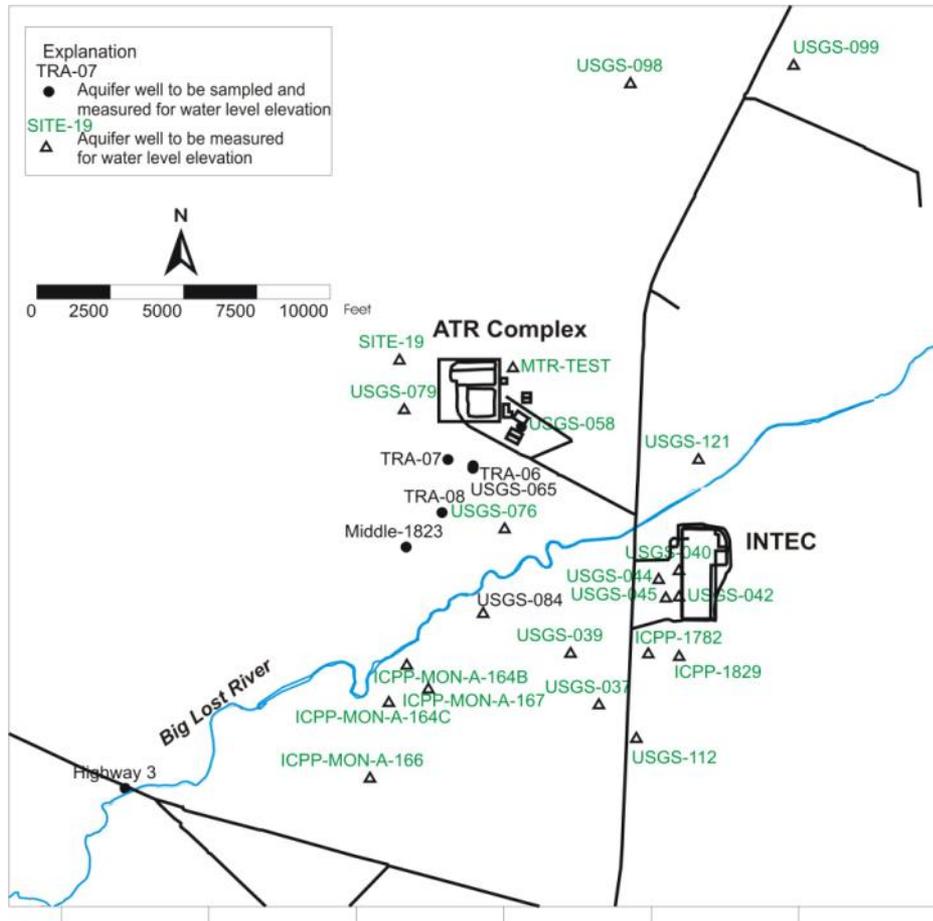
# WAG 2 Wells (ATR Complex)

- Well TRA-08 was deepened in 2010.
- If water levels continue to decline, USGS-065 may need to be deepened.

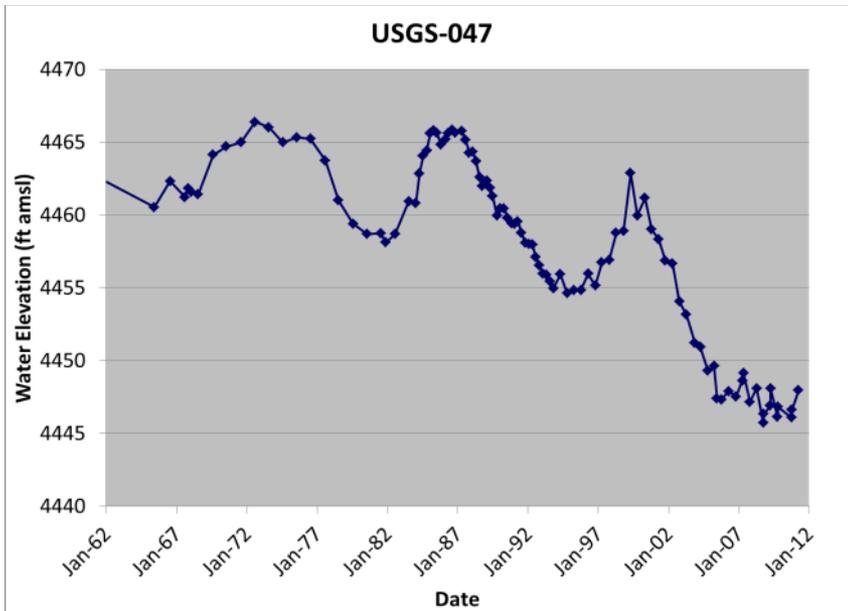
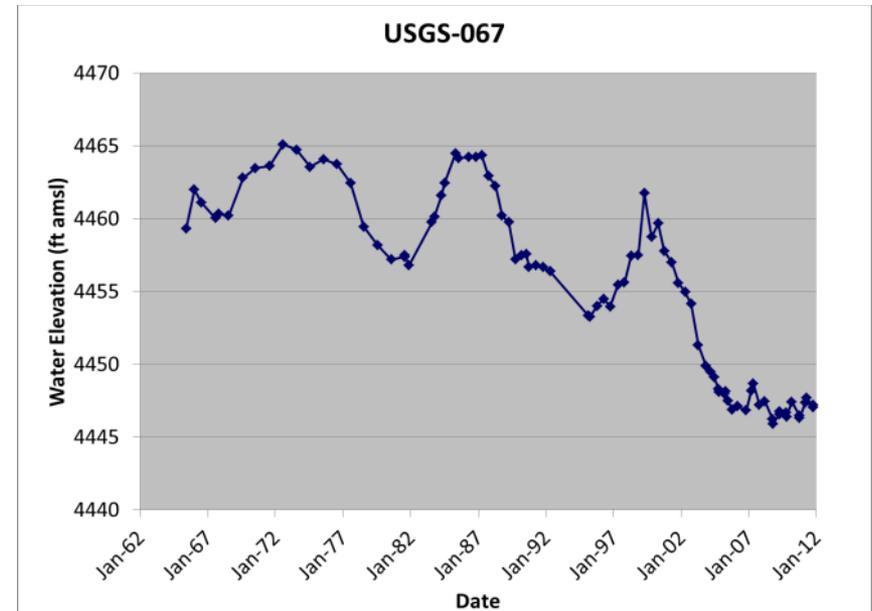
# WAG 3 (INTEC)

- Water levels have dropped >15 feet since 2000.
- Most of the decline occurred from 2000 to 2005.
- Water levels have been relatively stable since 2005.

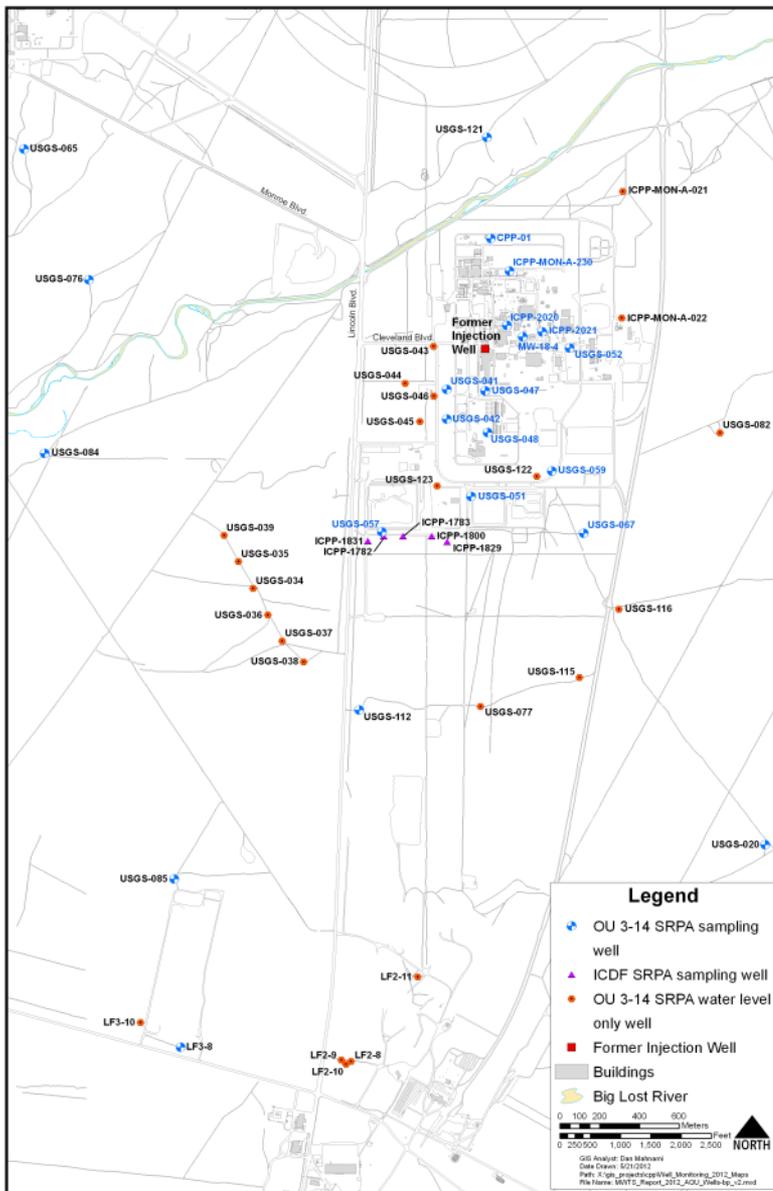
# WAG 3 Wells (INTEC)

- Well USGS-123 was deepened in 2004.
- If water levels decline 5+ feet, the following wells may need to be replaced or deepened: LF3-08, MW-18-4, USGS-121 (deepened).

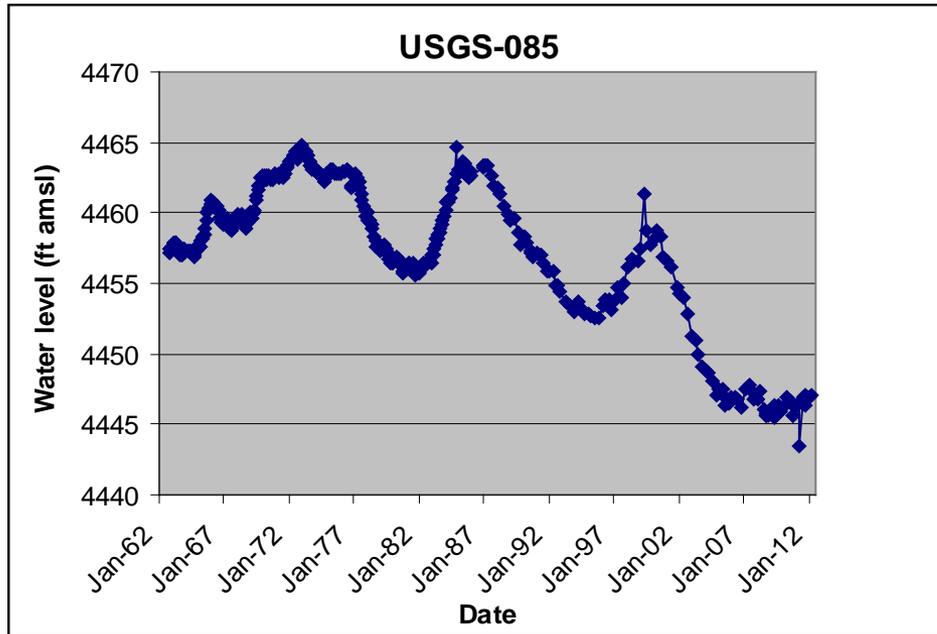
# WAG 4 (Central Facilities Area)

- Water levels have dropped approximately 11 feet since 2000, but most of the decline took place from 2000 to 2005.
- Water levels have been relatively stable since 2005.

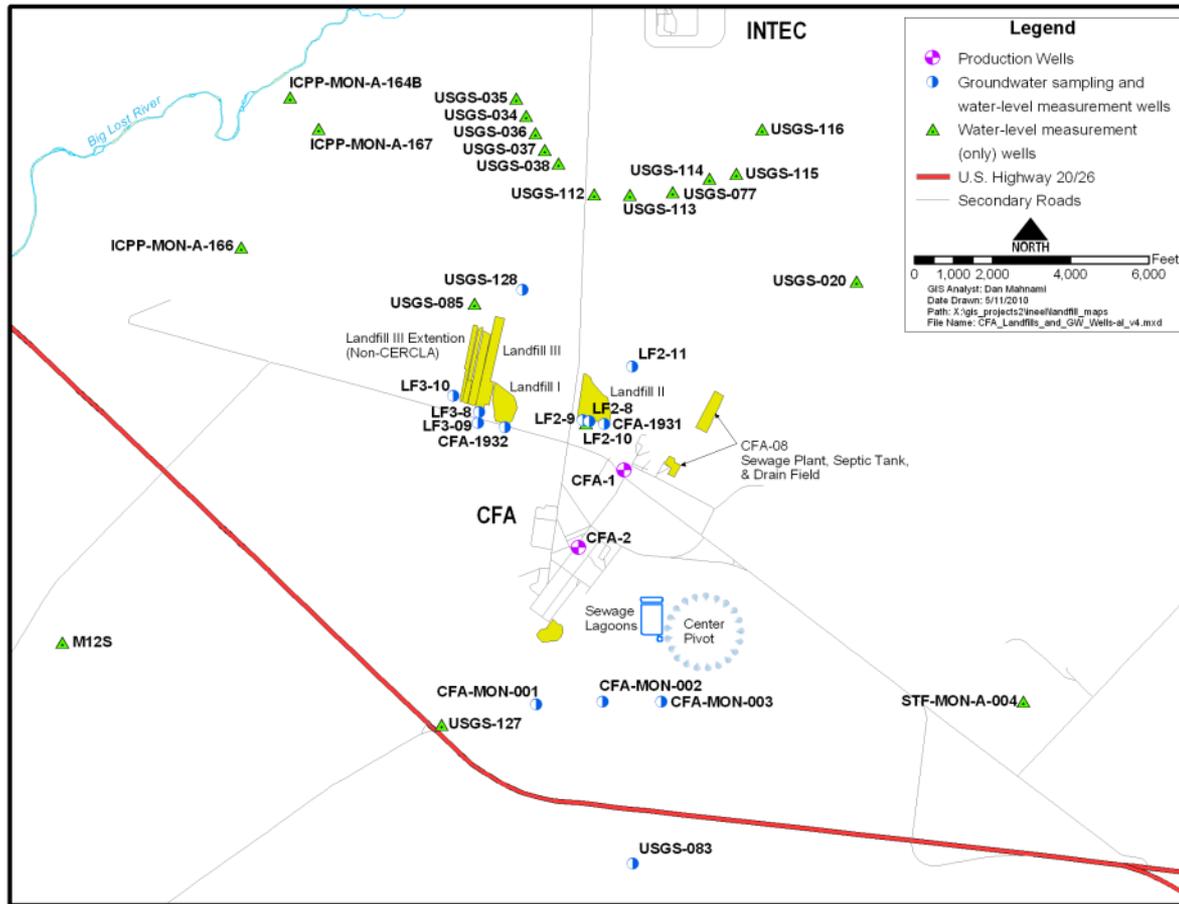
# WAG 4 Wells (Central Facilities Area)

- Pumps have been removed from wells LF2-08, LF2-09, LF3-08, LF3-09 and LF3-10.
- These 5 wells are currently sampled by bailer, and are in danger of going dry if water levels were to drop another 5-10 feet.
- LF3-09 and LF3-10 could be deepened, others would require replacement.

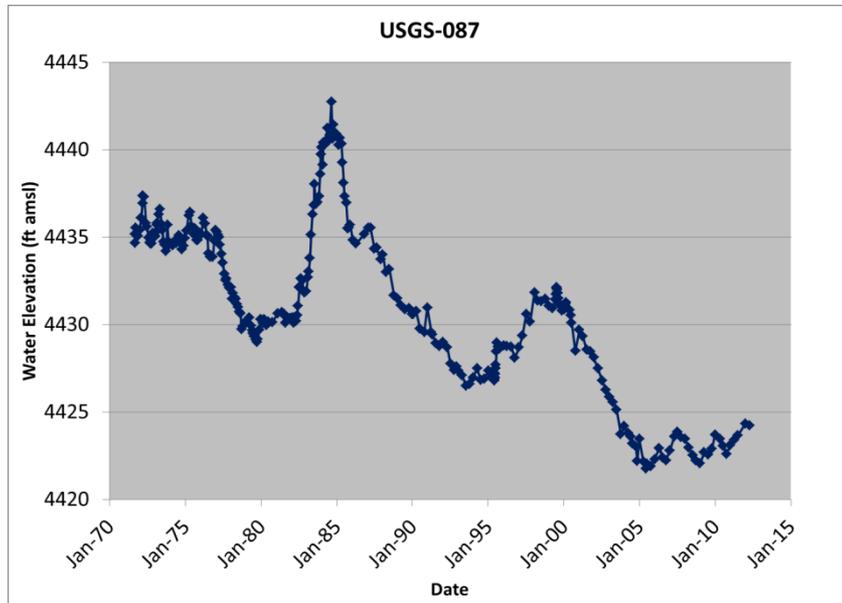
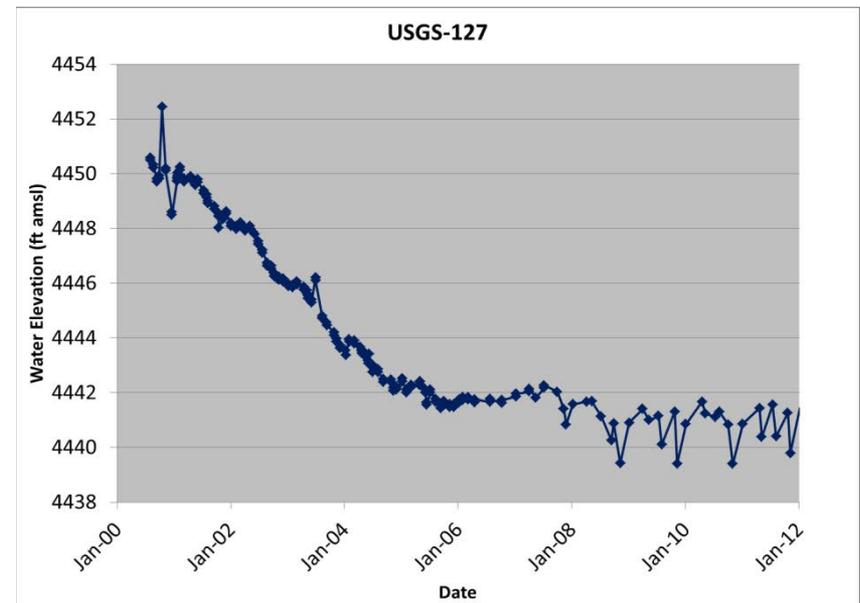
# WAG 7 (RWMC)

- Water levels have dropped approximately 9 feet since 2000, but most of the decline took place from 2000 to 2005.
- Water levels have been relatively stable since 2005.

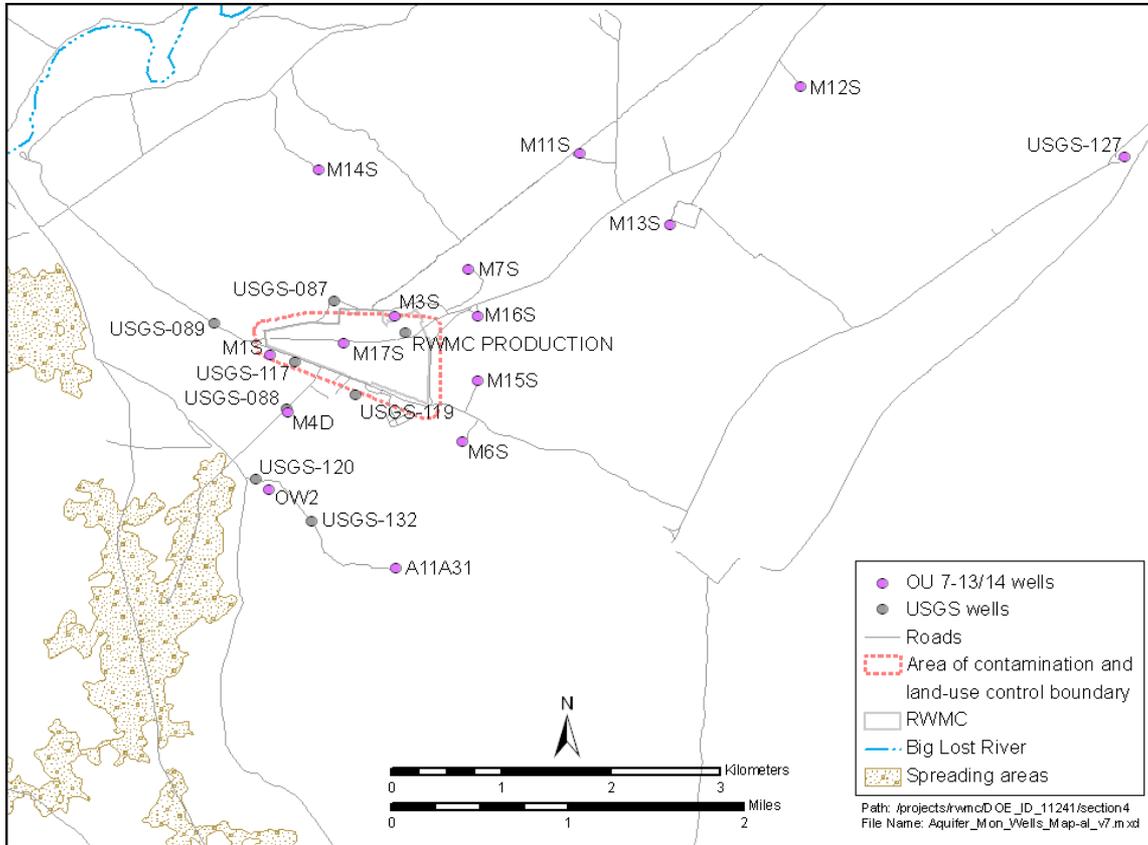
# WAG 7 Wells (RWMC)

None of the required aquifer monitoring wells are in danger of going dry.

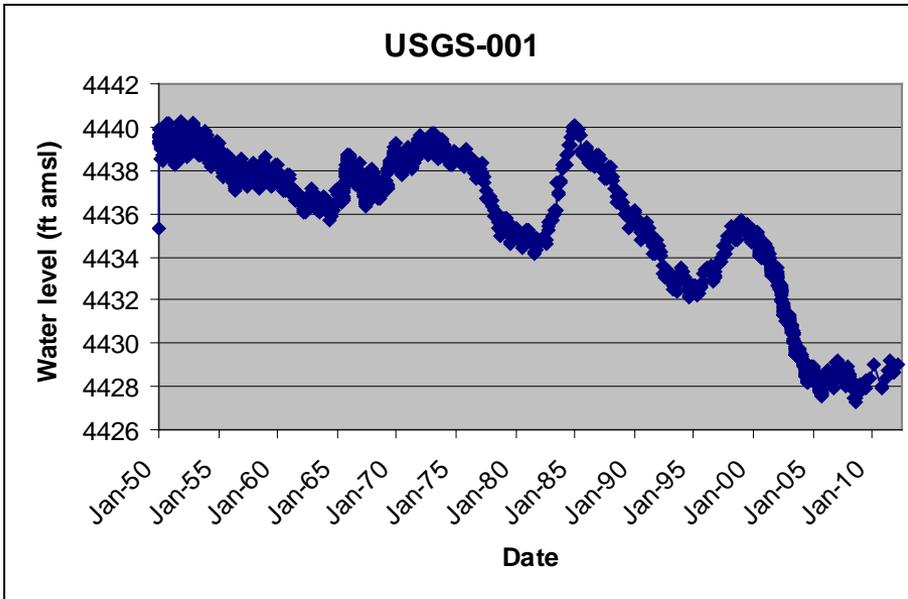
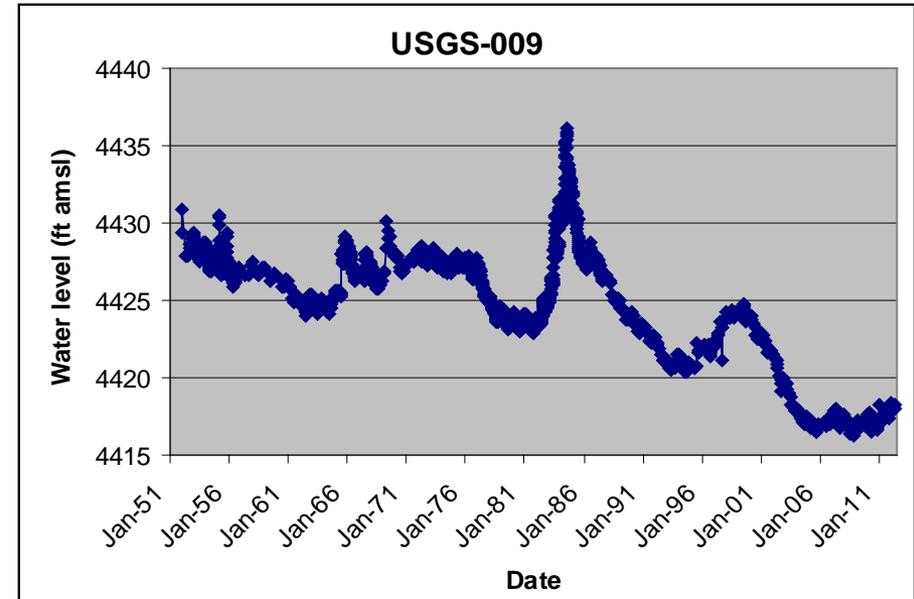
# WAG 10 (INL Sitewide Monitoring)

- WAG 10 monitors wells at and near the southern Site boundary.
- From 2000 to 2012, water levels dropped about 6-8 feet at USGS-001 and USGS-009.

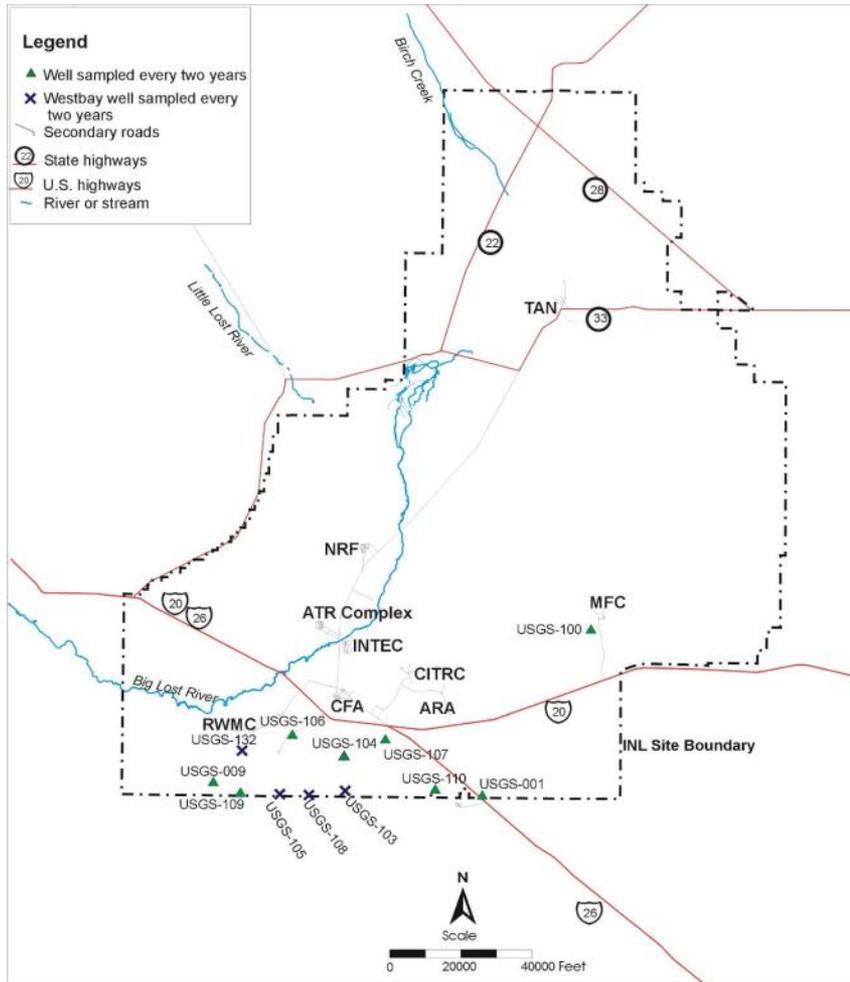
# WAG 10 Wells (Sitewide Monitoring)

- Water levels are currently measured only at wells that are sampled.
- Pumps may need to be lowered in USGS-100 and USGS-106 if water levels decline further.

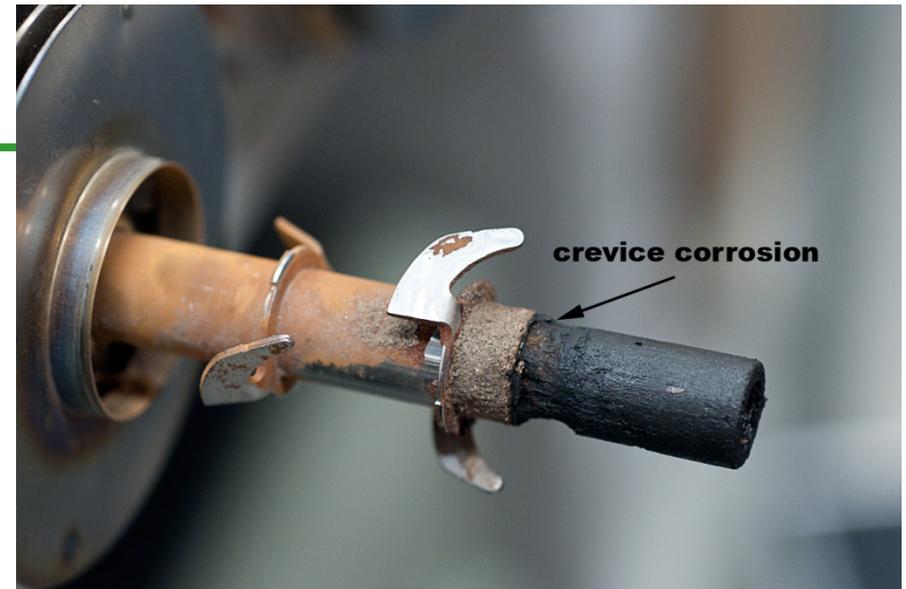
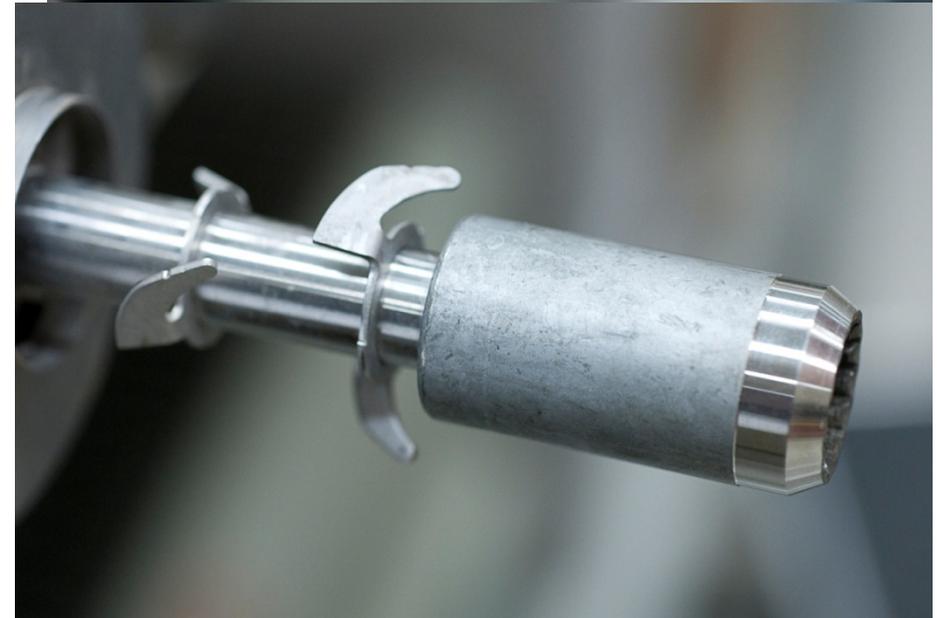
## Corrosion Evaluation

- Issues
  - Failure to pump water to the surface
  - Broken drive shafts
- Corrosion Evaluation
  - Dissimilar metal pump components
  - Pitting/thinning and buildup on pumps
- Corrective actions
  - Purchased pumps with same type of stainless steel components
