## Radiological Release Accident Investigations at the Waste Isolation Pilot Plant (WIPP) on February 14, 2014

Gary T. Staffo, PE, CSP, CPE  
Manager - US DOE Accident Prevention and  
Investigation Program  
Office of ES&H Reporting and Analysis

## Introduction

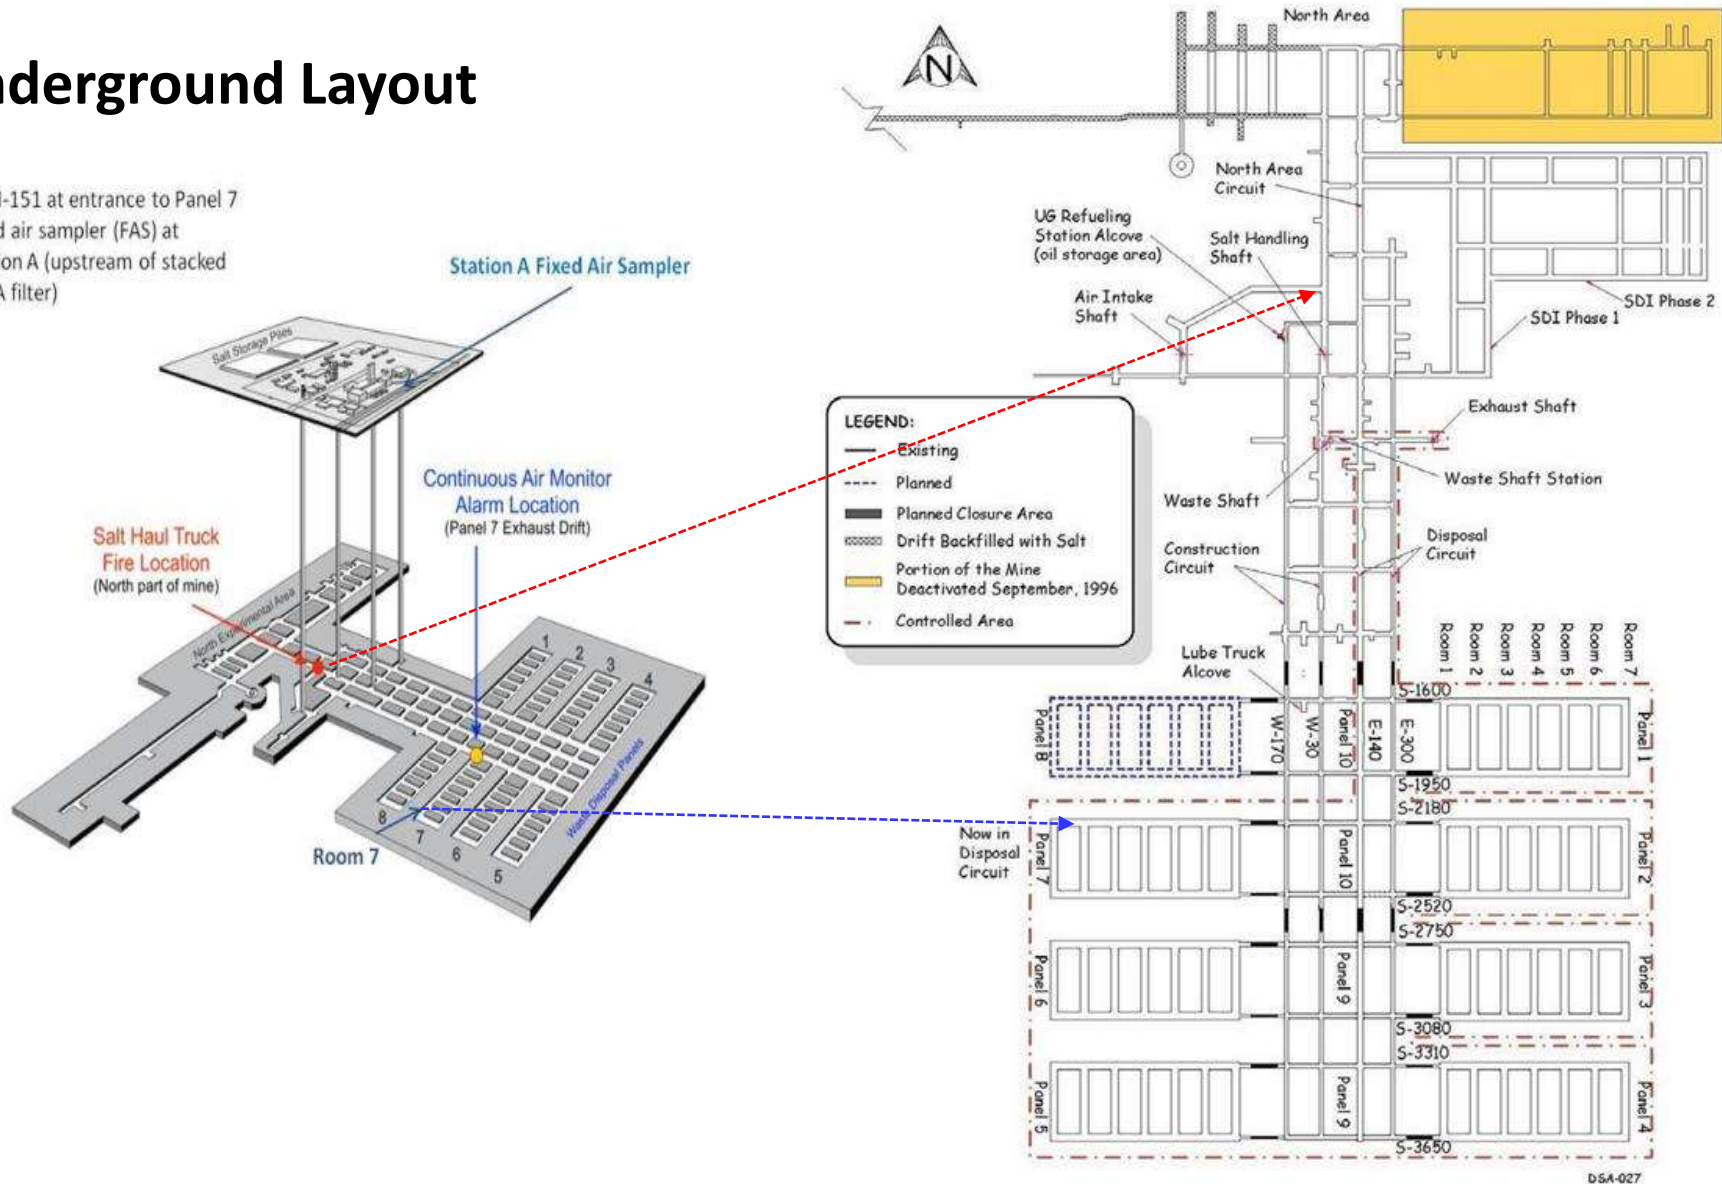
- CAM-151 at entrance to Panel 7
- Fixed air sampler (FAS) at Station A (upstream of stacked HEPA filter)

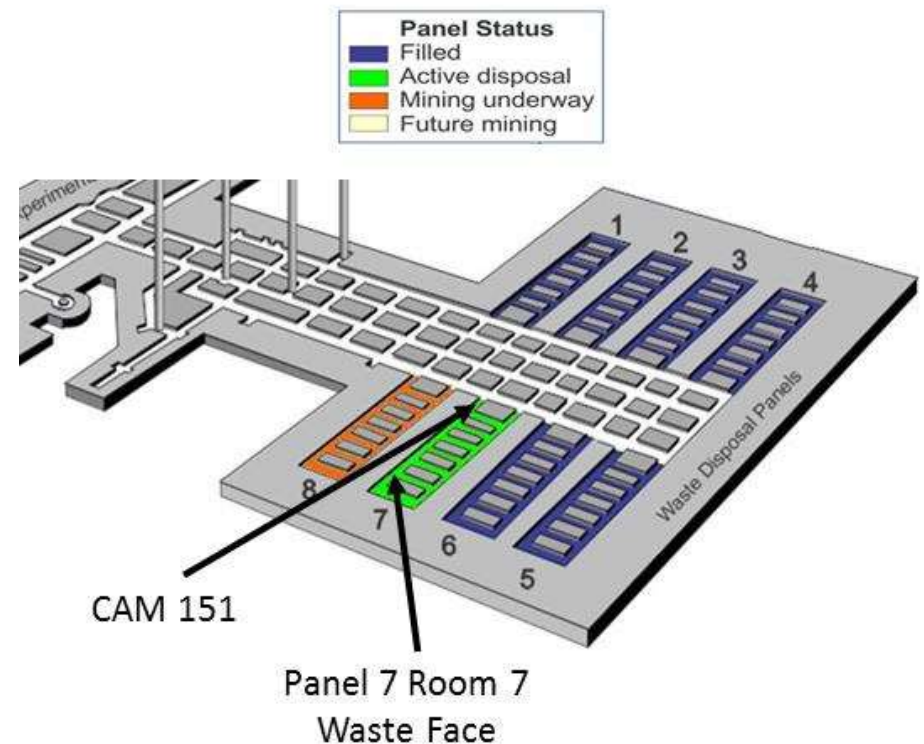
**Location of Panel 7 and CAM-151**

- Shortly after **11:10PM**, a release was detected by an underground continuous air monitor (CAM) which was monitoring airborne radioactivity levels in air exhausting from **Panel 7**, an active waste panel where TRU waste was being emplaced for disposal.
- An alarm was received on the Central Monitoring System (CMS) in the Central Monitoring Room (CMR) at the WIPP surface which initiated a shift to filtration of the underground ventilation.
- At approximately **11:13 PM**, a “HI RAD” alarm from CAM-151 was received on the CMS. *The “HI RAD” setpoint for this CAM is 30 Derived Air Concentration (DAC) for alpha and beta contamination.*
- Approximately one minute later, a “HI-HI RAD” alarm from CAM-151 was received on the CMS. *The “HI-HI RAD” setpoint is 50 DAC.* The CMS indicated that the CAM reading was **332 DAC**.

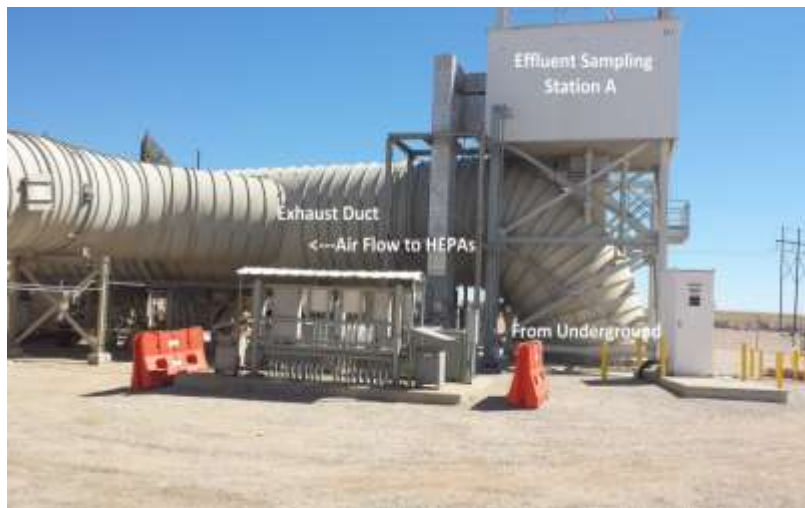
**Effluent Sampling Station A**

- On Saturday, **February 15, 2014**, the filters were counted at **7:15 AM**; the *RCM reported 4.4 million disintegrations per minute (dpm) alpha contamination on the filters from the effluent sample station upstream from the HEPA filters (Station A). Preliminary data indicated the presence of TRU materials.*

- **Station A** is *located over the underground ventilation exhaust elbow at the surface and samples using probes that extend 21 feet below the elbow in the Exhaust Shaft*. Station A contains three sampling skids, each splitting the sample and directing the air into three air samplers per skid.
- **Station B** samples from a point *downstream from the UVS fans and HEPA filters*. Station B contains two sampling skids, each splitting the sample and directing the air into three air samplers per skid.
- The effluent samplers collect *periodic* confirmatory particulate samples from the total volume of air being discharged. The samplers consist of a sample delivery system, a filter holder, and a vacuum supply.

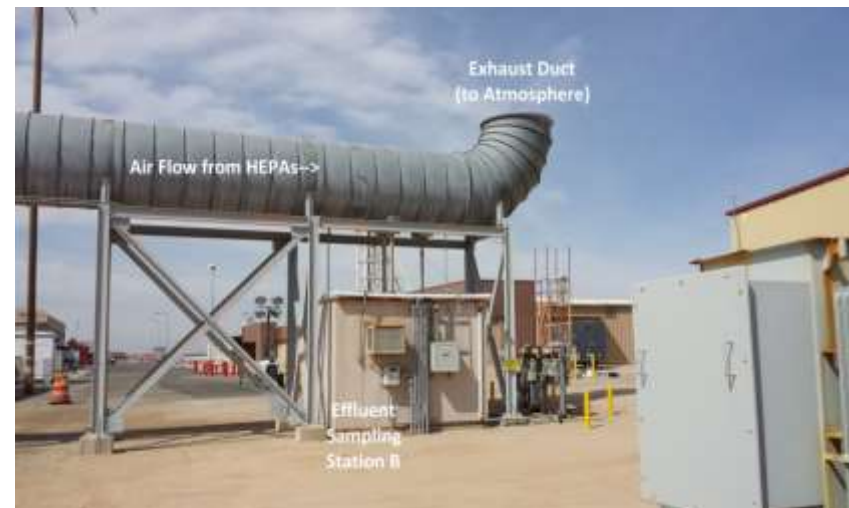
**Effluent Sampling Station B**

- Results from analysis of filters from the effluent sample station downstream of the HEPA filters (**Station B**) and at the discharge point to the atmosphere were reported at **9:15 AM** and *indicated 28,000 dpm alpha and 5,900 dpm beta contamination. This was the first indication that there was a release of contamination downstream of the HEPA filters to the environment.*

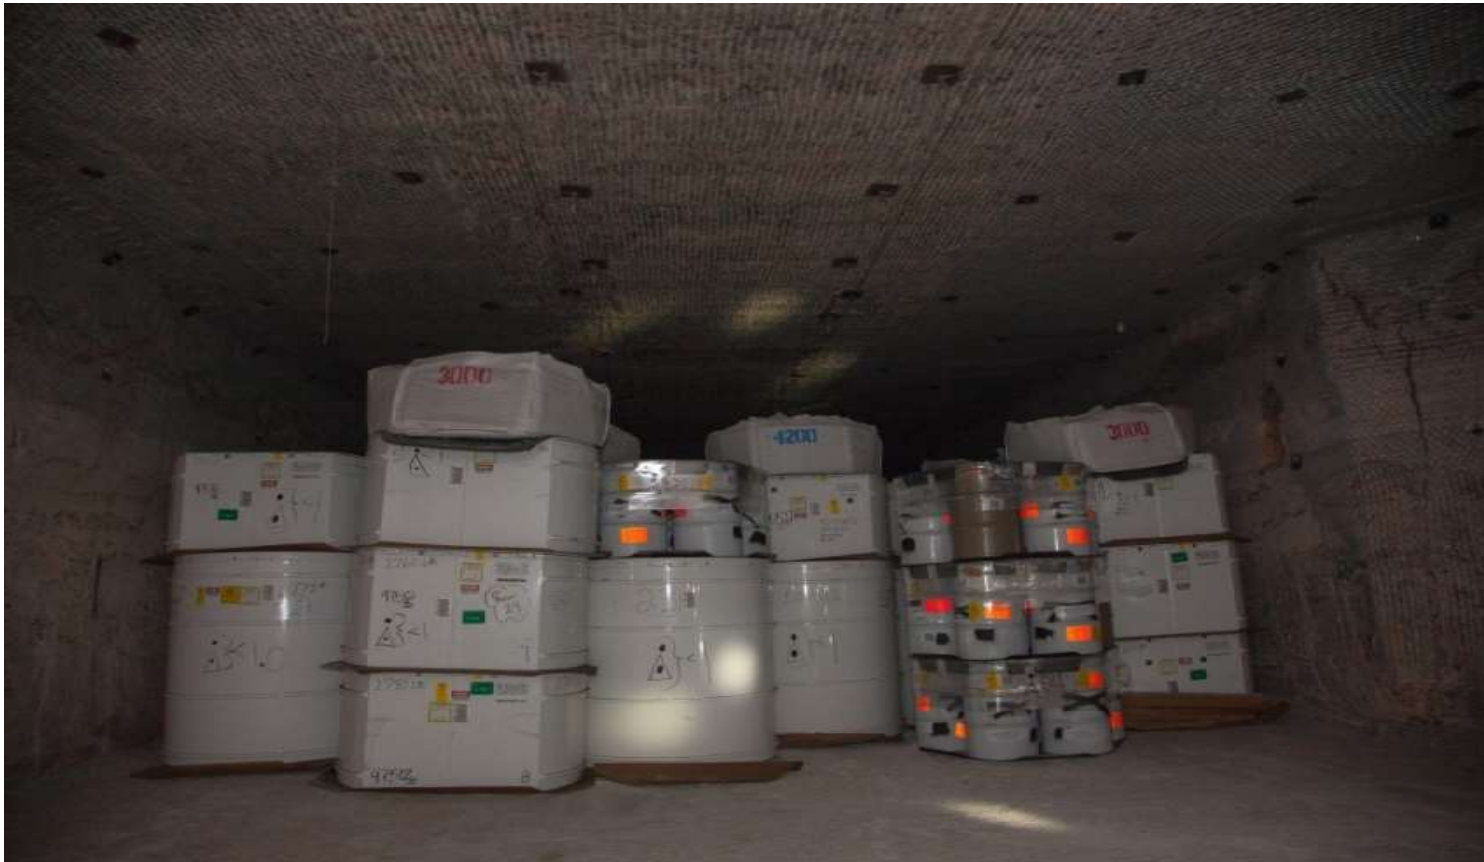
This photo of the **Panel 7 Room 7** waste face was taken only a few hours *prior* to the release event during an underground survey by the AI Board .
