# Joint Accident Investigation Report

**Construction Lifting Accident  
at the Los Alamos National Laboratory  
Results in Serious Injuries  
to a Subcontract Employee  
on December 19, 2018**

February 1, 2019

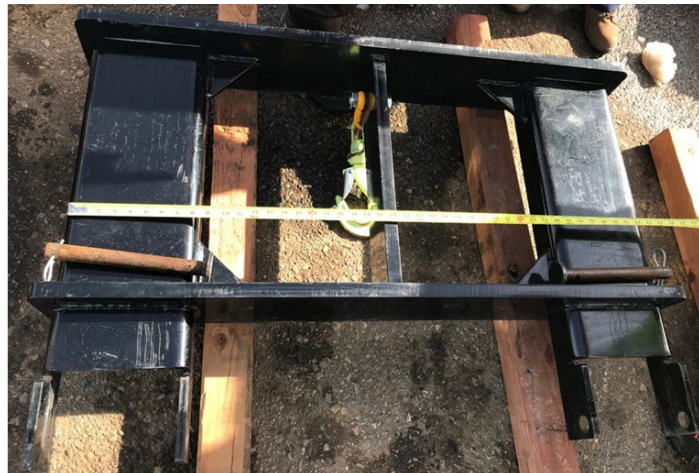
The safety pins for the JLG forklift attachment, which were required to safely secure the attachment to the forklift tines, were not permanently affixed to the attachment (Fig. 4). When not in use, the common practice was to store the safety pins in a side compartment within the cab of the JLG forklift. A1, J1, and J2 indicated they frequently used the JLG forklift with the attachment to perform material handling activities in the laydown yard.

Figure 4: JLG Telehandler Forklift Attachment with Safety Pins Not Inserted.

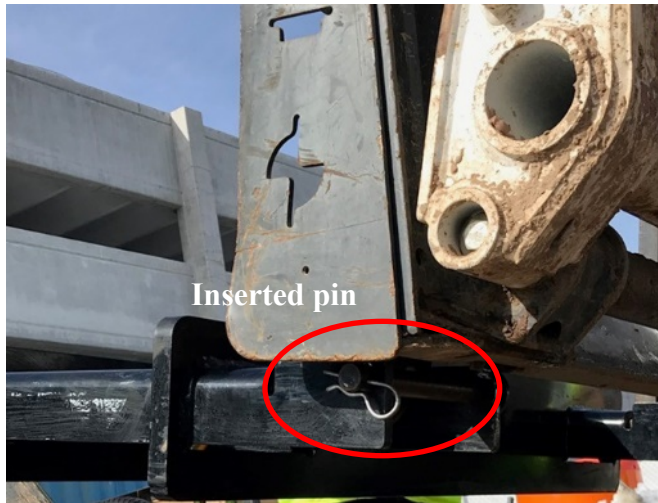
Although not designed or intended to be used with the Bobcat, the JLG forklift attachment fit over the Bobcat’s forklift tines.

Figure 6: JLG Forklift Attachment on Bobcat with Safety Pins Installed.

The crew in the laydown yard placed this lifting attachment onto the Bobcat’s forks and used it to perform material handling activities (Fig. 6). According to eyewitness accounts, on previous occasions when the Bobcat was used for lifting flanges, the crew had secured the attachment with the safety pins that held the lifting attachment in place. A1, who operated the Bobcat, was qualified to use both the JLG forklift and the Bobcat. Employees who were familiar with both machines indicated that the JLG forklift had more precise- and smoother- controls and that the boom assembly was more versatile.

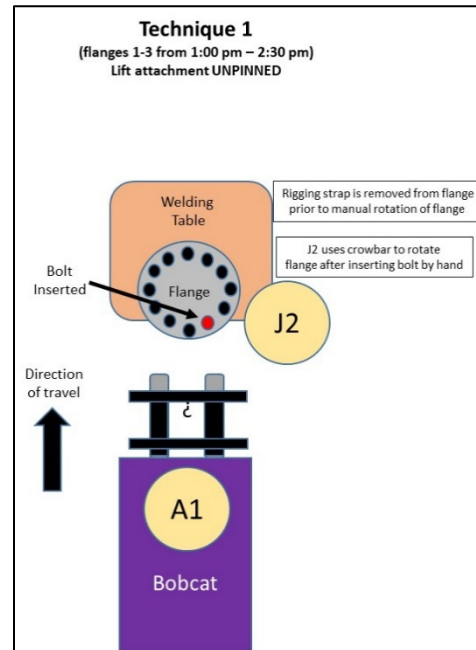
One technique to insert the bolts that was used by J2 (Technique 1) required the flange to be initially staged on the table so that a small area of the flange hung over the edge of the table. Following Technique 1, A1 and L1 staged the flange on the table with a small area hanging over the edge as depicted in Figure 8.

Figure 8: Technique 1 used for flange lifts 1–3 from 1:00PM–2:30PM.

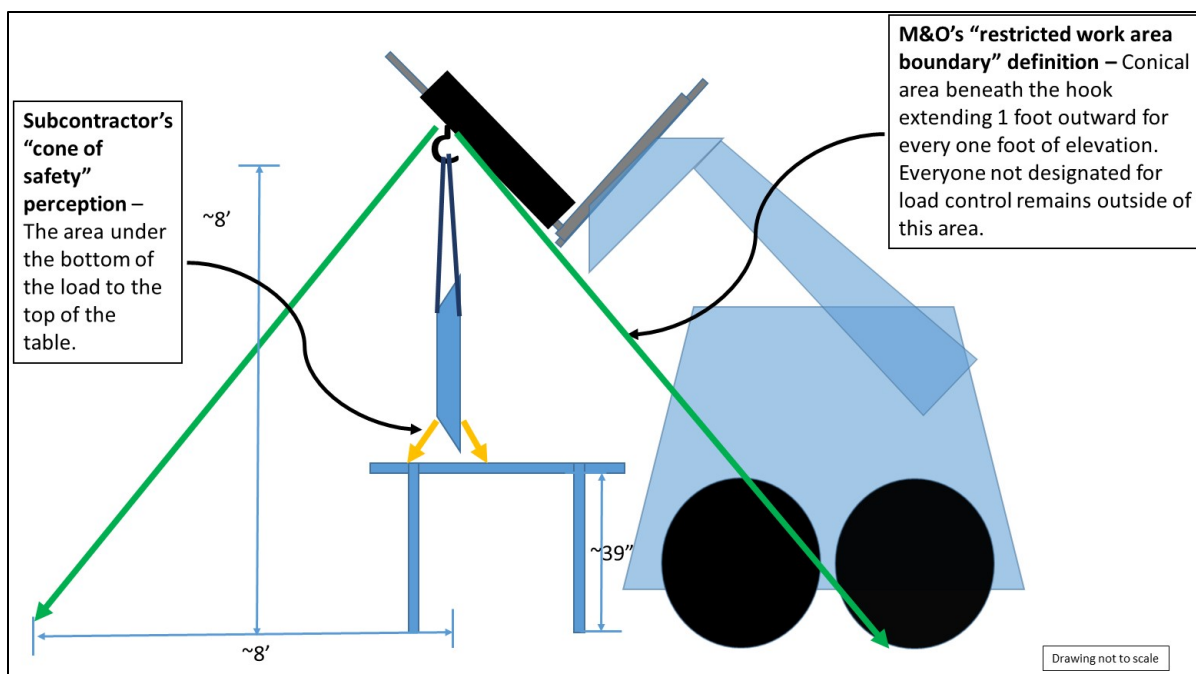
At the beginning of this last lift, the forklift tines were approximately 8-ft high, and the forks of the Bobcat were inclined. However, as A1 lowered the flange with the Bobcat's boom, the angle of the tines gradually declined toward horizontal. Using Technique 2 required all crew members to focus on the position and placement of the flange. Consequently, their attention was more on the flange immediately in front of them rather than the tines overhead. In using Technique 2, L1, J1, and J2, and to a lesser extent A1, were all within the restricted work area boundary and under the load beneath the attachment's lifting hook (Fig. 10). J1 was also directly in the path of the JLG forklift attachment and flange.

Figure 10: Diagram of restricted work area boundary for flange lift.

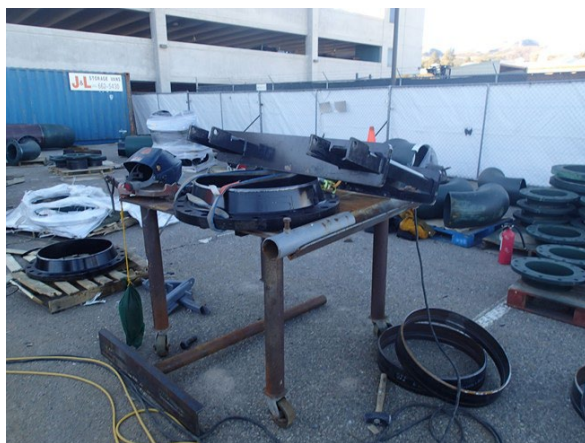
As the flange was getting close to lying flat on the bolts, J1 was leaning over the end of the table opposite the Bobcat, which positioned his arms, head, and upper torso above the flange but under the JLG forklift attachment. A1 continued to position the flange in the middle of the table and over the bolts by lowering the boom and slowly backing the Bobcat. When the flange was almost flat on the bolts, the 350-pound JLG attachment suddenly slid off the forks of the Bobcat and struck J1 in the face, arms, and upper torso (Fig. 11).

Figure 11: Welding Table with JLG Forklift Attachment and Flange after Accident.

Because all of the crew members were focused on the placement of the flange at the time of the accident, none of them could recall or explain exactly how the forks dropped below horizontal or how the attachment slipped off of the forks. A1 did not recall making any movements to the Bobcat controls that would have resulted in the forks suddenly shifting to a downward position. However, during the simulation following the accident, the operator for the simulation noted that the Bobcat controls were very sensitive and even touching the foot pedal that controlled the fork angle resulted in a sudden, jerky, downward

motion. Absent clear recollections of the eyewitnesses at the scene, inadvertent tapping of the foot pedal could have caused a sudden response of the controls and caused the forks to unexpectedly tilt below horizontal, which could have resulted in the attachment sliding off the forks.
