National Nuclear Security Administration

Accident Investigation Report

**Office of Secure Transportation
Vehicle Accident Resulting in a Fatality and
Serious Injuries to Four Additional Federal
Agents near Okemah, Oklahoma
on October 5, 2018**

January 2019

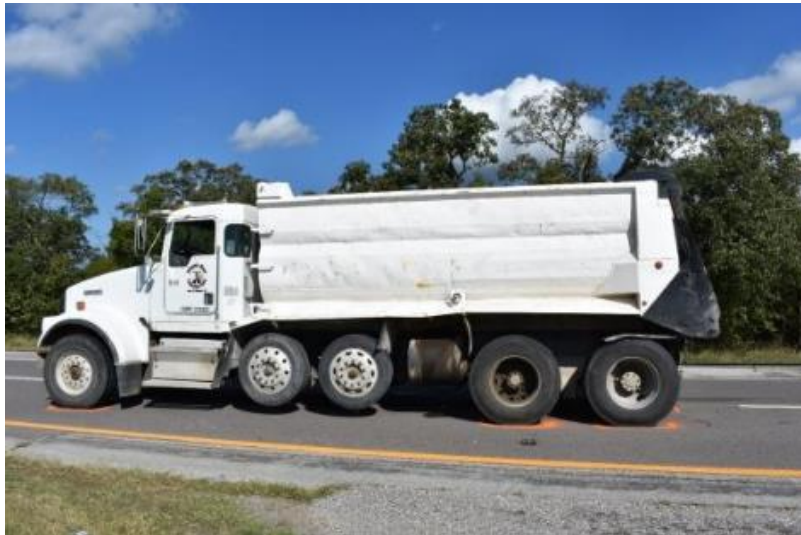
Figure 2-5. Photo of Dump Truck Involved in the Accident

The Dump Truck involved in the accident was a 1996 Kenworth with Minnesota license tag number YBP5657 (Figure 2-5). The Dump Truck is owned by Winding Road Construction Company of Big Fork, Minnesota. At the time of the accident, the Dump Truck was loaded with slabs of concrete removed from the highway as part of the construction project on I-40 near Okemah.

A post-accident inspection of the Dump Truck by the OHP revealed the brake lights and turn signals (front and rear) were not functioning. The upper taillight/brake light was barely visible from the rear and the yellow warning lights mounted on the outside mirrors were not visible from the rear.

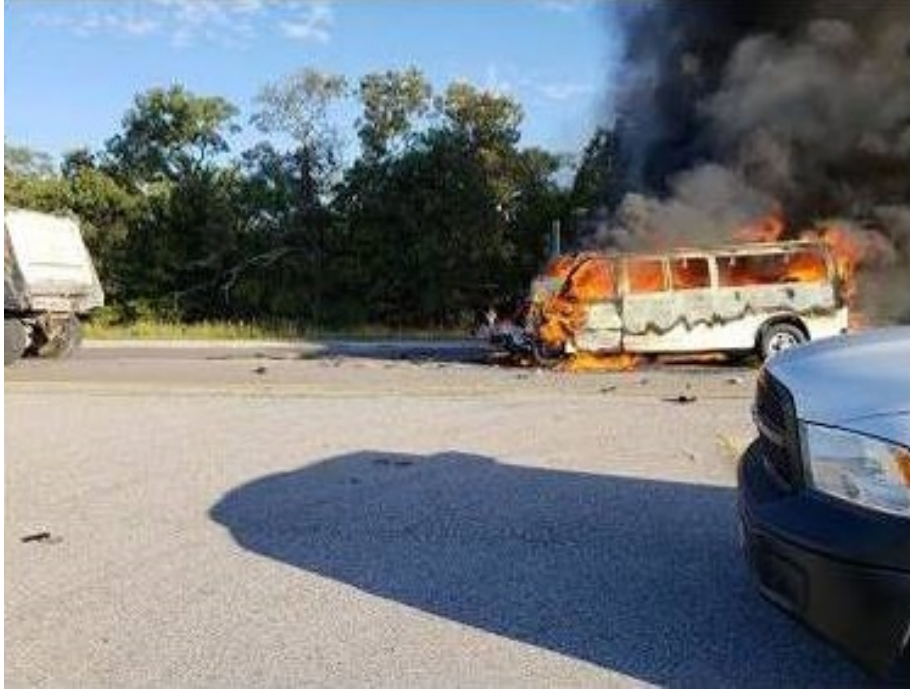
Figure 2-7. Photo Taken by Airman of Van on Fire Shortly After the Collision

After the accident, Van 1 was completely engulfed in flames (Figure 2-7). The intensity of the fire was verified through interviews with witnesses at the scene, as well as reviews of the dash cam video and audio from the first responding OHP State Trooper. The fire was confirmed to have started in the front of the vehicle but quickly spread to the remainder of the van – igniting the fuel tank. Several witnesses at the scene, including two law enforcement officers and the local fire chief, stated that they heard what sounded like rounds going off from inside Van 1 and “fireworks like” explosions from the passenger area.

One of the law enforcement officers at the scene stated that he believed the fire spread quickly after the initial explosion(s). Some witnesses stated they were told by Federal Agents at the scene of the accident to be careful because there were “rounds going off” inside of Van 1. An unknown Federal Agent at the scene was heard on dash cam audio identifying himself as a Federal Agent and telling someone that the sounds they heard were rounds going off. Other related comments by Federal Agents at the scene were also heard on dash cam audio.

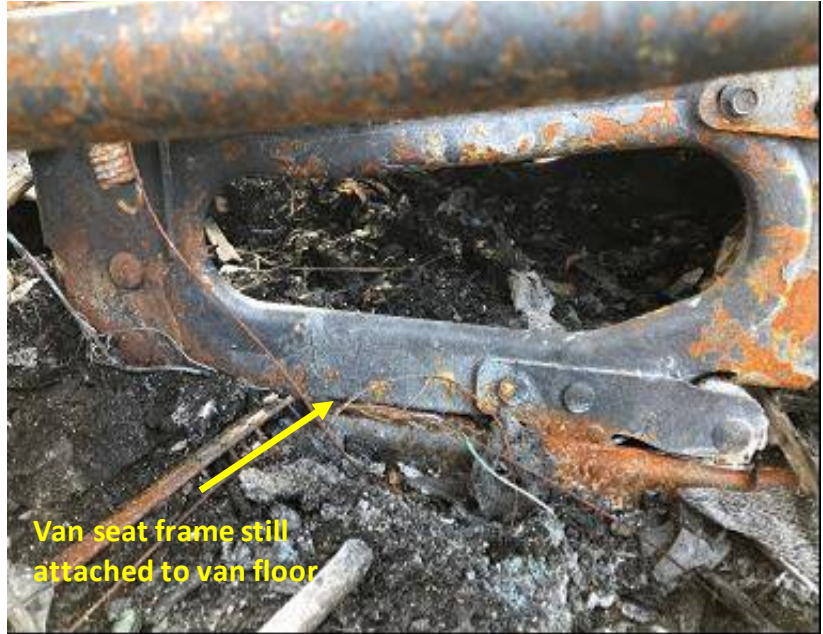
Figure 2-8. Bottom Frame of Van Seat

The Board confirmed that with the exception of the driver's seat, all the seats remained securely fastened to the floor of the van (Figure 2-8). Accident scene photos indicate the driver's seat bent up and forward, [The driver's seat was removed at the crash site at the request of the OHP investigating officer to see if there were any remnants of the airbag control module under it so the Board could not verify if it had broken loose.]

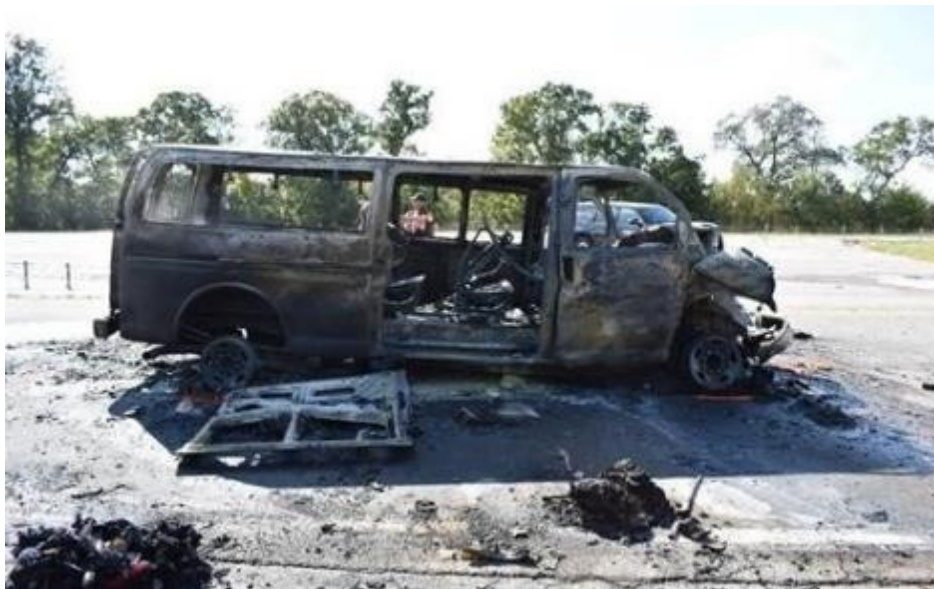
Figure 2-9. Side View of Van Damage from Fire and Collision

The airbag control module, also known as the airbag electronic crash unit, was destroyed as a result of the high intensity fire and no information could be obtained from it. The seat belt pretensioner devices were also destroyed, and they could not be removed for examination to determine if they had been activated. It could not be determined if the airbags had actuated because there were no remaining remnants of the airbags due to the fire (Figures 2-9 and 2-10).

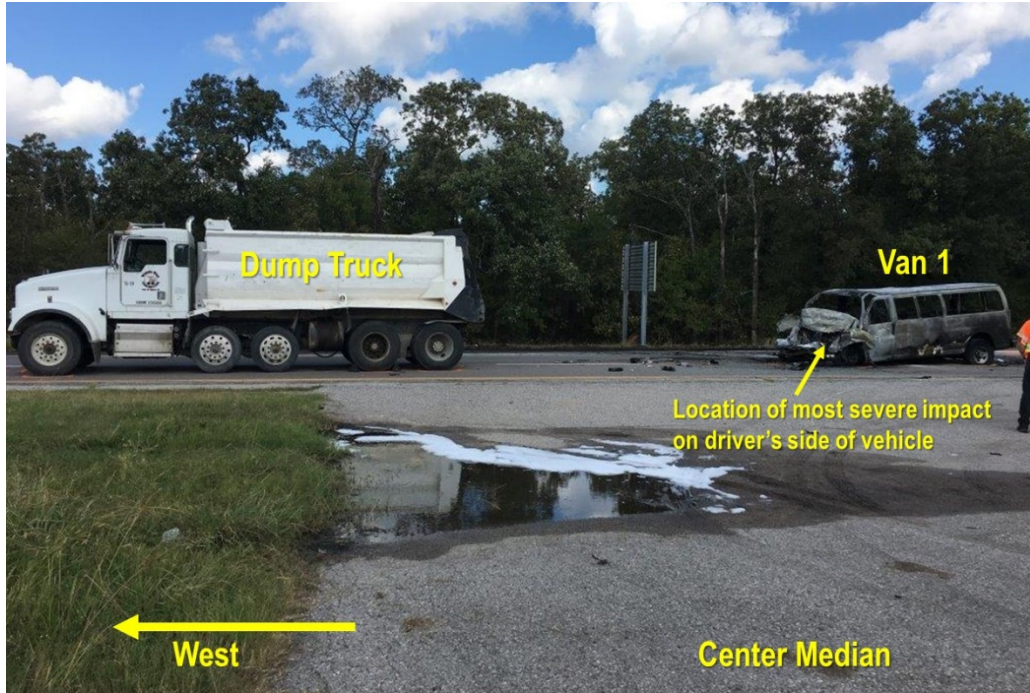
Figure 2-13. Photo Taken at the Accident Scene

The Dump Truck was a 1996 Kenworth dump truck described in Section 2.4.2. "The Vehicle" with a single driver and no occupants (Figure 2-13). The Dump Truck was hauling concrete slab debris from a construction area in the work zone to a dump site in Henryetta (east of the accident site).

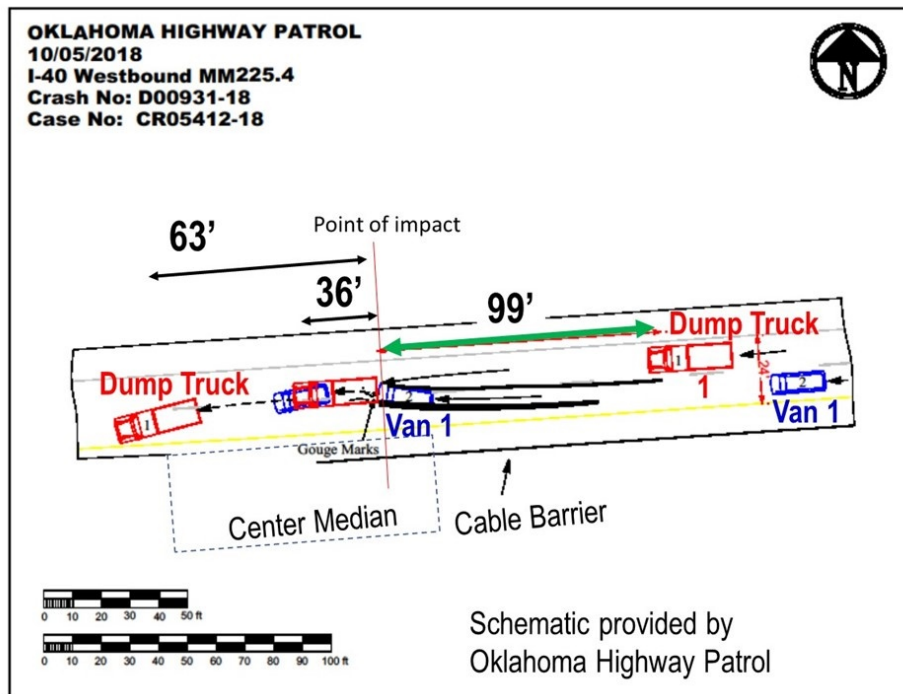
Figure 2-15. Schematic of Collision Scene from OHP Department of Public Safety

According to the OHP Report, the Dump Truck was on the shoulder, west of where the lane closure ended, either stopped or moving slowly. There were an unknown number of vehicles in front of the van as it came out of the lane closure. After the lane closure ended, the Dump Truck was in the right lane near the shoulder. The Dump Truck driver began moving towards the left lane to cross the center median at a location where there was an opening in the cable barrier. As he approached the break in the barrier, he slowed to complete the U-turn. Van 1 driver noticed the Dump Truck and sped up to pass. The Dump Truck driver stated that as he moved into the left lane, he noticed a van moving up behind him at a high rate of speed. Van 1 driver realized that the Dump Truck had moved into the path of the van, braked hard as he swerved to the right in an evasive action. About the same time, the Dump Truck driver attempted to move back into the right lane to avoid colliding with the van. At this point, Van 1 struck the rear of the Dump Truck. The Dump Truck came to a controlled stop approximately 63 feet west and approximately eight feet south of the initial impact area. Van 1 came to rest approximately 36 feet west of the initial area of impact (Figure 2-15).

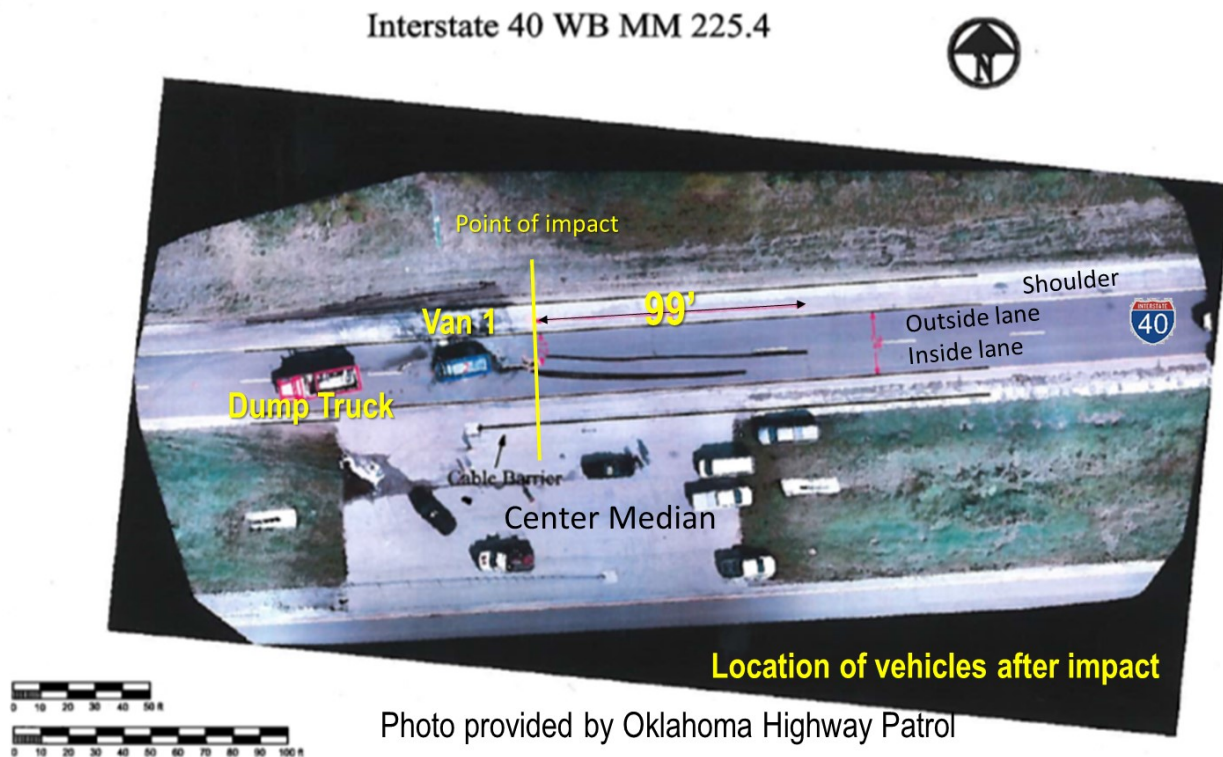
Figure 2-16. Drone Photo of Collision Scene from Oklahoma Highway Patrol Collision Report

The Dump Truck driver stated to an OHP Trooper that he was driving 55 mph in the right lane and was going to turn across the median at a location where there was an opening in the cable barrier. He further stated that when he looked, there was nobody in the left lane so he moved to the left lane (Figure 2-16). As he began to slow to make a left turn into the median, Van 1 approached him from the rear at a high rate of speed and struck the rear of the Dump Truck. There was no indication of lane change provided by the Dump Truck because the brake lights and turn signals were not operating on it. The front seat passenger in Van 1, FA 3, stated that he recalls the Dump Truck veering back to the right at the last moment in an attempt to avoid the collision but ended up in the path of Van 1 who was steering right to avoid the Dump Truck.

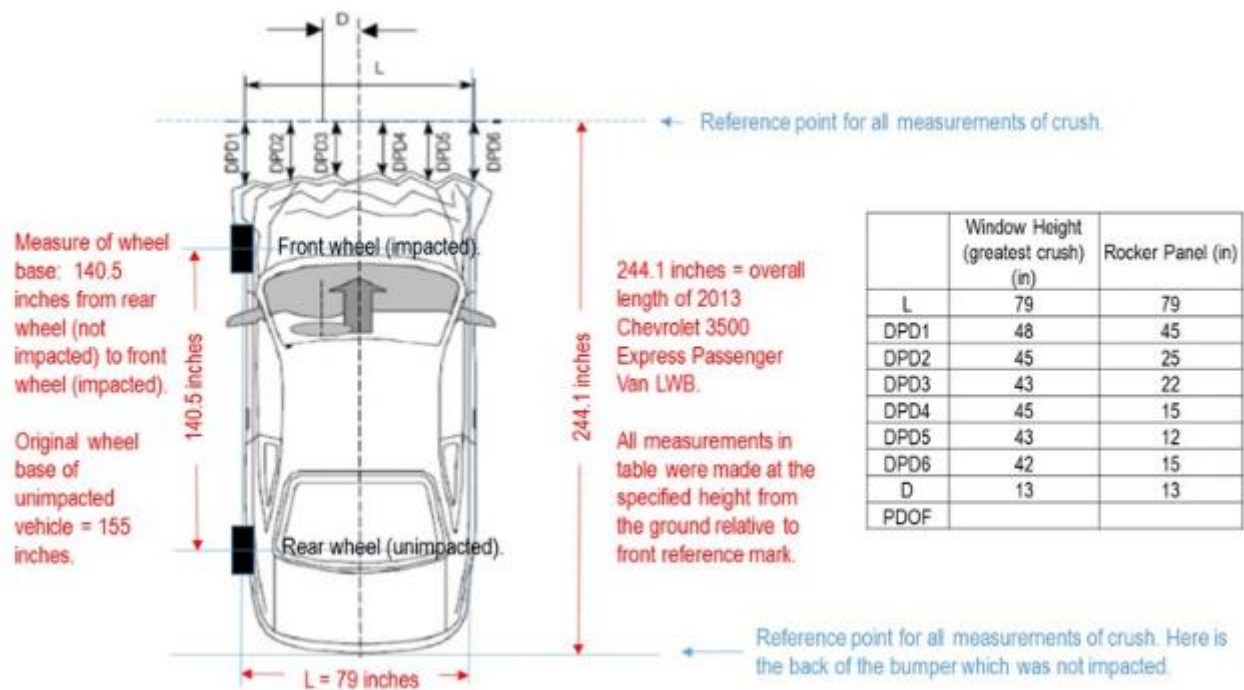
Figure 2-17. Vehicle Deformation Measurements to Support EDCRASH Analysis

The independent vehicle accident consultant’s analysis indicated that the speed of the Dump Truck was between 27 mph to 35 mph at time of impact based on post-crash controlled braking using a range for braking efficiency. His analysis also indicated a speed loss of 60 to 65 mph to Van 1 due to impact. Accounting for 99 feet of skid marks, the independent vehicle accident consultant determined that the speed of Van 1 prior to taking evasive actions was between 75 to 80 mph (exceeding the posted 55 mph speed for the construction zone by 20 to 25 mph).

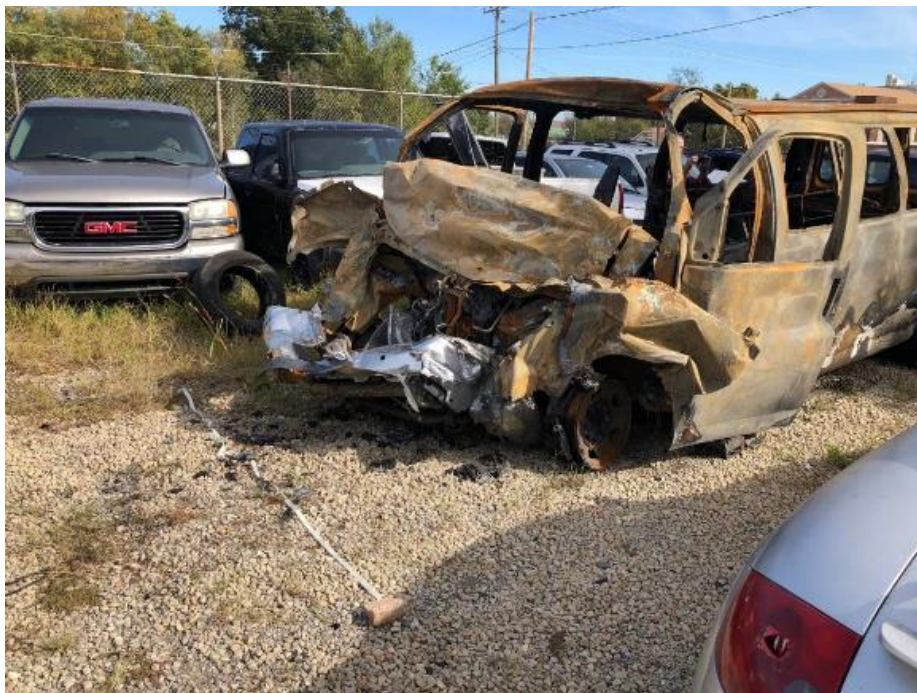
Figure 2-19. Photo Showing Extensive Damage to Front of Van

The front end of Van 1 was severely crushed, pushing the engine back into the occupant compartment. There was also significant damage to the backs of the first and second bench seats, presumably from the occupants of the seats behind them impacting the backs of the seats.

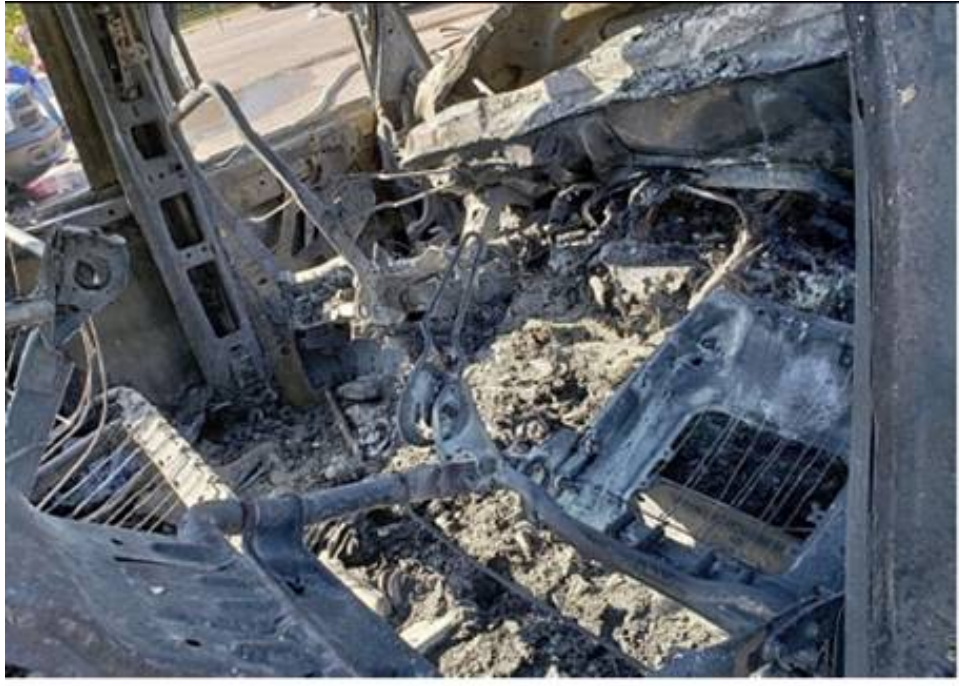
Figure 2-23. Driver's Seat Deformation Due to Rear Impact

seat 2. Additionally, the degree of deformation in the driver's seat (Figure 2-23) indicates significant impact from behind the seat.

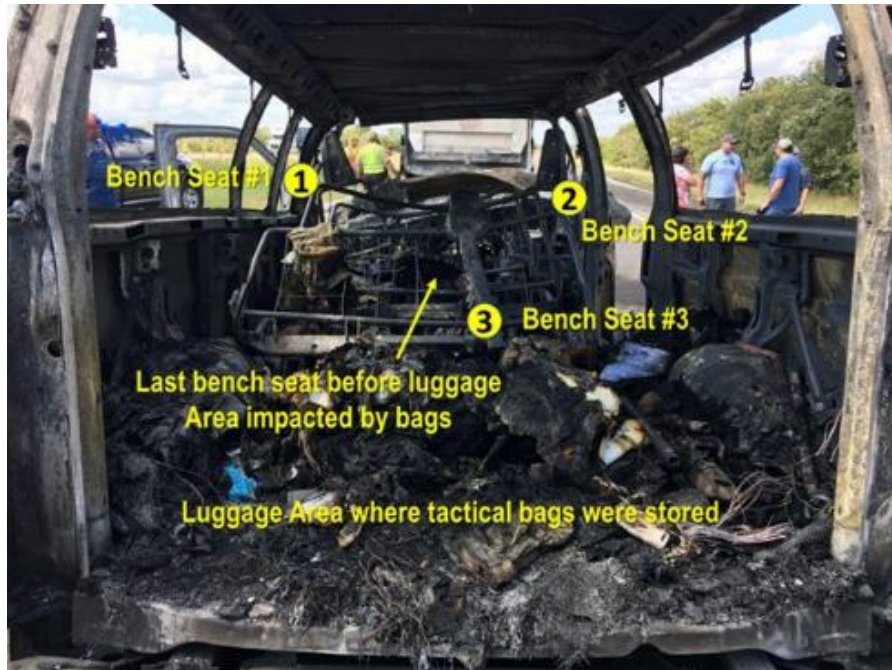
Figure 2-24. Photo of Back of Van Showing Impact of Tactical Gear behind Bench Seat 3

There is no established policy for the use of cargo restraints or cargo limitations for GSA vehicles used as they were on the day of the accident.
