OES 2019-01

June 2019

## Uranium Accumulation Discoveries at Y-12

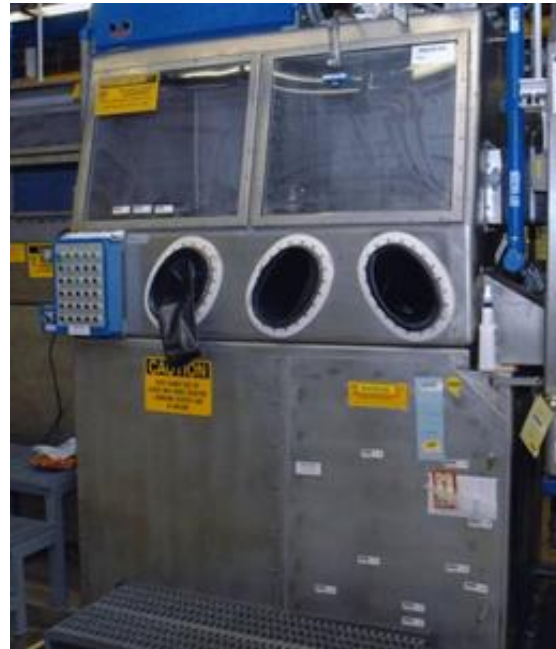
*Figure 1. Knockout Glovebox*

In June 2017, in preparation to repair a hydraulic leak in a knockout glovebox (see Fig. 1) within the Reduction area<sup>1</sup> of Building 9212, radiological survey measurements were taken for equipment below the glovebox. The results of these surveys indicated that more than 800 grams of enriched uranium had unexpectedly accumulated in the sand separator beneath the glovebox. Given the potential for moderation within this unfavorable-geometry

equipment, this situation represented a significant nuclear criticality safety concern.

CNS immediately responded by suspending operations in the subject glovebox until the necessary analysis could be performed and additional criticality safety controls could be implemented. Subsequent to taking these immediate actions, CNS performed a root cause analysis and executed a series of Extent-of-Conditions evaluations intended to ensure necessary crosscutting programmatic improvements were identified and implemented.

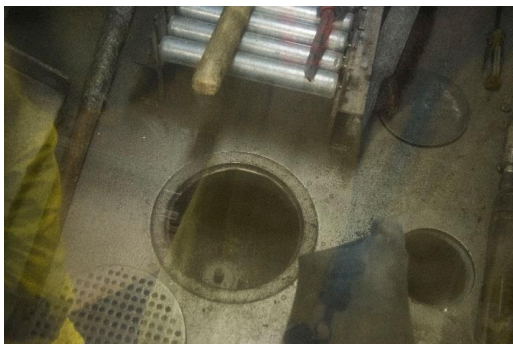
*Figure 2. Floor of the Knockout Glovebox*

Several years ago, the knockout process was modified with regards to how slag produced during the Reduction process was dispositioned. The historical process involved routing the slag through a chute in the floor of the knockout glovebox into a can beneath the glovebox (see Fig. 2). The new process involved putting the slag into a tray, which was then handed-off to an adjacent hood. At the time the process was modified, operators errantly assumed that material was no longer collecting in the can at the end of the chute beneath the glovebox. In reality, a mixture of MgO sand and uranium was slowly (over a period of years) accumulating in the can, accumulating up the chute, and eventually accumulating up the sand separator (see Fig. 3). The root cause analysis team determined that the following three root causes led to the unanalyzed 'process drift' and unexpected accumulation of uranium in the sand separator:

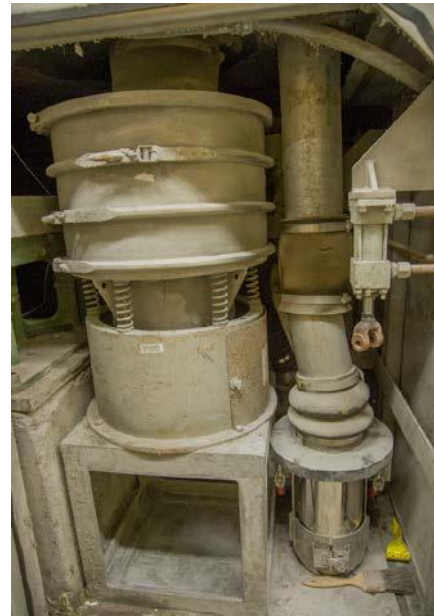
*Figure 3. Sand Separator and Slag Collection Chute*

reactor vessel and separated for disposition. Some of the reaction products are swept into a 'sand separator' through a hole in the floor of the glovebox. The purpose of the sand separator is to mechanically separate MgO sand from other reaction products.

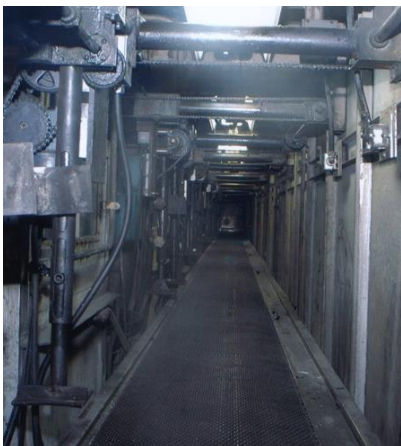
*Figure 4. Conveyor within the Casting Line*

Between November 2017 and March 2018, while executing the Extent-of-Condition reviews described above, CNS identified three additional instances of unexpected accumulations of uranium in casting line of Building 9212. Specifically, the three instances involved (a) non-uniform accumulation of oxide below the casting line (see Fig. 4), (b) a large quantity of legacy oxide and small pieces of metal in a difficult-to-access area of the casting line, and (c) accumulation of oxide in bowls beneath the casting furnaces (see Fig. 5). These accumulations were inconsistent with assumptions (both explicit and implicit) made in applicable criticality safety analyses.
