OES 2019-02

June 2019

The Importance of Reporting Near Misses

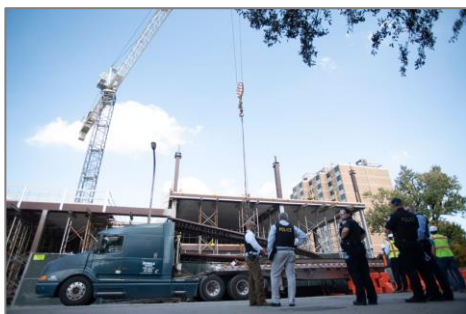
One month after the hoisting equipment failure at LANL, a similar incident resulted in a fatality and a severe injury at a non-DOE construction site in Evanston, IL. A crane was lifting steel support beams for a 9-story apartment building when the rigging failed, causing the beams to drop 30 feet and strike the workers. See Photo 1.

Photo 1. Construction site in Evanston, IL where worker was killed. (Photo credit: C. Boyle/The Daily Northwestern)

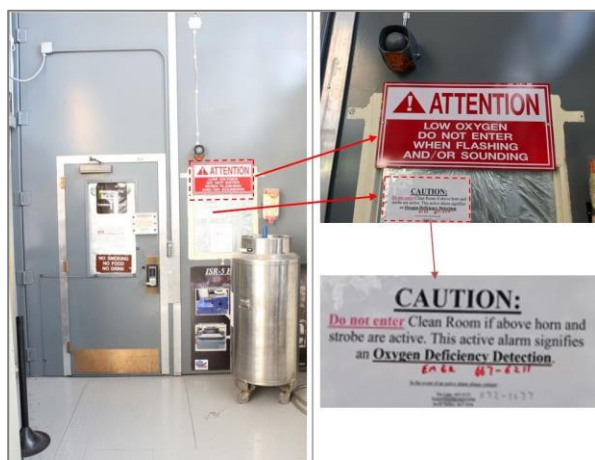
On September 13, 2017, a Subject Matter Expert (SME) entered a room at LANL while a low oxygen alarm was activated. The SME was responding to the alarm and, on arrival to the entrance of the room, identified a relief valve on the thermal vacuum system that was releasing liquid nitrogen inside the room. The SME isolated the relief valve by turning the supply valve off, placing the system in a safe configuration, and then left. The low oxygen alarm stopped sounding within 20 minutes of the SME isolating the relief valve. This was an incorrect response to the alarm. The SME exhibited a lack of adherence to and knowledge of the requirement that prohibited entry into the room during the activation of the low oxygen alarms. The low oxygen alarm posting in the room was located at a height of 11 feet--a height where it was not obvious to workers--and did not include any contact information. Additionally, the building emergency plan had not been updated to reflect the low oxygen alarm emergency response requirements for the room. Following this incident, a power disconnect emergency shut-off switch was installed next to the room entry door, which will close the main liquid nitrogen tank and the associated valves during an emergency. The sign was relocated to eye-level height and modified to include contact information (see photo 2). The building emergency plan was updated. Personnel were instructed to not enter the room when the low oxygen monitors are sounding an alarm, and a drill was conducted. A Lessons Learned article, ID: LANL-2017-945 was developed for this event. (ORPS Report NA--LASO-LANL-PHYSCOMPLX-2017-0001)

Photo 2. Images from Lesson Learned ID: LANL-2017-945, showing warning sign at entrance to laboratory
