OES: 2020-01

February 2020

ORPS Data Indicates Work Process Deficiencies at Active Deactivation and Decommissioning Projects

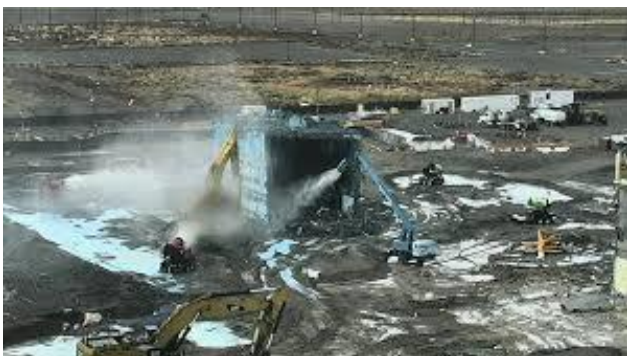
From December 14-19, 2017, contamination was discovered outside posted radiological boundaries at the Hanford Site Plutonium Finishing Plant (PFP) demolition zone (see Photo 1), resulting in contamination to personnel and spread to uncontrolled areas.

Photo 1. Demolition of the Plutonium Finishing Plant

Several factors contributed to the release and spread of contamination, including failure in expected performance with respect to decision making, rigorous use of processes, and work force communications. Significant factors included demolition activity rates exceeding work control specifications derived from computer modelling predictions of release plume migration, and diluting fixatives against manufacturer's recommendations when applying the contamination control agent at higher elevations at the Plutonium Reclamation Facility. Additionally, risks and

consequences associated with emerging and changing conditions were not adequately reviewed and evaluated, whereby the normalization of deviations became a recurrent, pervasive theme illustrated by the event.

The absence of negative performance indicators (e.g., detected airborne contamination), gave the organization a false sense of security, enabling it to increase the rate of demolition activities whose work control hazards were not adequately analyzed, documented, or controlled. (ORPS Report EM-RL--CPRC-PFP-2017-0018)

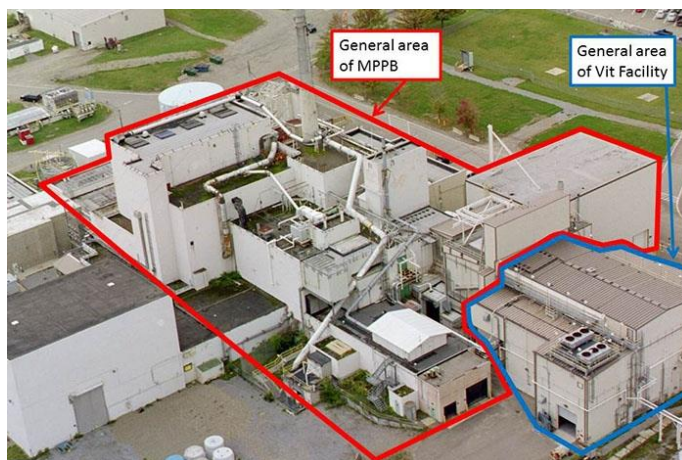
On November 5, 2018, a completed radiological survey of the Waste Reduction and Packaging Area (WRPA) dock and adjacent paved work area indicated contamination with the highest direct reading of 105,299 disintegrations per minute (dpm) beta-gamma per 100 square centimeters (cm²). This area at the West Valley Demonstration Project had been previously controlled due to identified contamination from water found leaking from the Solvent Storage Terrace (SST) roof and through various places in the Main Plant Process Building (MPPB), eventually exiting the MPPB through the WRPA dock and running outside to uncontrolled paved work areas (see Photo 2). A radiation control technician observed that the water

Photo 2. Deactivated Main Plant Process Building at the West Valley Demonstration Project

was tinted blue, indicating that it had come in contact with commercial-grade fixative recently applied to a facility within the MPPB. Staff identified that the water had flowed outside the WRPA dock, across the work area, and down to a drainage pipe that went under a roadway intersection. Notifications were made and controls (ropes and barricades) were put in place to control the water and restrict access. Operations personnel were dispatched to the MPPB roofs to inspect for plugged drains. It was discovered that the SST roof drain was plugged. Once it was unplugged, water drained normally. There had been heavy rainfall the previous five days which totaled approximately three inches. The lesson to be learned from this event is that the maintenance of facilities being deactivated for demolition must be carefully reviewed to consider the risks associated with reduced inspection or maintenance frequency. (ORPS Report EM-OH-WVDP-CHBW-CF-2018-0004)

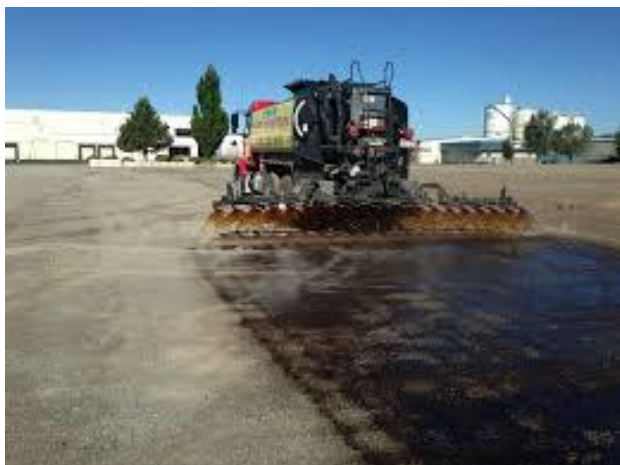
On the morning of March 31, 2016, during the performance of a routine boundary survey of an outdoor concrete pad on the northeast corner of C-333 (which was posted as a Contamination Area, or

Photo 3. Application of dust palliatives for dust suppression

CA) at the Paducah Gaseous Diffusion Plant, several small areas of contamination were discovered on gravel and tar outside the boundary. Total contamination up to 950,000 dpm/100 cm² beta/gamma was discovered. Total alpha contamination was less than the administrative limits (the limits are 5,000 dpm/100 cm² total beta/gamma

and 1,000 dpm/100 cm² total alpha). The source of radioactive contamination was determined to have come from the maintenance and storage of contaminated items between 1952 and 1990, which spread from the pad to the surrounding area. After site characterization identified an area of outdoor contamination, the concrete pad was posted for contamination between 1995 and 2004. In 2004, the surrounding area was sealed with gravel and tar (see Photo 3). When responsibility of the Paducah Gaseous Diffusion Plant was transitioned from the previous U.S. Nuclear Regulatory Commission licensee back to DOE, the pad area was posted as a CA. However, the radiological conditions of the pad and surrounding area were not completely identified, documented, or communicated by the transferring entity to DOE through routine surveys, historical evidence, etc. It was apparent that the material discovered outside the CA boundary came from deterioration of the sealant placed over the contaminated pad, and had spread outside the confines of the boundary, making it imperative to monitor the conditions of outdoor radiological areas for deterioration prior to completing the transfer of property to DOE. (ORPS Report EM--PPPO-FPDP-PGDPDEAC-2016-0004)

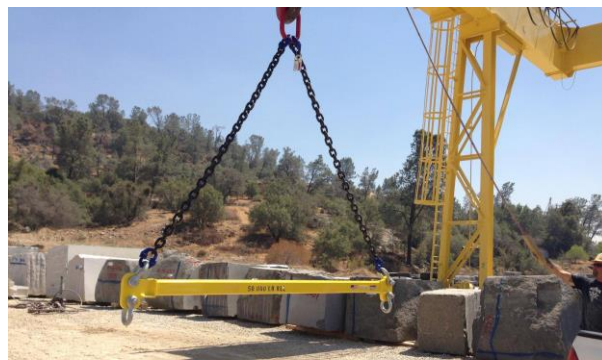
On July 26, 2018, a spreader bar (see Photo 4) was removed for use by another site contractor without project authorization from the Plutonium Finishing Plant (PFP) (212Z) lag yard storage area (posted Radiological Buffer Area, or RBA). Craft personnel from another site contractor had coordinated directly with a radiological control technician (RCT) to perform a radiological survey, and coordinated with Mission Support Alliance, LLC (MSA) teamsters to transport the

Photo 4. Example of a spreader bar used for hoisting and rigging

spreader bar for inspection and installation of inspection tags. However, the RCT surveyed a different spreader bar in the same area, not understanding which spreader bar was being requested for movement. On July 26, 2018, the spreader bar (that had not been surveyed) was loaded onto a flatbed truck and exited the PFP RBA via the normal access route and received the standard tire surveys (hand and foot equivalent for RBA egress).

Upon exiting PFP on July 26, 2018, the teamsters drove the flatbed truck from PFP to Building 6290 (MSA Ironworker loft), where the spreader bar remained in the truck. On July 30, 2018, the truck containing the spreader bar was driven to Building 2355 Stevens Drive in Richland, Washington (an offsite facility) for an unrelated job task. The spreader bar remained in the truck at all times. The truck returned the same day to Building 6290. On July 31, 2018, the spreader bar was off-loaded into the Building 6290 yard. On August 6, 2018, the spreader bar was moved to the Building 6290 rigger loft high-bay (a non-radiological area), where it was inspected and tagged.

On August 7, 2018, due to an individual concern that the spreader bar had originated at the PFP facility, a radiological survey of the item was requested and performed. During the survey activity, one localized area of removable contamination was identified. The section of the bar was wrapped in plastic and placed into a Radiological Material Area.

This event illustrates the need to: (1) follow a formal process (including appropriate surveys) for removing equipment or material from an RBA, and (2) ensure proper communication, component identification, and control of equipment or material within radiologically controlled areas. (ORPS Report EM-RL--CPRC-PFP-2018-0006)
