## **Appendix E**

### **Photos from September 20, 2018 Site Visit**

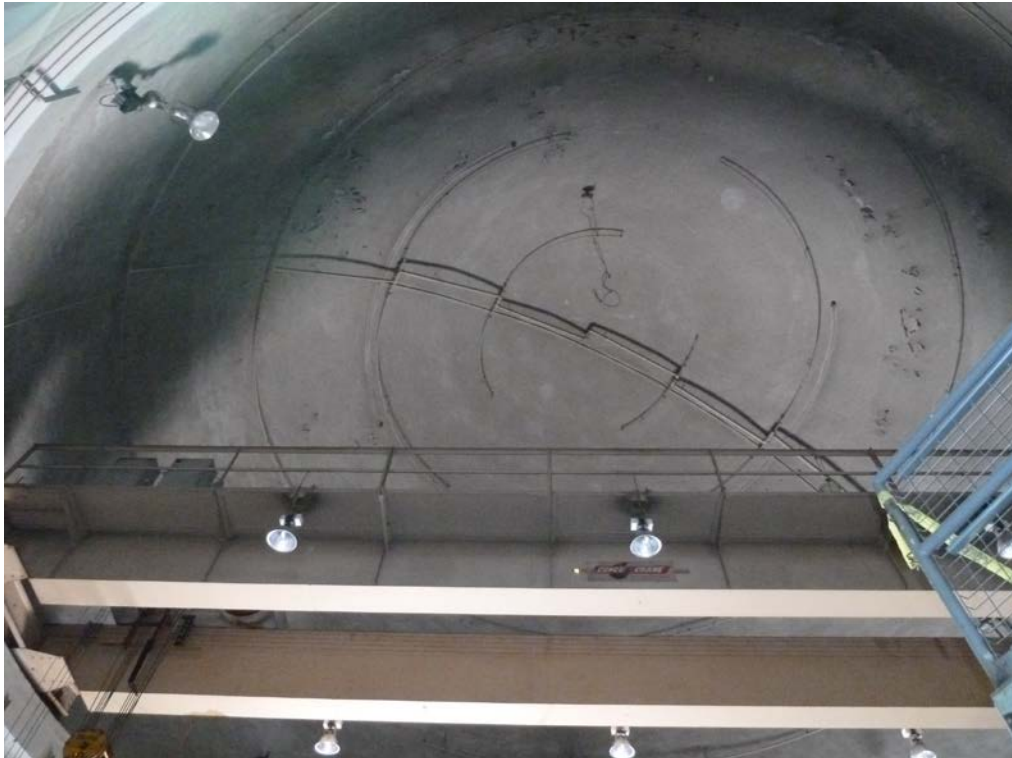
**Photo 2.** Flaking lead-based paint (LBP) containing polychlorinated biphenyls (PCBs) on the ceiling of the aboveground containment dome.

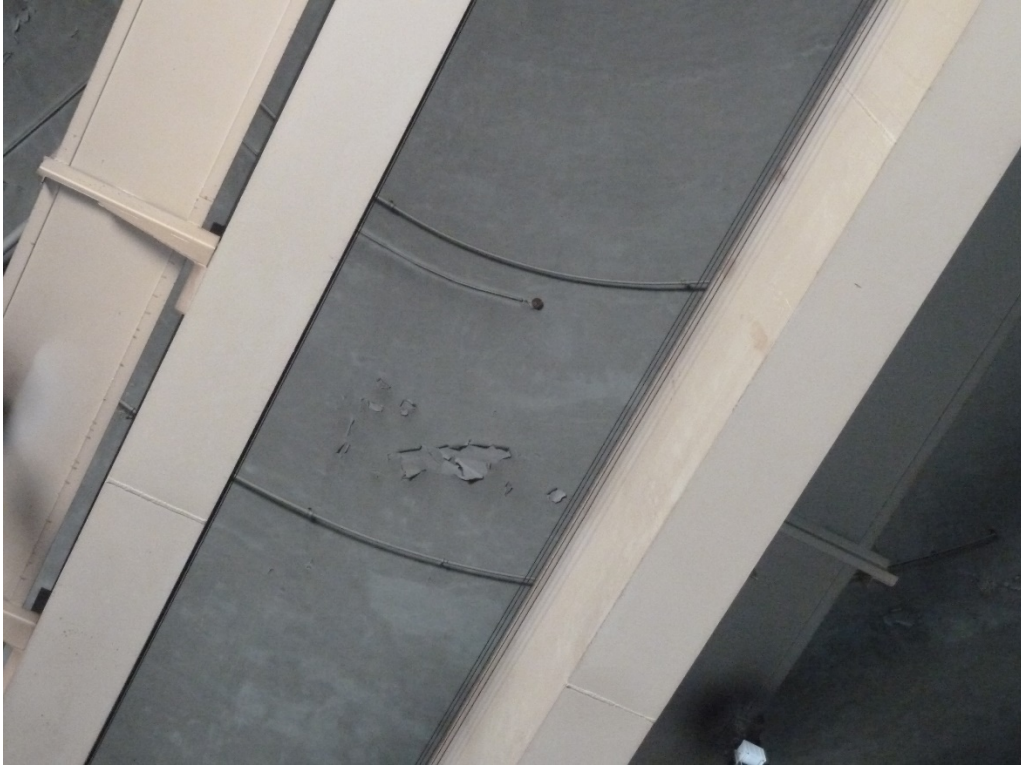
**Photo 3.** Close-up of flaking LBP containing PCBs on the ceiling of the aboveground containment dome.

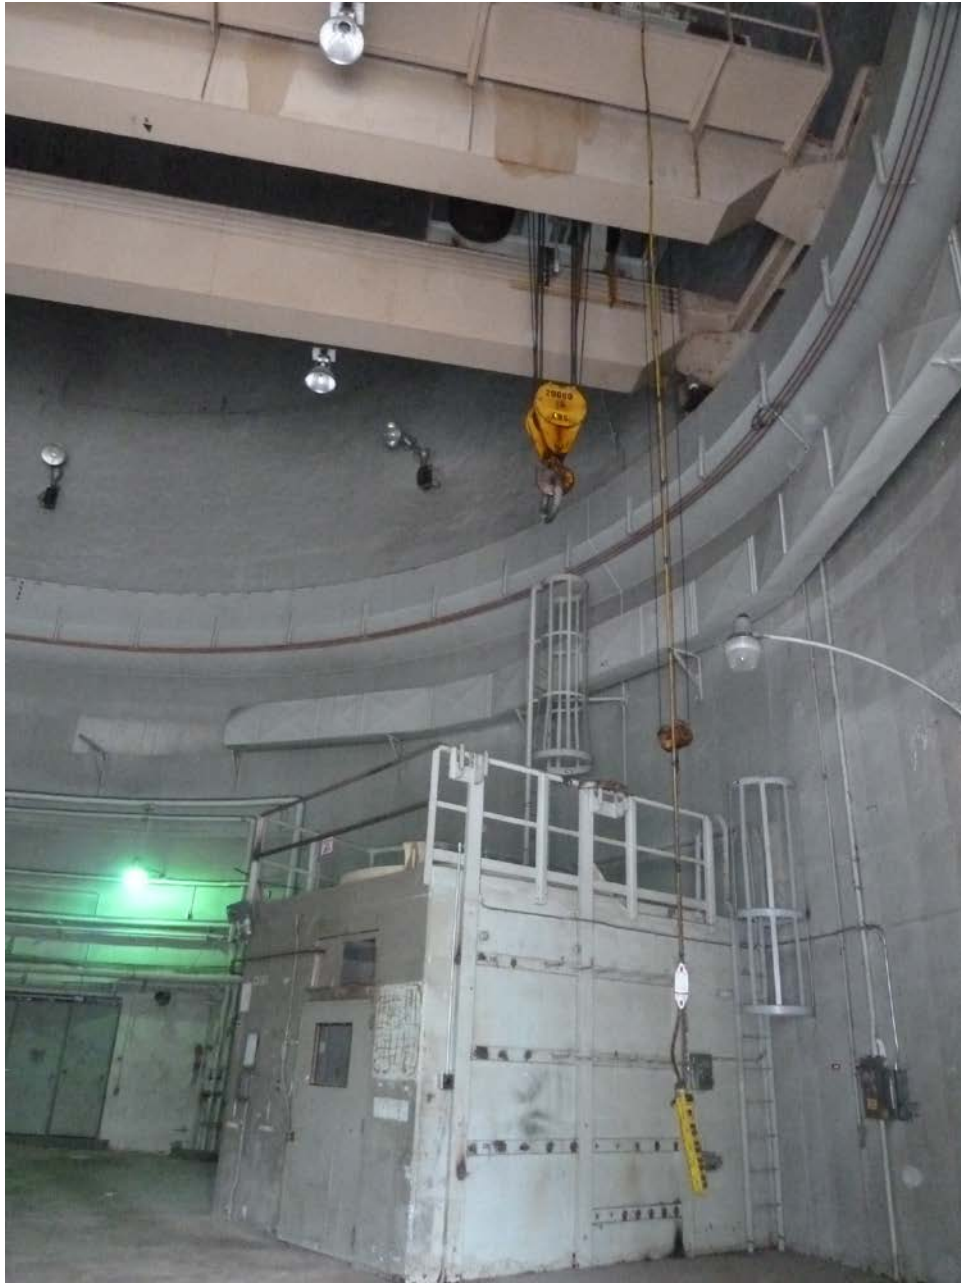
**Photo 6.** Portion of interior of aboveground containment dome. Brown paint shown in photo contains lead and PCBs. Handrails and interior surfaces of steel containment dome also contain layer(s) of LBP with PCB constituents.

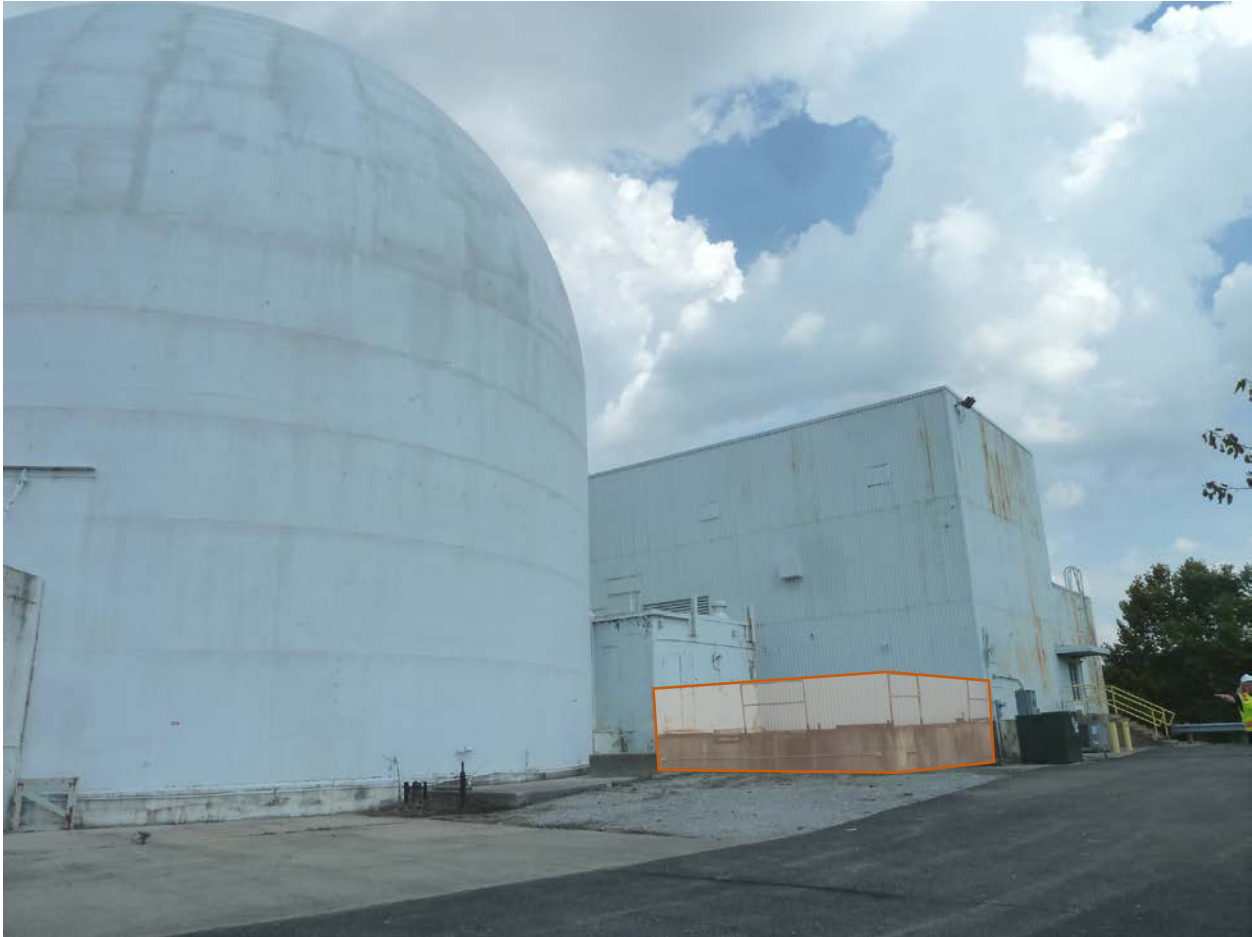
**Photo 7.** Steel containment dome above the belowground entombment in left of frame. Administration building shown in right of frame. Building between the containment dome and the administration building is an outdoor locker previously used for chemical storage. The concrete pad adjacent to the outdoor locker (indicated with orange outline and tint) may contain PCBs due to previous storage of equipment and fuels.

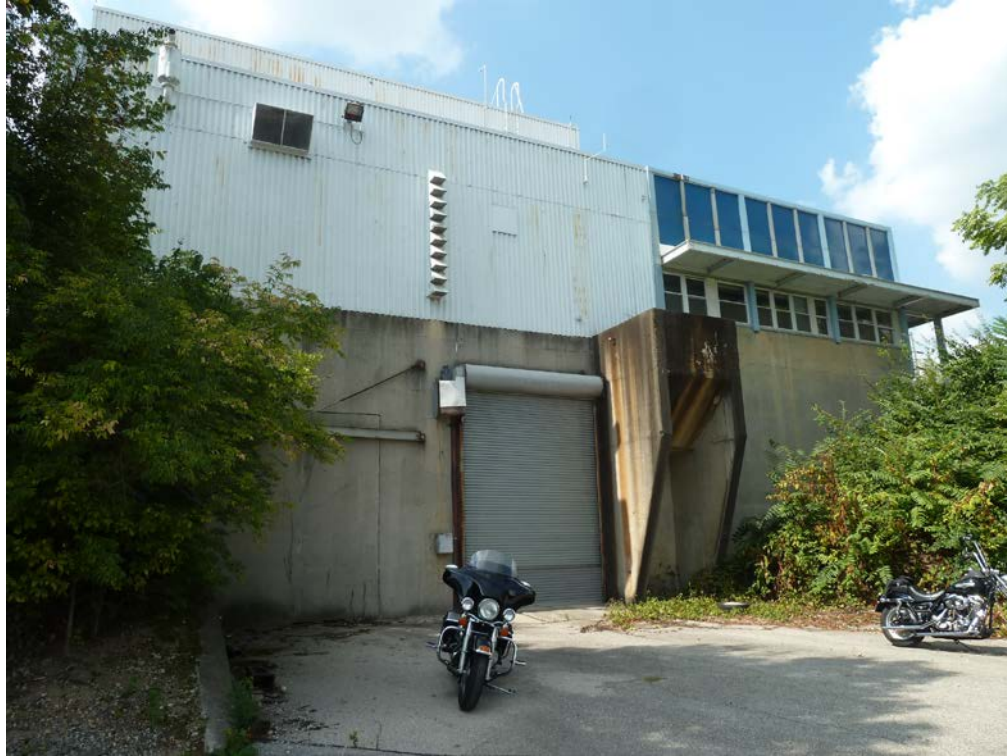
**Photo 8.** Eastern side of administration building. Blue panels between windows in right side of frame contain asbestos.

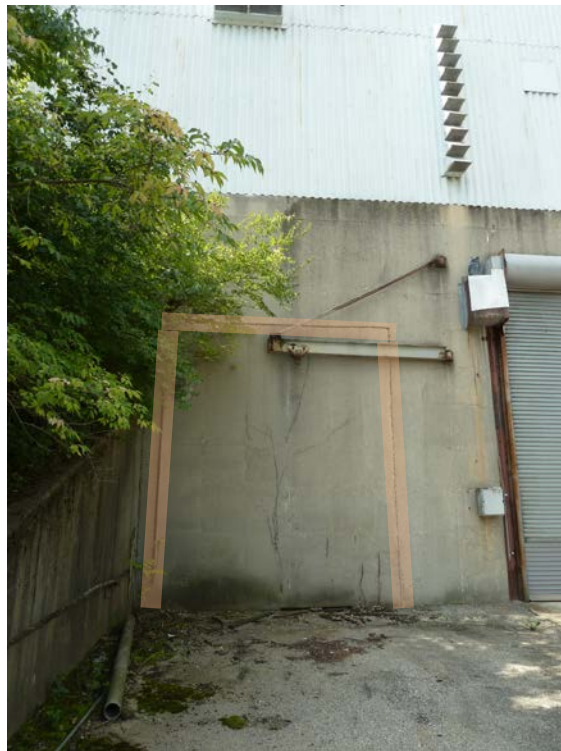
**Photo 9.** Caulk/epoxy, which may contain asbestos, within the seam of the concrete on the eastern side of the administration building (indicated with transparent orange coloration).

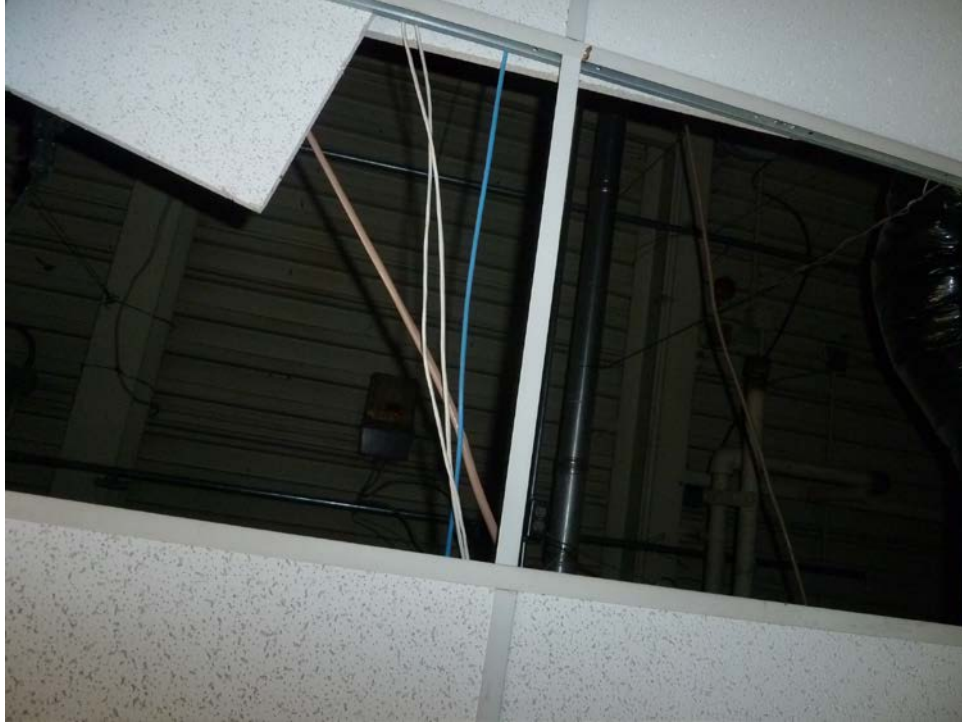
**Photo 10.** Example of I-beams (in background) and drop ceilings (in foreground) in the administration building which contain LBP (and also PCBs) and asbestos, respectively.

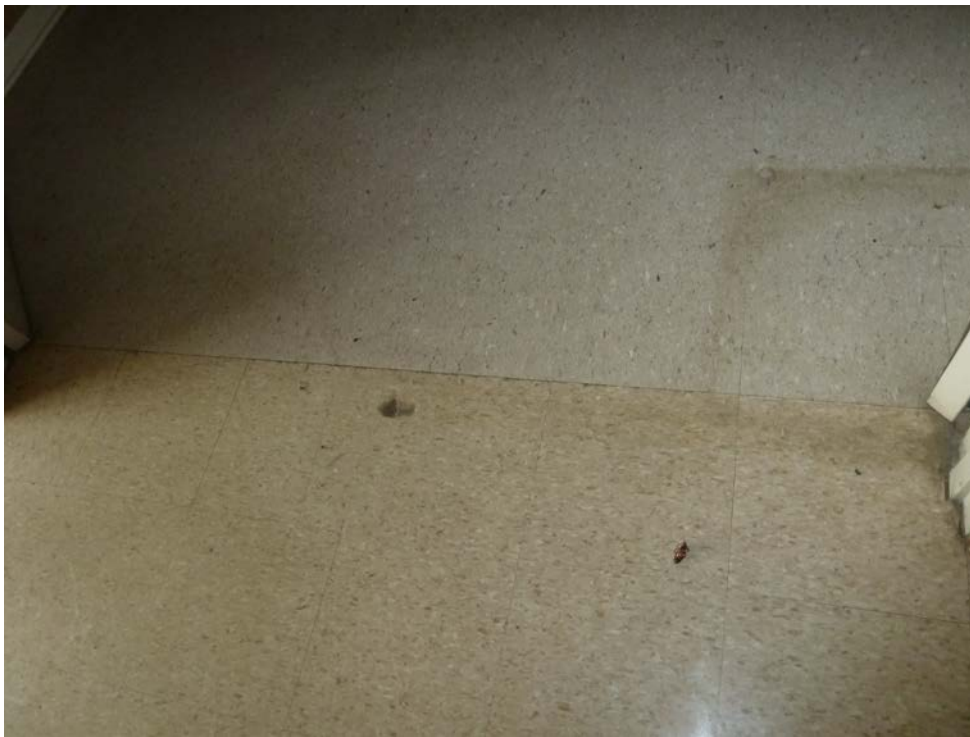
**Photo 11.** Darker floor tiles in bottom portion of frame contain asbestos and will be abated prior to the proposed demolition. Newer tiles in upper portion of frame do not contain asbestos and therefore will remain in administration building. Floor tiles within three offices within this building contain asbestos.

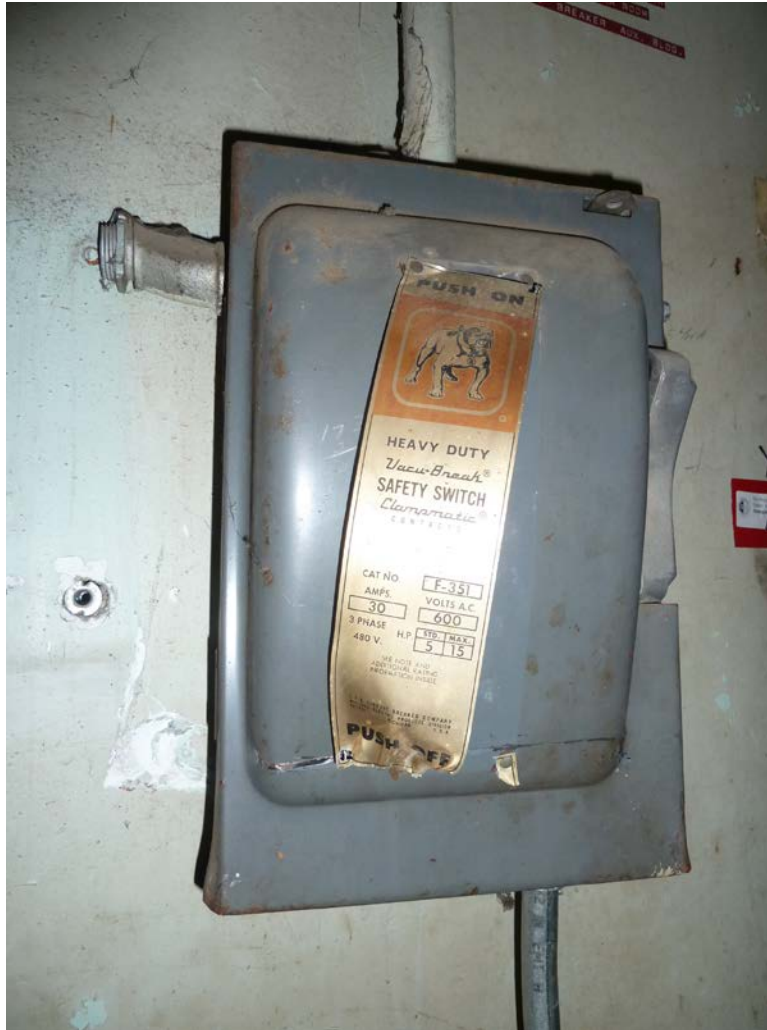
**Photo 12.** Example of a switch which likely contains mercury. Such switches are throughout the aboveground buildings at the PDRS, and would be handled by trained workers and disposed of at state-approved facilities.

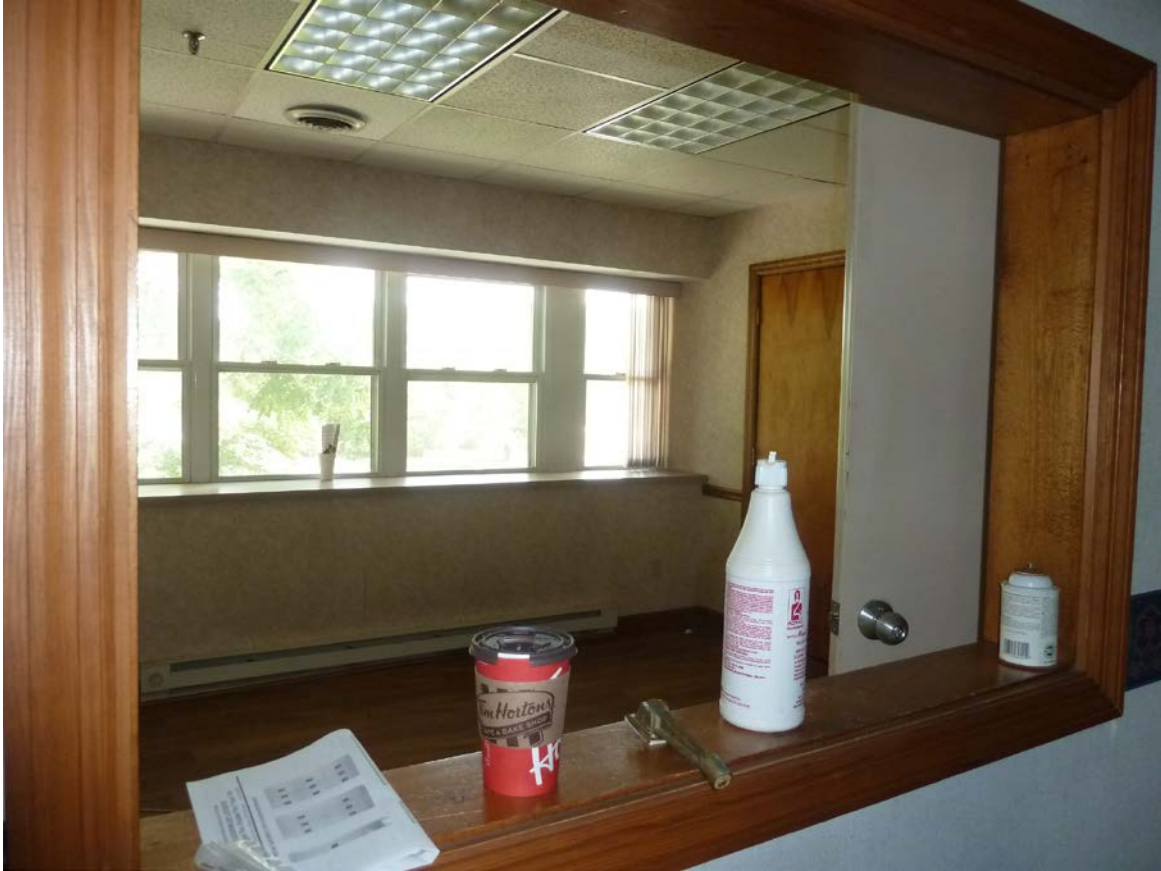
**Photo 13.** Northernmost office in the administration building. Drywall and wall paneling have LBP. False wood flooring overlies asbestos flooring and therefore will need to be removed during abatement. False walls were constructed to create the three offices. These will need to come out during asbestos abatement, as well, so that the ACM flooring can be accessed.

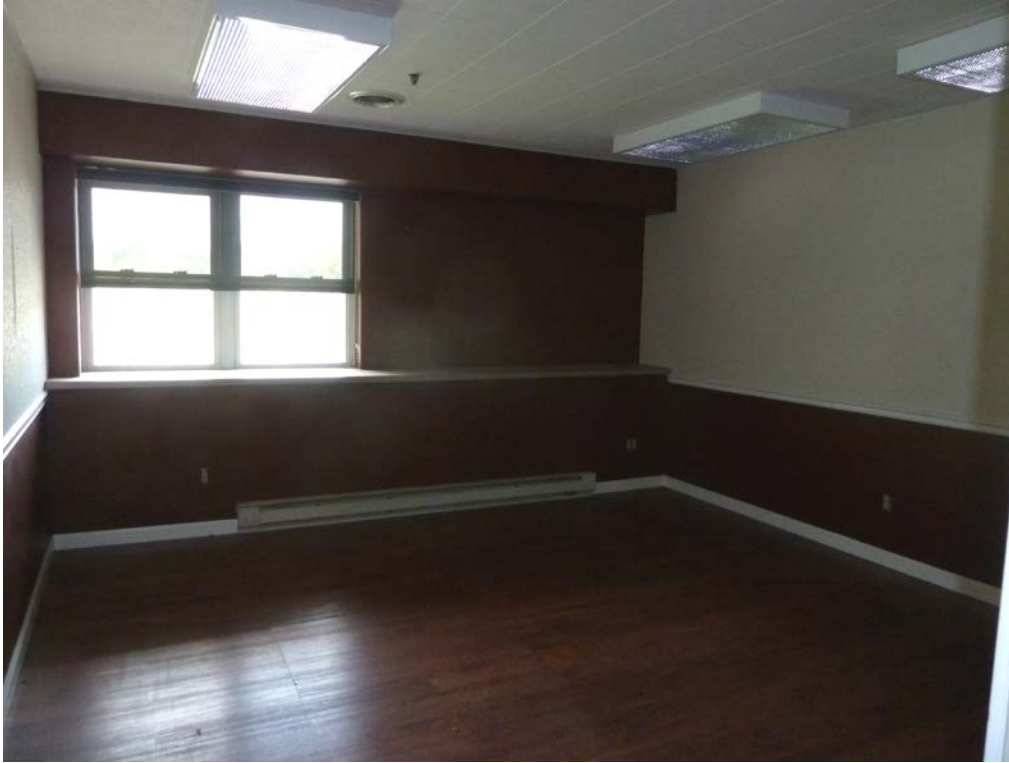
**Photo 14.** One of the three offices in the administration building. The falls wood floors overlie ACM flooring, which will be abated prior to the proposed demolition.
