### **Asbestos Abatement Project Closeout Report**

# **Asbestos Abatement Project Closeout Report for the Piqua, Ohio, Decommissioned Reactor Site**

**September 2019**

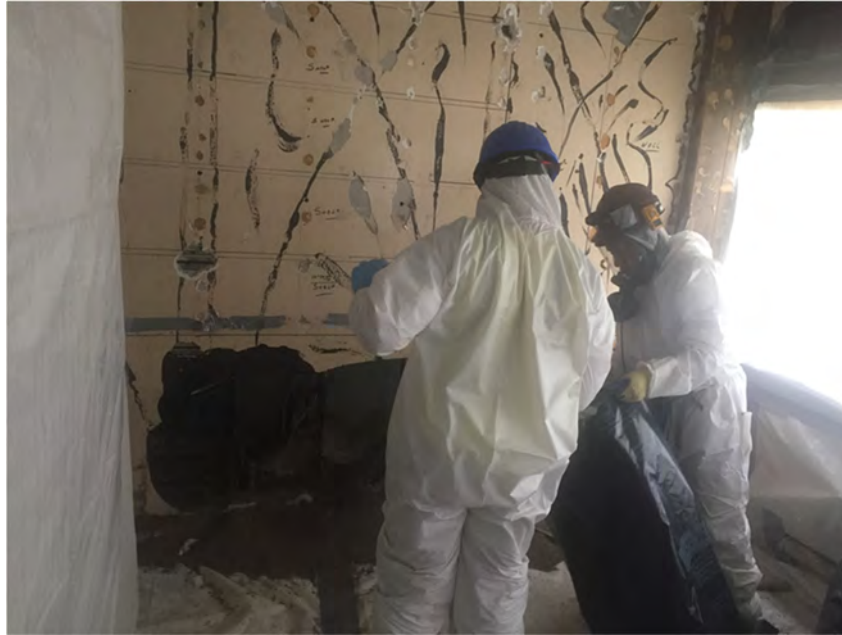
*Photo 8. Asbestos Workers Removing Vermiculite for Disposal*

The abatement effort was proceeding as planned in early May 2019 when, during the abatement of the vermiculite in the plenum, an unforeseen discovery was made. The actual volume of 2224 square feet and widespread location of vermiculite within the plenum far exceeded the localized 155 ft<sup>3</sup> identified in the 2016 hazard assessment survey. The survey captured approximately one open bag of vermiculite from atop the spray-in insulation. As the plenum abatement proceeded, it became apparent that the entire plenum was filled with vermiculite hidden by the spray-in insulation.

Photo 8 shows two asbestos abatement workers in proper PPE and inside a containment area, shoveling vermiculite (that poured out from the Administration Building north wall area onto the floor) into asbestos disposal bags.

In response, the LMS project lead, the Neuber project manager, and the Rii project manager discussed at great length the next steps to safely approach abatement in the plenum area given the widespread amount of vermiculite throughout. Specifically, the Piqua Project Team discussed an approach to establish containment for safely performing an exploratory search for vermiculite behind the first floor walls (i.e., in the office area and locker room that are directly below the plenum). On May 20, a new containment area was established for potential vermiculite. Additional vermiculite was discovered behind several walls on the first floor, and abatement proceeded.

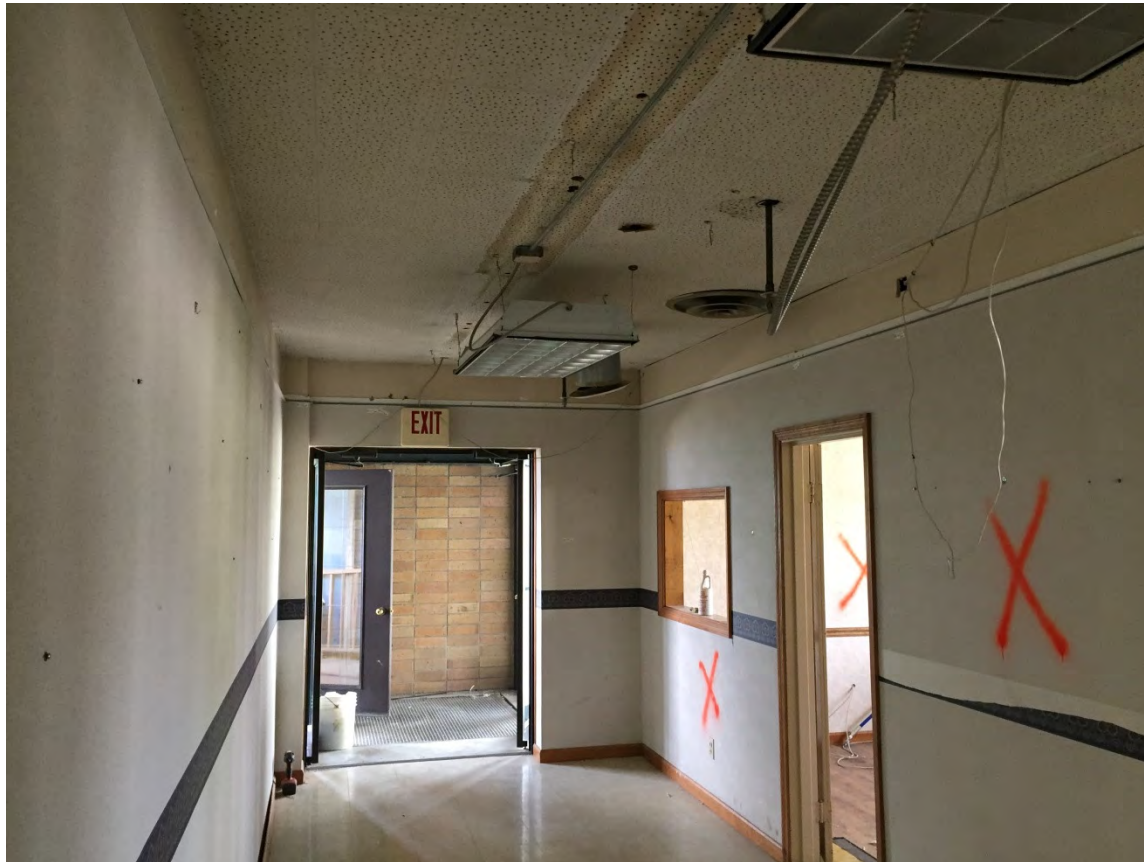
*Photo 9. Piqua Administration Building, First Floor Office Area, Before Abatement*

The Administration Building consists of three stories above grade and a full basement, and the floor space ranges from 5332 ft<sup>2</sup> at the basement level to 355 ft<sup>2</sup> at the third level, for a total of 11,718 ft<sup>2</sup> including stairways. The first and third floors required selective demolition of interior wall construction, and it took place after the decommissioning of the Reactor Building. In particular, new construction occurred on the first floor to include three new front offices, a redesigned conference room, and redesigned laundry area and locker room accommodations, all with dropped ceiling installed. Similarly, an office area was established on the third floor. Photo 9 shows the first floor front office area with walls marked for selective demolition, ACM floor tiles in hallway, and laminate flooring in an office. Photo 10 shows the same area after removal of vermiculite, selective demolition of walls, removal of ceiling tiles, and abatement of ACM floor tiles. Photo 10 also shows the removal of ACM piping that was tied to the wall-mounted radiator.

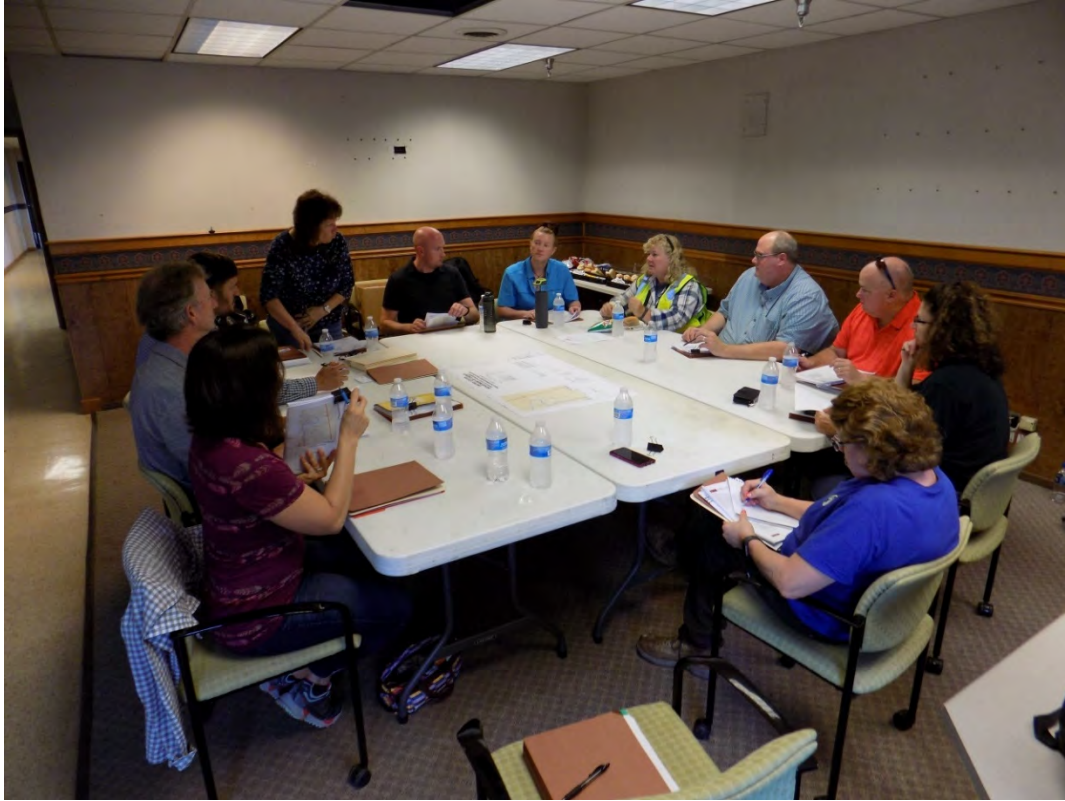
*Photo 11. Piqua Administration Building, Conference Room, Before Abatement*

Photo 11 shows the first-floor Administration Building conference room before abatement. The area included false rear walls, a dropped ceiling, and carpeting. The room required selective demolition since the room had concealed ACM pipes, ACM floor tiles, and ACM mastic. Photo 12 shows the same room after selective demolition and abatement of those ACM materials.

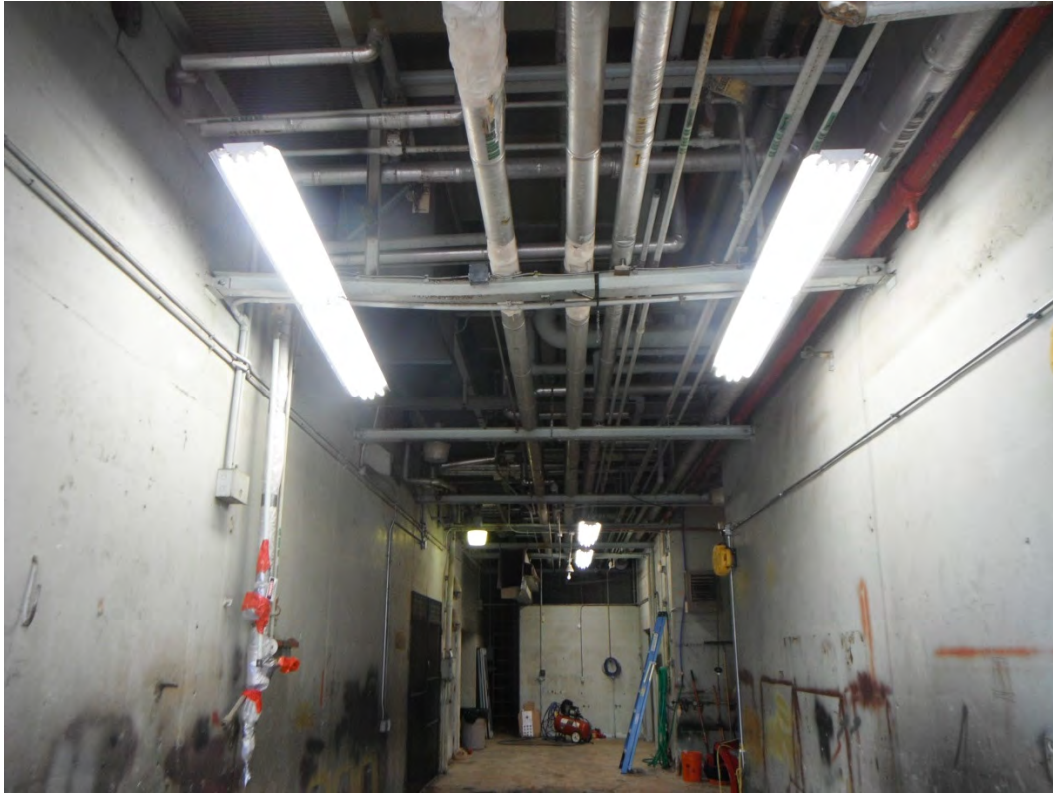
*Photo 13. Piqua Administration Building, Basement Level Hallway, Before Abatement*

Photo 13 and Photo 14 are before and after images of the Administration Building basement level hallway. More than 2500 linear feet of ACM pipes were glove bagged, cut, and wrapped for disposal. This area required scaffolding and scissor lifts to access the pipes.

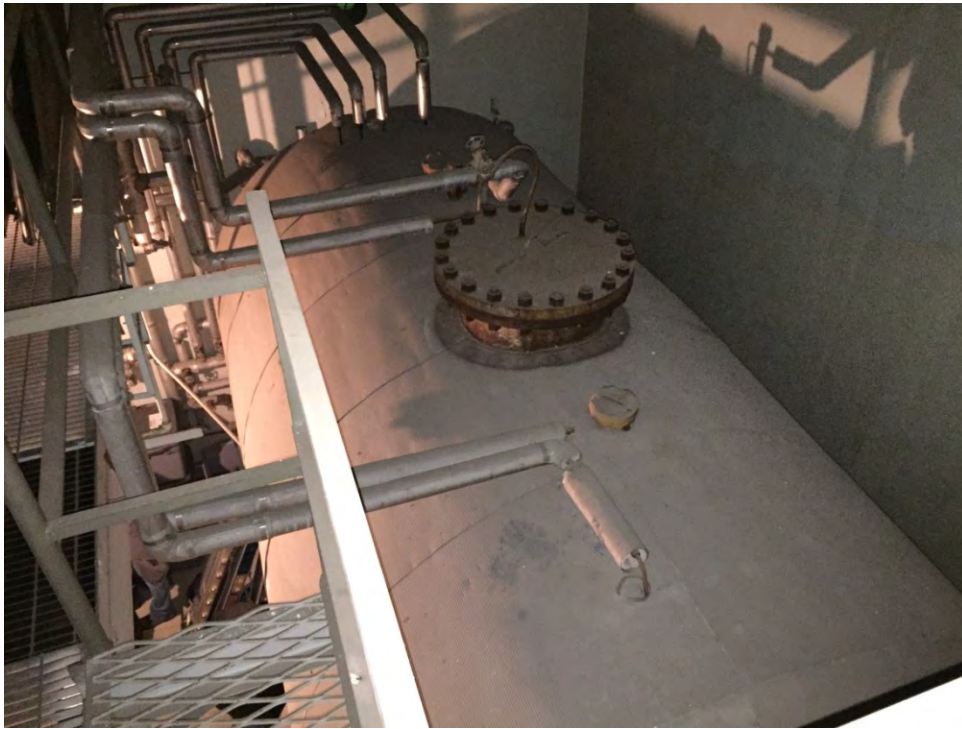
*Photo 15. Administration Building, Basement, Large Chemical Tank Before Abatement*

Photo 15 and 16 illustrate the large chemical tank inside the Administration Building before and after abatement. In Photo 15, the view is from above the tank that has metal-jacketed ACM. In Photo 16, the metal jacket and the ACM has been removed to reveal the heating coils on the tank.

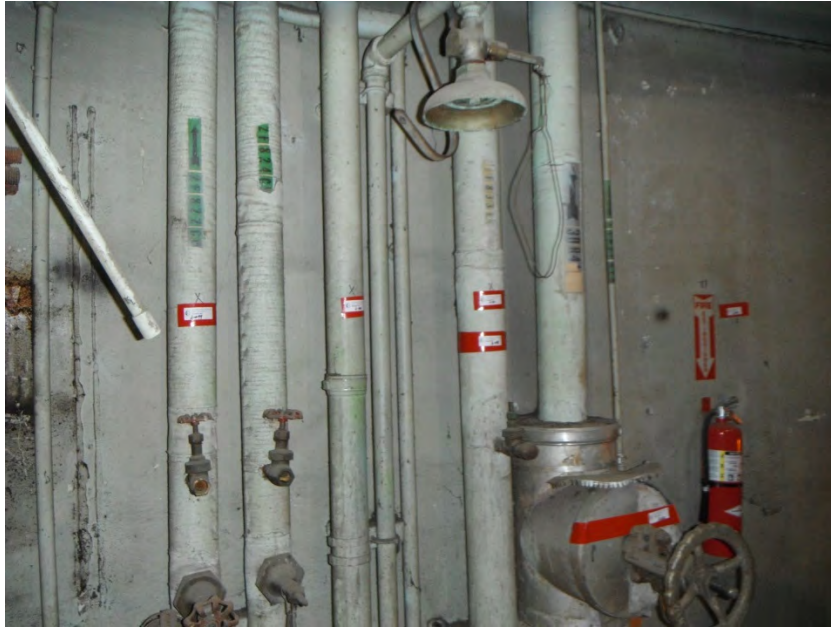
*Photo 17. Reactor Building, Level 100, Before Abatement*

The 4380 ft<sup>2</sup> Reactor Building has an above-ground containment dome known as Level 100 that extends 68 feet high. The portion of the Reactor Building below grade has several levels and extends 44 feet below ground level. Photo 17 shows a section of ACM pipes requiring abatement located at Level 100 in the Reactor Building. Photo 18 shows the same area after the ACM pipes had been removed.

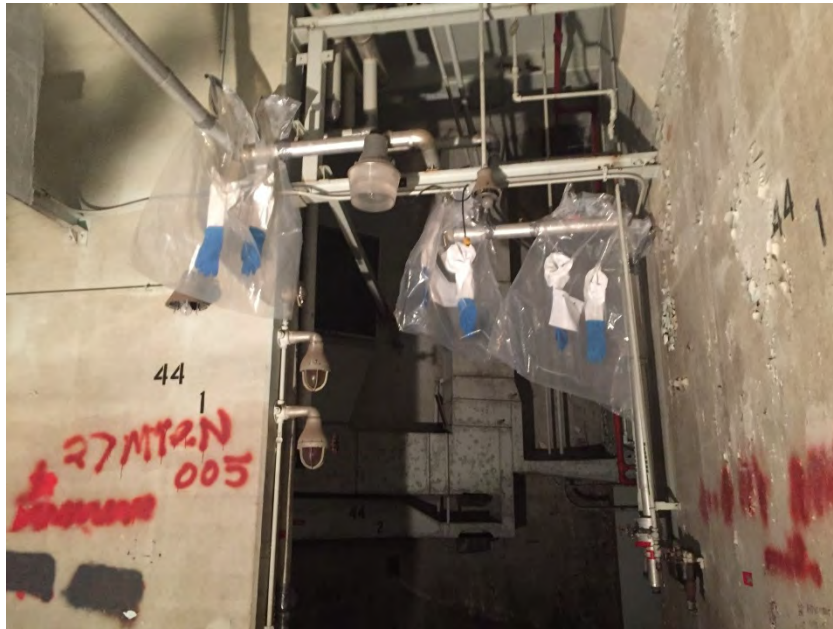
*Photo 19. Reactor Building, Level 56, Before Abatement*

Photo 19 shows the placement of glove bags in preparation of removal of ACM pipes in an area on Level 56 in the Reactor Building, and Photo 20 shows the same area after the ACM pipes had been removed. That removal required the use of a scissor lift due to the area limitations and height of the pipes.

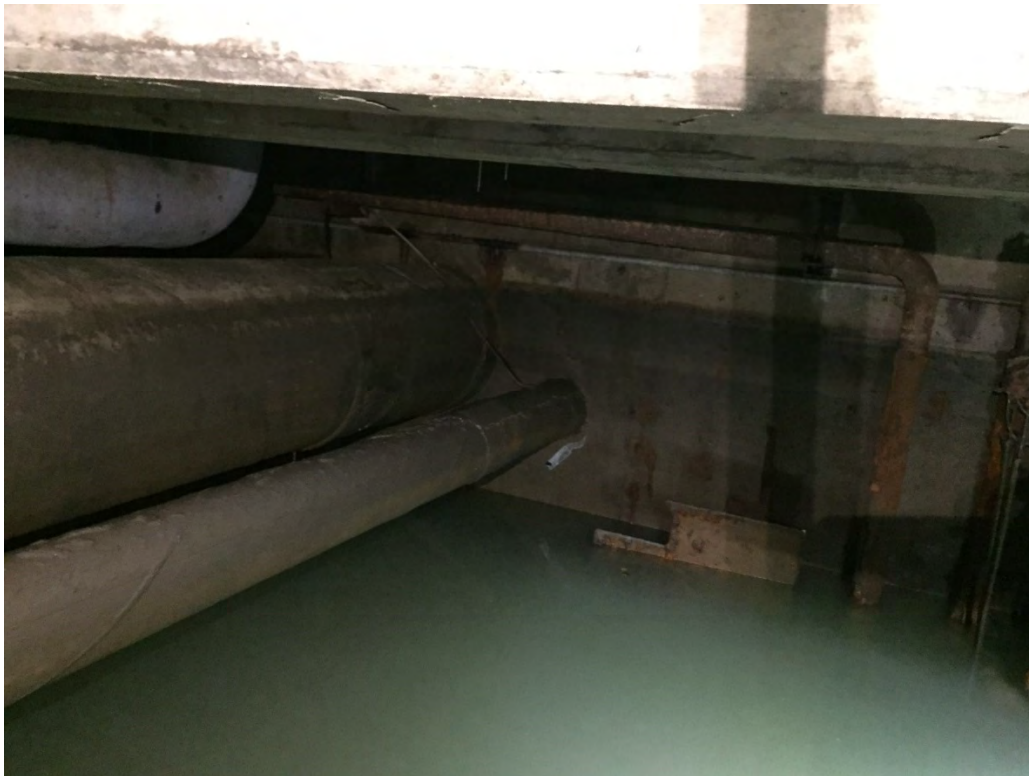
*Photo 22. Water in the North Vault, Before Abatement*

Each of the utility vaults had standing water that required pumping. Before the pumped water could be released to the environment, it was filtered through a micron filter because the vault contained ACM pipe insulation. The pipe insulation was deteriorated, which meant that asbestos was in the water and found friable in the floor debris. Once the standing water in the north vault was pumped down to floor level, workers discovered a lower tiered vault (i.e., a 20 × 20 room that was not identifiable on the original as-builts) directly below the north vault. The lower tiered vault was filled with 8 feet of water. That water had to be pumped out before anyone could enter the lower tiered vault, where workers determined ACM was present.

Photo 22 shows the north vault with standing water. Photo 23 shows the poor condition of the ACM pipes and ACM in the floor debris in the north vault after the pumping and before the abatement. Photo 24 shows the final condition of the north vault after abatement.
