Integrated Waste Treatment Unit

April 26, 2022

Idaho Cleanup Project

IWTU Update Agenda

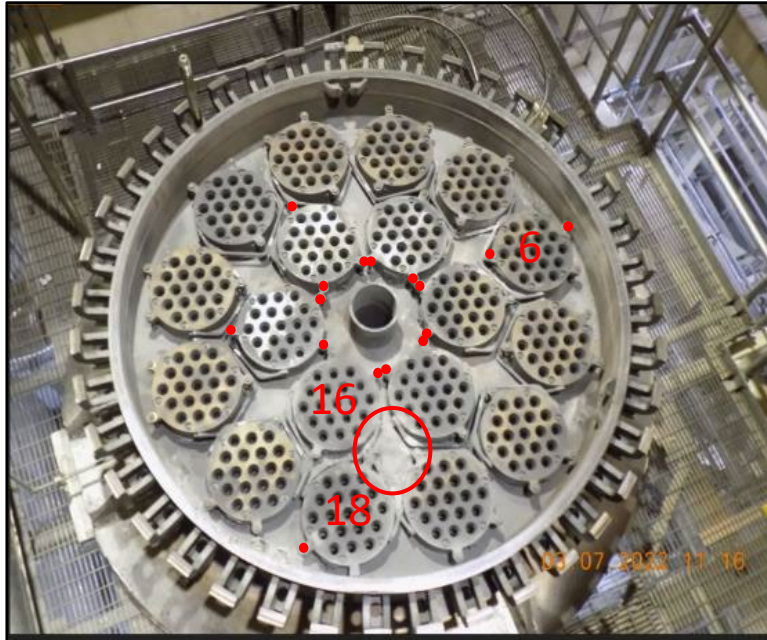
Loose hold down hardware (red dots)
Accumulation of carbonate bypass (circled)

- Conducted joint design review
- Cleaned, inspected and measured all mating surfaces
 - Vessel main tubesheet
 - Hold down lugs
 - Filter bundle sub tubesheets
- Implemented minor design changes
 - New bolting hardware material
 - New positive locking mechanism
 - Revised installation instructions, measurements and inspections
- Re-assembled PGF vessel
- Mockup Testing at Hazen
 - Attempt to induce agglomerations
 - Investigate recovery/mitigation strategies

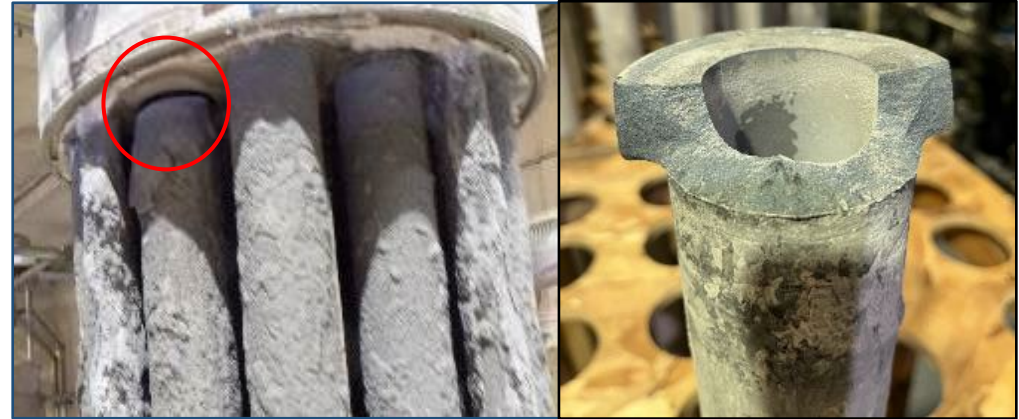
Two broken elements in bundle #16
Sent for failure analysis at Dominion Engineering

Required tie-down hardware preload and/or
surface seal was not developed or maintained
on two bundle assemblies

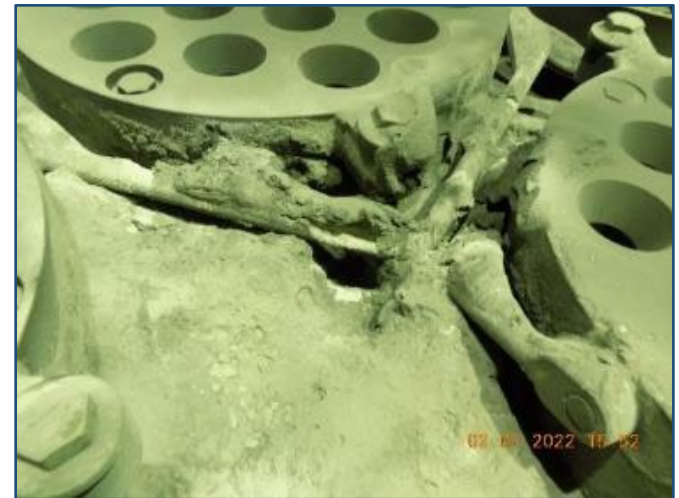
Closeup of carbonate accumulation
on tube sheet near bundle #18

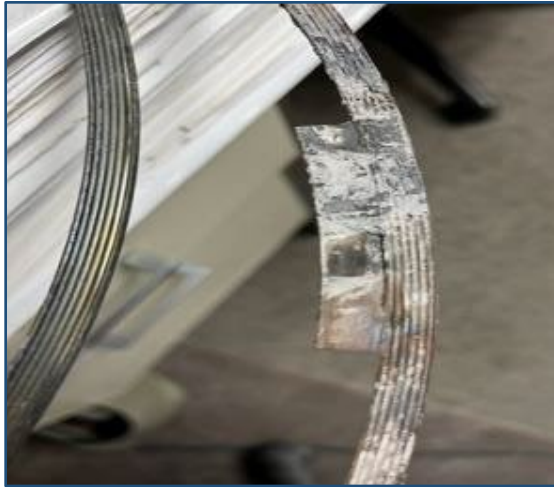
PGF bundle main gaskets intact but showed evidence of bypass

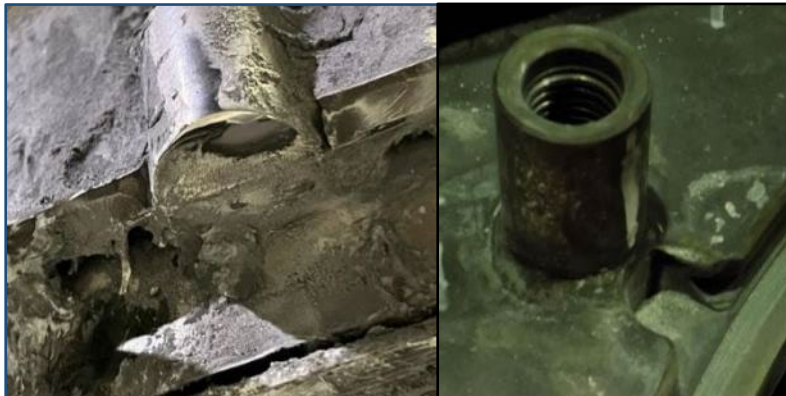
Potential interference between sub tubesheet and main tubesheet; debris inside tie down lugs

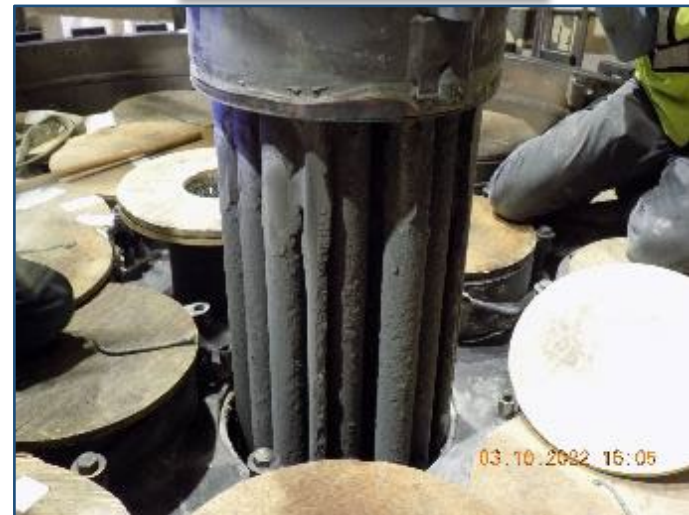
PGF bundles relatively clean with no bridging/excessive material build up indicating effective blowbacks

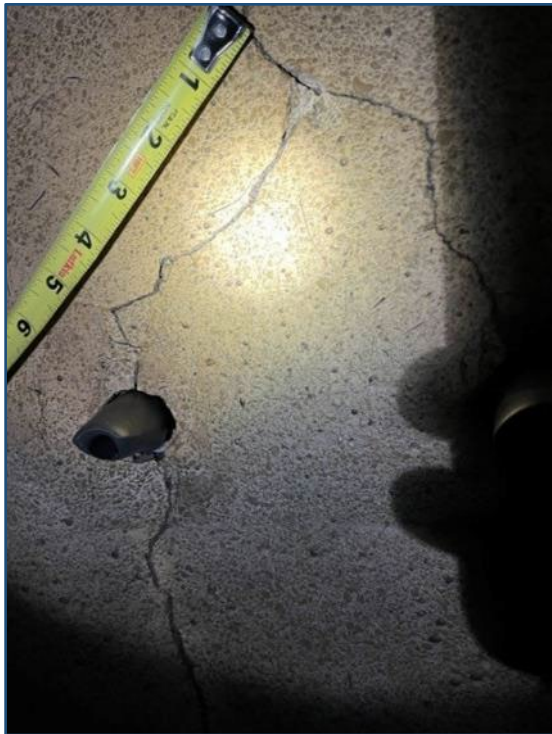
Shallow cracks in refractory

- Refractory inspected and repaired by industry expert
 - JT Thorpe
- Begin fabricating spare piping penetrations
 - Install in a future outage
- Reduce CRR bed high differential temperature alarm
 - Earlier warning of potential bed de-fluidization
- Revise procedures to direct controlled shutdown sooner
 - Reduce impact of potential CRR bed agglomerations

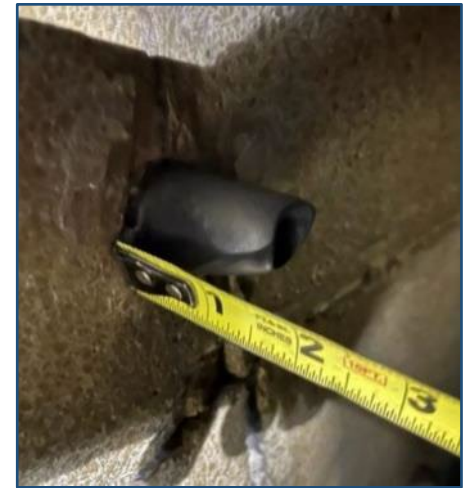
Eroded CRR piping penetration

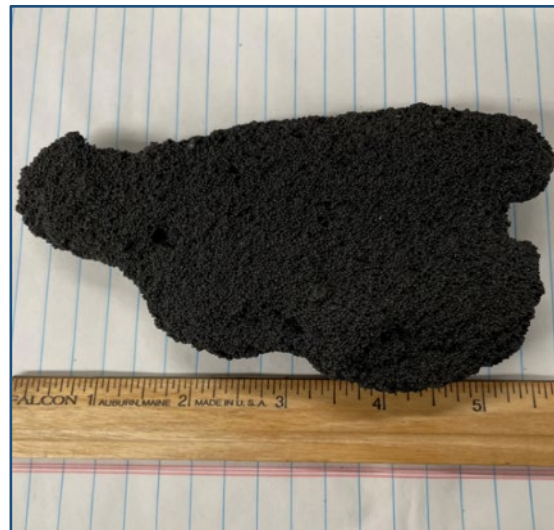
Sample CRR bed agglomeration;
less than 150 lbs of agglomerate
from nearly 7000 lbs of bed material

Refractory in good shape
overall with minor cracking,
spalling and erosion which
should be correctable with
minor repair work
