Moab UMTRA Project  
2019 Flood Response Summary

Revision 0

August 2020

**Moab UMTRA Project  
2019 Flood Response Summary**

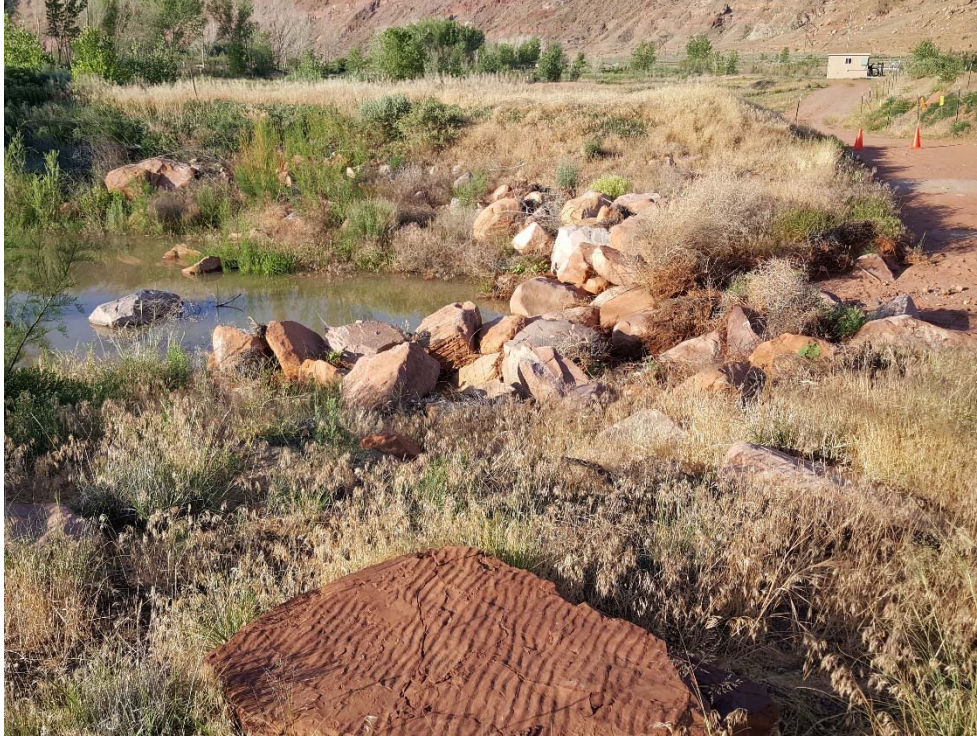
*Photo B-1. River Water Backing Up into Lower Reach of Moab Wash*

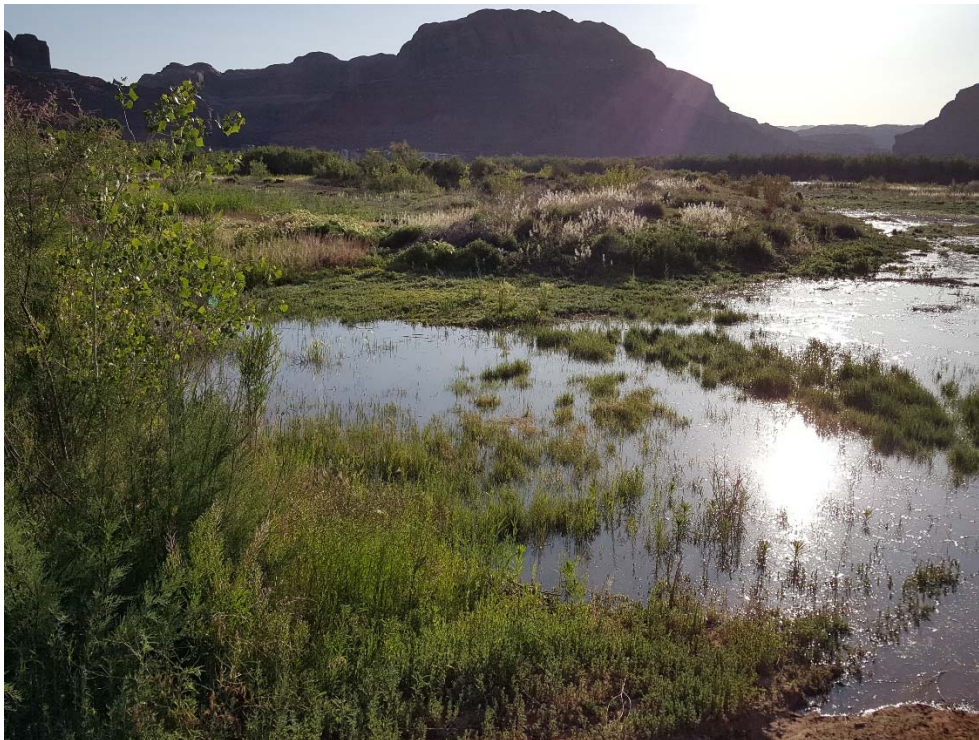
*Photo B-2. North Off-pile Area*

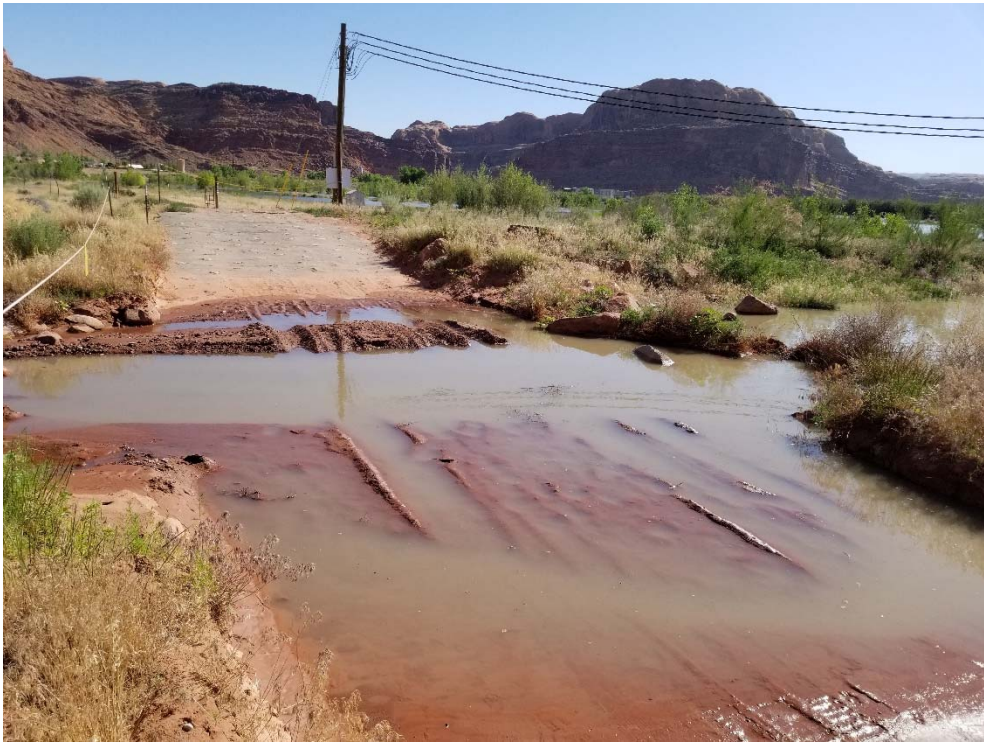
*Photo B-5. Moab Wash Lower Crossing*

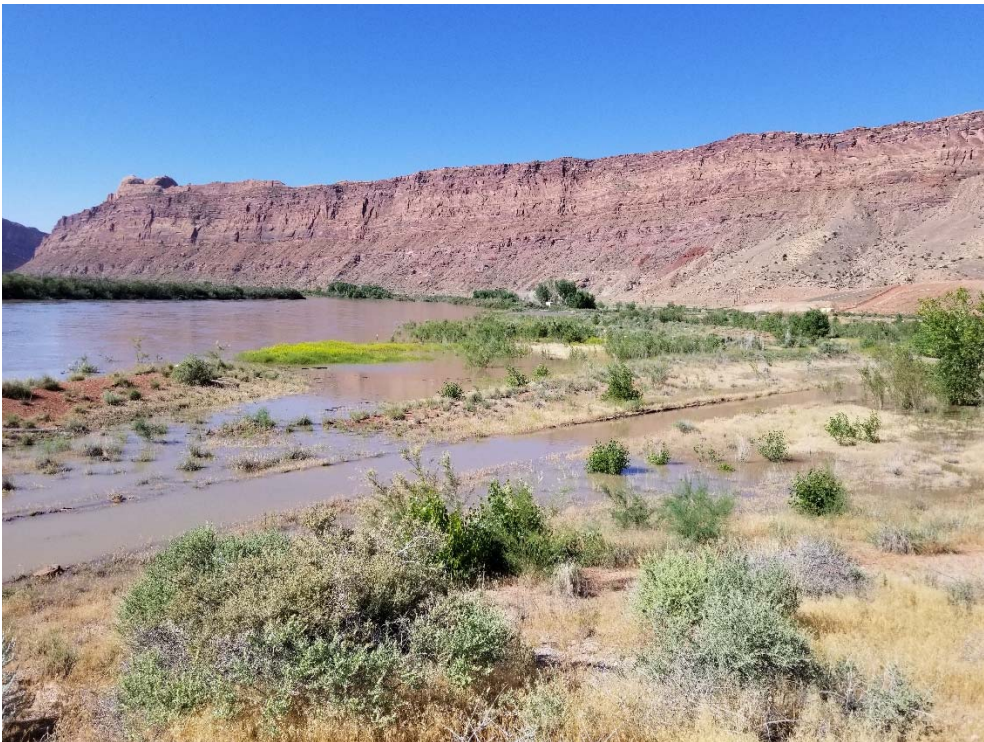
*Photo B-6. North Off-Pile Area*

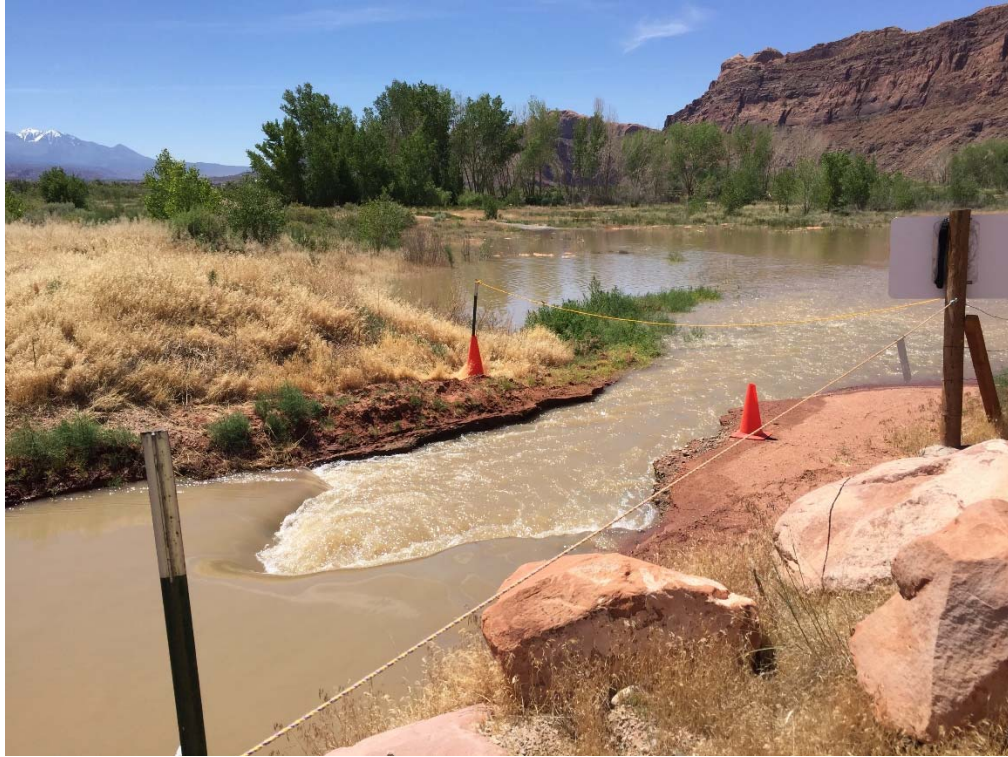
*Photo B-7. Water Flowing from Moab Wash into Well Field*

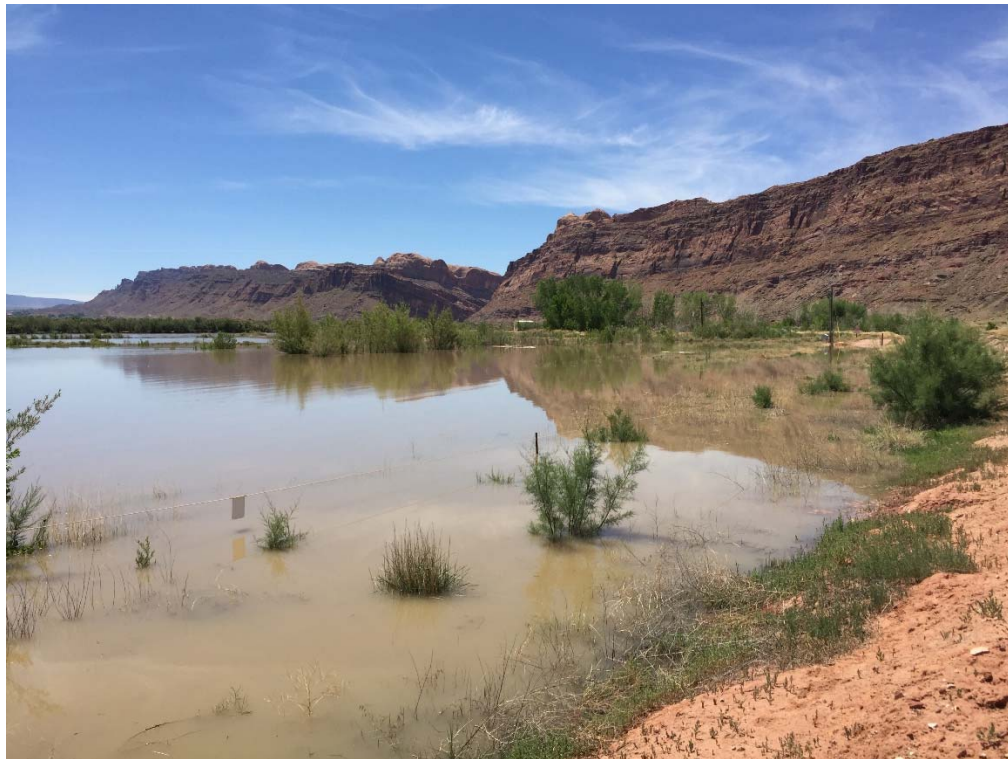
*Photo B-8. North Off-Pile from Contamination Area*

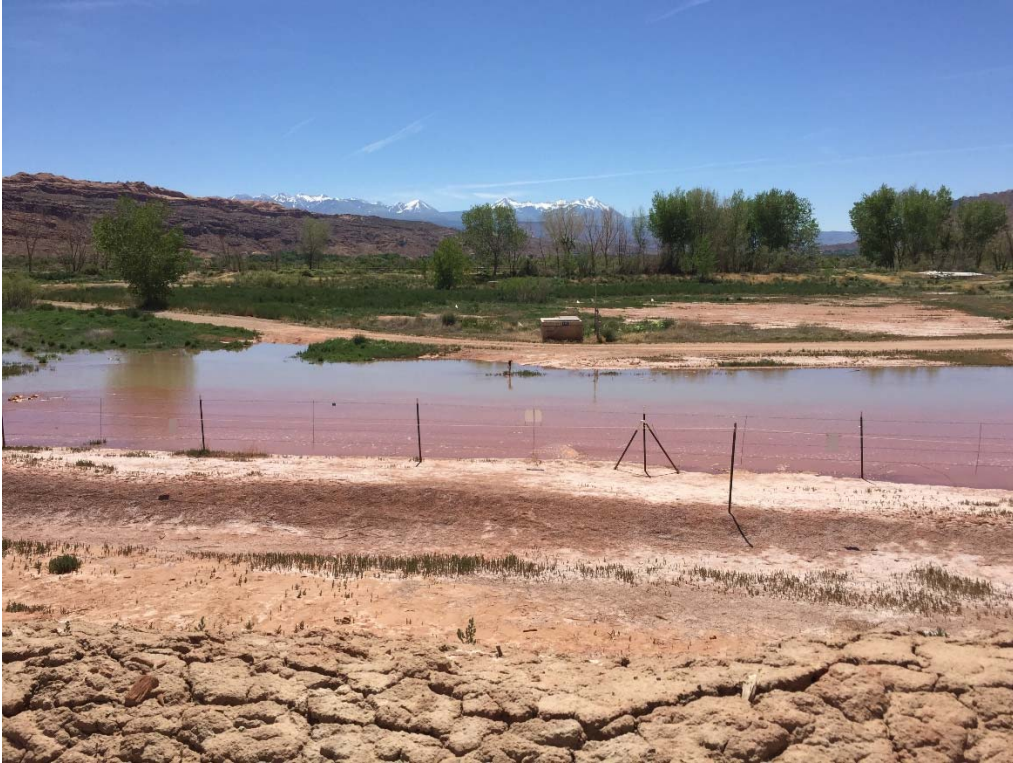
*Photo B-9. Well Field from Contamination Area*

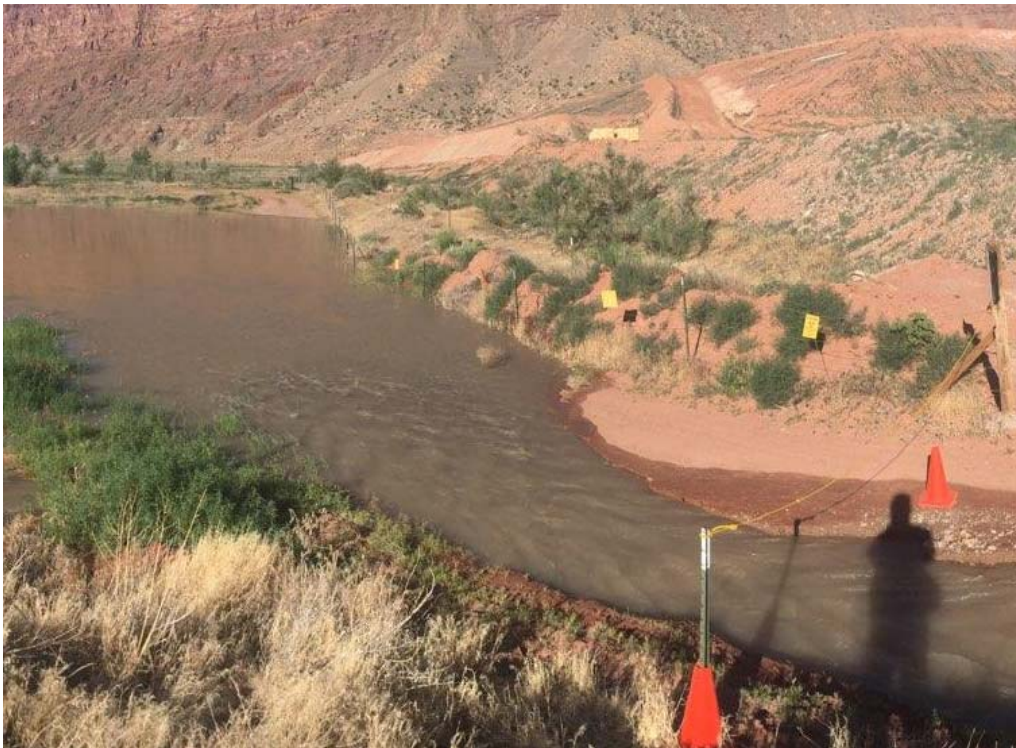
*Photo B-10. Water Flowing into Well Field from Moab Wash*

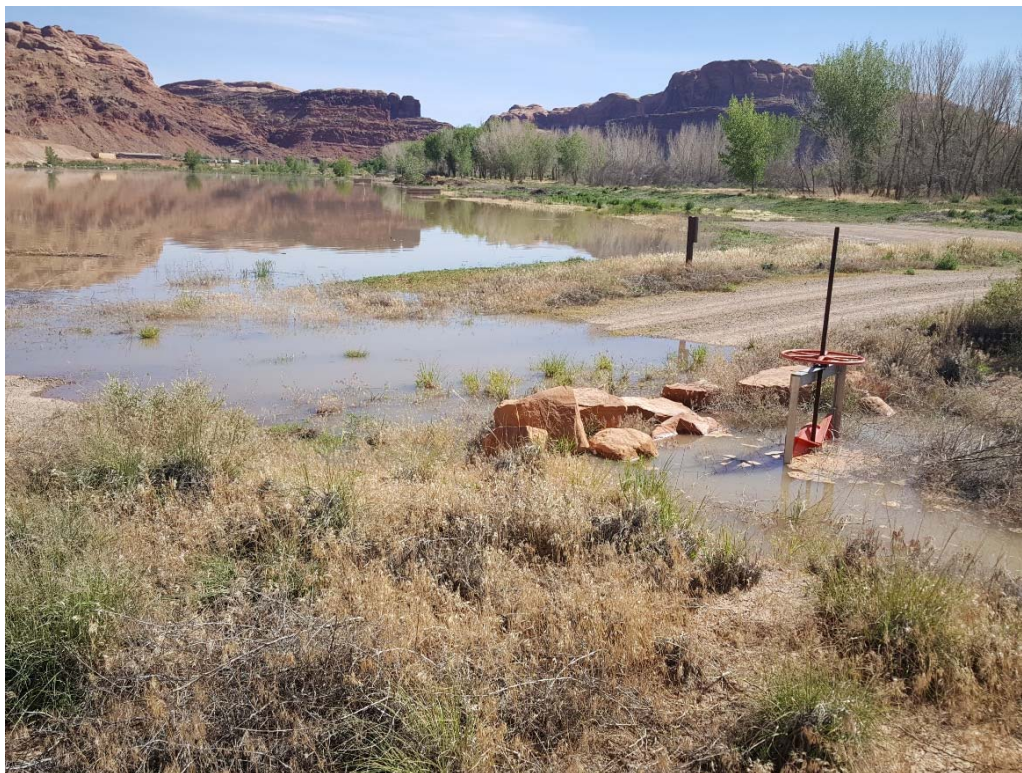
*Photo B-11. Drainage Channel through South Off-pile Area*

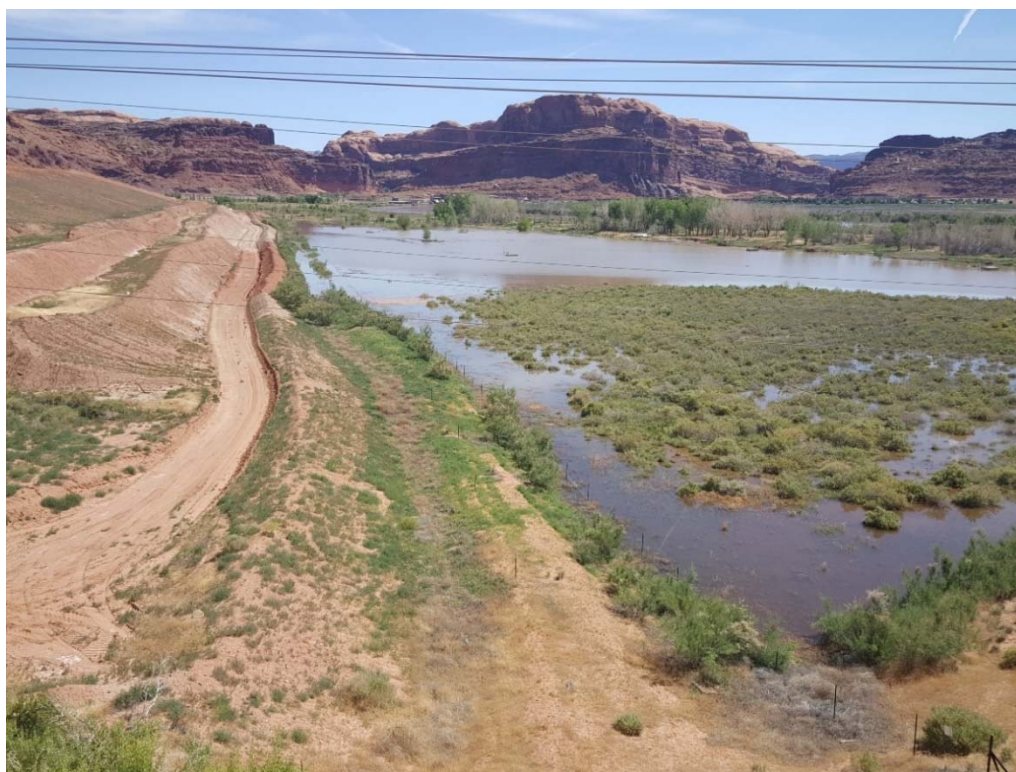
*Photo B-15. Ponded Water in Well Field from Hwy 279*

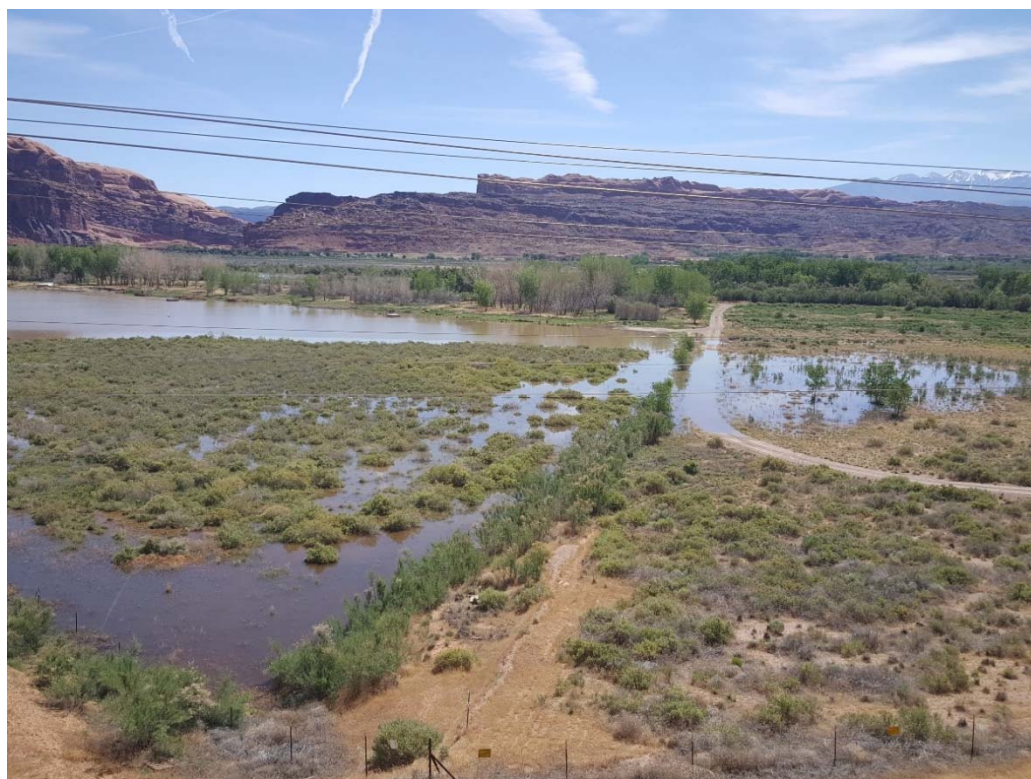
*Photo B-16. Ponded Water in Well Field from Hwy 279*

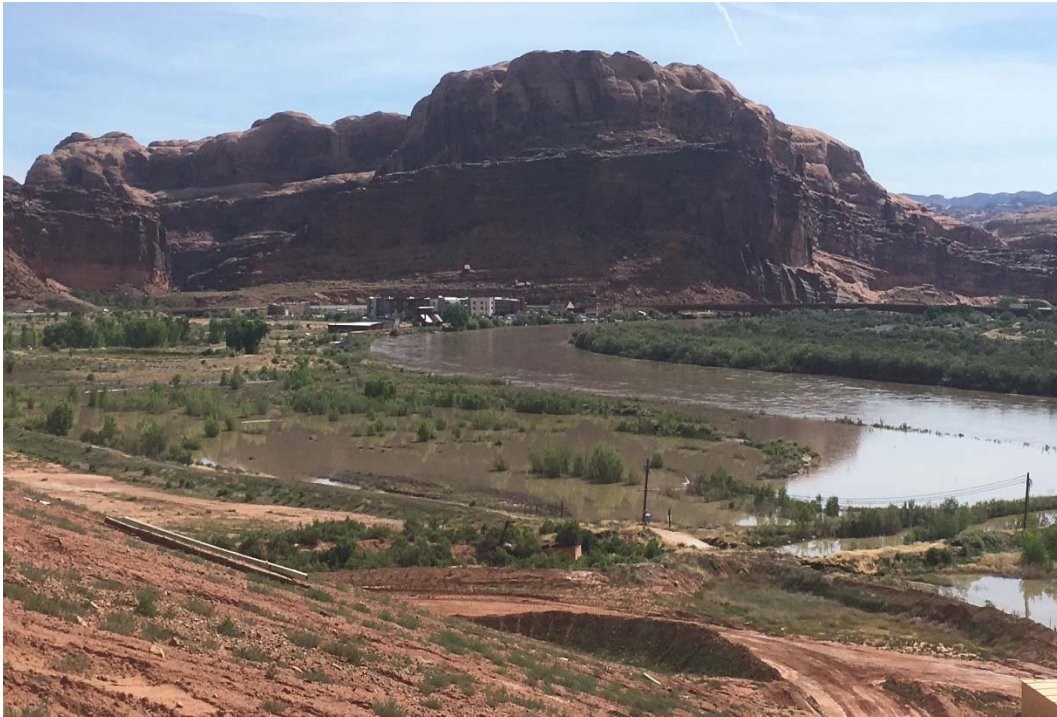
*Photo B-17. North Off-Pile from Contamination Area*

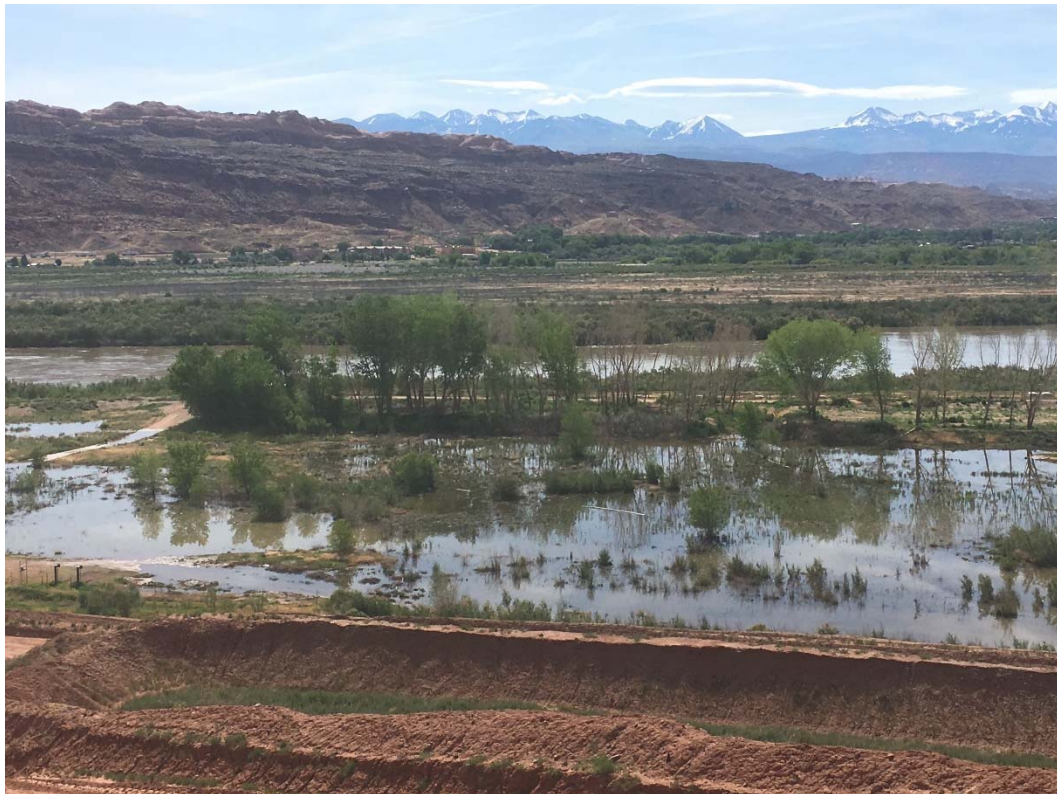
*Photo B-18. South of Moab Wash from Contamination Area*

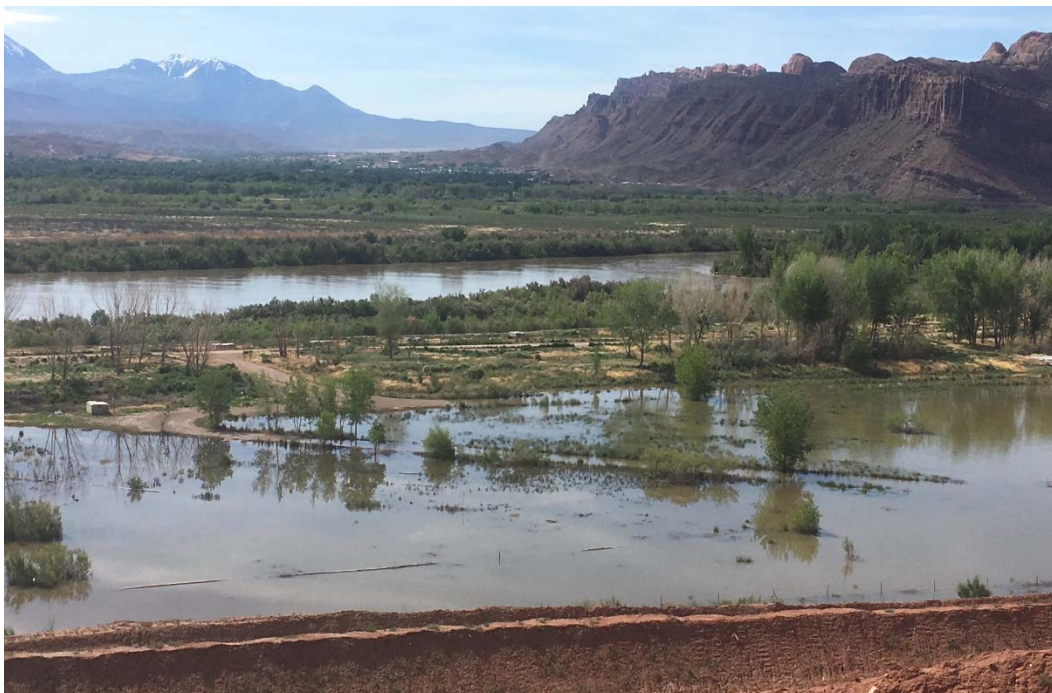
*Photo B-19. Northern End of Well Field from Contamination Area*

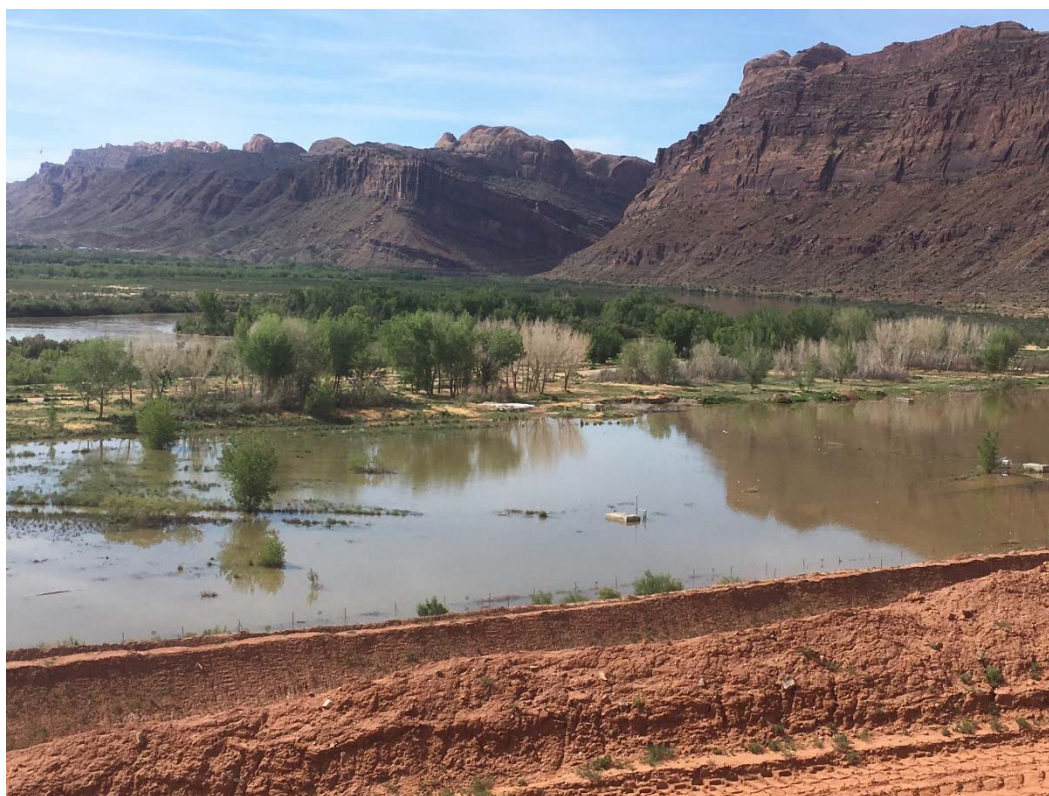
*Photo B-20. Southern End of Well Field from Contamination Area*

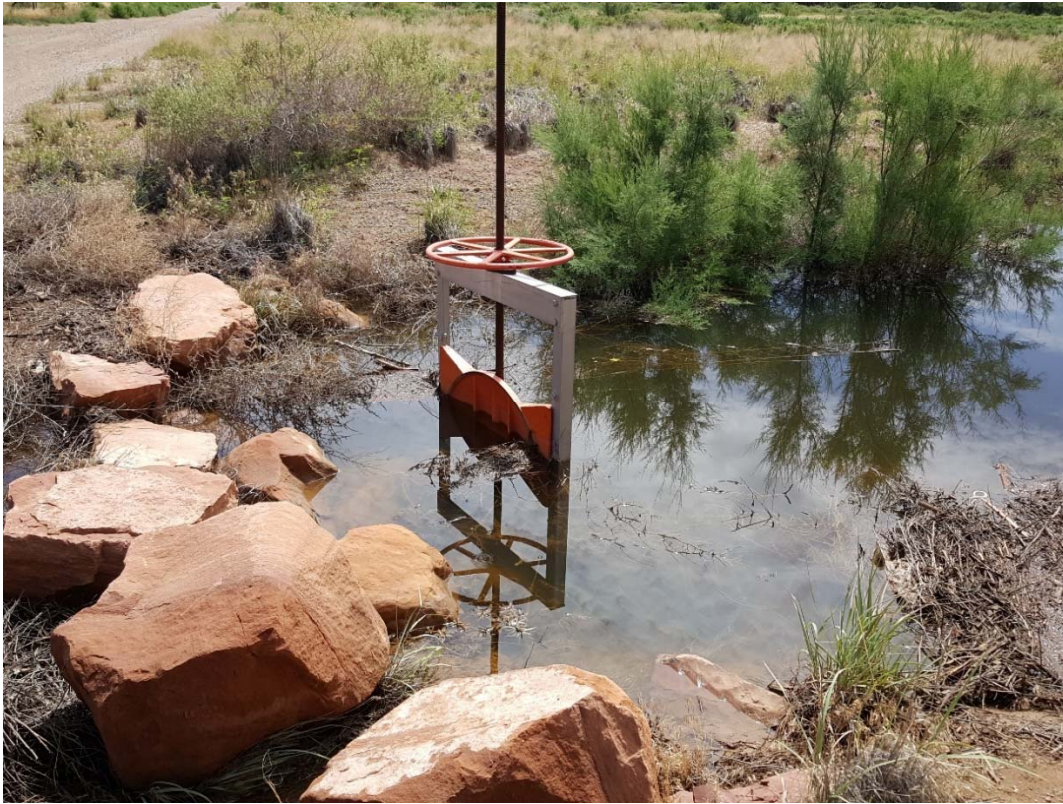
*Photo B-21. Drainage Channel through South Off-pile Area*

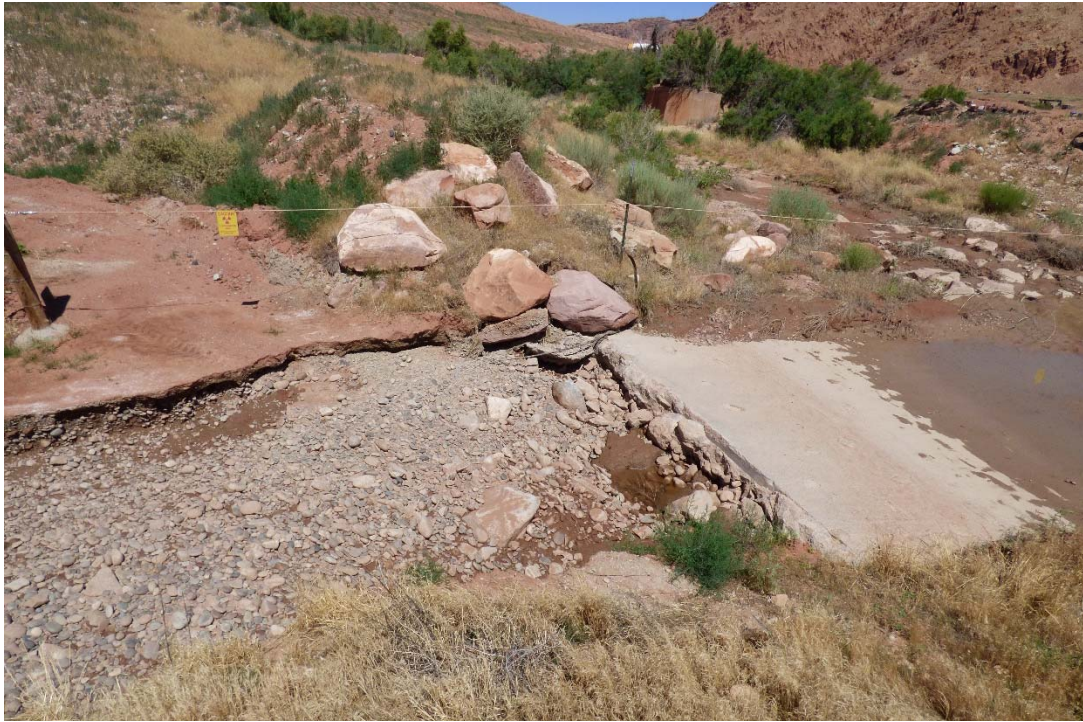
*Photo B-23. Moab Wash Lower Crossing Erosion Damage*

- Damage caused by flood water erosion in the vicinity of the Moab Wash lower crossing was repaired by the end of July.

- Flooding in the well field area may have been prevented by increasing the elevation of the southern side of the Moab Wash lower crossing. An evaluation should be made during flood preparations to determine if additional actions should be taken to prevent flooding of the well field area.

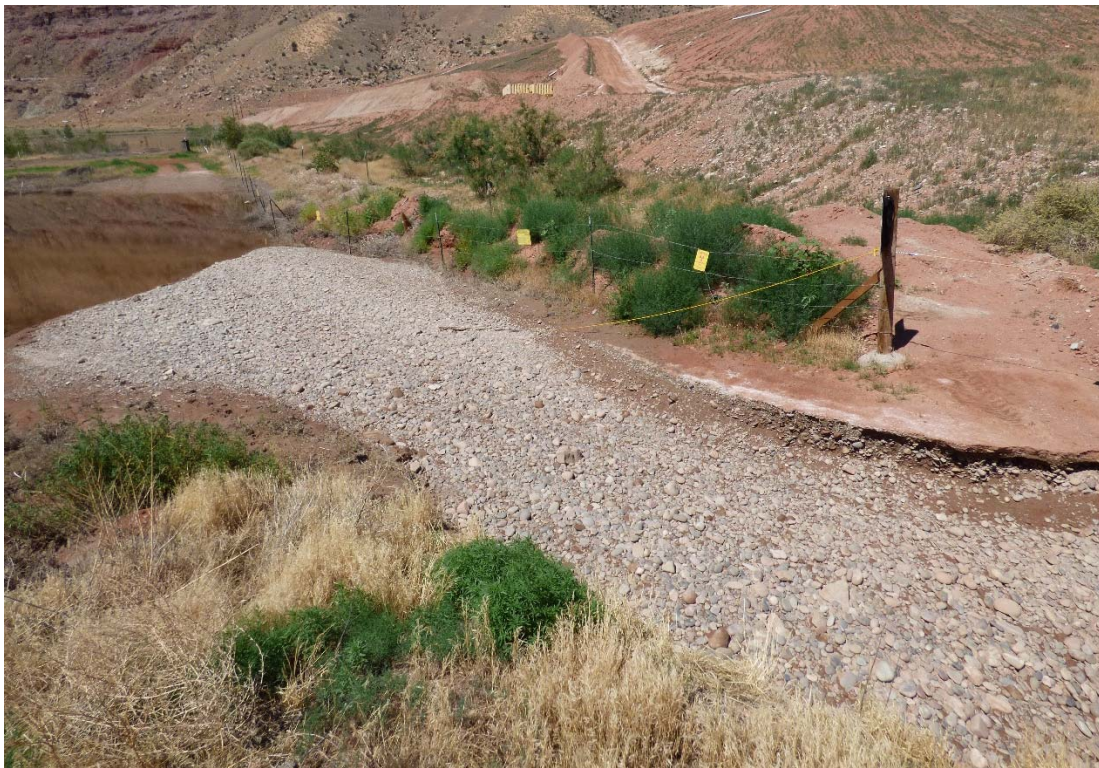
*Photo B-24. Moab Wash Lower Crossing Exposed Gravel*

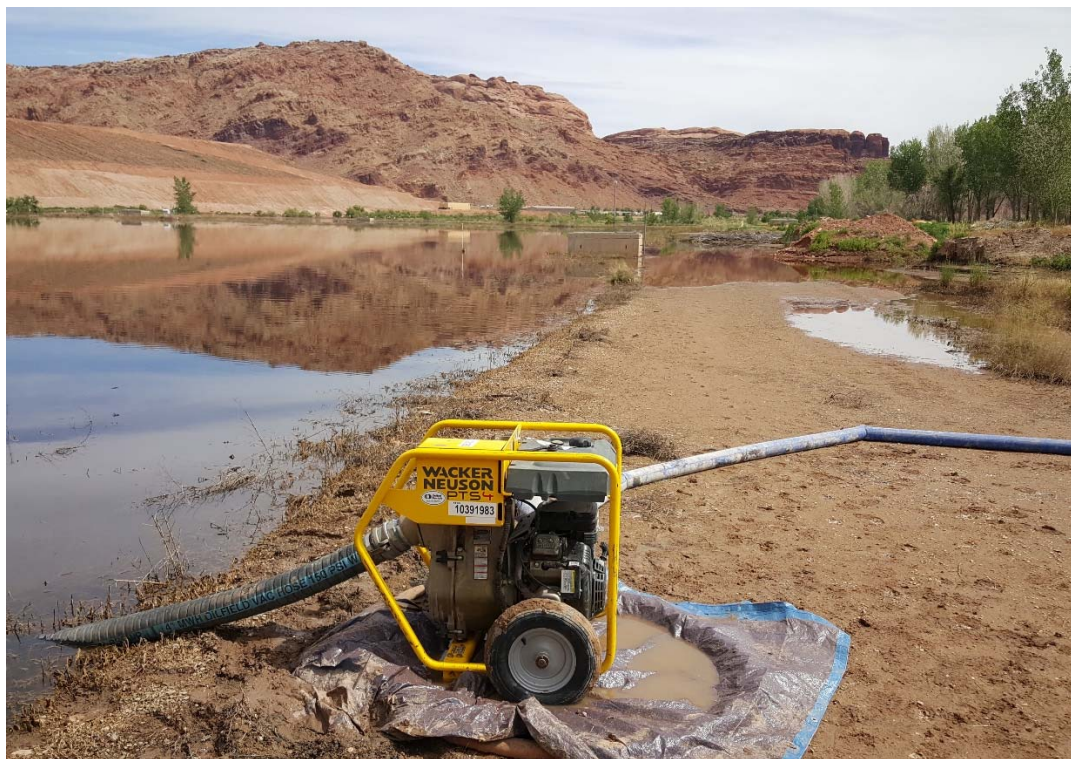
- After the river peaked, the ponded water in the well field area had to be pumped out because the water did not flow back through the channel as expected.

*Photo B-25. Trash Pump Transferring Water from Well Field to the Irrigation Plot*

- The transfer pump was utilized through July 17, at which time it was returned to the rental company. Between June 25 and July 17, an estimated 3.9 million gallons of water were transferred to the nearby flood irrigation plot.

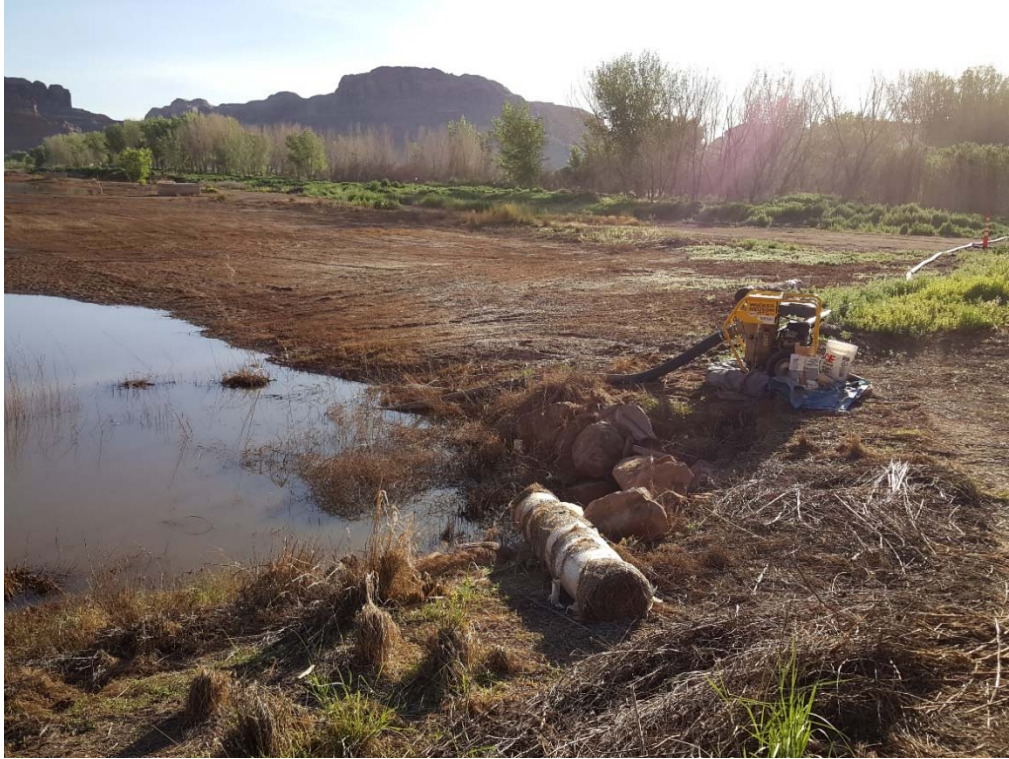
*Photo C-1. Trash Pump Set Up at Southern End of Well Field*

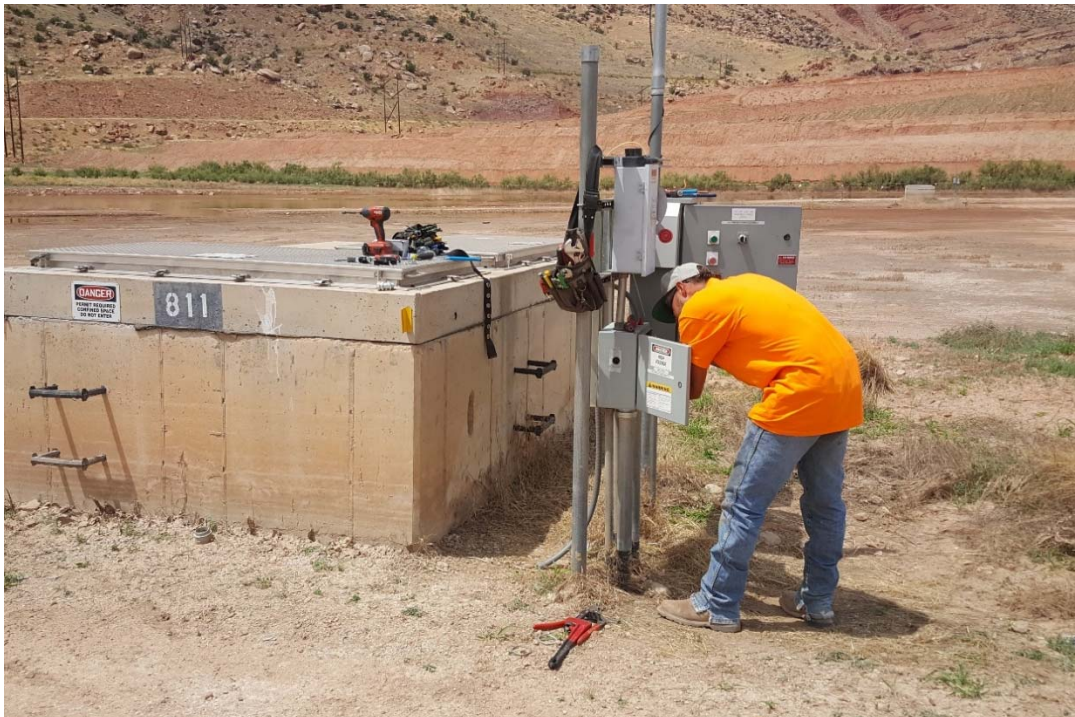
*Photo C-4. Replacing Electrical Components on Well 0811*

- On July 30, MorStorage was brought back on site to replace the pumphouse to the original location using a roll off truck.
- On July 31, BODEC Electric began reinstalling all variable frequency drives, transformers, and electrical components for the extraction wells. All of the associated electrical panels were inspected, labeled, and tested. Locks and tags were removed from the main disconnect, and power was restored to the well pumps. All work was completed following National Electrical Manufacturers Association *Evaluating Water-Damaged Electrical Equipment* and *Guidelines for Handling Water-Damaged Electrical Equipment*. This work was completed by August 12.
