Moab UMTRA Project Hillside Geology Assessment

May 2009

U.S. Department
of Energy

Office of Environmental Management

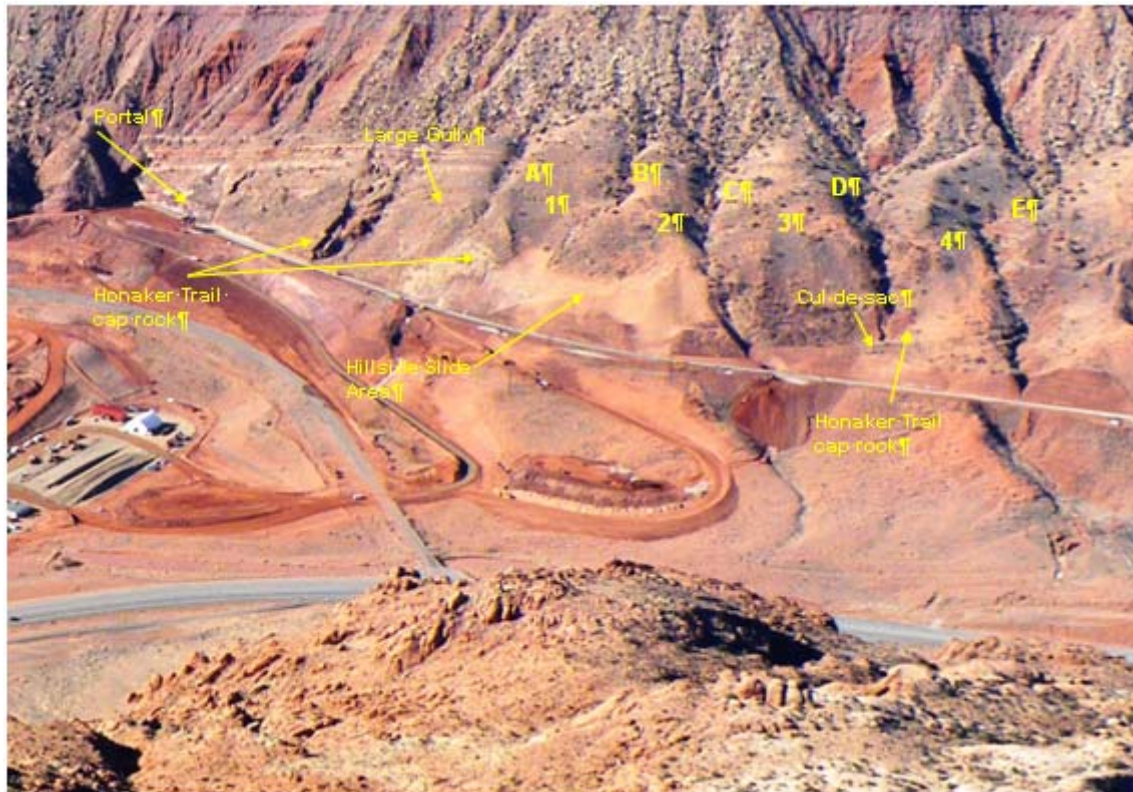
Photo 1. Railroad Adjacent to Moab Site and Hillside Locations

The hillside monitoring began in February 2009 (approximately 1,900 ft northwest of the portal) after a landslide occurred on a newly excavated slope along the Moab Fault trace. Many stepped sand features present above the excavation were monitored for movement by measuring stakes located both upslope and downslope of these features. Several of these locations mentioned in this report are referred to with specific names (e.g., cap rock, cul-de-sac). Photo 1 includes descriptive names for each of these locations.

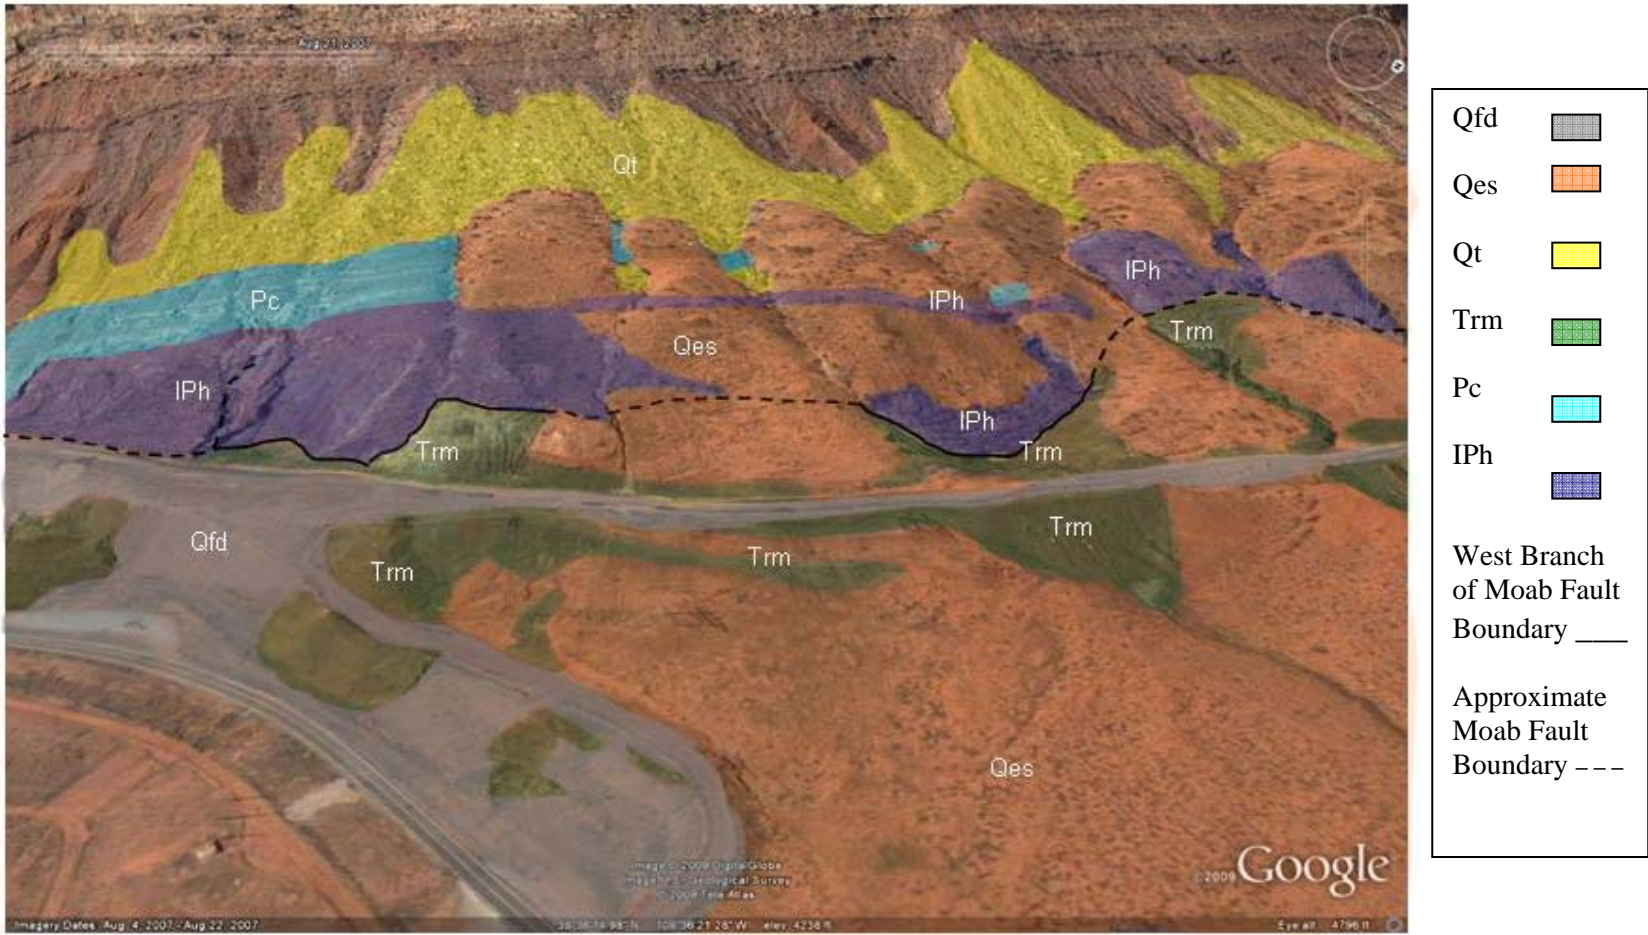
Figure 1. Geologic Map of Hillside Before Construction Activities

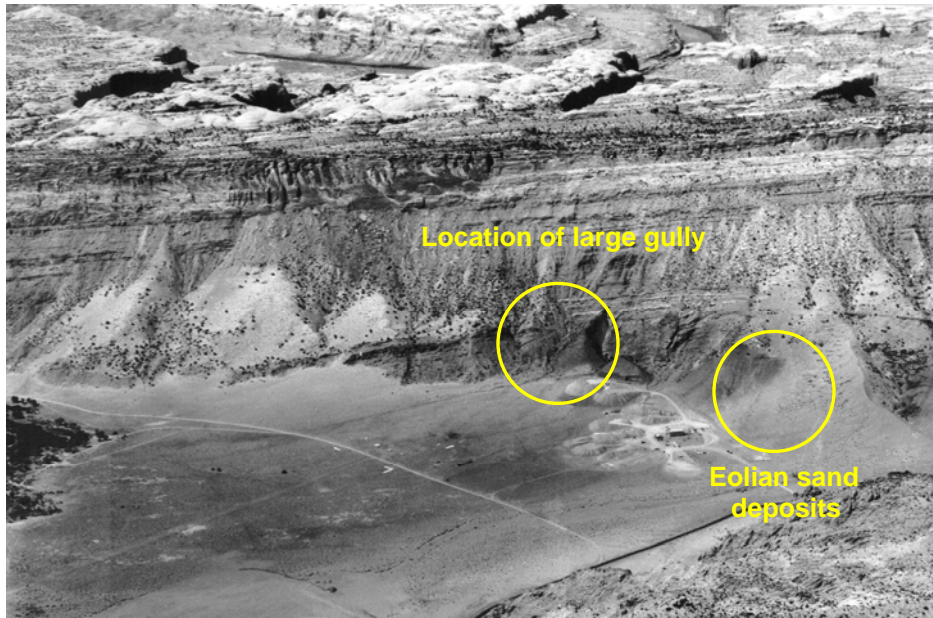
A photograph taken in 1955 before rail construction was used to determine the original morphology of the hillside (Photo 2). The photograph shows that a large gully was once present before the construction of the portal. The east flank of the large gully was believed to have been blasted back during the portal construction. The amount of downslope eolian sand was also greatly diminished during construction activities.

Photo 2. Portal Hillside in 1955 Before Rail Construction

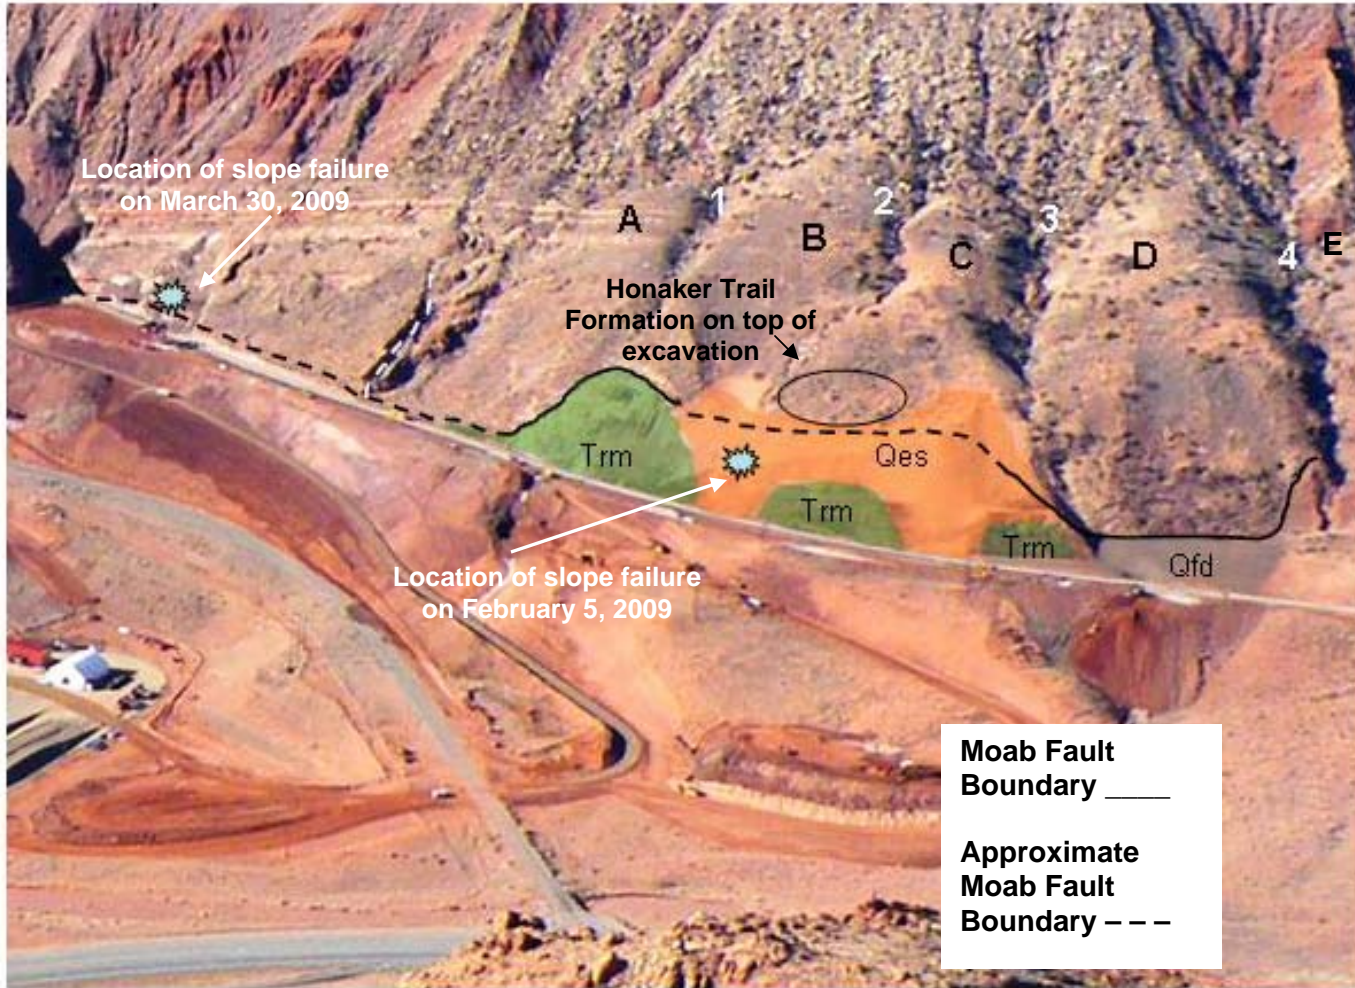
The 1962 construction activities also altered the surficial geology of the hillside. During the hillside excavation, the Moenkopi Formation was exposed where there was once Quaternary eolian sand (Figure 2). Also, a gully bounded by an embankment for the railroad, forming a depression at a location of 2,206 ft from the portal, was filled in with soil from the construction activities (the cul-de-sac).

Figure 2. Changes to Geologic Map After Rail Construction

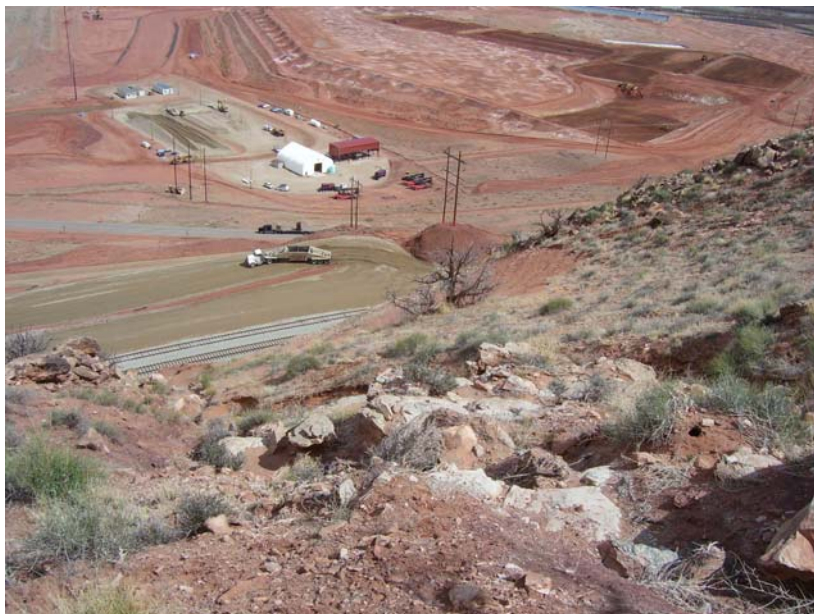
Drainage Channel 2 is the channel that could possibly have the most profound impact on the new rail construction because it meets the rail at the location of the February 2009 slope failure. It is possible that the presence of the drainage may have been a factor in the slide that occurred on this slope. There are areas of stepped bedrock outcrops near the talus slope within this drainage channel. Downslope, however, the drainage cuts into the eolian sand and eventually cuts down to the Honaker Trail bedrock immediately above the excavation area (Figure 1 and Photos 14 and 15). During a significant storm event, sand would likely be transported downslope of this drainage channel.

Photo 14. Drainage 2 Looking Downslope at Bedrock Above Excavation

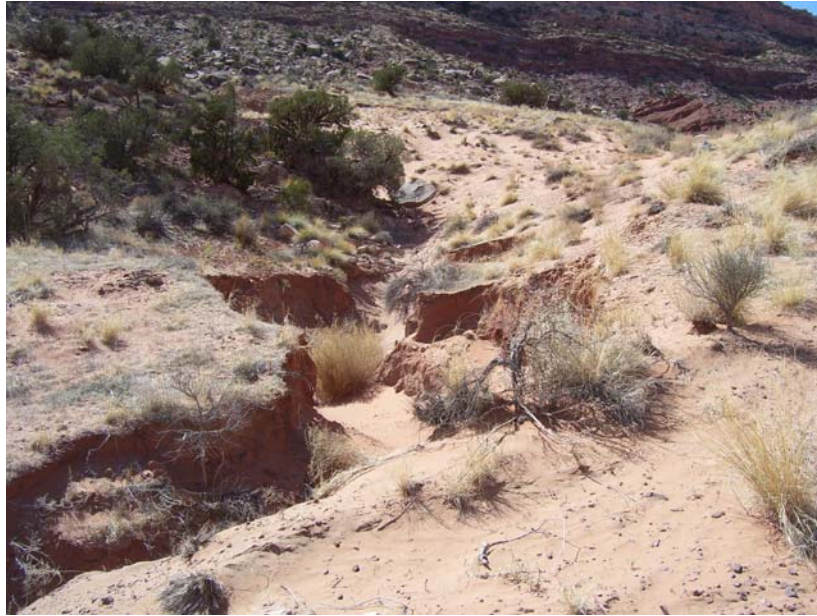
Photo 15. Drainage 2 Looking Upslope Where Sand Has Been Eroded

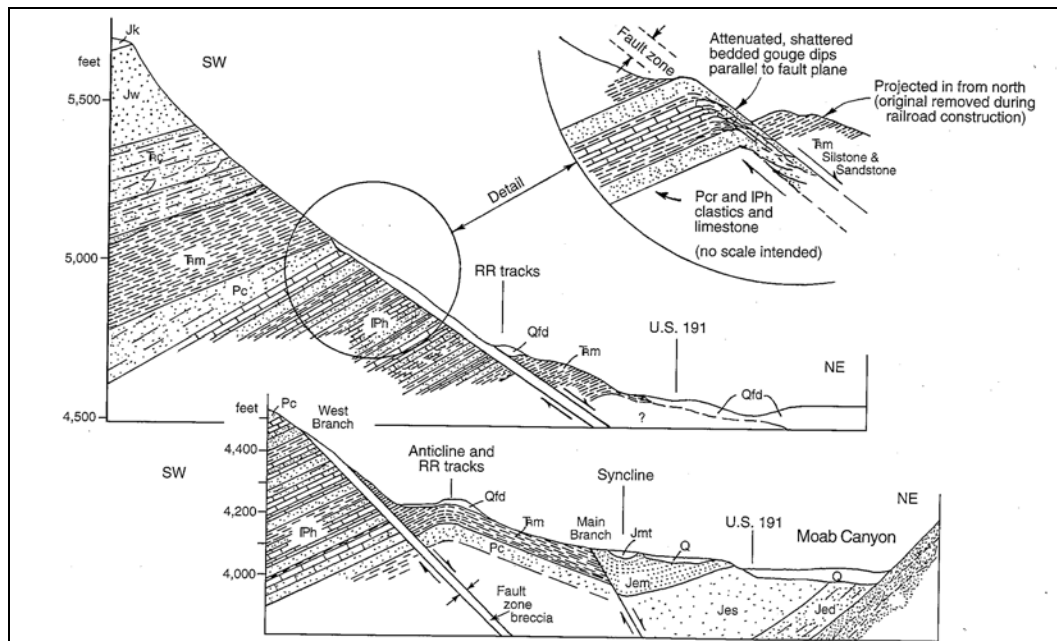
The two areas of slope failure in February and March 2009 occurred along the slip plane on the west branch of the Moab Fault (Figure 2). The first slide occurred along a portion of the fault that was covered by eolian sand, and the excavation of the slide material revealed a smooth face of the Moenkopi Formation. It is likely that this fault plane was also weakened by the drainage channel that cuts through this surface (Photos 21 and 22). This slip plane can be traced northwest towards the bowl and south towards the Honaker Trail cap rock and the location of a minor slope failure event near the portal.

Figure 3. Schematic of Geometry of Moab Fault Along Rail Tracks

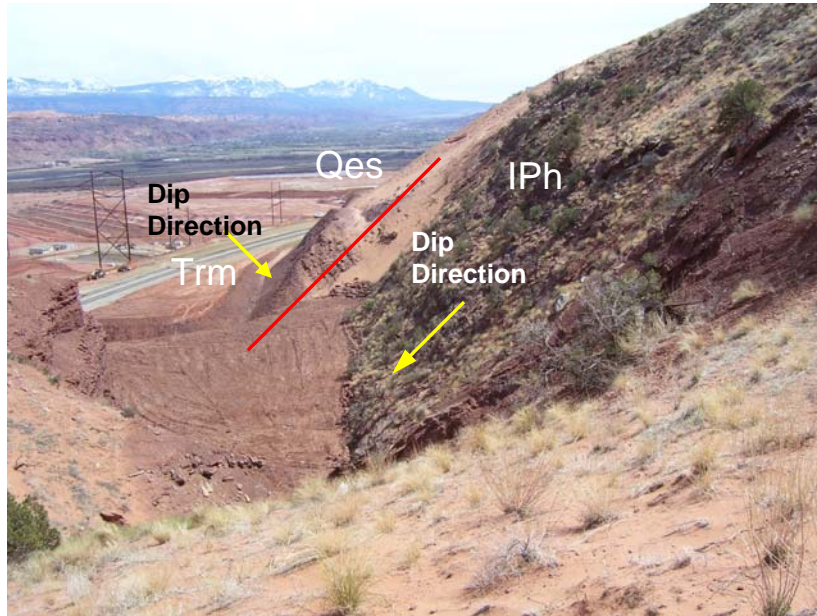
Photo 19. Fault Depicted in Figure 3

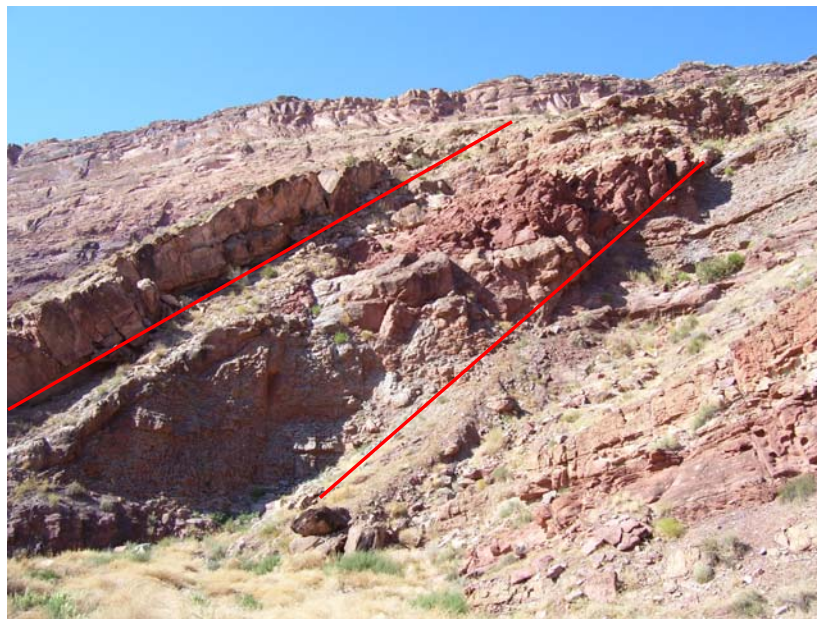
Photo 20. Faulted Surfaces Within Main Gully and Fault Offset Between Honaker Trail and Moenkopi Formations

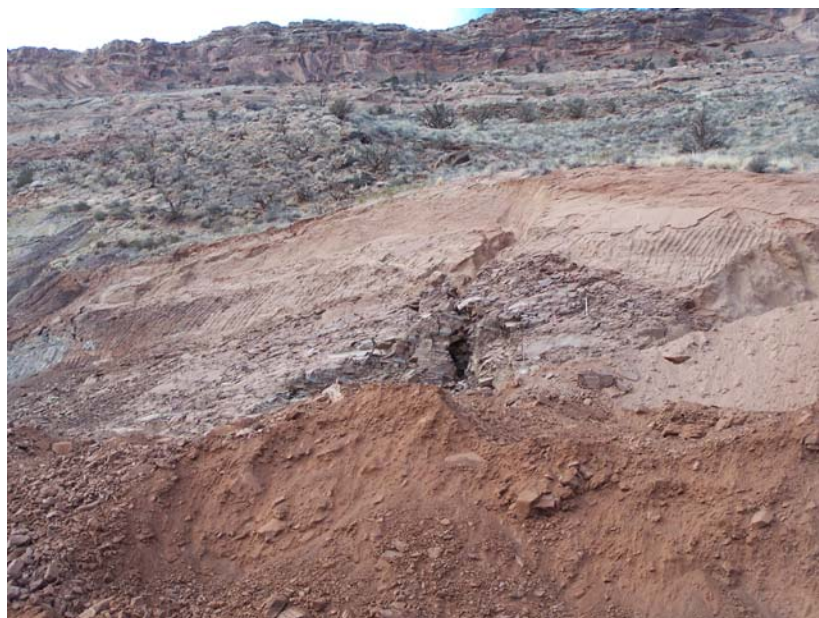
Eolian sand above the hillslope excavation (upslope of the location pictured in Photos 21 and 22) exhibited many stepped sand features and surficial cracking within the sand. Following the slide on February 5, 2009, slope monitoring began to determine if any continuing movement is occurring.

Photo 21. Hillslope One Day After February 2009 Slide

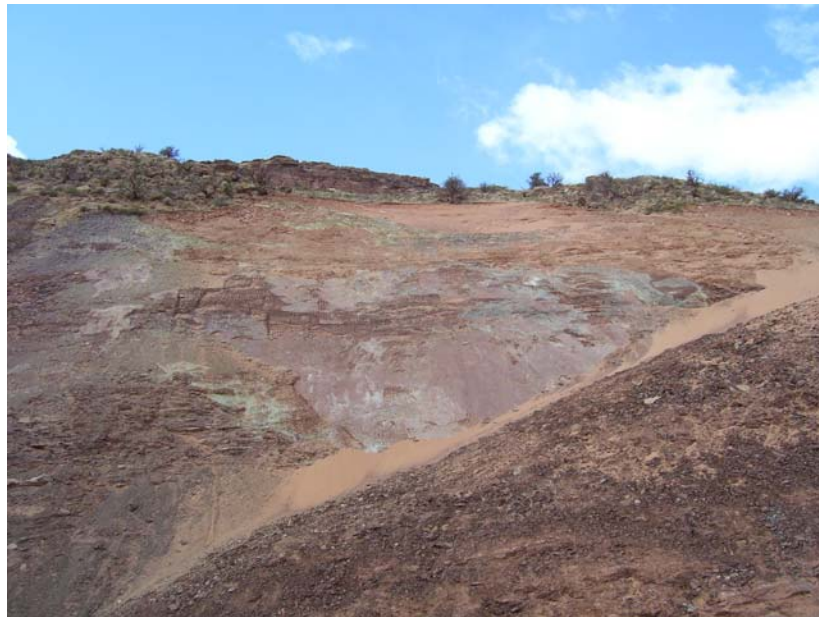
Photo 22. Hillslope Slide Area After Cleaning of Slumped Material

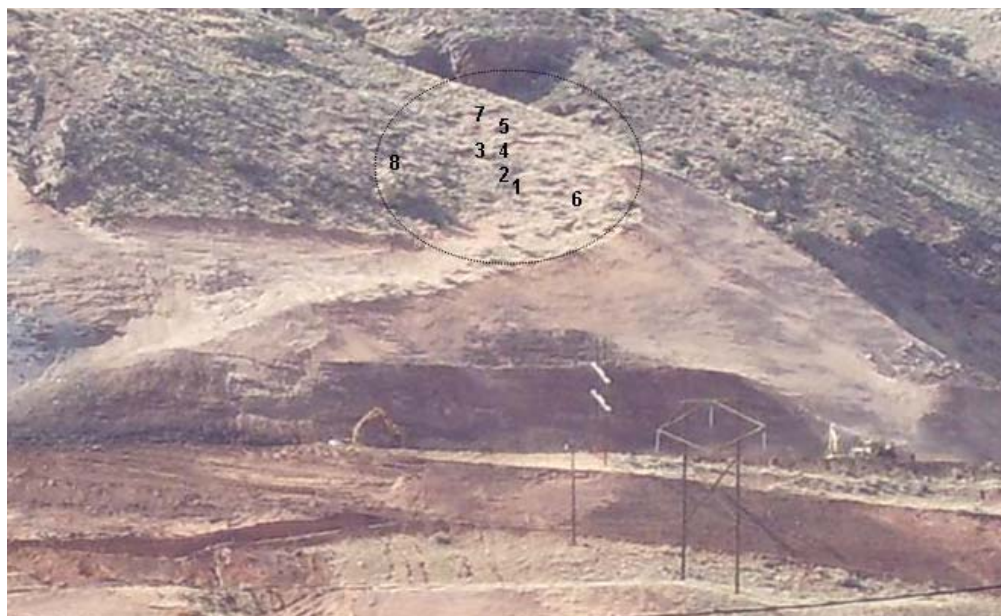
On February 9, 2009, five locations of stepped sand and surficial cracking were staked and photographed (Photo 23), and global positioning system (GPS) coordinates were collected. The staked locations represent areas both above the slide area and along the excavated area immediately to its north that exhibit movement such as slumping or surface cracks. During this time, the hillside monitoring was completed once a week. On February 25, three additional locations were identified and photographed, and the locations were recorded with a GPS unit. Wooden stakes were placed upslope and downslope of each feature, and the distance between the two stakes was measured to the nearest tenth of an inch (Table 2). At this time, the frequency of the monitoring was increased to once a day. While some surface sloughing was noted, major movement was not recorded on the slope. Photographs of the eight staked locations are included in Attachment A.

Photo 23. Staked Locations Monitored on Hillside

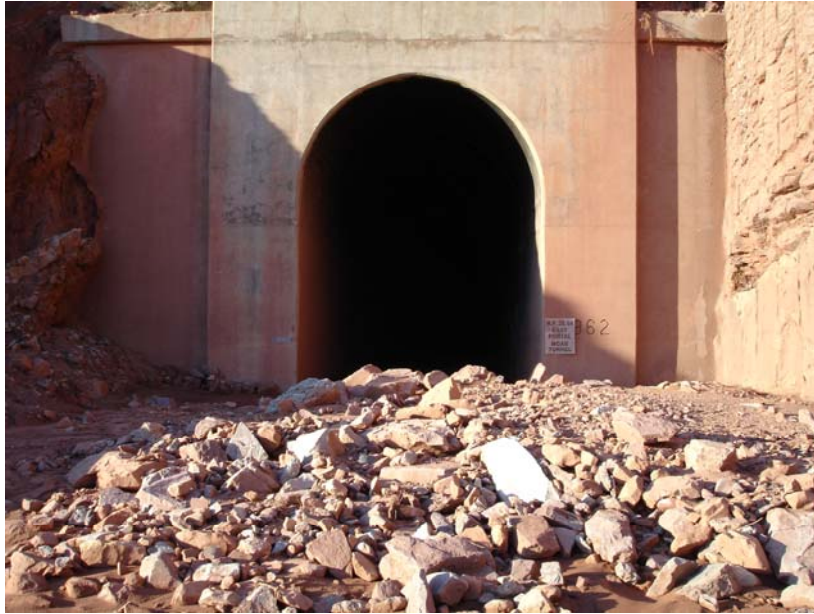
The photographs of the storm damage reveal areas of future potential concern. The 1955 photograph (Photo 2) shows a large gully located just northwest of the portal. During rail construction in 1962, the southeast flank of the gully was removed; however, photos from July 2006 show that this is a location of high-energy erosion during significant storm events. Along the Honaker Trail cap rock (Photos 24, 25, and 26), mostly silt, sand, and gravel covered the rail line.

Photo 24. Rockfall Near Portal

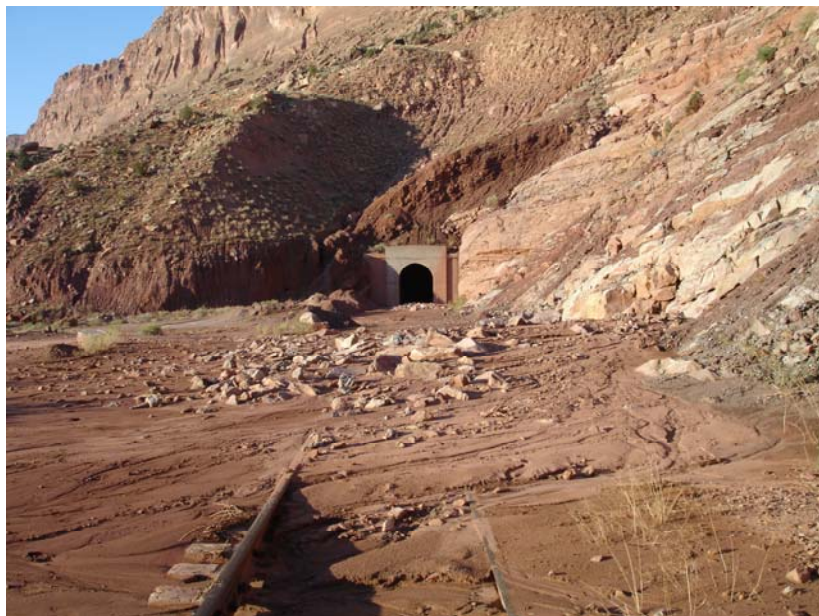
Photo 25. Rock and Sand Debris Flow Southeast of Honaker Trail Cap Rock

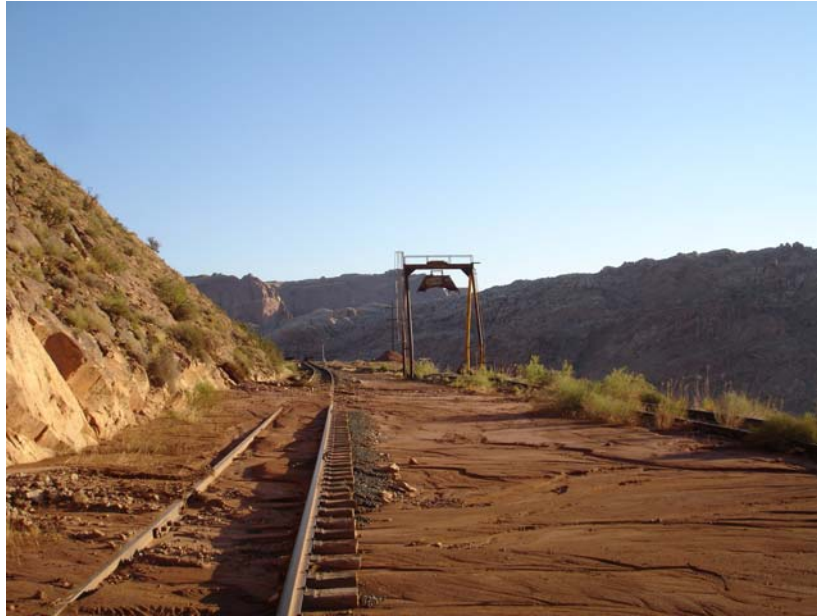
Photo 26. Facing North Towards Old Gantry Crane and Honaker Trail Cap Rock

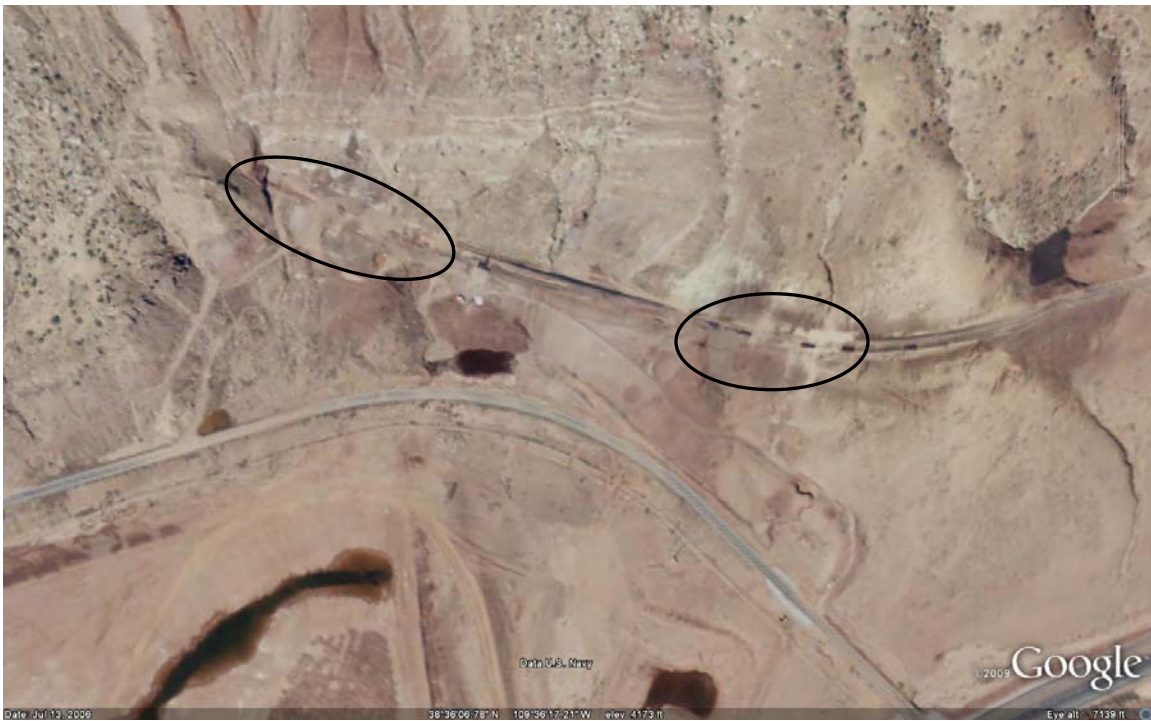
An aerial photograph taken in September 2006, two months after the flash flood event, shows other areas of potential concern. For example, it appears that the location of the February 2009 slope failure consisted of a deep drainage channel and was covered with debris (Photo 27). The area near the cul-de-sac also appears to have contained minor debris flows.

Photo 27. Rail Damage from July 2006 Flash Flood

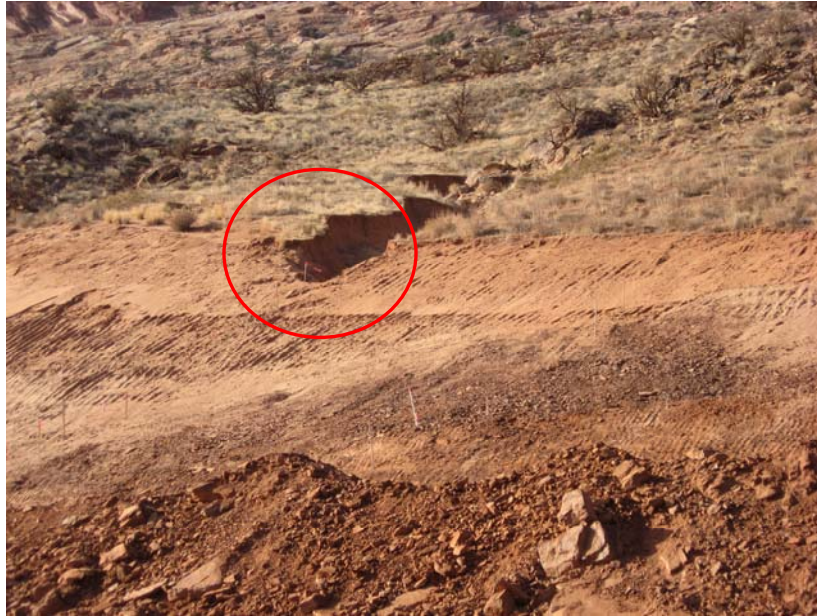
Photo 28. Hillside Excavation Showing Junction of Drainage Channel and Excavated Face

To mitigate the impact of storm events, the need for a control structure on drainage channels should be further evaluated. It is recommended that some sort of break be installed where Drainage Channel 2 meets the excavated slope to slow the velocity of storm water that could potentially damage the rail line (Photo 28). In addition, the base of the Moenkopi along the rail elevation has accumulated windblown sand and is blocking the drainage ditch that leads to culverts to the north and south (Photo 29). Also, site drainage should be closely monitored for sloughing or windblown deposits that may impede flow. The sand in the ditch may prohibit proper water drainage and may cause storm water to spill out towards the rail.

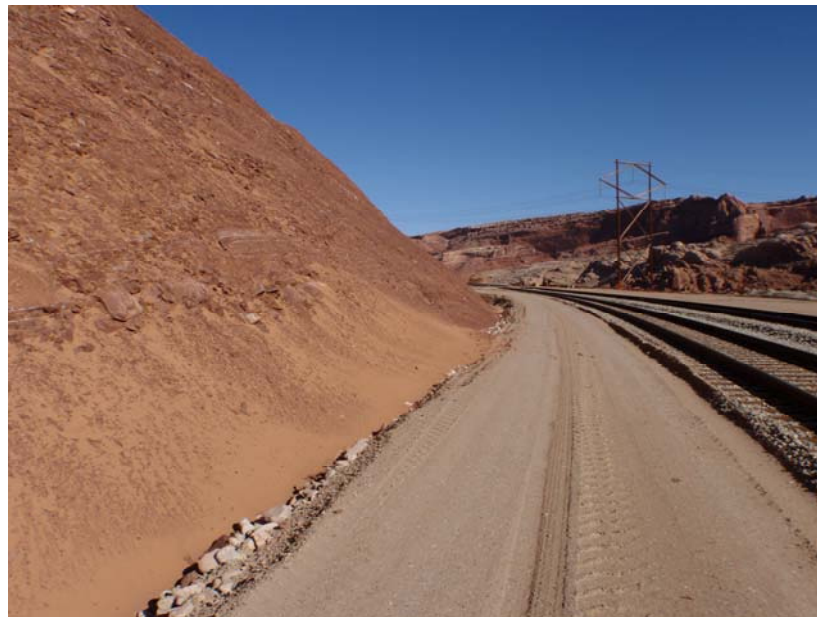
Photo 29. Windblown Sand in Drainage Ditch Along New Moenkopi Exposure on Excavated Hillside
