NYSERDA

July 14 Storm Events and Effects on Erosion Controls in Erdman Brook and Frank's Creek

August 25, 2015

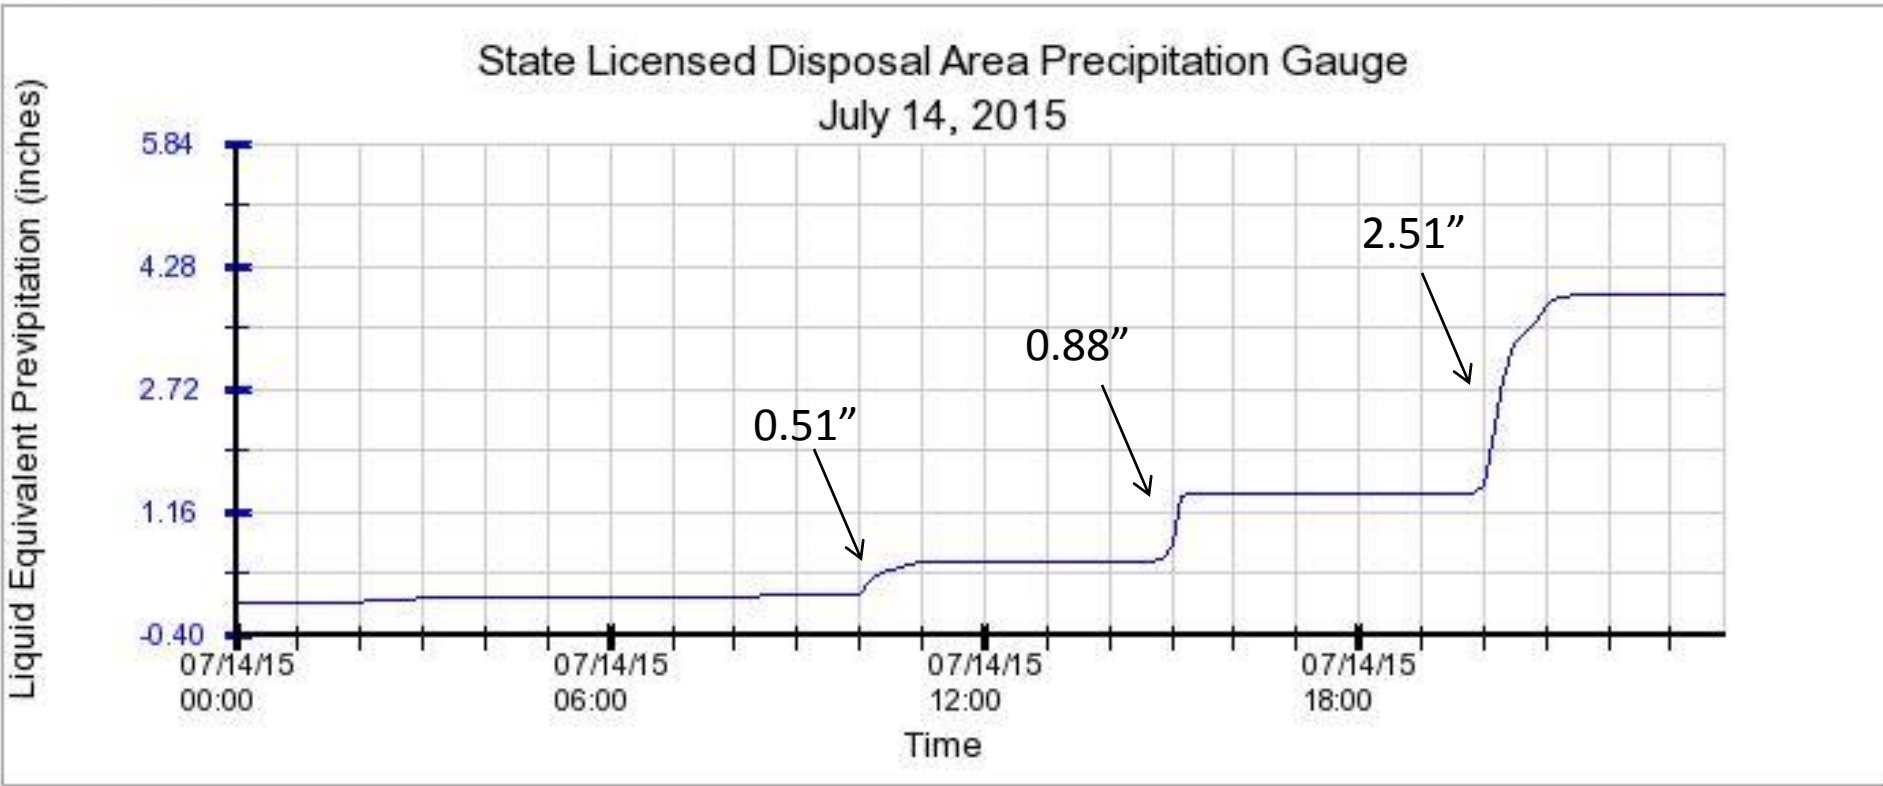
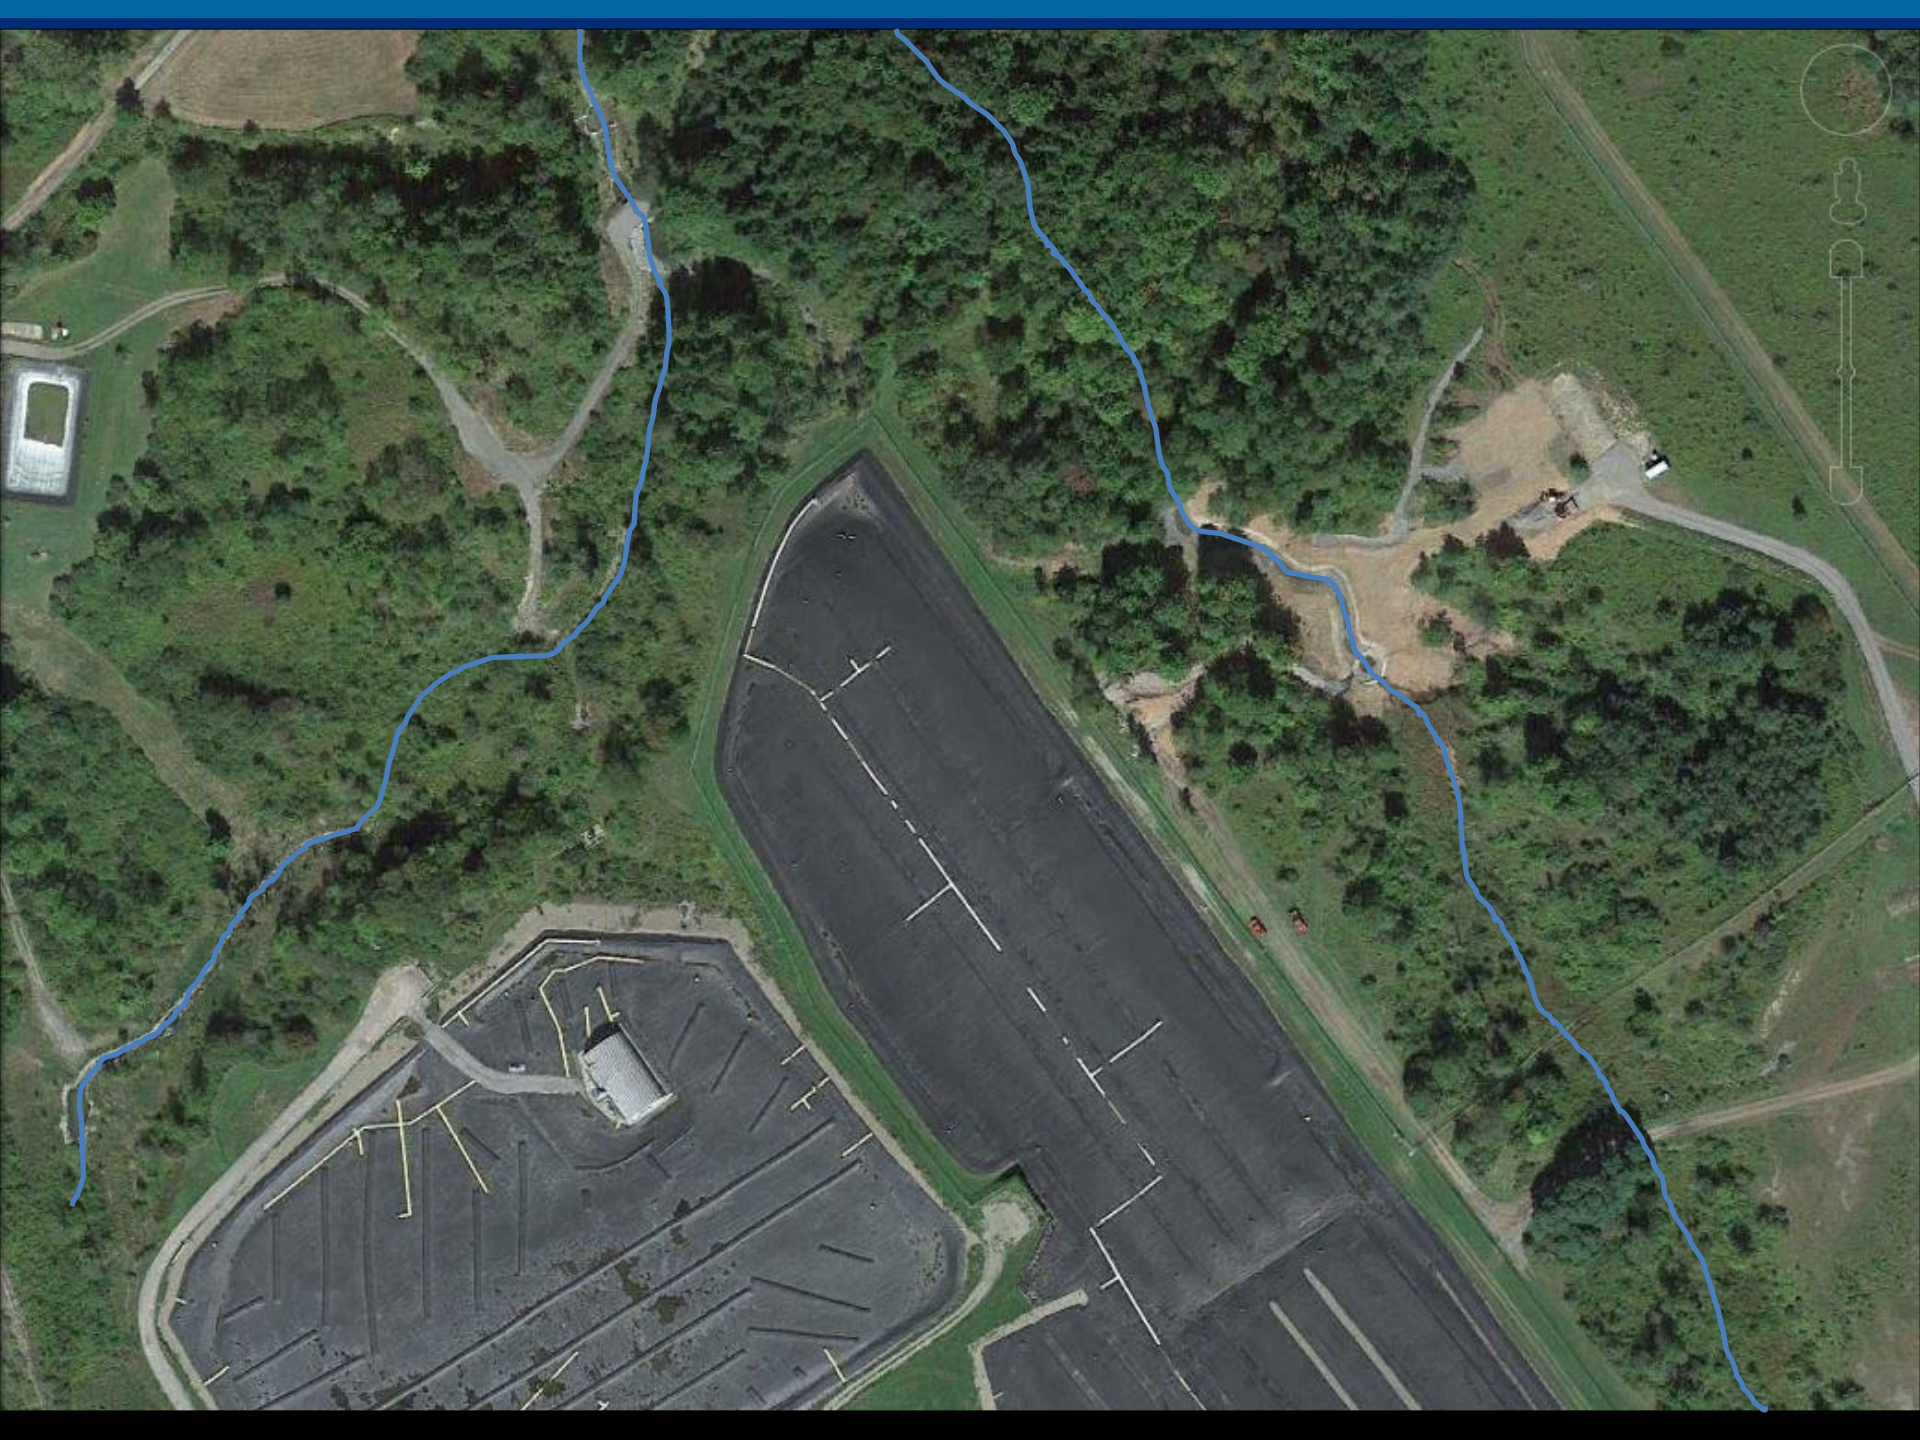
Data Graph

- Total rainfall for the day = 3.90 inches
- 3.9 inch total for 24 hours is slightly larger than the 10-year recurrence interval total of 3.7 inches
- Rainfall received from 8:00pm to 8:30pm totaled 1.80 inches, which is equivalent to a 100-year recurrence interval for a 30 minute rainfall

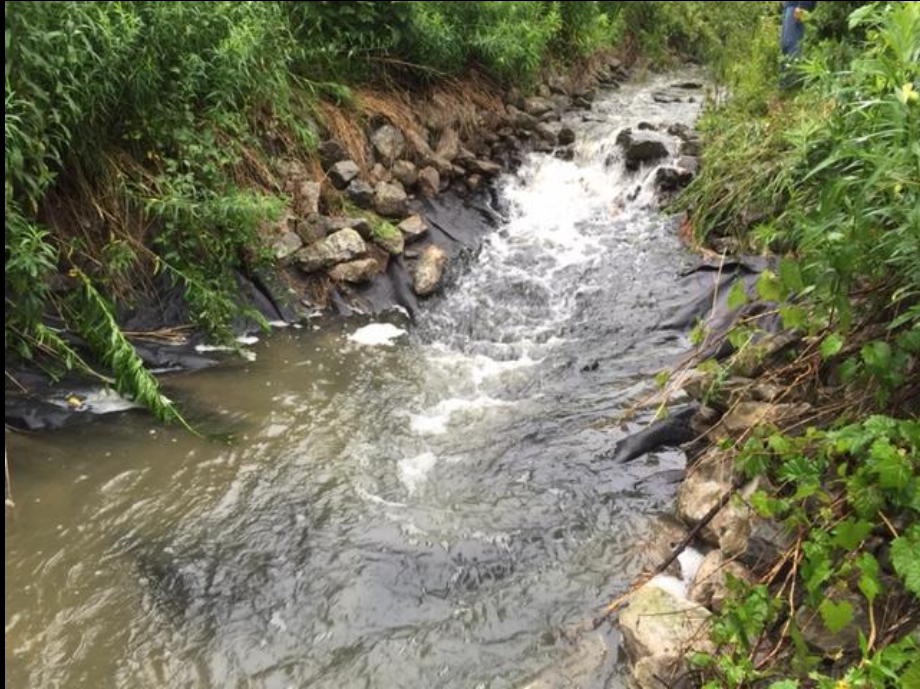
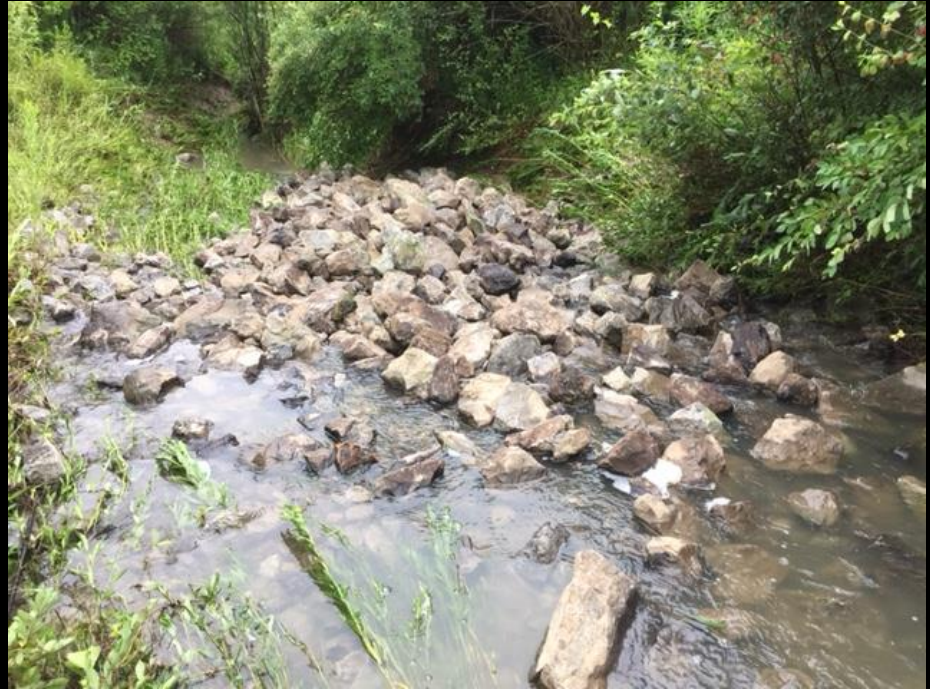
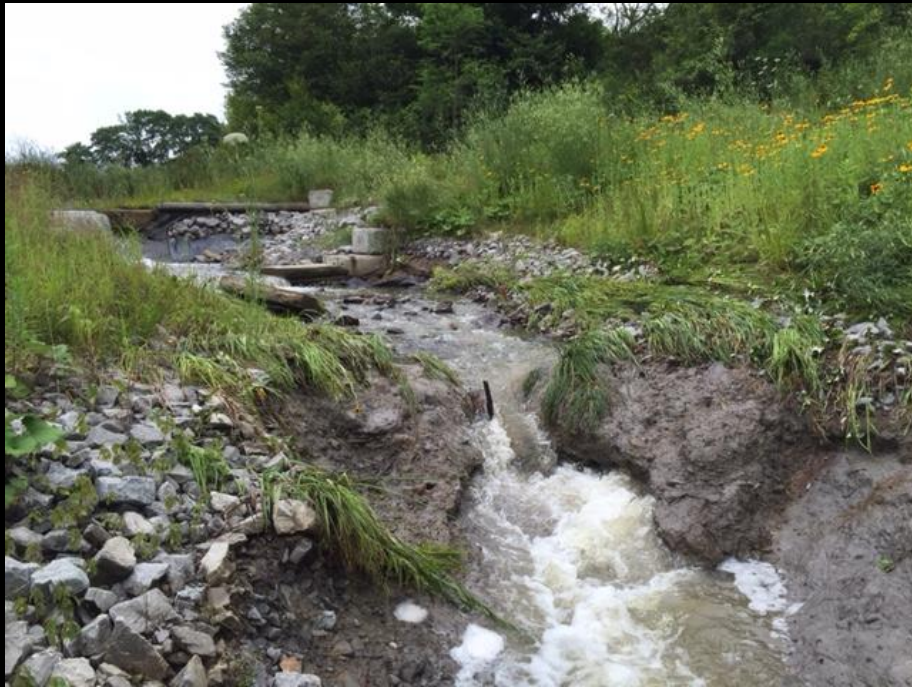
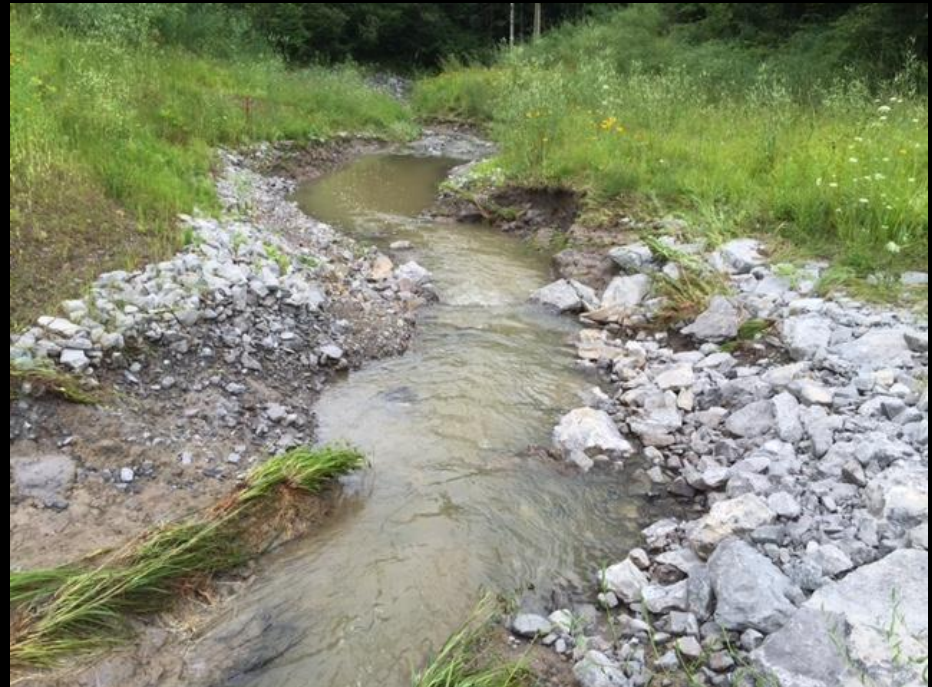
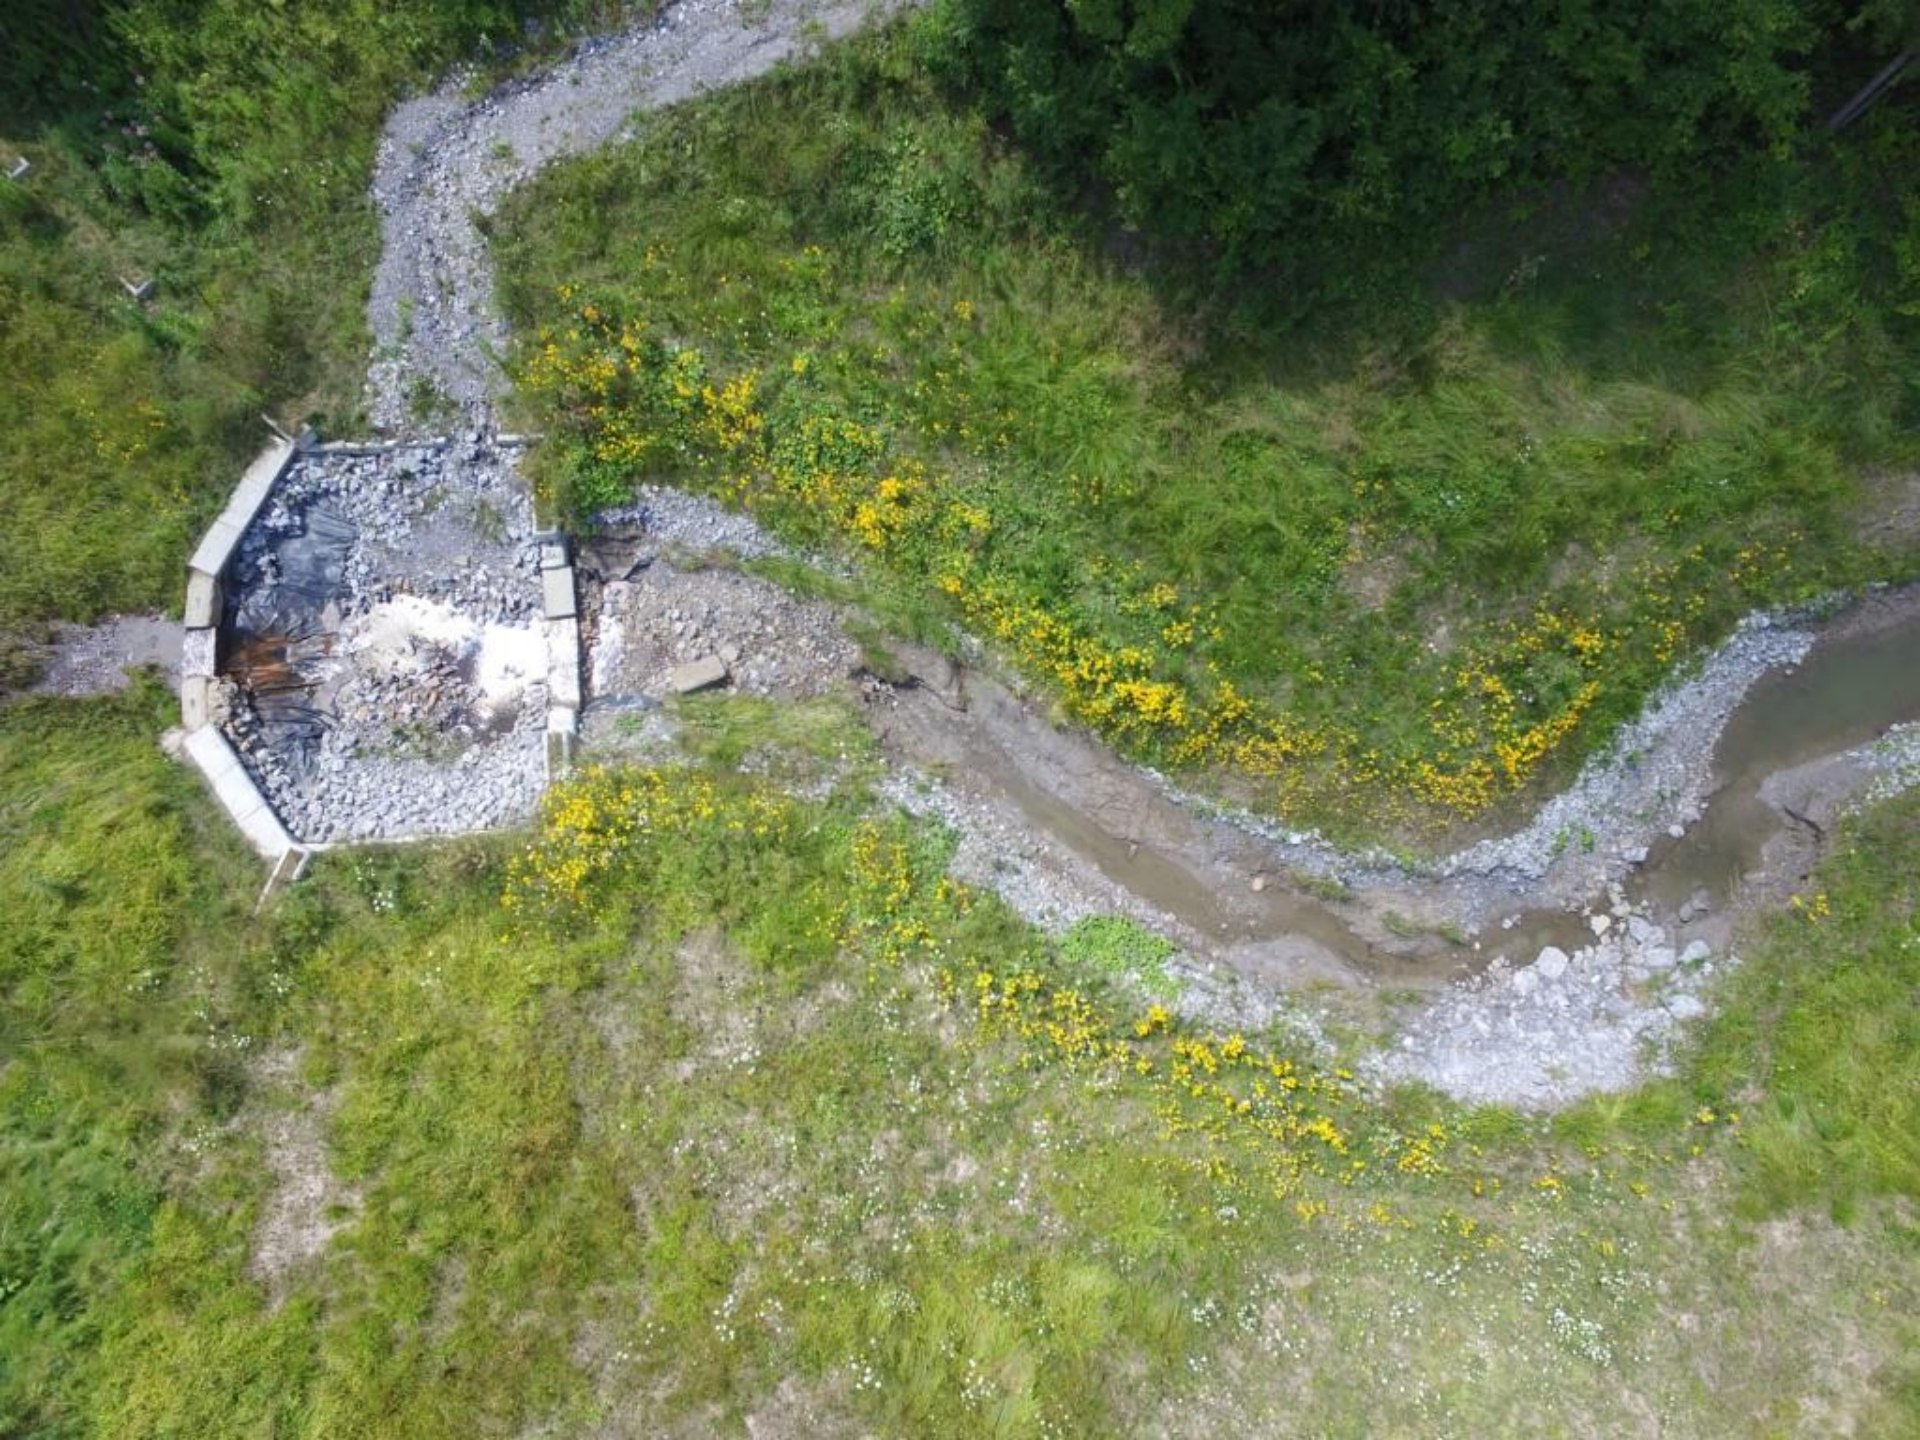
- Erosion controls functioned as designed
- Grade control structures withstood the high flows
- Some channel armoring (rip-rap) was displaced
- On Frank's Creek, some scour (erosion) of the stream banks and stream bed occurred.
- Effects not unanticipated – erosion controls not designed to be permanent installations, would require maintenance

- Repairs will be performed on Erdman Brook and Frank's creek this year
- Repairs will generally be to replace in kind, with certain enhancements
- Enhancements include additional stone check dams and weirs intended to further reduce flow velocities and dissipate energy during large storm events.

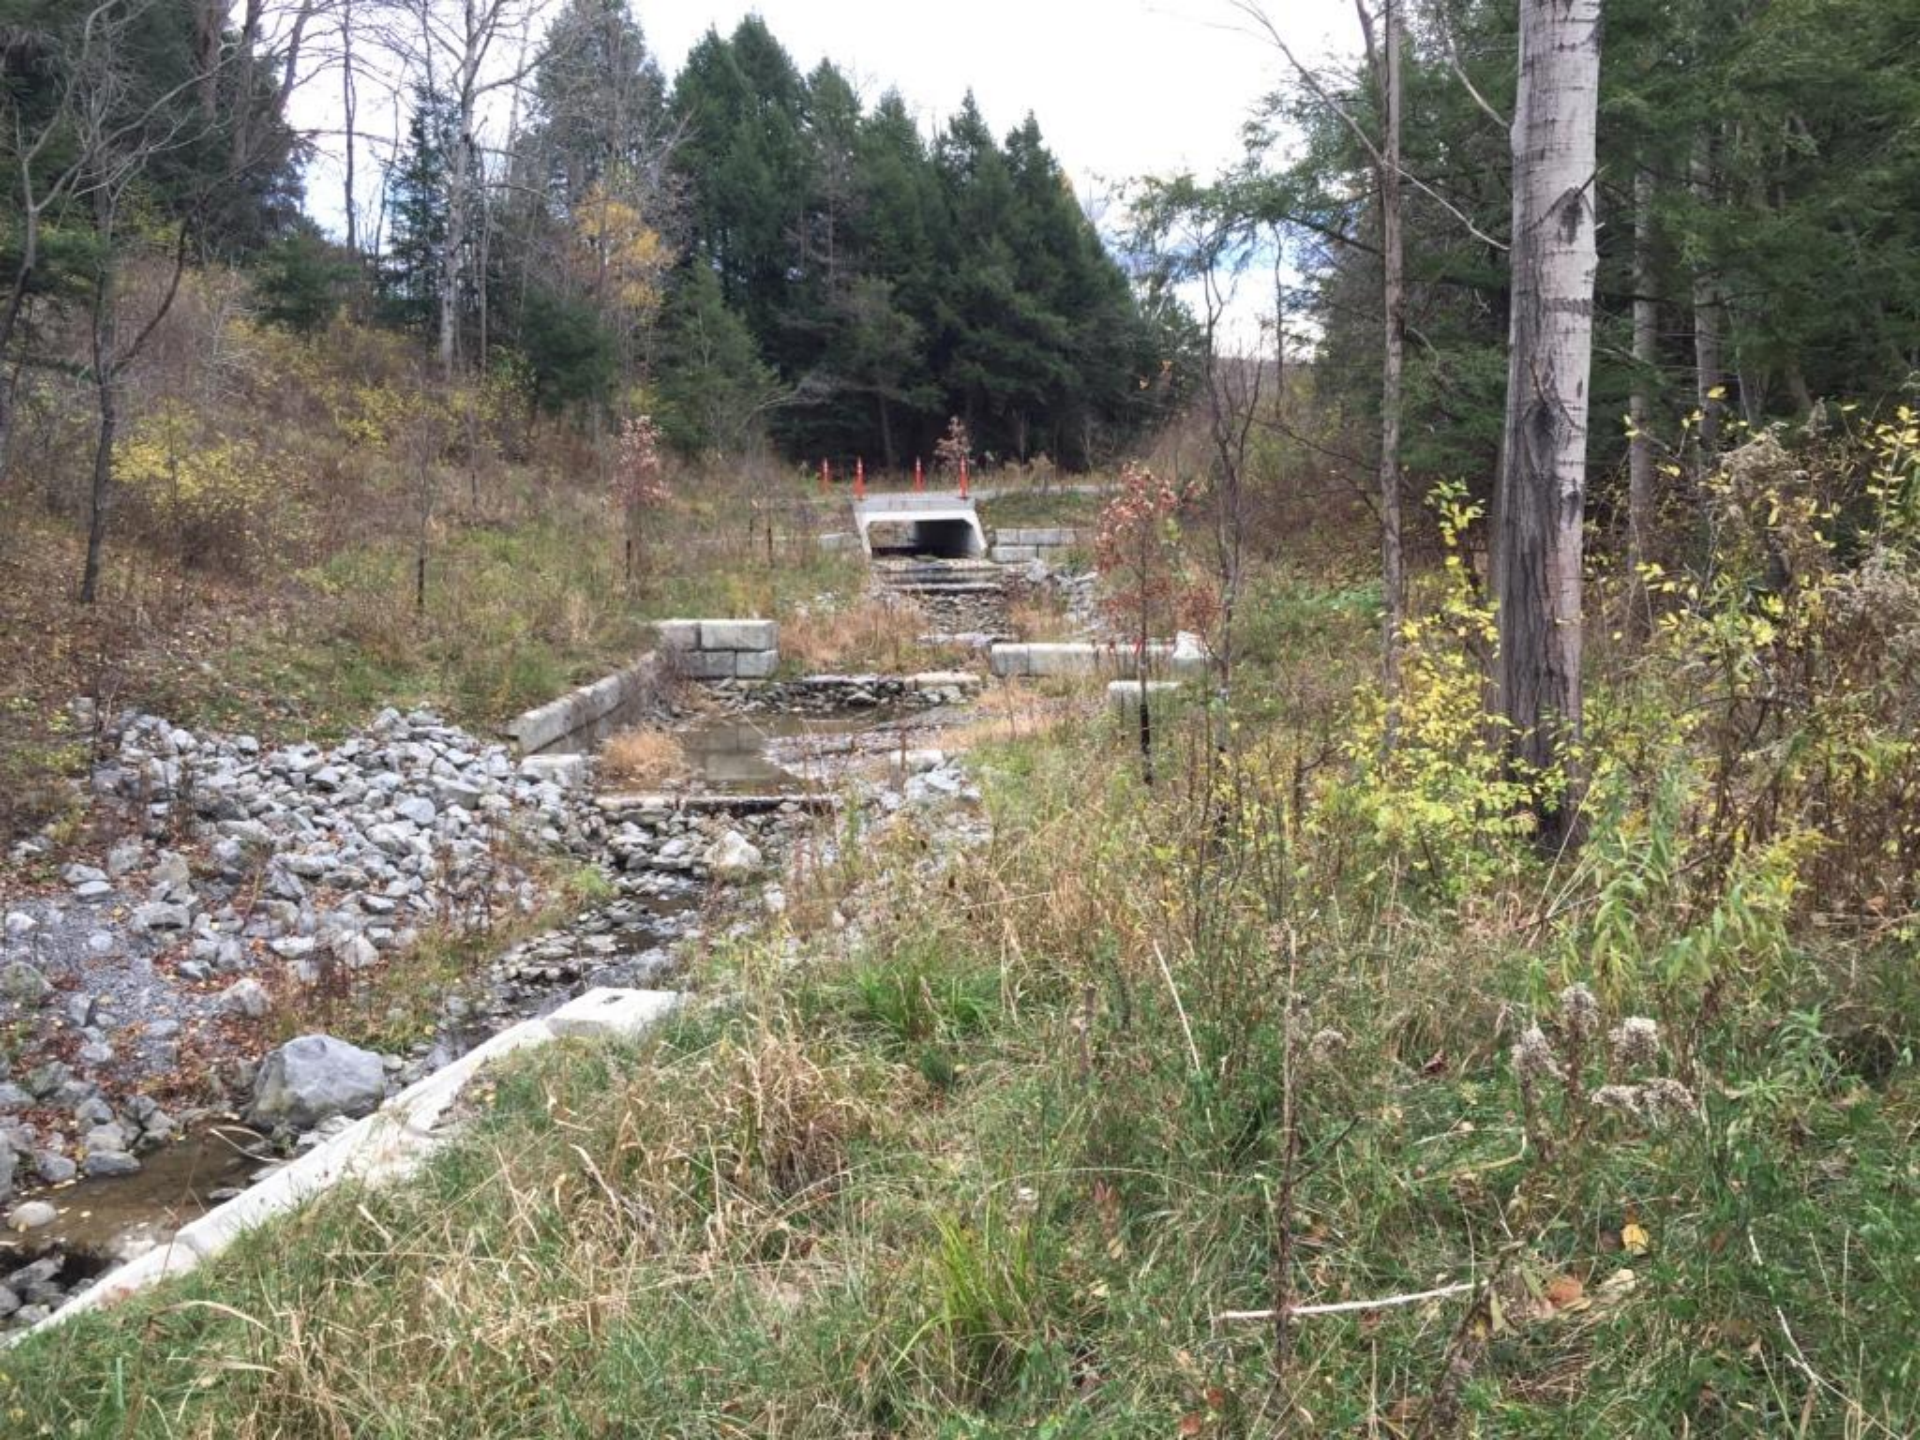
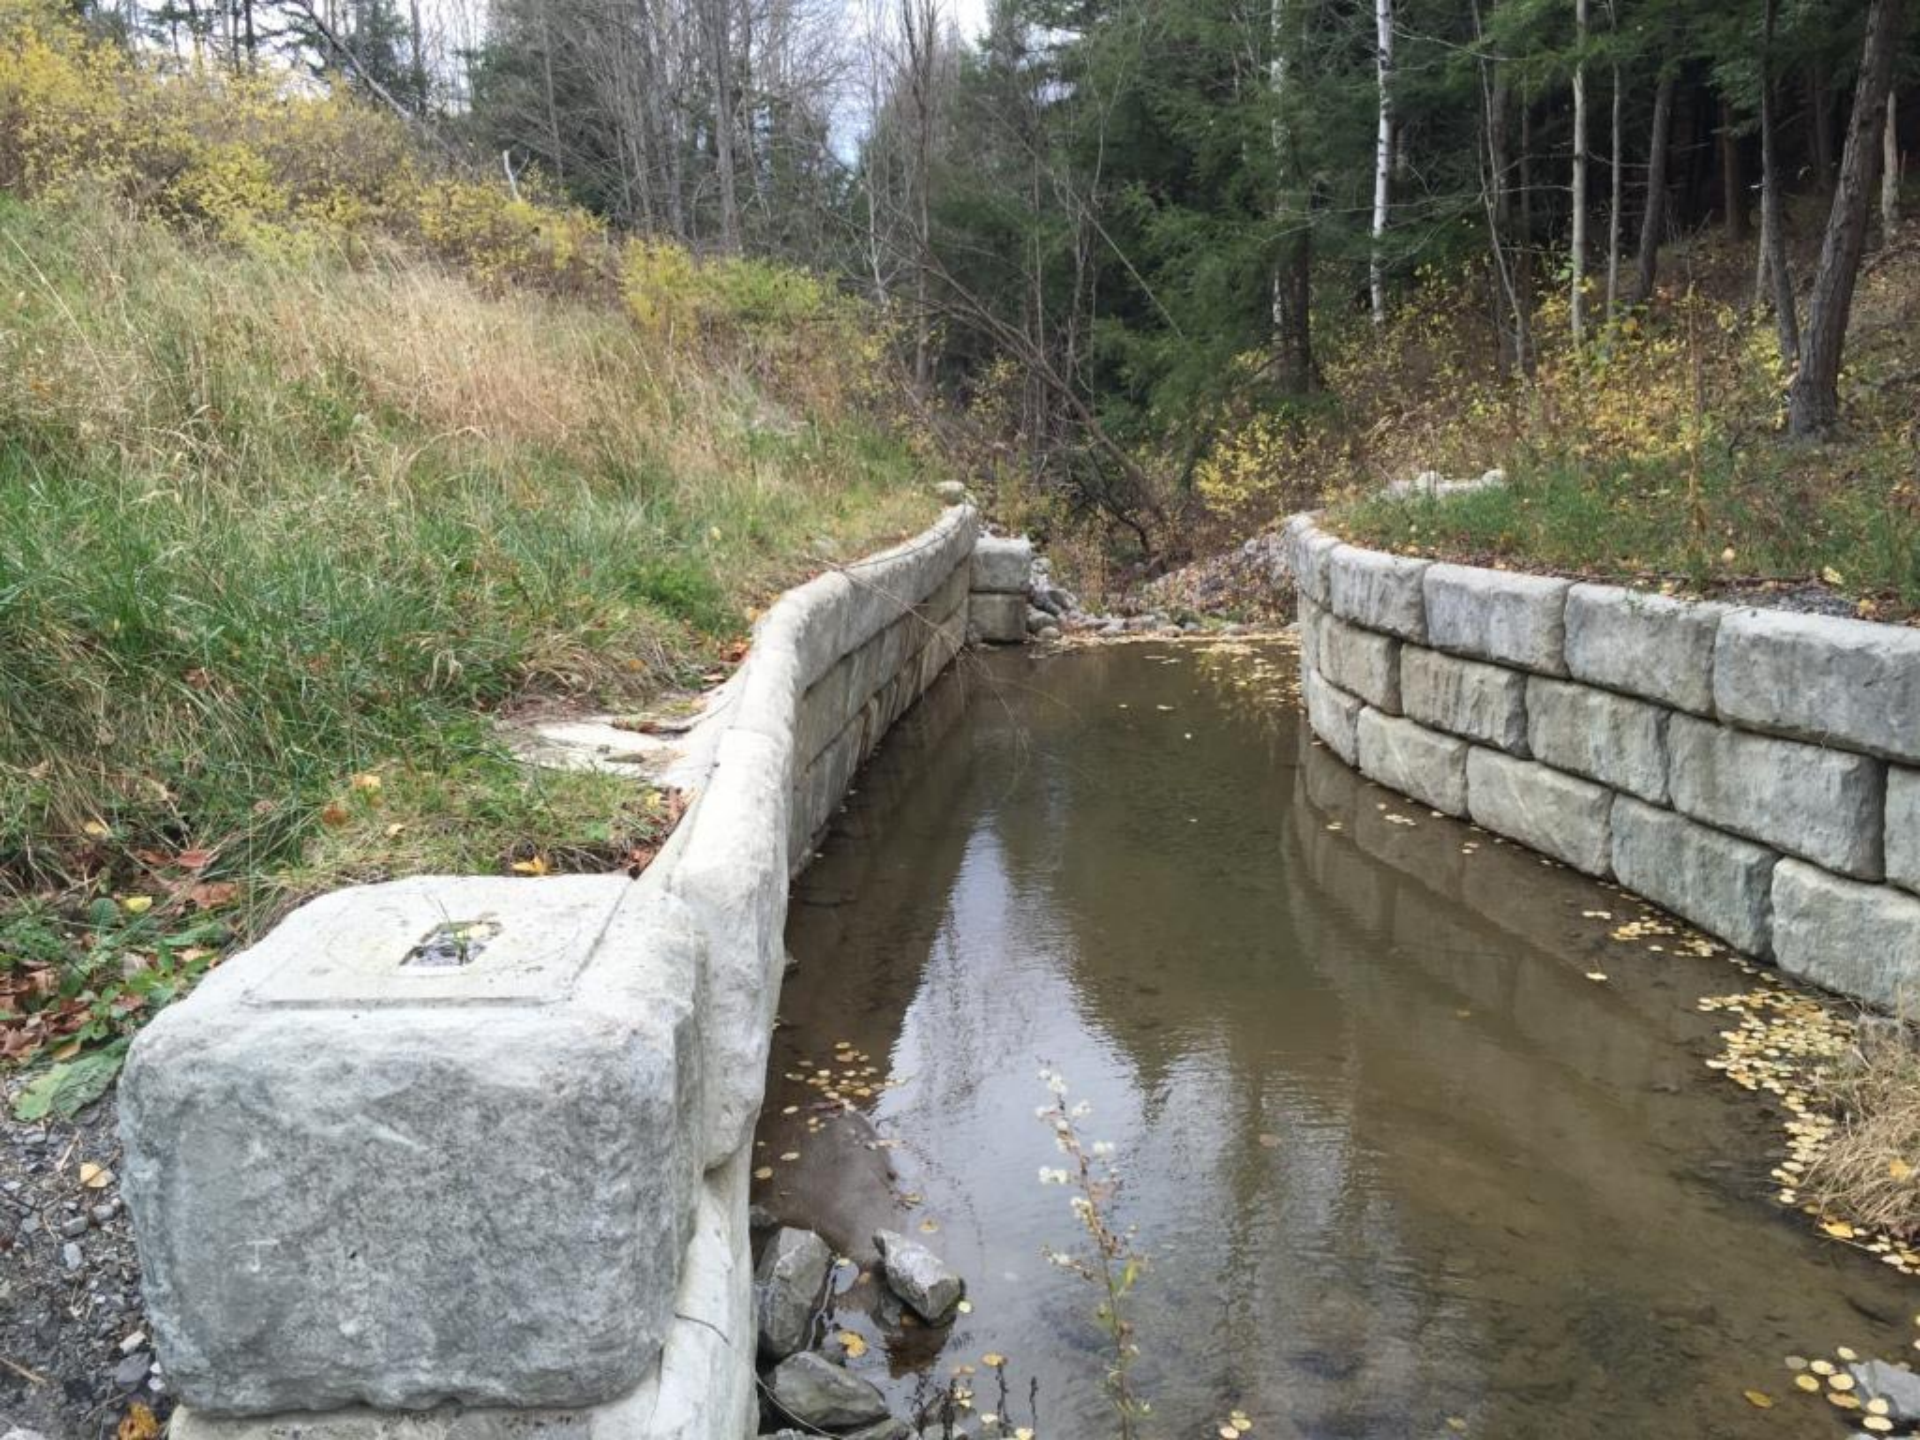
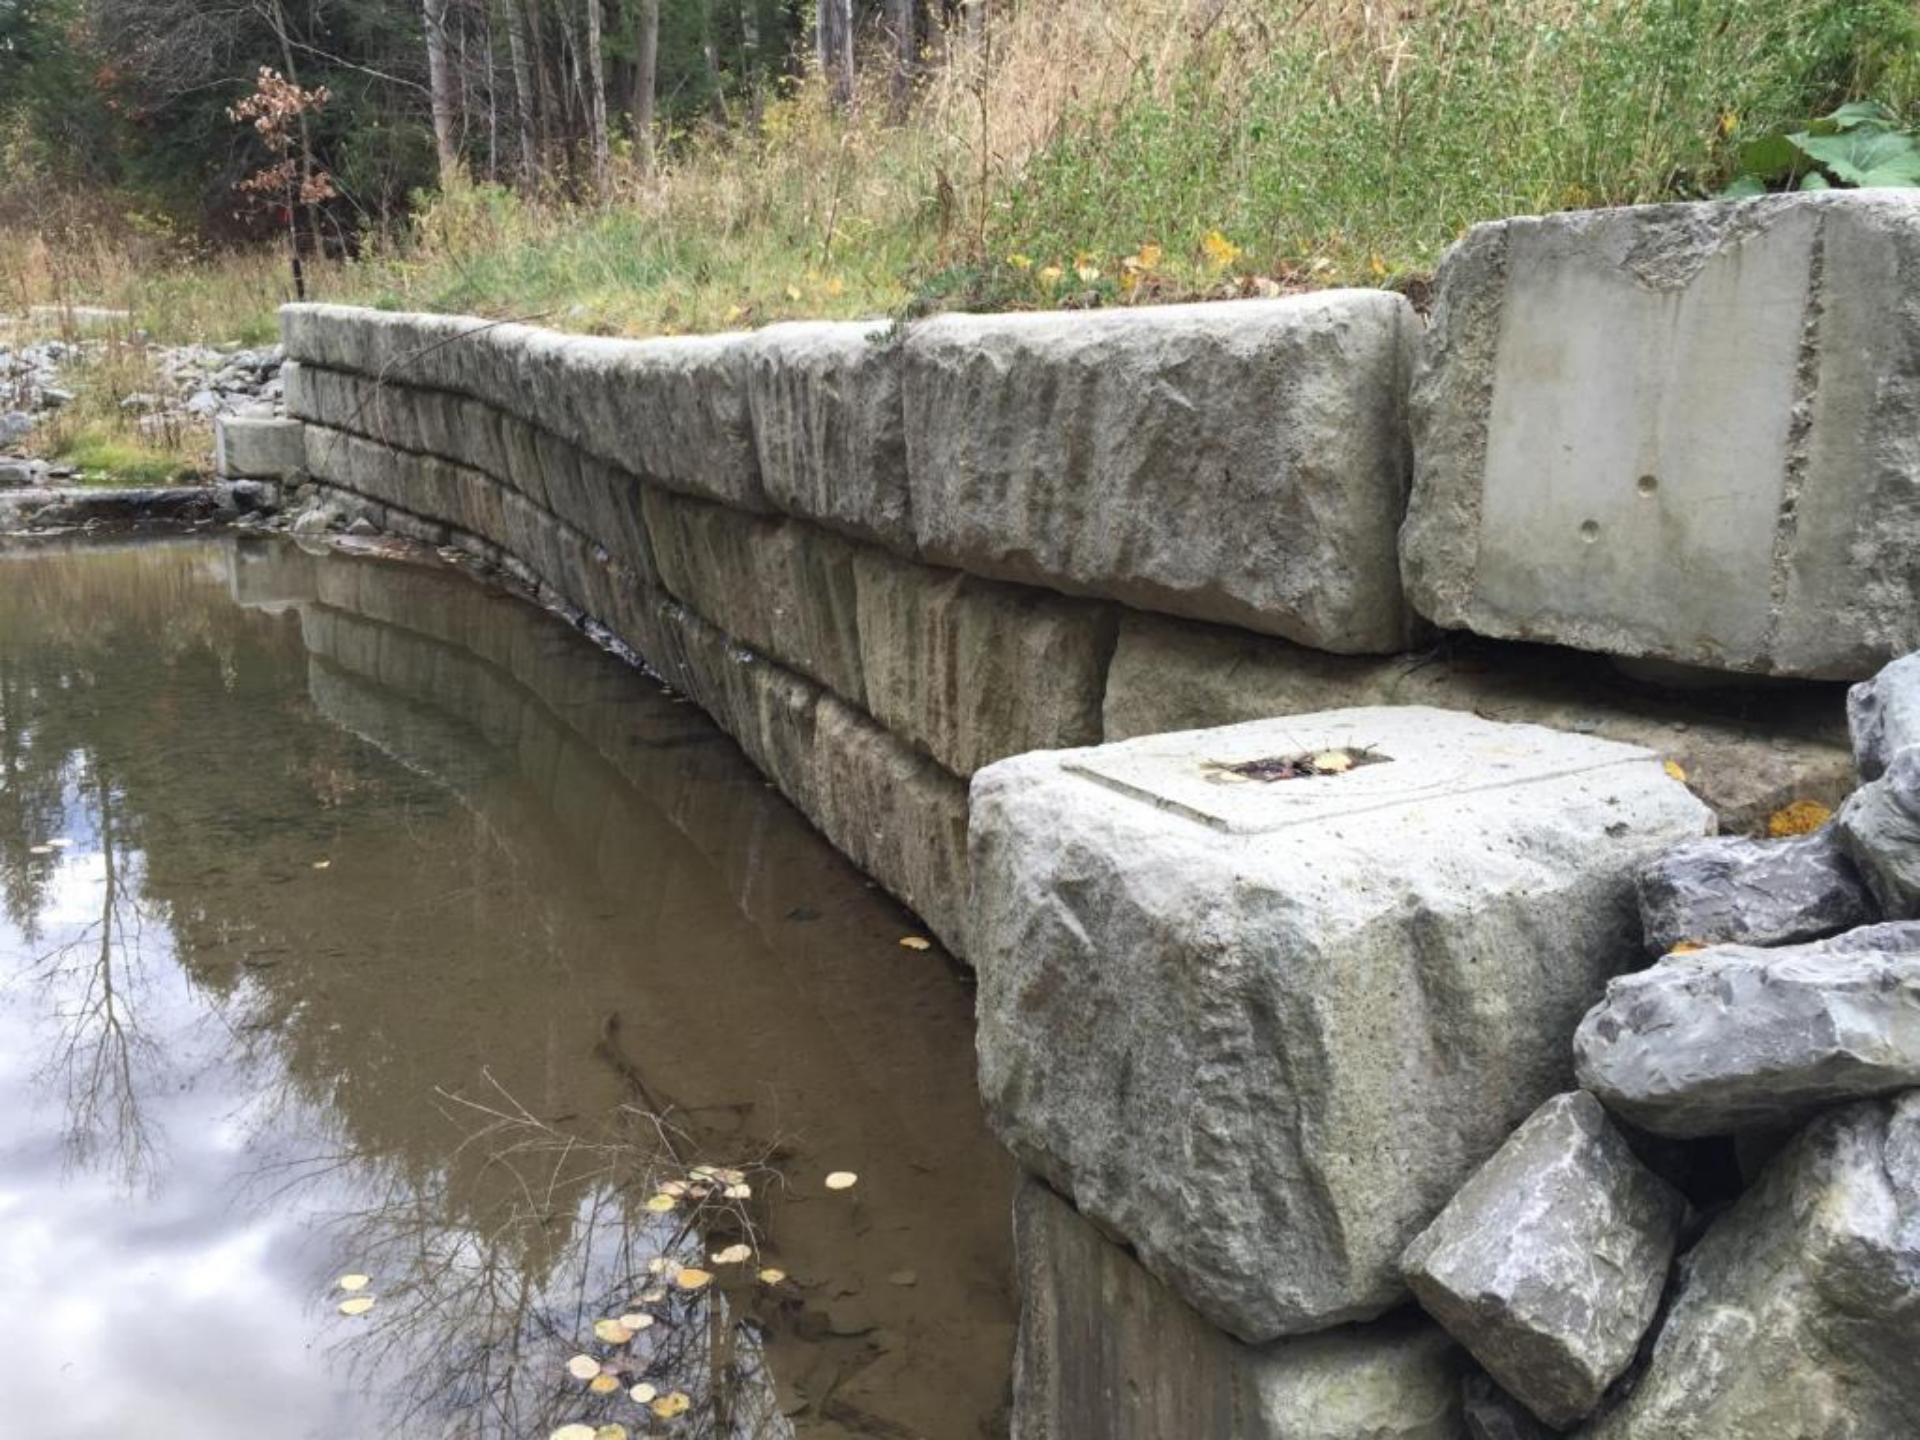
Erdman Brook Retaining Wall

- Part of the erosion controls installed on Erdman Brook in 2011-2012, a retaining wall at the downstream end of the structures began to show evidence of leaning
- Pressure and movement of the slope behind the wall causing it to move, exacerbated by groundwater and freeze/thaw cycles
- Wall will require repair and redesign

- Later this year, temporary bracing support will be installed to prevent further movement
- Design options are currently being evaluated for the repair/replacement of the wall
- Repair/replacement is planned to occur in 2016 field season.
