Savannah River Site

SRNS Independent Investigation Team Report:  
Tritium Unloading Puncture Event (U)

SRNS-RP-2015-00071

February 26, 2015

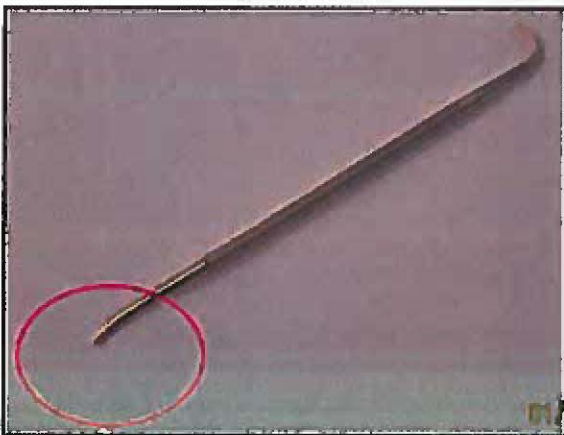
Figure A. O-ring extraction tool designed with shepherd's hook at one end and straight tip at the other end

During the o-ring removal effort, the adapter plate is held in one hand and the tool in the other. As the operator is pushing the sharp end of the tool with one hand, the other hand is in the line-of-fire and susceptible to a puncture wound should the tool slip away from the adapter groove. A strong engineering presence in the field could have identified the difficulties and the excessive force employed to remove o-rings, and possible improper tool use.

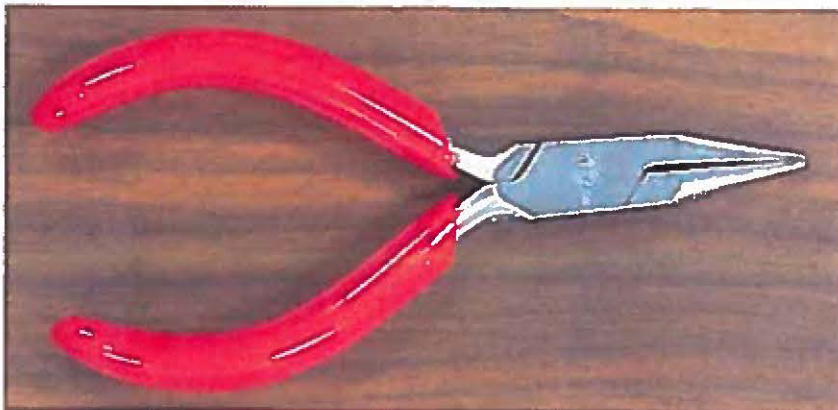
After closer examination, the investigation team discovered that procedure SOP 233-57000 (Revision 41) introduced a new section, 4.4, "Special Tools, Measuring and Test Equipment, Parts, and Supplies", which did not include the o-ring extraction kit. The tool listed for o-ring extraction was a pair of needle nose pliers (Figure C).

*Figure C. A pair of needle-nose pliers such as this is the tool specified for o-ring extraction.*

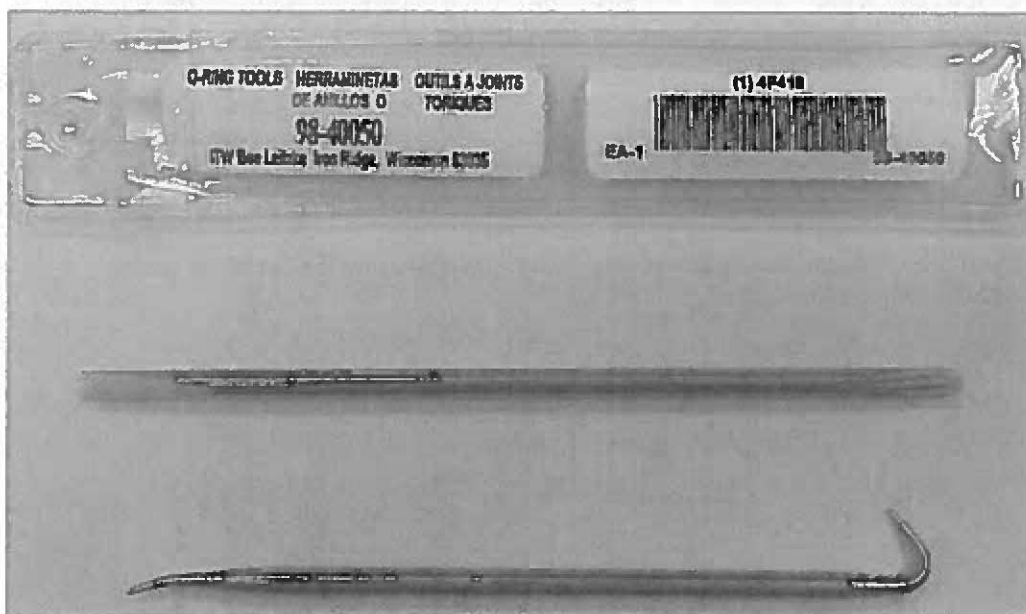
On January 27, troubleshooting continued to correct process leaks that had been ongoing for several days and turned over from shift to shift. This operation was being conducted in accordance with SOP 233-57000, "Fixturing Operations in Unloading", Section 5.7 Troubleshooting. During turnover, the previous shift identified o-ring replacement for positions 5 and 8 as the next steps to be performed in the troubleshooting section. Previous troubleshooting steps were not documented in the troubleshooting comments section of the procedure as required by step 5.7.4. One of the off-going shift operators stated in an interview that he noticed the o-ring extractor tools were not included in the section 4.4 special tools list but did not turn over that observation to the oncoming operator. Two operators stated that they performed a task analysis but admittedly did not review the "Prerequisite Actions" section. They reviewed only the steps of section 5.7 that they intended to perform that shift. The FLM did not verify that the operators performed an adequate task analysis. The pre-job brief was not accomplished in accordance with the requirements of TRIT-1304 or the 2S manual because an informal pre-job briefing card was used in lieu of a documented brief. Additionally, all items on the pre-job briefing card were not adequately covered. The FLM provided a set of o-ring extraction kit tools to the operators for o-ring removal, indicating that they were the best tools for the job based on past experience. The kit consisted of two brass tools. One tool is designed with a straight tip similar to the tip of a ballpoint pen at one end and a shepherd's hook at the other end (at bottom in Figure D). The second tool is designed with a forked end and a blunt end (in the middle in Figure D).

Figure D. The two tools in the o-ring extraction kit

The FLM did not verify that the tools were on the section 4.4 special tools list. He indicated that he did not check that they were on the list since he had always used these tools for this task. Interviews determined that various

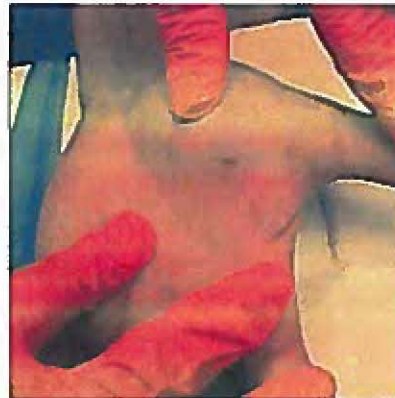
Operator A (injured operator) dressed out, entered the contamination area (CA), opened the glovebox airlock sash hood, and passed in new o-rings and the 2 o-ring extraction tools contained in the o-ring extraction kit. Operator B retrieved the o-rings and one of the tools and proceeded to work on an o-ring at position 8 while Operator A was exiting the CA. Operator B did not wear over gloves during the evolution because he did not consider the tool he was working with to be a sharp. The particular o-ring extraction tool he was using for work was blunt on one end. Operator B was able to remove the o-rings at his station using the second tool with blunt and forked ends. Operator A proceeded to enter position 5 and evaluated o-rings at this position. Operator A determined that the o-ring on the adapter plate was degraded and needed replacement. He proceeded to remove the o-ring from the underside of the adapter plate with the pointed end of the second tool while holding the adapter plate in his left hand and the tool in his right hand. After some difficulty and multiple pushing motions, the tool slipped and penetrated through the 30 mil butyl glove-port glove (Figure F), the nitrile glove (Figure G), and the cotton liner (Figure H) with a glancing blow, breaking the skin on his left palm near the thumb (Figure I).

Figure I. The puncture wound to the left palm of Operator A

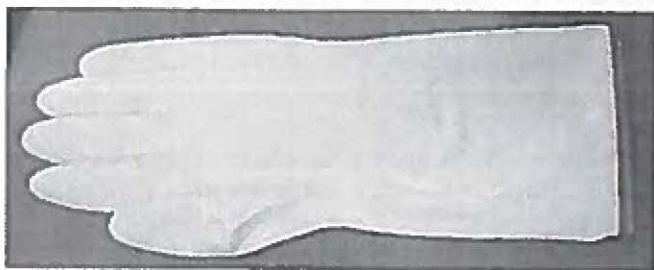
He also was not wearing over gloves (Figure J). In an interview, Operator A stated that he believed the over gloves were for contamination control. In Part 2 of the fact finding, Operator A said he recognized that over gloves should be used when dealing with sharps and he now recognized that he was using a sharp, but stated that the over gloves were not present in the glovebox nor did the procedure flag him to use them. Additionally, he recognized that he used the tool in an unsafe way by applying a significant amount of pressure with the sharp pointed towards his unprotected hand that resulted in the puncture wound to his left hand.

Figure J. 20 mil. over glove
