SITE CERTIFICATION SUMMARY

This Site Certification Summary provides information about the **Aliquippa, Pennsylvania, Site**. The U.S. Department of Energy Office of Legacy Management is responsible for long-term stewardship of the site under the **Formerly Utilized Sites Remedial Action Program**.

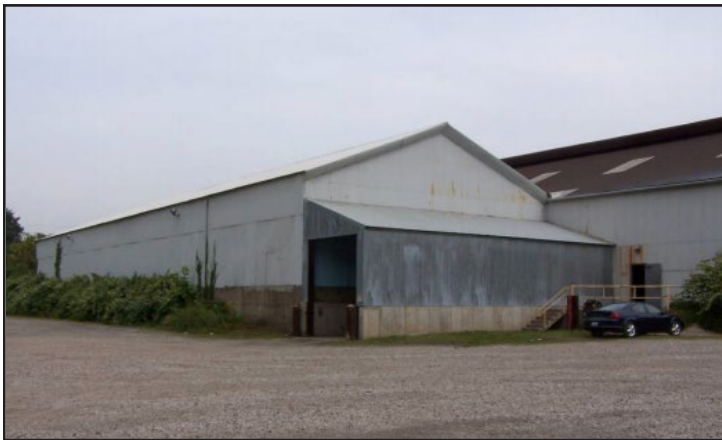
Front of remediated building at the Aliquippa site (September 2005).

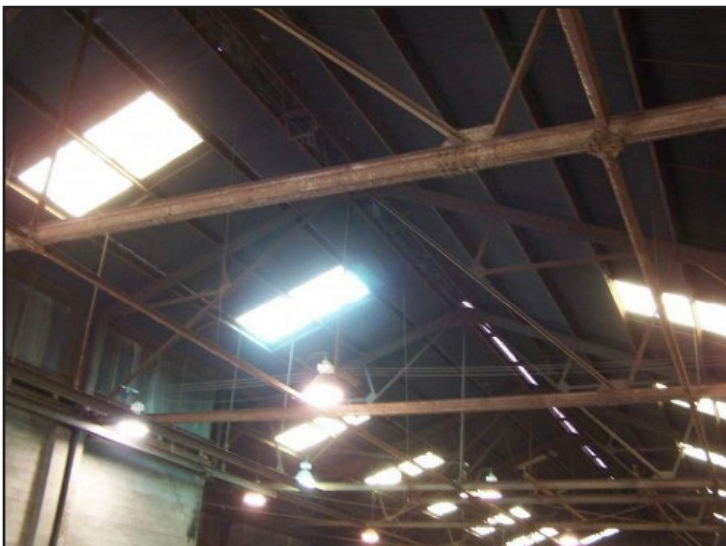
Roof system where supplemental limits were applied at the Aliquippa site (September 2005).

assessment justified the establishment of supplemental limits for the roof panel joints, the area between the roof panels and purlins containing contaminated dust and debris, and the three concrete support pedestals in Building 3. The exposure risk to workers and members of the public was very low relative to the high cost of performing remedial action.
