SITE CERTIFICATION SUMMARY

This Site Certification Summary provides information about the **Chicago North, Illinois, Site**. The U.S. Department of Energy Office of Legacy Management is responsible for long-term stewardship of the site under the **Formerly Utilized Sites Remedial Action Program**.

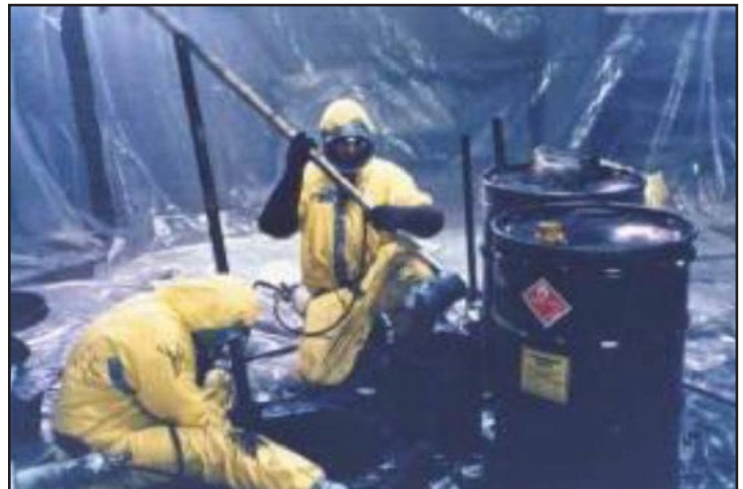
Removing sludge and placing it in drums at the Chicago North site (1987).
