U.S. DEPARTMENT OF
ENERGY

Accident Investigation Report

**Tree Felling Fatality at the Oak Ridge Reservation on
August 11, 2023**

November 6, 2023

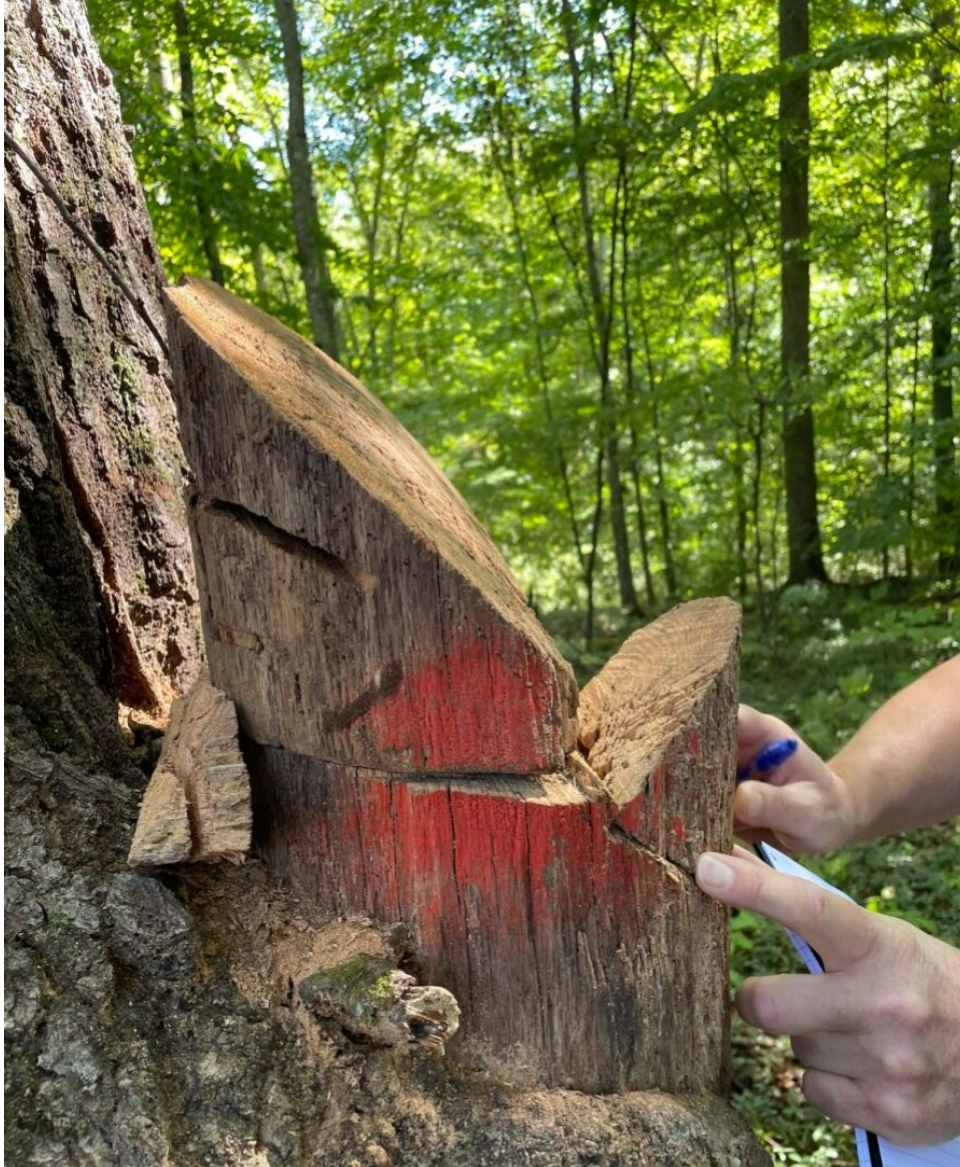
Figure 2-6. Multiple Cuts to Dead Limb

ETW-1, ETW-2, CoTW-1 and CoTW-2 stopped work to have lunch at approximately 1230. After finishing lunch, CoTW-1 and CoTW-2 returned to work on QUCO2 at approximately 1300 when CoTW-1 made the final cut to the base of the dead limb. At that time, CoTW-2 was holding the tag line down the hill from the base of the QUCO2. Based on the Board's review of documents and review of physical evidence, it was evident that multiple cuts had been made into the dead limb (see Figure 2-6). However,

the Board could not verify the sequence of the cuts due to the inability to obtain direct witness statements.²

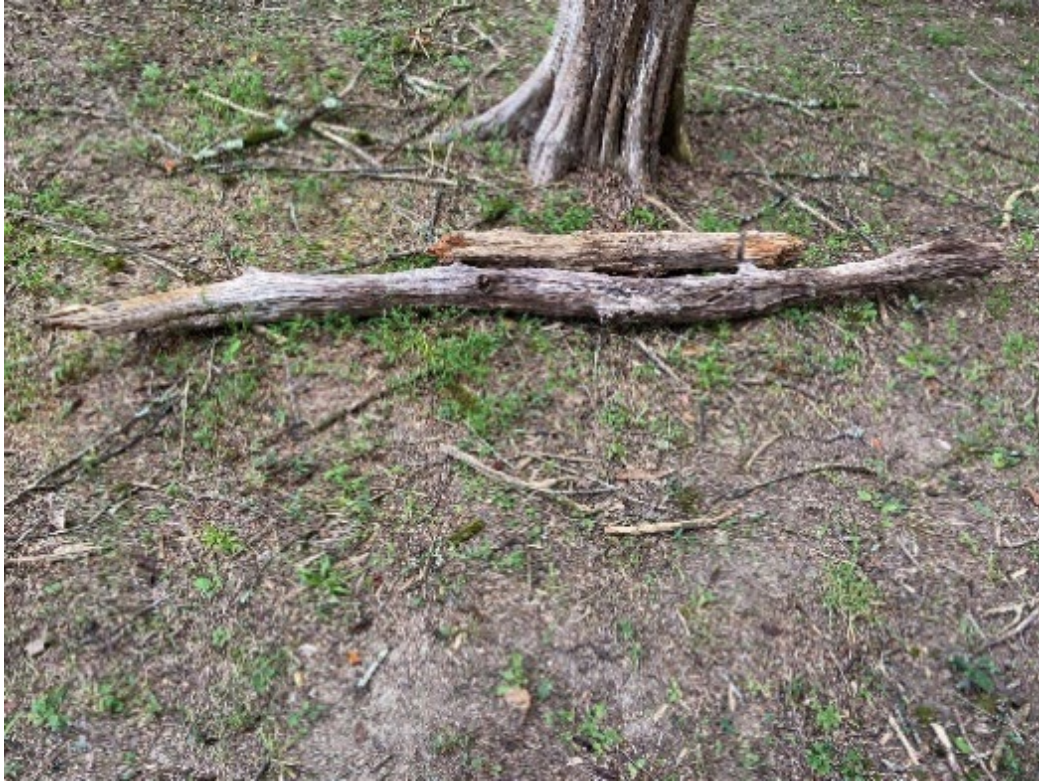
Figure 2-7. Top Part of Dead Limb Broken into Two Pieces (Post Accident)

of the dead limb breaking into two pieces (see Figure 2-7). Based on physical evidence and interviews, the 10-foot section of the dead tree limb struck the helmet of CoTW-1.

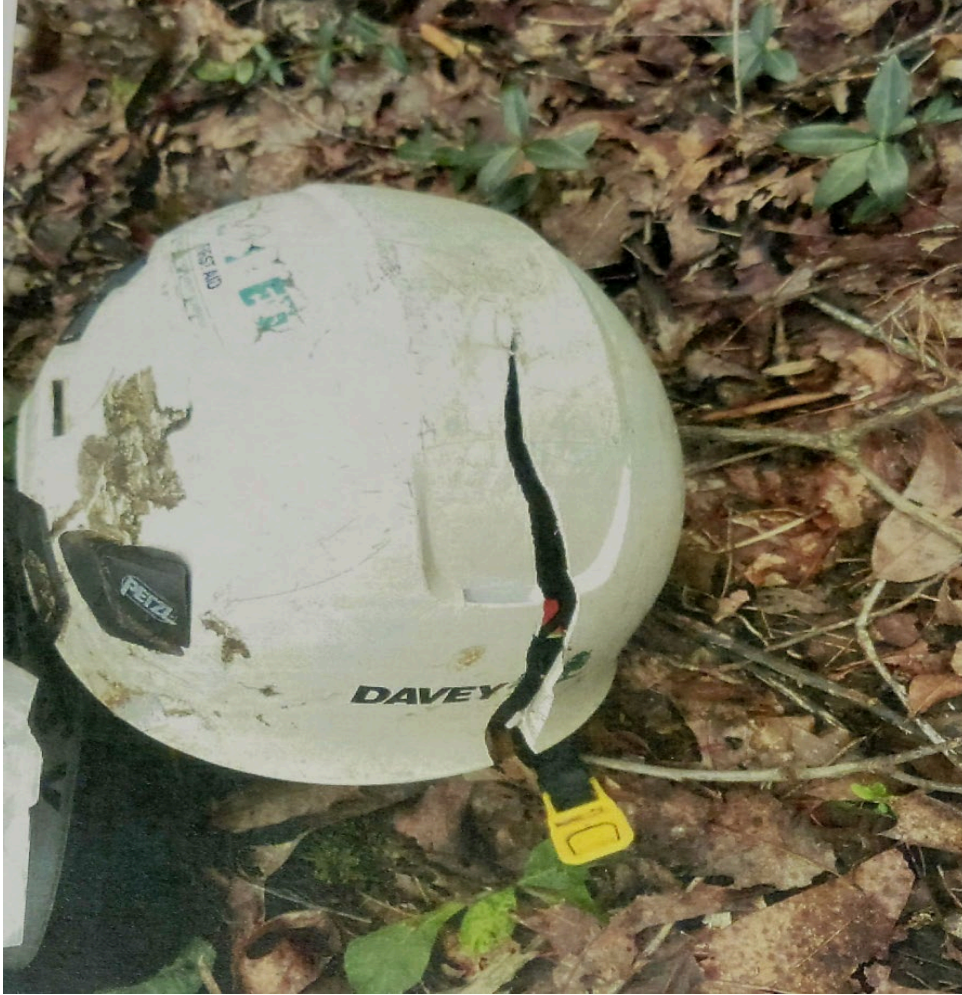
Figure 2-8. Davey Issued Petzl Helmet (photo taken by ORPD)

The Davey-issued Petzl helmet being worn at the time, was split in the front (see Figure 2-8). The helmet was not recovered due to it being placed in the ambulance and delivered with CoTW-1 to the hospital.

Follow on discussions with the Davey Vice President of Health and Safety indicated that CoTW-2's Davey issued helmet would likely be of the same manufacturer and model worn by CoTW-1. An inspection of CoTW-2's helmet determined it was also a Petzl helmet. The helmet was marked inside as meeting ANSI Z89.1 (type 1, class E) requirements which means the helmets are tested to meet a force transmission of 1,000 lbf (pound force to the person). However, it is estimated the 10-foot-long dead limb piece weighing 50 pounds would have an estimated force transmission far in excess of the 1,000 lbf based on the ANSI-Z89.1 force calculation.

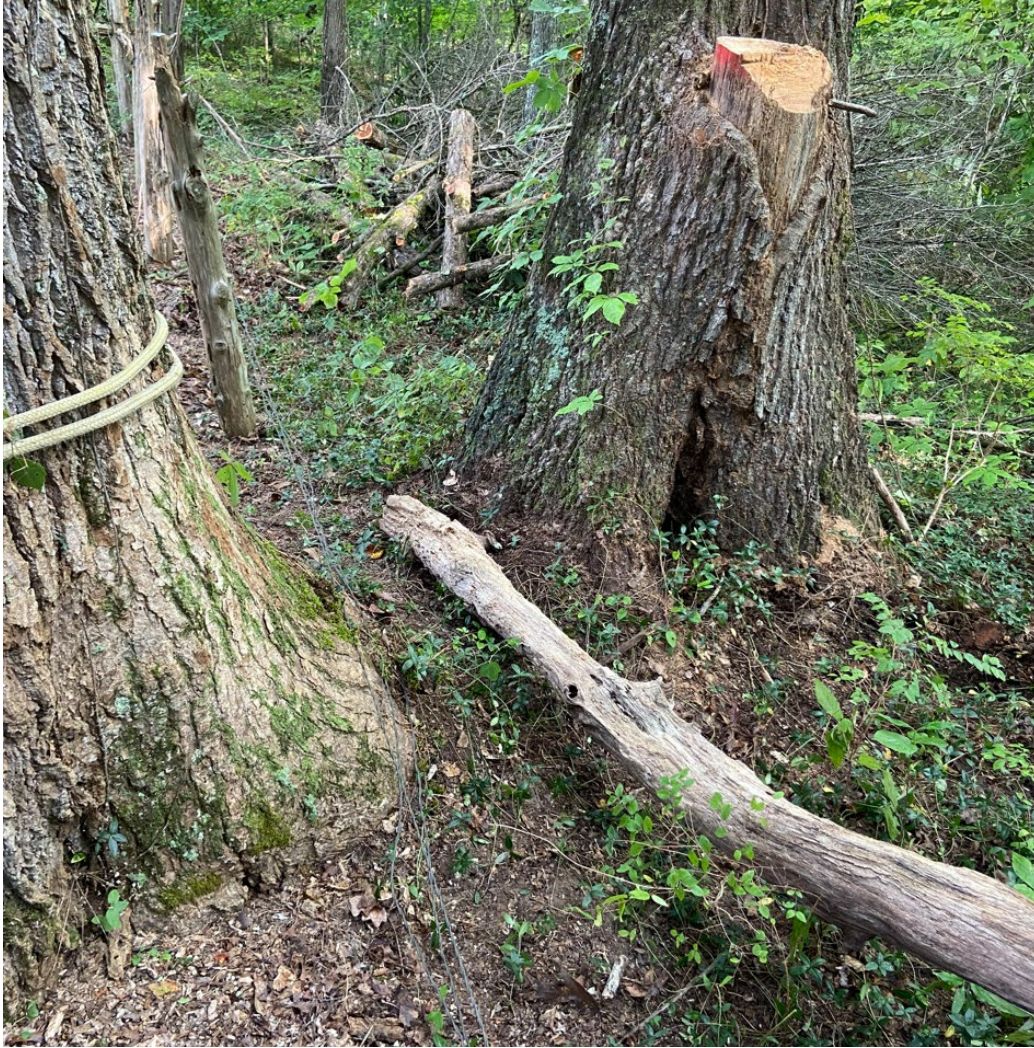
Figure 2-13. 10' dead limb position (as recreated)

At the time of the accident, the ETMC work crew (ETW-1 and ETW-2) were sitting in a work truck when ETW-1 stated they saw the 10-foot section of dead limb hit CoTW-1. They immediately left the truck and ran toward CoTW-1. Before they could get to CoTW-1, CoTW-2, who was holding the tag line for the dead limb, had arrived and was assessing the injured worker’s condition. According to the ETMC workers, CoTW-1 was laying on their left side with the 10-foot section of dead limb lying beside them. (see Figure 2-12).

Note: Figure 2-13 was not taken at the time of the accident. The limb was subsequently moved to this position to reflect the expected location based on documents and images reviewed as well as interview results.

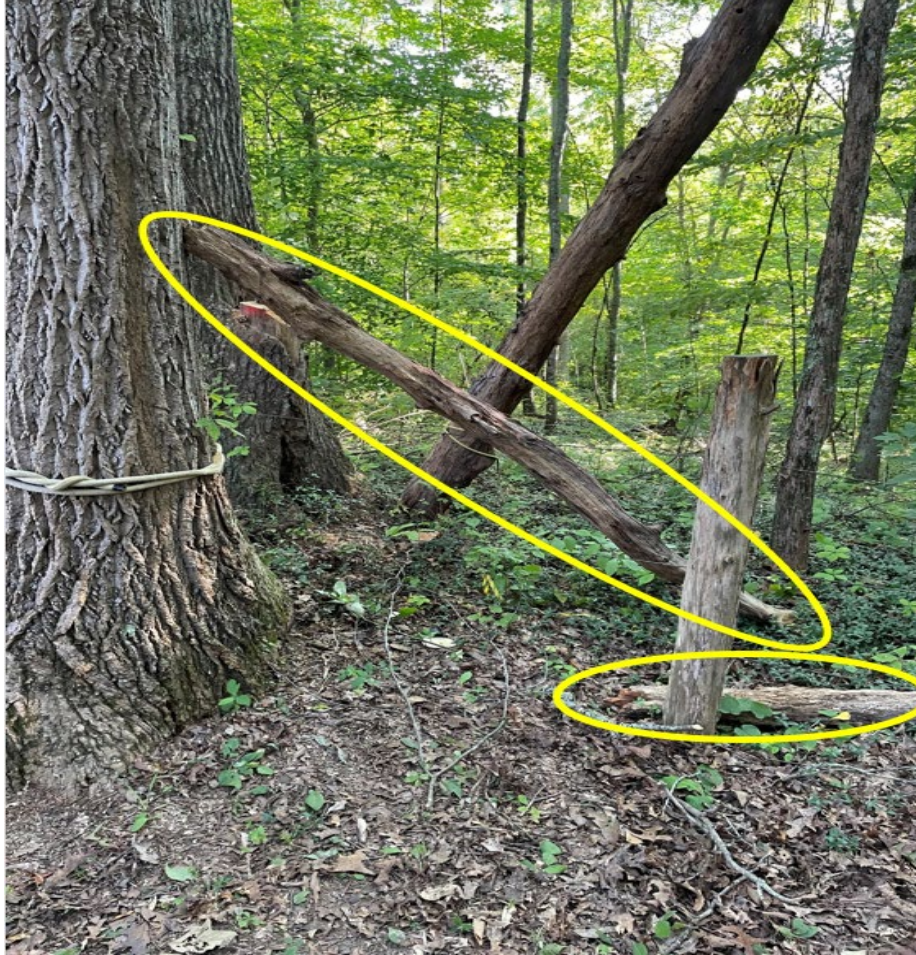
Figure 2-16. Two Distinct and Separate Pieces of Dead Limb

During this walkthrough, two distinct and separate pieces of dead limb were identified as likely being involved with the event. This was based upon their similar physical appearance to the large dead limb which had initially been cut, location to the accident scene, and witness interviews (see Figure 2-16). The Board, with support of OSO, scheduled to have these limb pieces weighed, measured, and fit tested to verify if these were one-and-the-same as the main dead limb. Weight testing occurred on August 23, 2023, with the support of ORNL personnel.

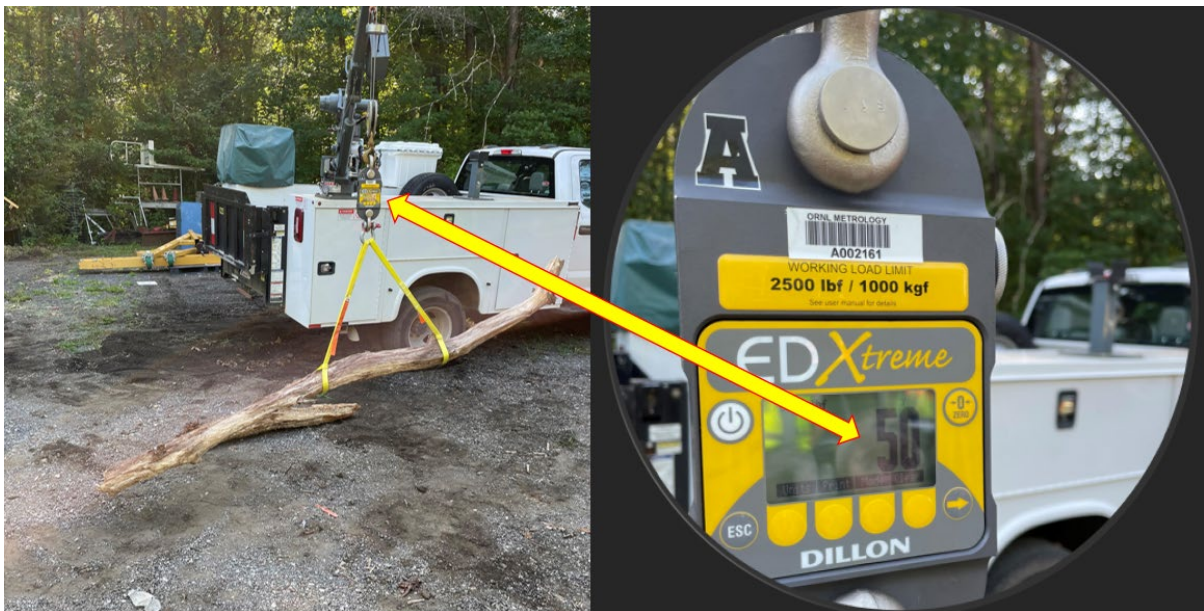
Figure 2-17. Long Dead Limb Piece

The longer dead limb piece weighed ~ 50-lbs (weight included one shackle and two nylon rigging straps) and measured in at approximately ten feet long (see Figure 2-17).

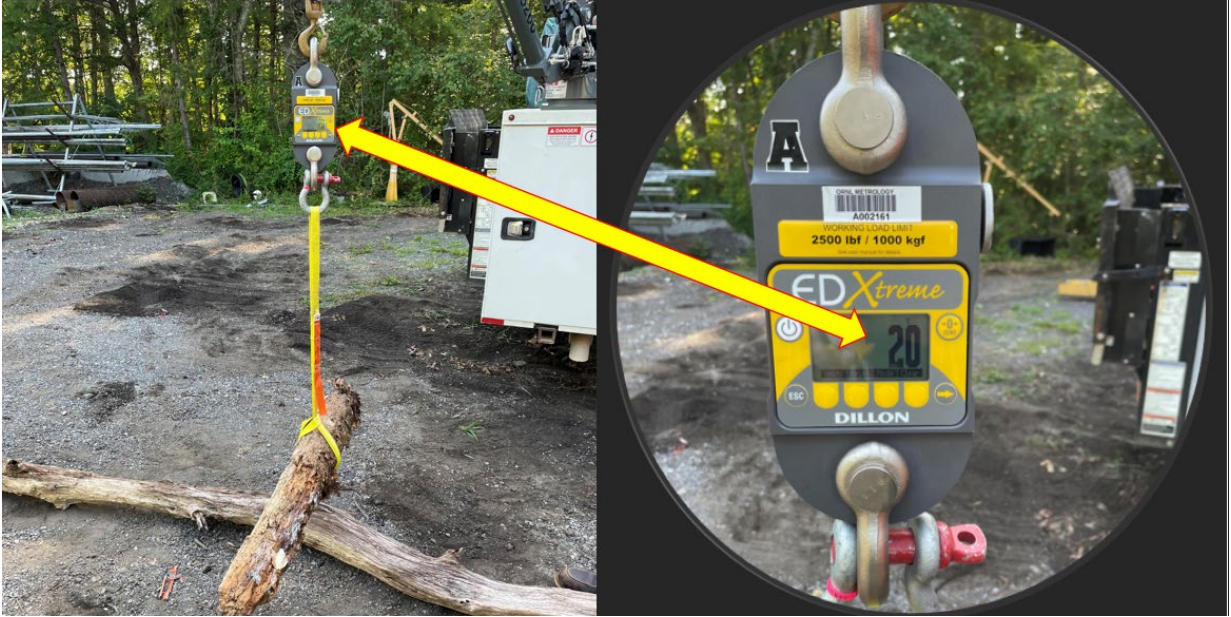
Figure 2-18. Short Dead Limb Piece

The shorter limb piece weighed ~ 20-lbs (weight included one shackle and one nylon rigging strap) and measured approximately four feet long (see Figure 2-18).

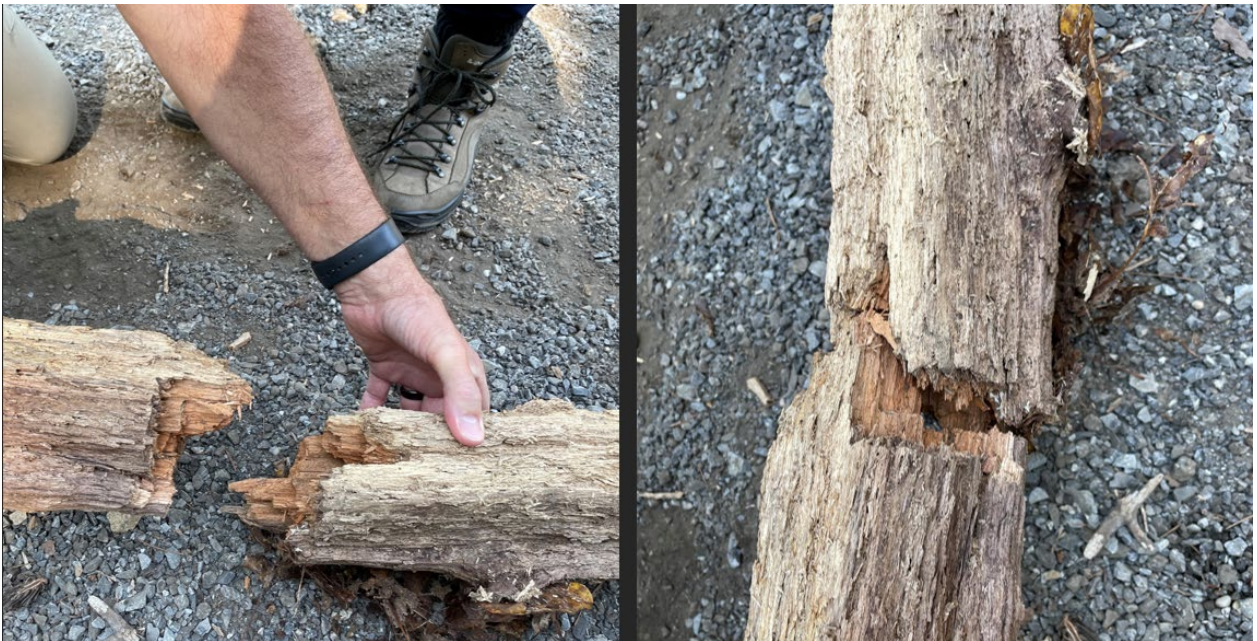
Figure 2-19. Fit Test of Both Limb Pieces

The fit test of both limb pieces appeared to match as seen in Figure 2-19. This indicates all three pieces were initially joined.

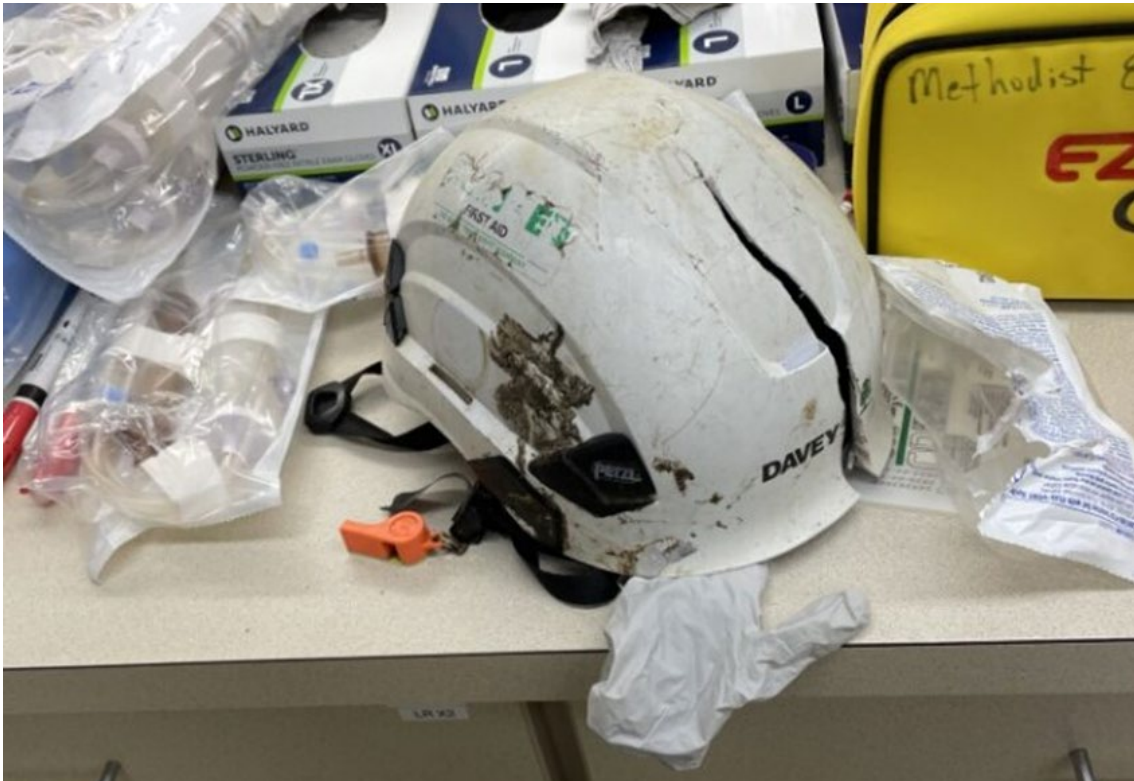
Figure 2-23. Petzl Helmet Worn by CoTW-1 (photo taken by ORPD)

Though CoTW-1's Petzl helmet was not provided to the Board for examination, it would be warranted for any associated PPE involved with a traumatic head injury (i.e., hard hat, helmet, etc.), be taken with the victim and provided to the attending physicians to aid in diagnosis of injuries sustained. In this case, CoTW-1's Petzl helmet was removed from the scene, placed in the transporting ambulance, and provided to MMC Emergency Room Staff upon arrival (See Figure 2-23).

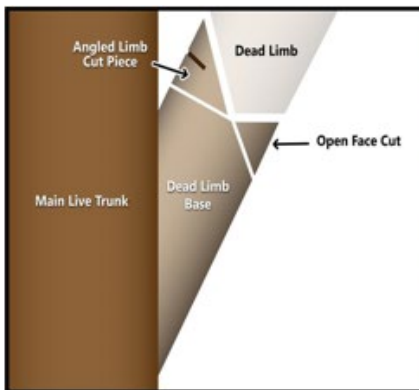
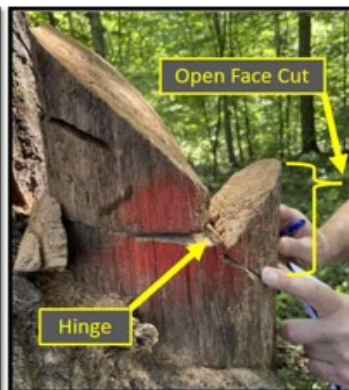
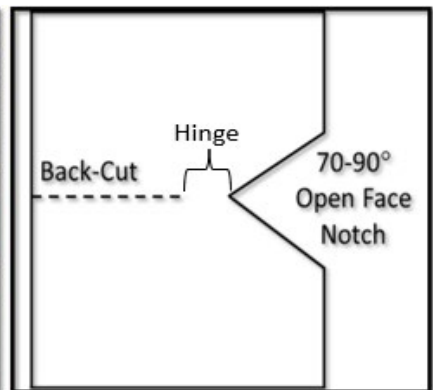
On August 31, 2023, the AIB consulted with arborists at the accident scene to evaluate the cuts made to the base of the dead limb. Figure 3.3 represents a recreation of the cuts as if the dead limb is still in place during the final cut. Figure 3.4 shows numerous cuts to the dead limb including an open face cut with limited “hinge” remaining on the stump, (see arrow in figure 3.4). Figure 3.5 illustrates the expected number and type of cuts (described in ANSI Z133-2017) utilizing an open face notch and back cut with sufficient hinge to fell the dead limb.
