SITE CERTIFICATION SUMMARY

This Site Certification Summary provides information about the **Seymour, Connecticut, Site**. The U.S. Department of Energy Office of Legacy Management is responsible for long-term stewardship of the site under the **Formerly Utilized Sites Remedial Action Program**.

Seymour, Connecticut, Site Certification Data Summary Worksheet

Seymour, CT, Site

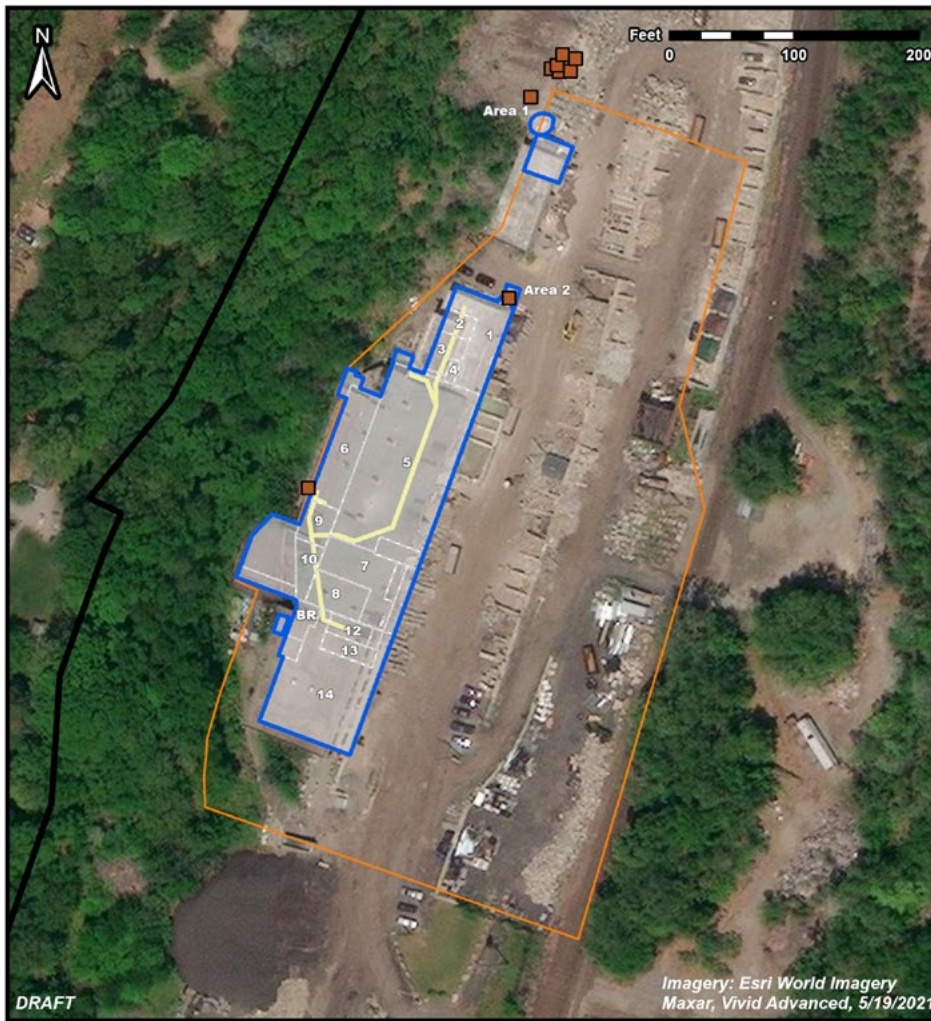
Seymour, Connecticut, Site Map

*Maximum allowable gamma radiation exposure
is 20 μ R/h above background;
All measurements include a background reading
of at least 9.3 μ R/h;
All samples within DOE criteria.
