Independent Assessment of Conduct of Operations at the Hanford Site Waste Treatment and Immobilization Plant

May 2024

Office of Enterprise Assessments
U.S. Department of Energy

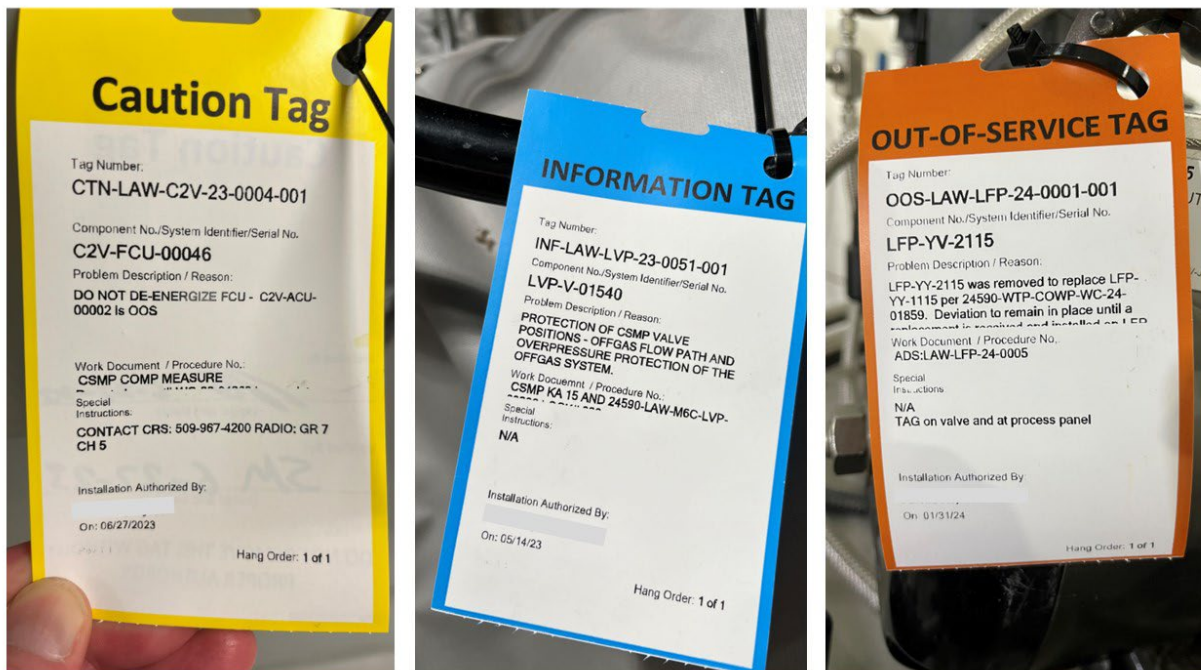
found in the tag log. Third, tags I-19-060 and O-191-2 had identification numbers that were inconsistent with the numbering convention generated by eSOMS. Finally, LAW has a significant number of legacy tags, including caution tags, quality assurance hold tags, and out-of-service tags, that could impact startup readiness. (See OFI-BNI/WTCC-7.)

Figure 1 – Examples of tags with truncated text

Deficiency D-BNI/WTCC-5: BNI/WTCC does not ensure that all tag information is verified to be legible and complete. (DOE Order 422.1, att. 2, requirements 2.i.(2) and 2.r; 24590-WTP-GPP-RACO-CO-0019, sec. 6.3.4.d; and 24590-WTP-GPP-RACO-CO-0018)

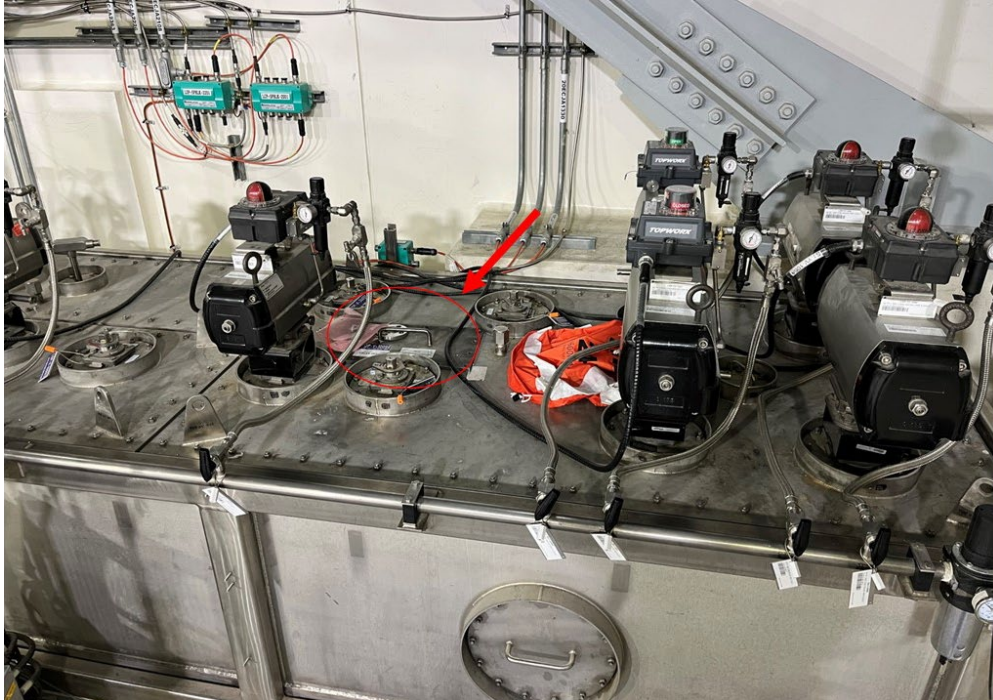
Figure 2 – Valve LOP-V-10094 is beneath the orange foreign material exclusion (FME) cover. The label identifying the valve is on the removed cover plate, circled in red.

- During SBS sampling, personnel were observed manipulating the wrong valve. The label used was not permanently affixed to the component or to the other valve in the enclosure. Instead, it was attached to a cover plate above the component that had been removed. See further discussion in section 3.16 of this report.
- Pipes in the steam plant lacked flow-direction indication.
- Labeling for temporary modifications and temporary equipment were not always used, even when left installed between activities.

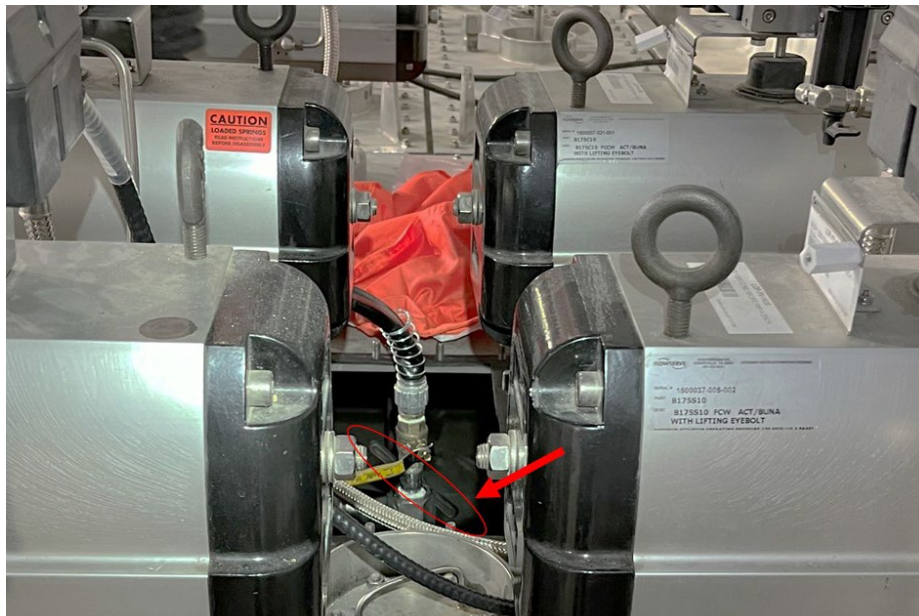
- The temporary ball valve that the operator was improperly using to throttle sample flow was part of a hose/fitting assembly that the SOM stated had been installed under step 4.4.5 of 24590-WTP-COWP-WC-23-05123, which allowed for the use of unspecified “extra fittings...for ease of sampling” (see figure 3). However, this step had been marked not applicable (“N/A”) in the field copy of the work instruction.

- The temporarily installed hose/fitting assembly had been left installed for an extended period of time and was not tracked as a temporary modification or otherwise identified with a tag or label to provide operators with information about its purpose or operation.

Figure 3 – Temporarily installed hose/fitting assembly on LOP-V-10094. The valve operator for needle valve LOP-V-10094 is circled in red (behind the hose/fitting assembly). The valve operator for the temporary ball valve is the yellow handle in the foreground.

Deficiency D-BNI/WTCC-9: BNI/WTCC operators did not perform work in accordance with procedures. (DOE Order 422.1, att. 2, requirement 2.p; 24590-WTP-GPP-RACO-CO-0016; and 24590-WTP-COWP-WC-23-05123)
