Coeur d'Alene Tribe Energy Efficiency Feasibility Study

Coeur d'Alene Tribal Benewah Medical Center Front Entrance

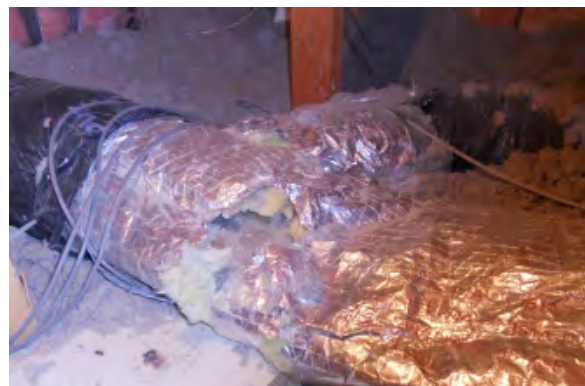
Figure 2. Public Works attic space showing crushed ducting, impacted duct insulation and loose-fill cellulose attic insulation.

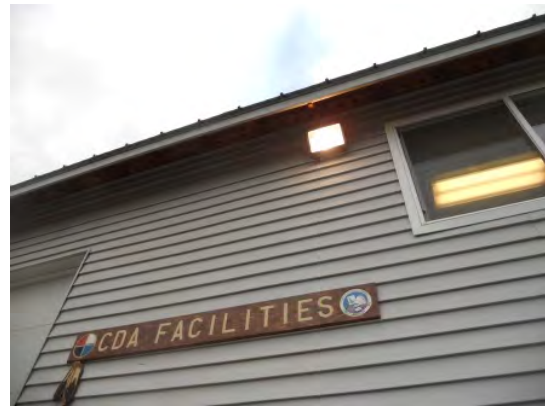
Figure 3. CDA Facilities Building

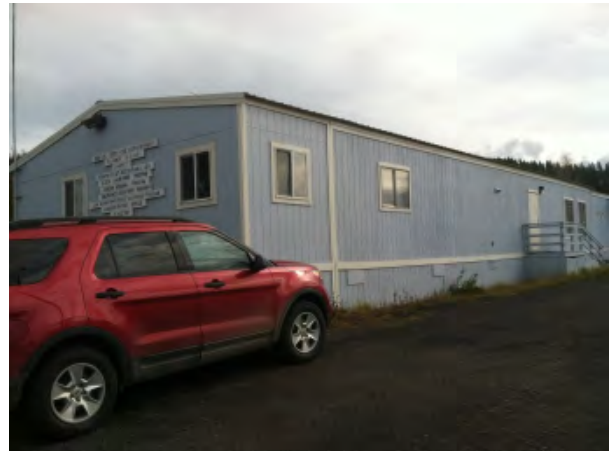
Figure 4. Social Services Facilities

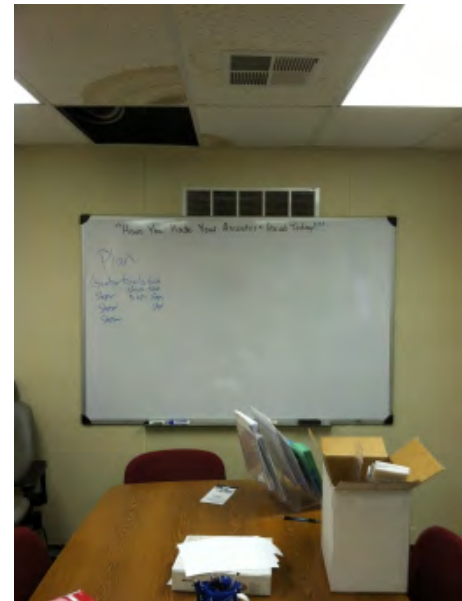
Figure 5. Whiteboard shown blocking the return air register in the Career Renewal office conference room. Also note staining in acoustic tile ceiling from previous moisture intrusion.

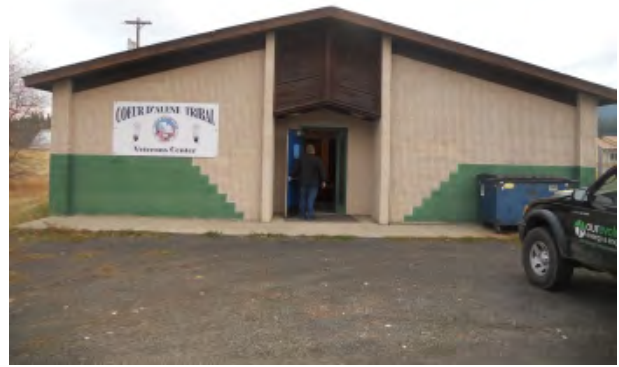
Figure 6. Veteran's Center

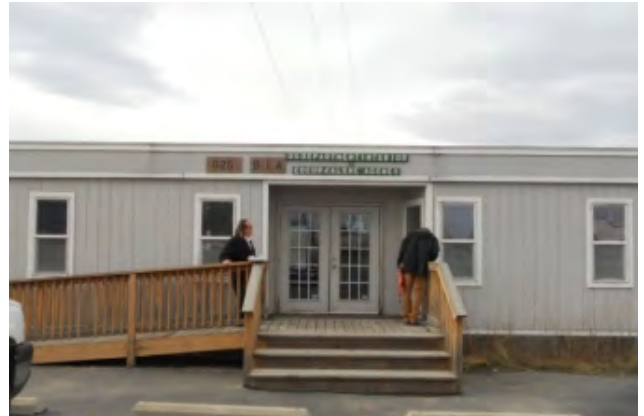
Figure 8. Bureau of Indian Affairs Office

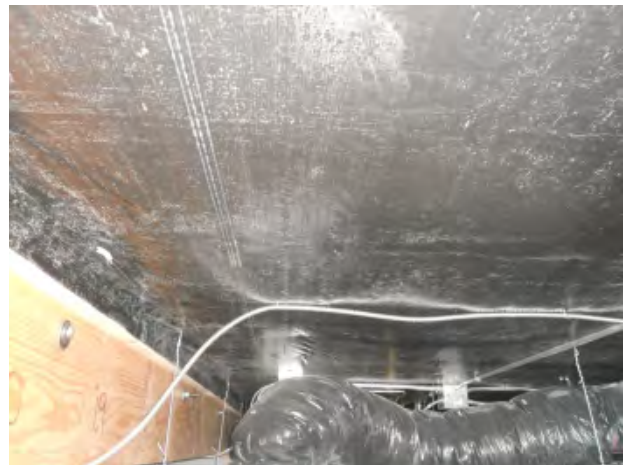
Figure 9. BIA attic detailing rigid insulation and flexible ducting

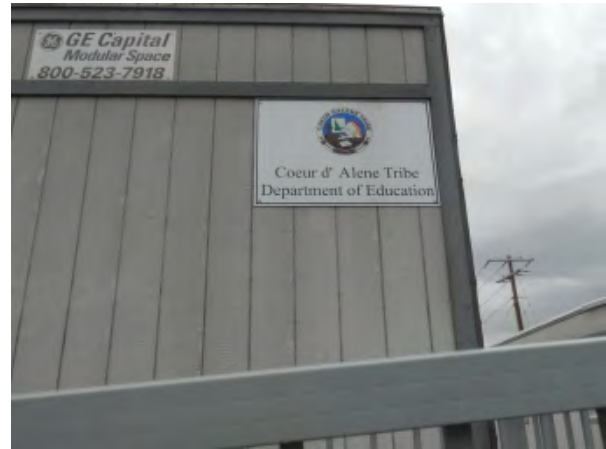
Figure 11. Department of Education Office

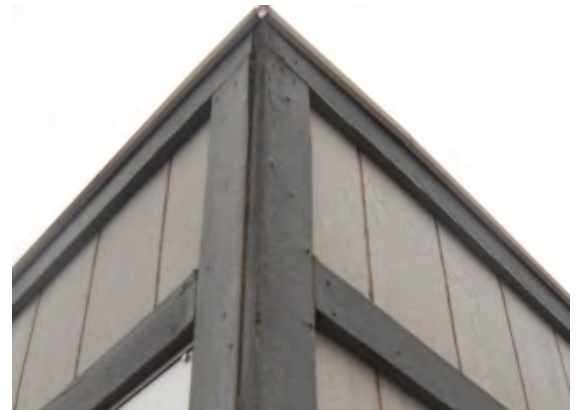
Figure 10. Education building aluminum channel and water impacted cornice.

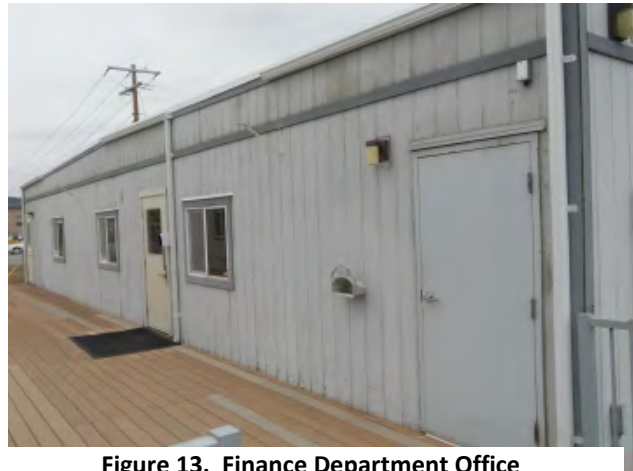
Figure 13. Finance Department Office

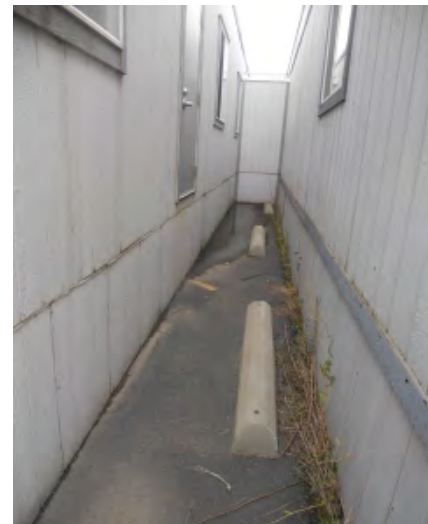
Figure 12. Standing water in contact with building siding in rear alcove.

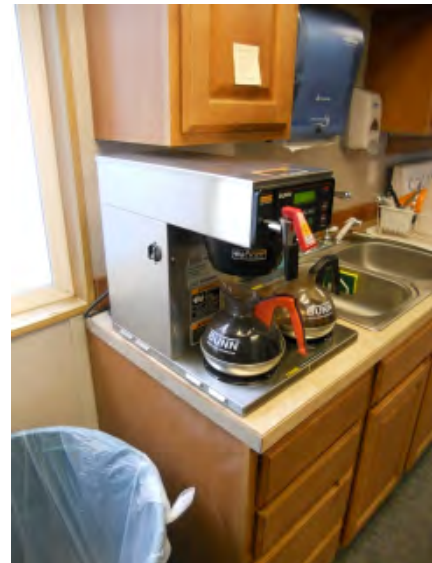
Figure 14. 1,800-watt, Bunn coffee maker in break room

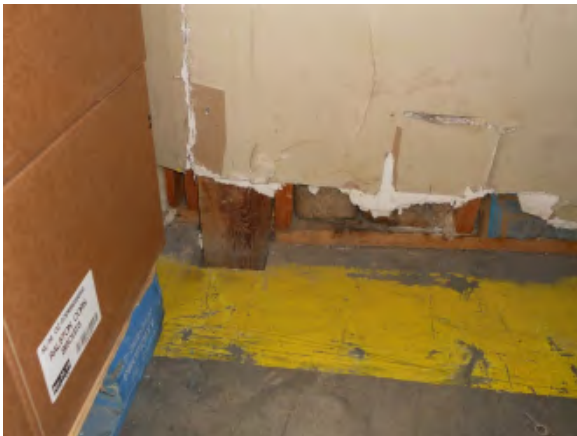
Figure 16. Impacted wall system with visible penetrations to the outside

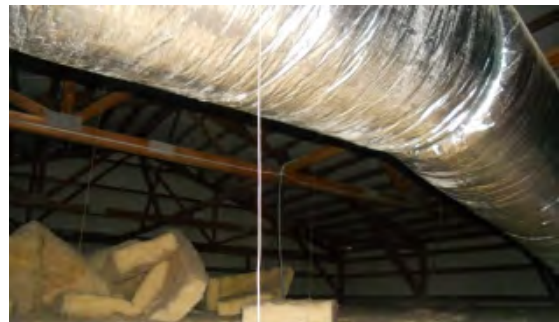
Figure 17. Displaced insulation above suspended ceiling

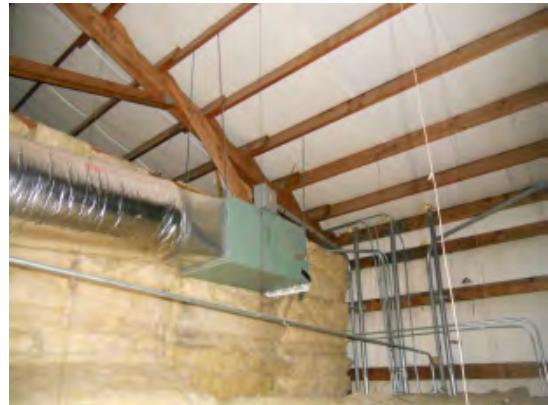
Figure 18. Electric resistance heater unit suspended from roof truss. Note edge of excessively large media filter.

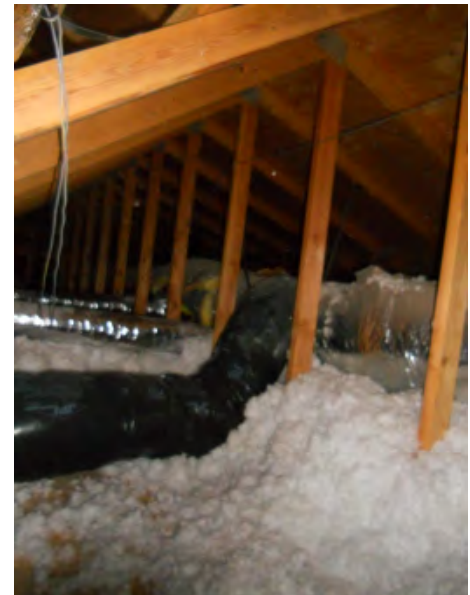
Figure 21. Phase I roof insulation unevenly distributed.

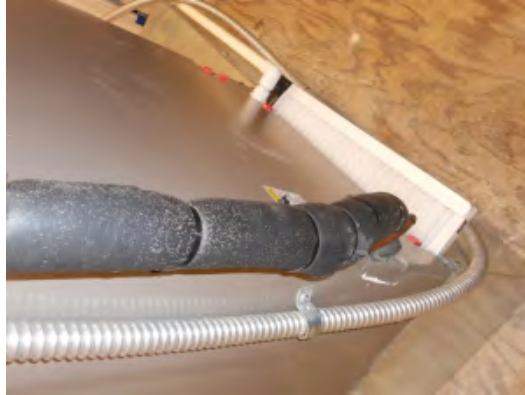
Figure 22. Phase I downstairs AHU with poorly fitted filter and missing filter cover.

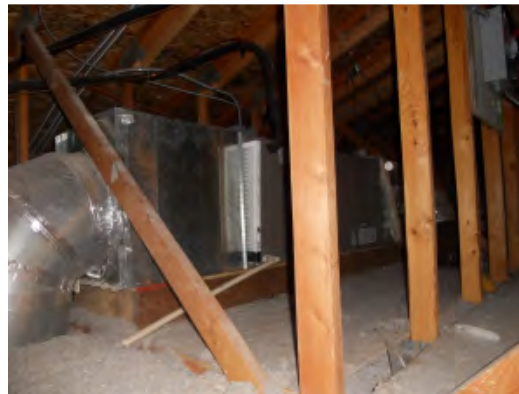
Figure 23. Phase II upstairs AHU with poorly fitted filter and missing filter cover

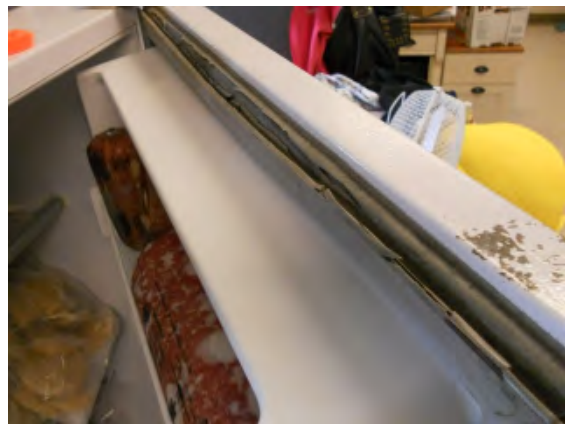
Figure 24. Compromised door gasket on Signature2000 freezer unit

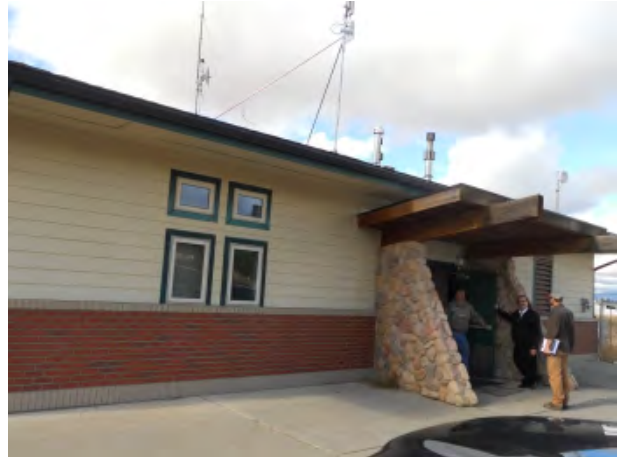
Figure 25. Rose Creek Longhouse

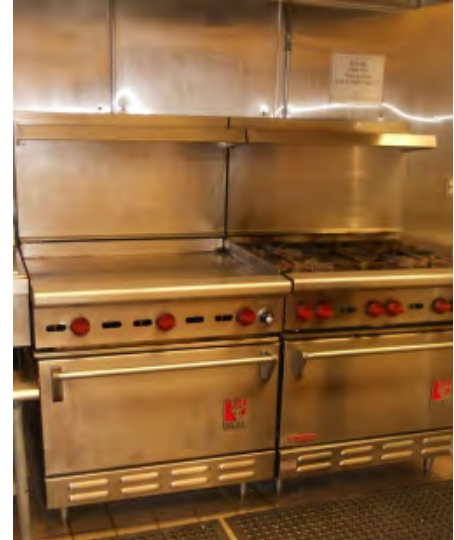
Figure 26. Wolf commercial ovens in kitchen at longhouse.

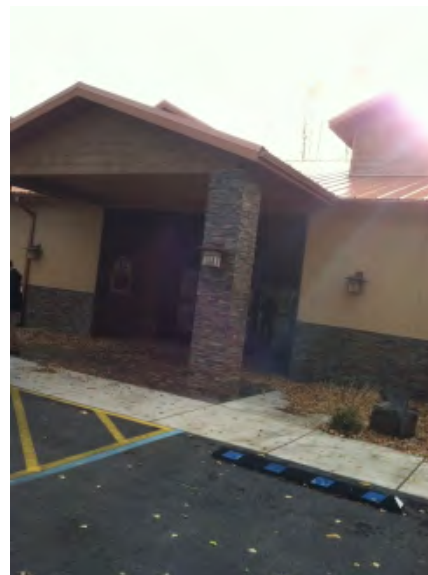
Figure 27. DeSmet Longhouse entry way

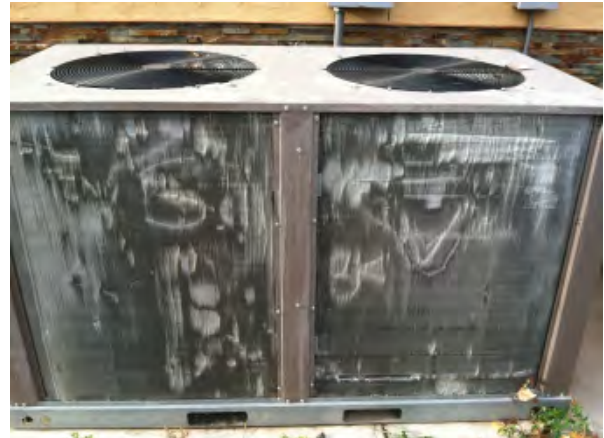
Figure 28. York, 2-ton heat pump detailing extensive damage to the heat exchanger fins.

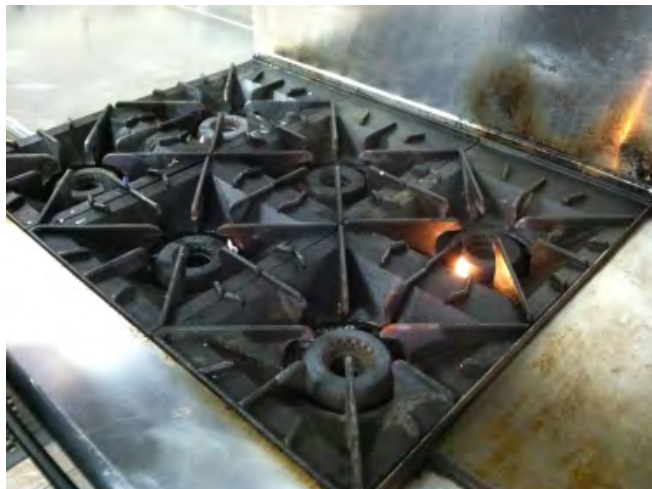
Figure 29. “Lazy” pilot flame observed on commercial range.

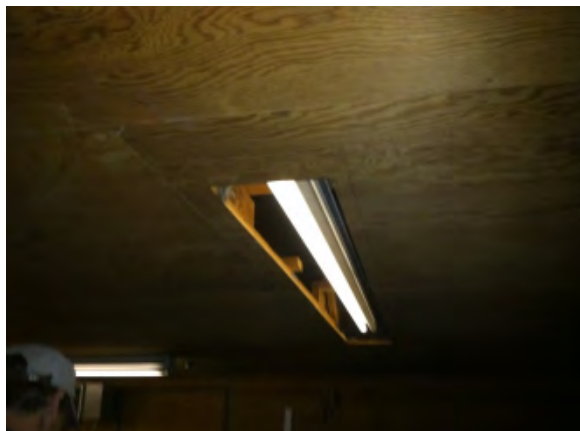
Figure 31. Shop ceiling showing recessed lighting in unsealed ceiling penetration.

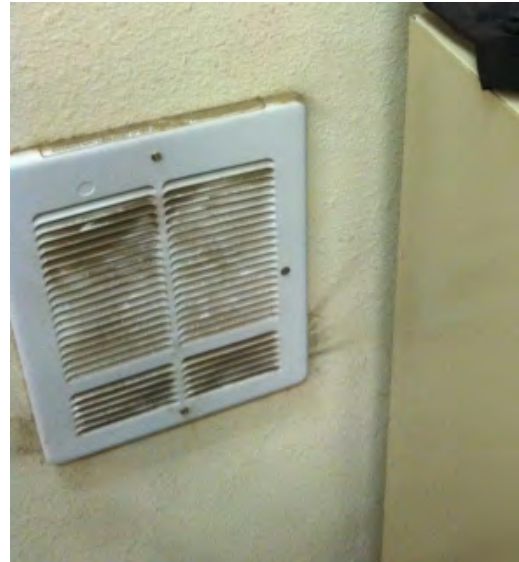
Figure 32. Example electric wall heater with dust and debris noted.

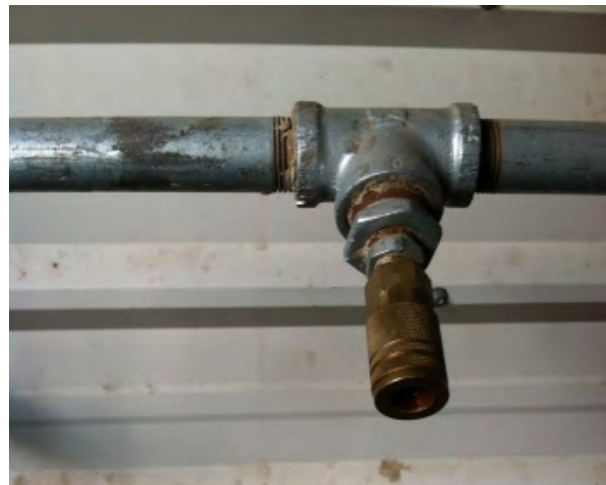
Figure 33. Compressed air distribution system showing significant corrosion around fitting.

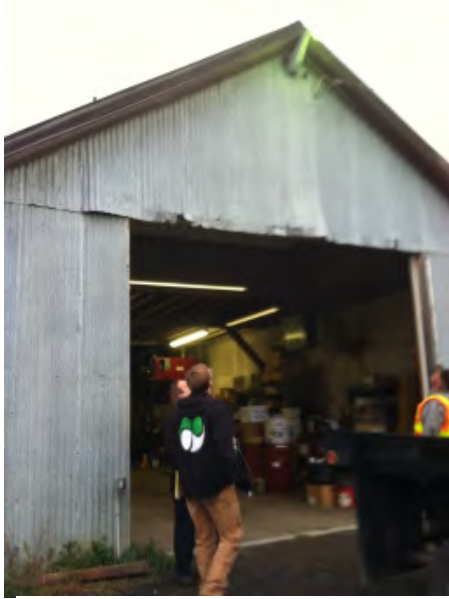
Figure 35. "Old" Roads Maintenance Shop showing metal halide lamp operational during daylight hours

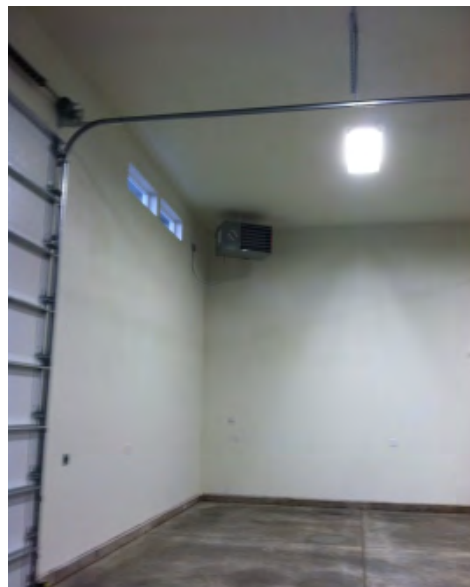
Figure 36. New Shop interior showing Modine unit heater and high output T-5 linear fluorescent lighting.

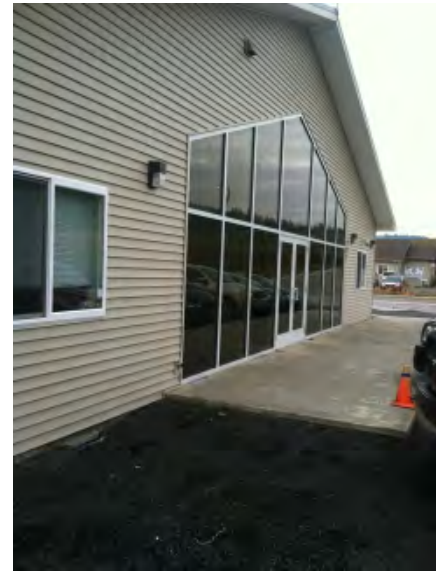
Figure 37. Department of Natural Resources north entry

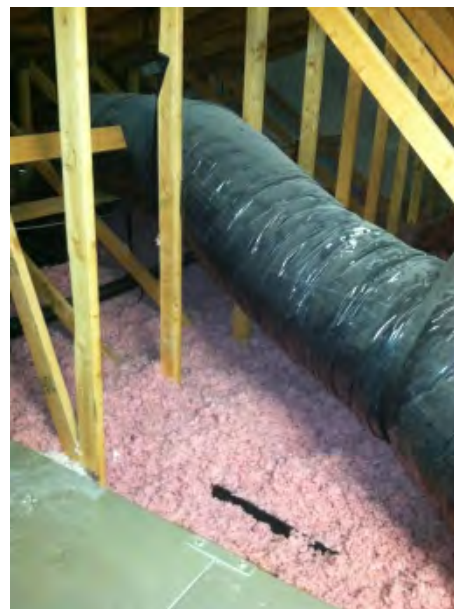
Figure 38. Insulated flexible ducting and loose fill fiberglass insulation observed in the central attic mechanical room.

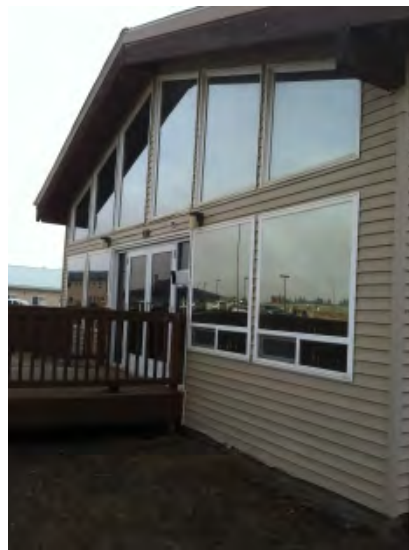
Figure 39. Felix Aripa Building north entrance.

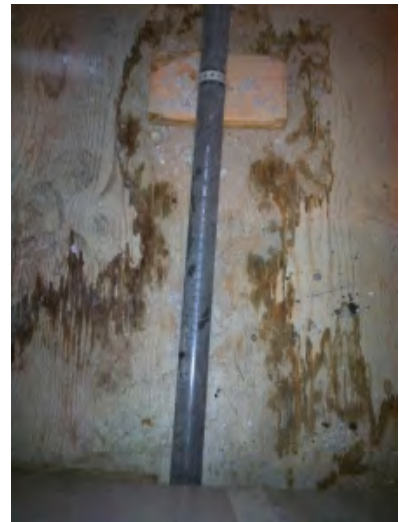
Figure 41. Moisture staining observed on mechanical catwalk adjacent to air handler.

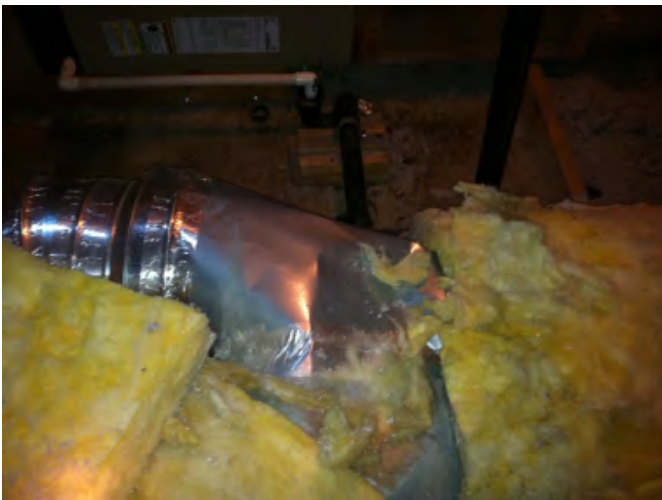
Figure 40. Crushed ducting, impacted duct insulation and foil take on HVAC distribution system.

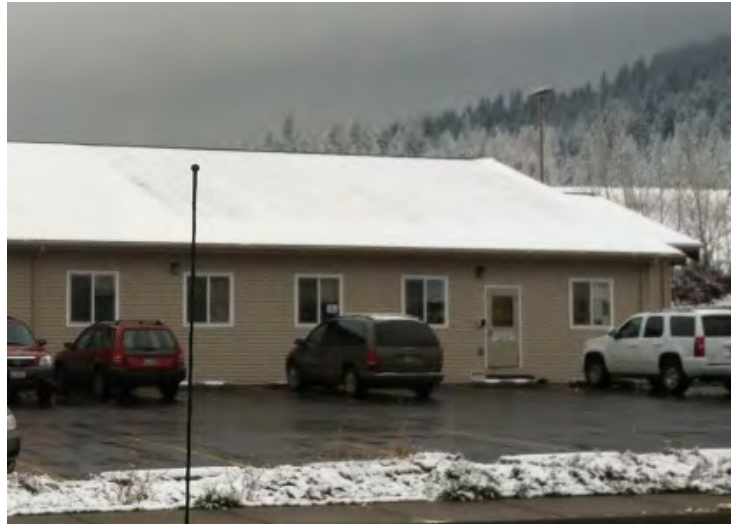
Figure 43. Felix Aripa roof detailing differences in snow melt over connected sections of the roof. Note color of roof deck on north side of structure.

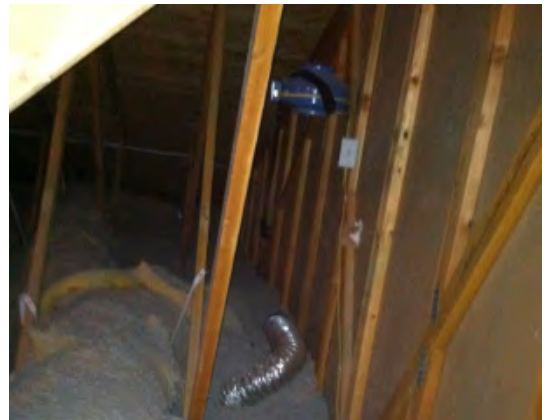
Figure 42. Disconnected bathroom exhaust fans noted in attic.

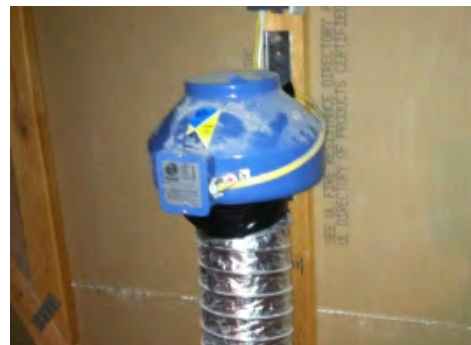
of these units was disconnected from the roof penetration ducting and was thus exhausting air into the attic space. This can lead to moisture buildup in the attic. The second exhaust fan was disconnected from both the bathroom vent and attic penetration therefore, instead of exhausting air from the bathroom it is circulating air within the attic space and allows uncontrolled air leakage from the conditioned space. Though this does not likely cause damage to the building, it is not serving the zone it is designed to serve.

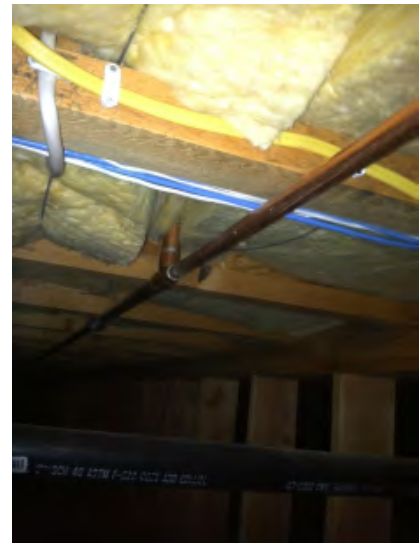
Figure 44. Uninsulated, copper hot water piping in crawlspace

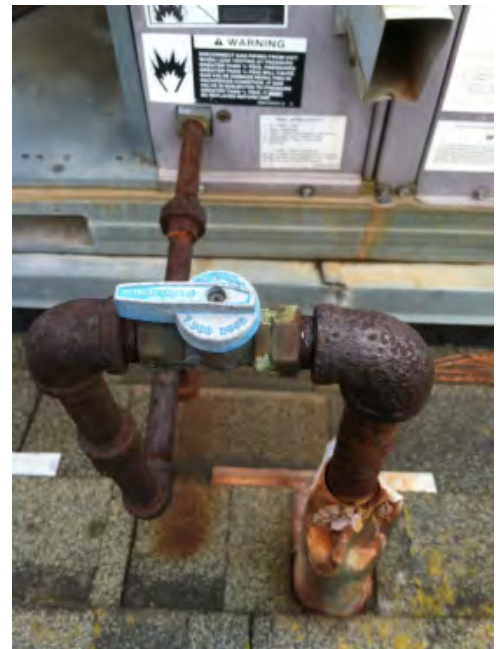
Figure 46. Corrosion noted in propane supply piping.

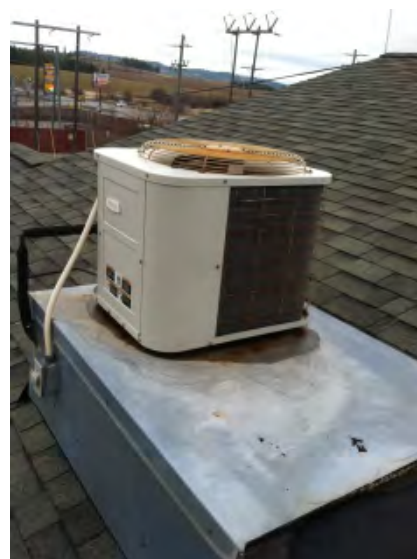
Figure 47. Bryant air conditioner condenser with obvious signs of corrosion and deterioration.

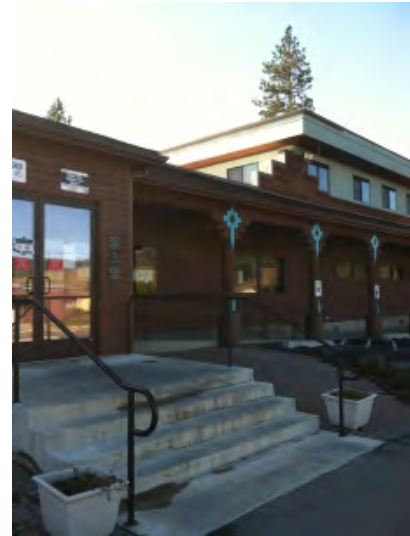
Figure 48. Old Benewah Medical Center front entrance with hydronic ice melt system embedded in sidewalk and steps

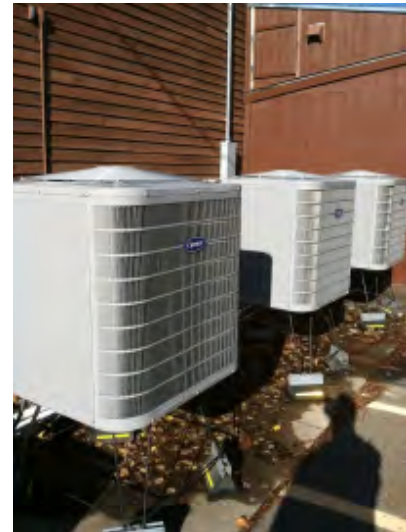
Figure 49. Energy Star rated Carrier Puron Heat Pumps.

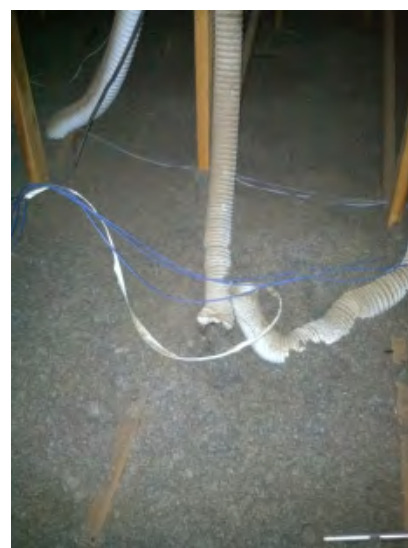
Figure 51. Improperly terminated bathroom exhaust fans.

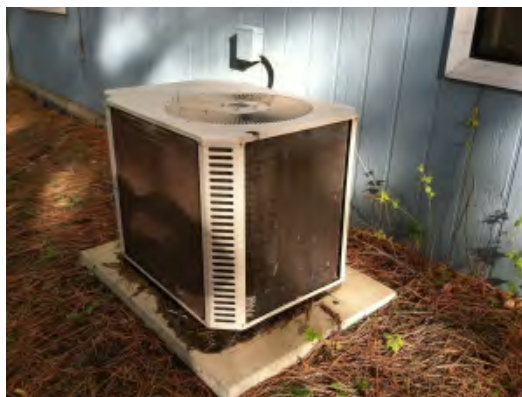
Figure 53. York air conditioner condenser with obvious signs of deterioration.

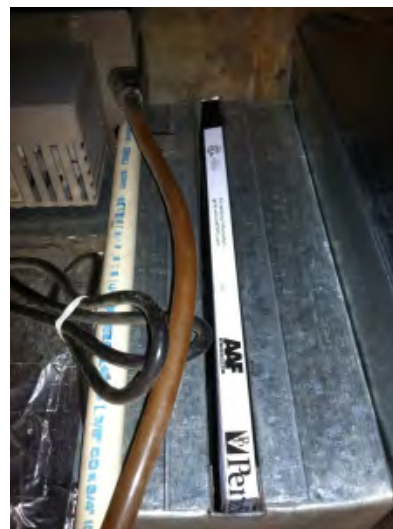
Figure 52. Improperly sized furnace filter with no filter access door in place.

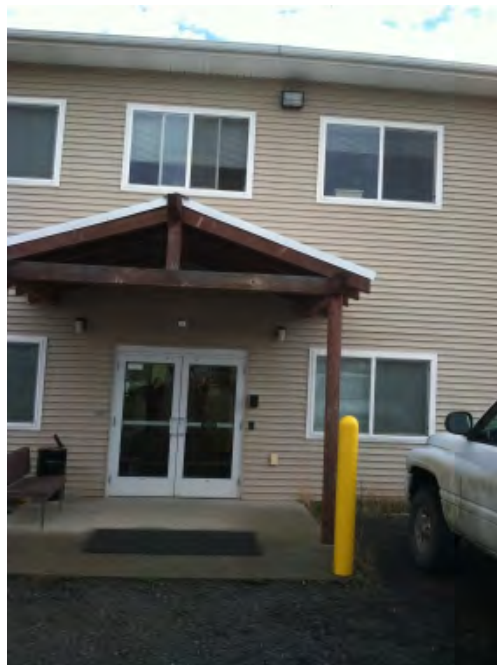
Figure 54. Technology Center front entry.

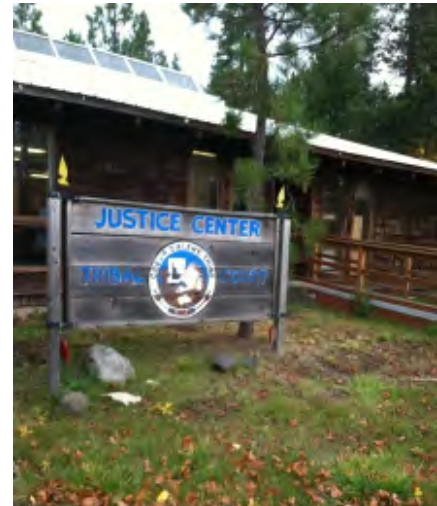
Figure 55. Tribal Court Services Building

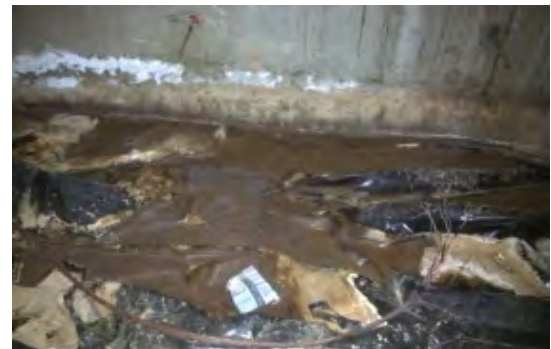
Figure 56. Standing water observed in crawlspace

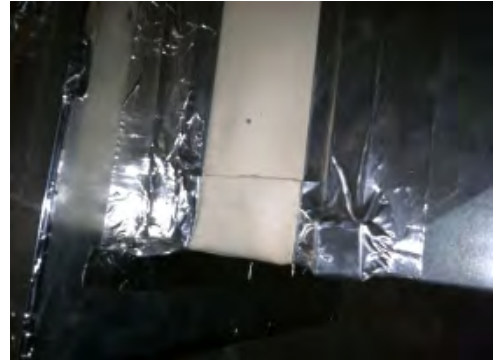
Figure 58. Aluminum duct tape holding together return side of Ruud air handler ducts

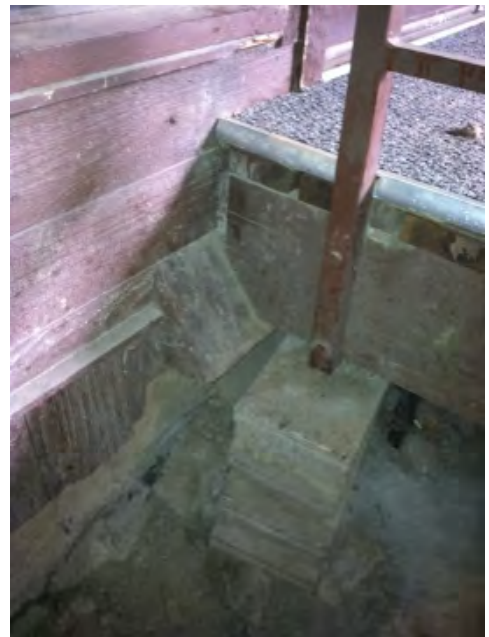
Figure 57. Outside air intake beneath front entry walkway too close to grade level in very dark and moist location

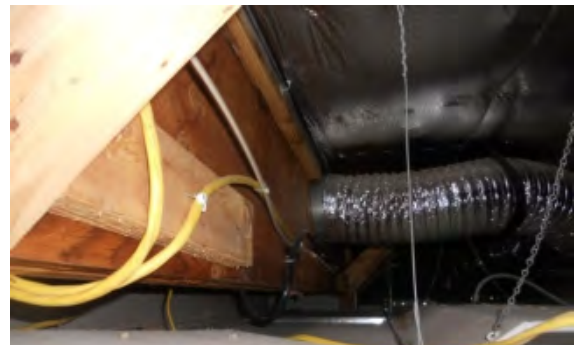
Figure 60. Existing ceiling insulation and duct work penetrating structural roof member.

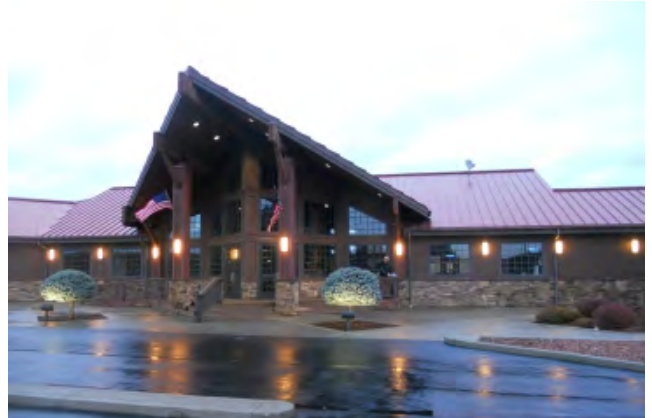
Figure 61. Circling Raven Golf Course Pro Shop

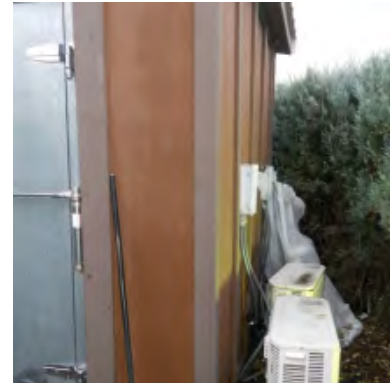
Figure 62. Kitchen air conditioning condenser units detailing potential impacts due to location

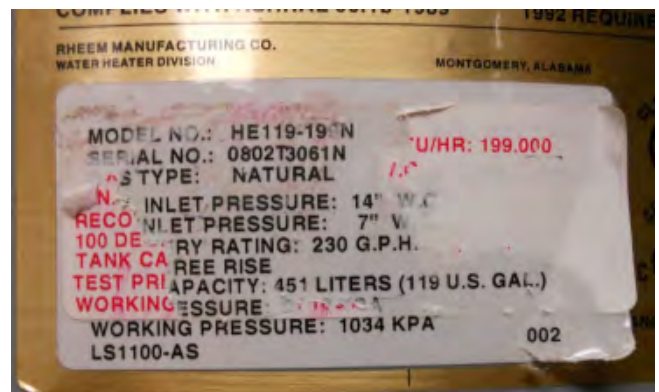
Figure 63. Water heater nameplates showing multiple labels

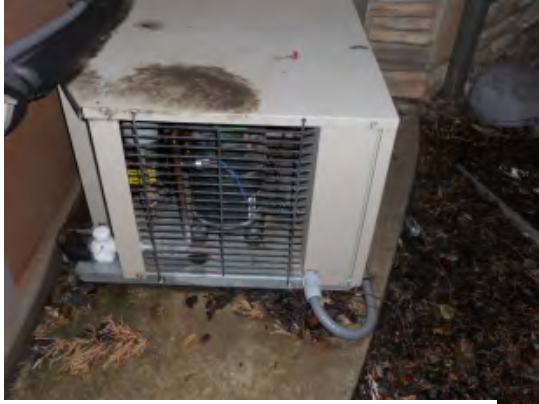
Figure 65. Walk-in cooler condenser with frozen expansion valve

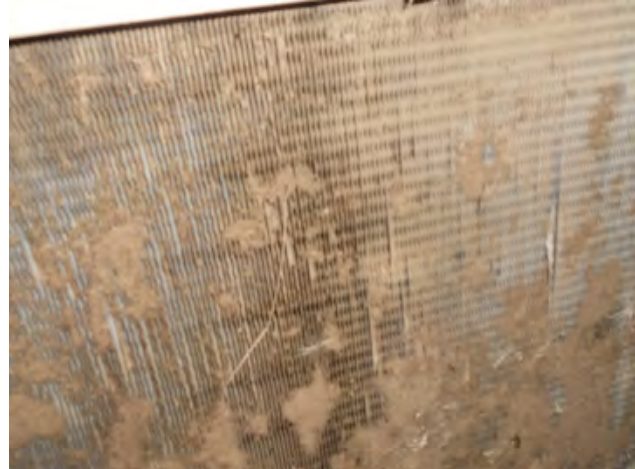
Figure 64. Walk-in cooler condenser fins impacted by debris.

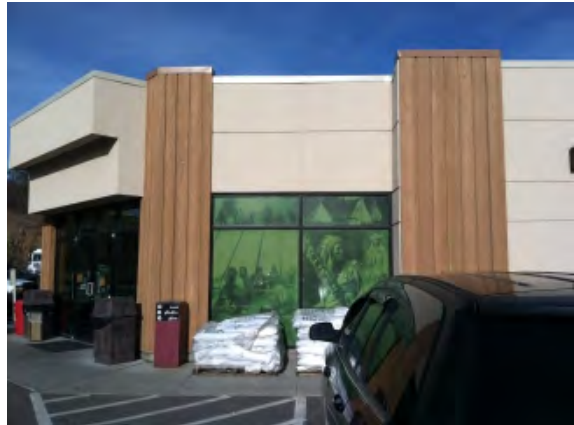
Figure 68. Tribal Conoco Service Station

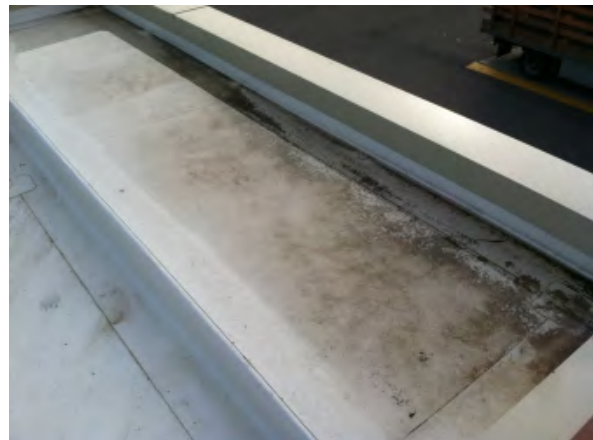
Figure 70. Standing water on roof above entry way.

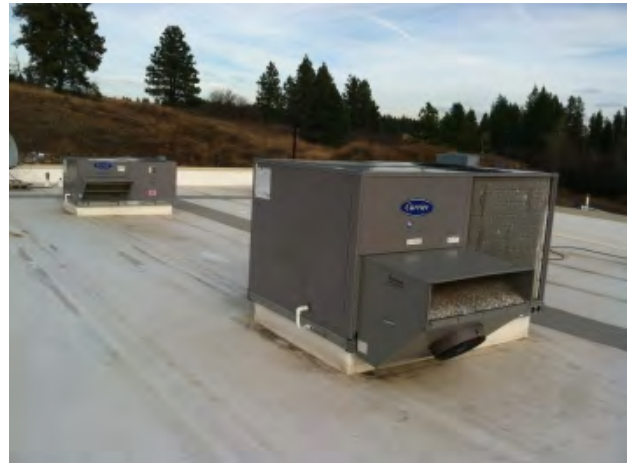
Figure 71. Packaged roof top heat pumps (RTUs).

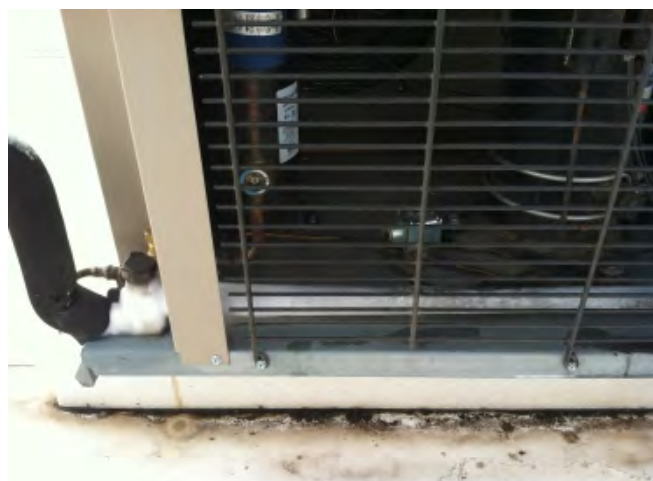
Figure 72. Icing noted at expansion valve on cooler condenser.

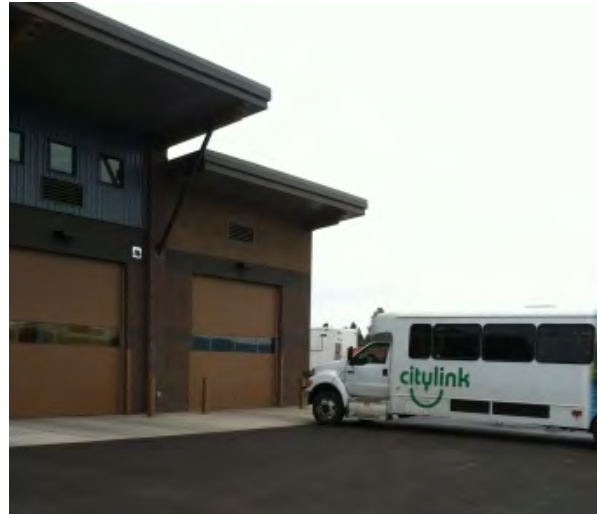
Figure 73. City Link Bus Garage

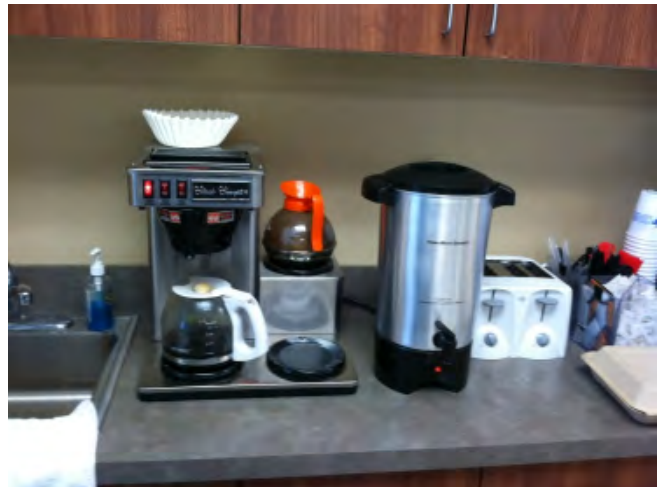
Figure 75. Break room coffee makers.

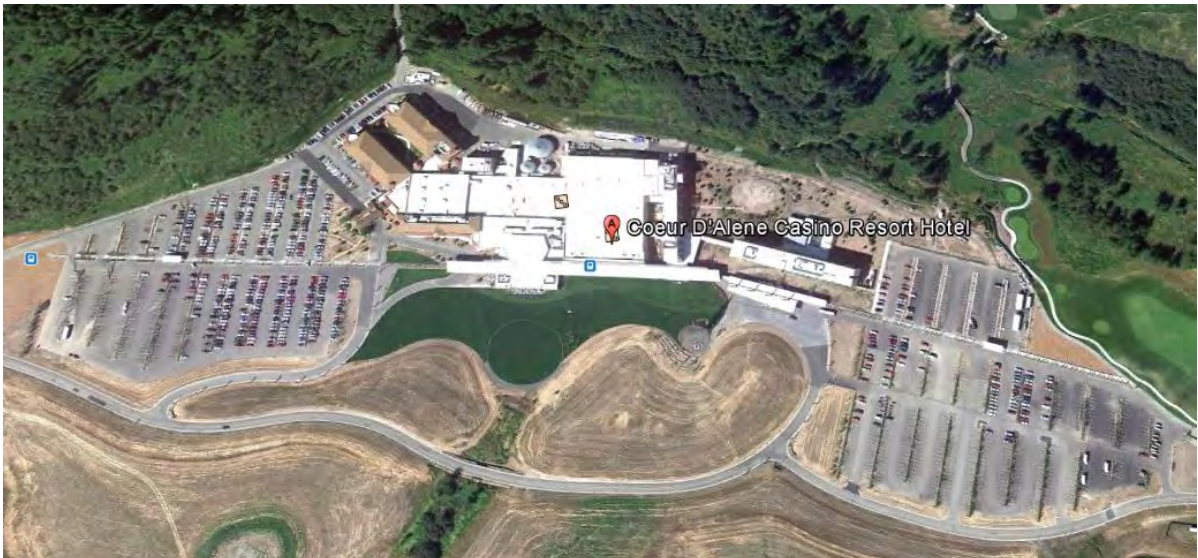
Figure 76. Coeur d'Alene Casino Resort Hotel Campus. Note: Image does not show the Spa Towers wing or the extensive parking lot now located on the south side of the Casino.

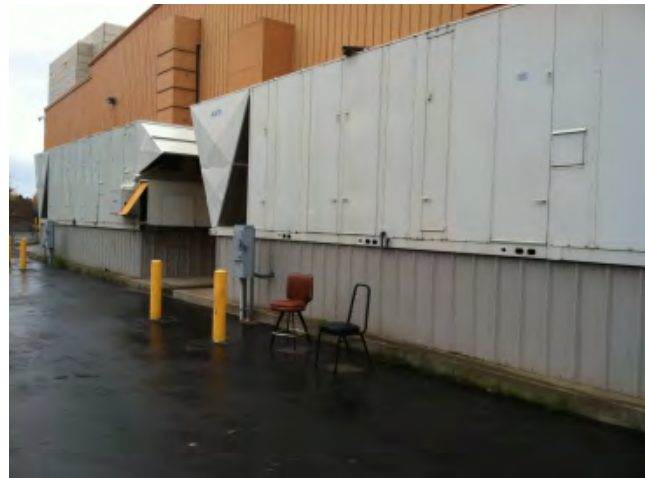
Figure 77. Large, ground mounted, Aaon packaged chillers and propane furnaces.

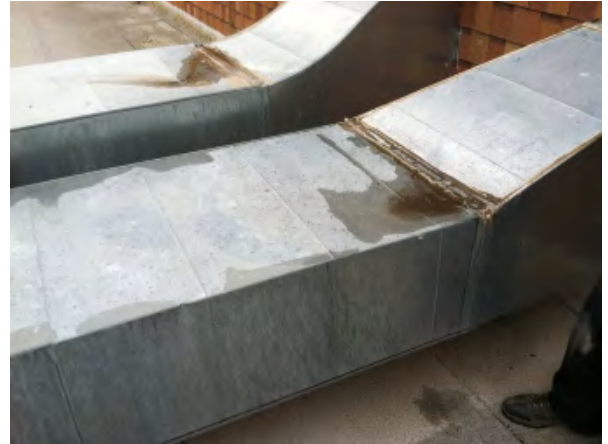
Figure 78. Impacted duct seals on Lennox that serves Presidential Suites.

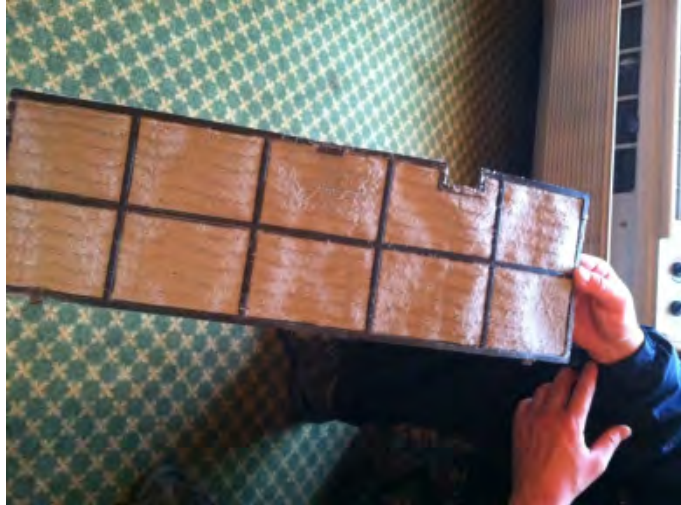
Figure 79. Soiled room PTHP filter in need of maintenance

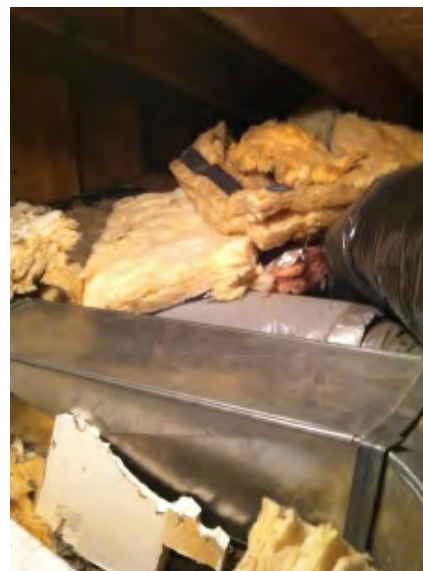
Figure 81. Displaced attic insulation and damaged HVAC distribution system.

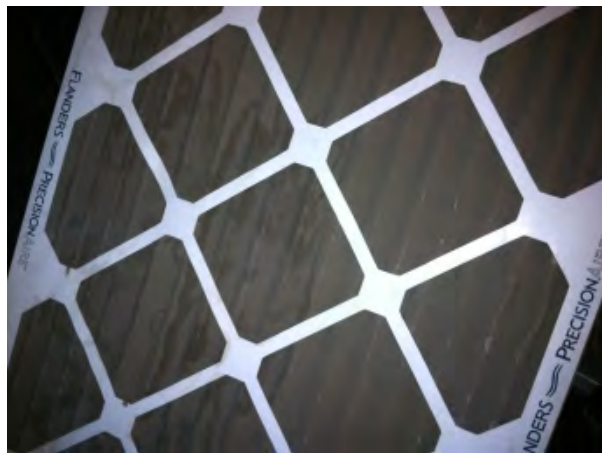
Figure 82. Extremely soiled HVAC air filter.

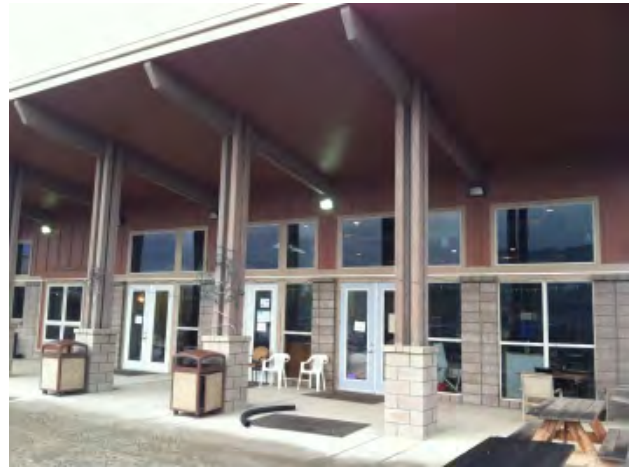
Figure 83. Senior Housing Complex

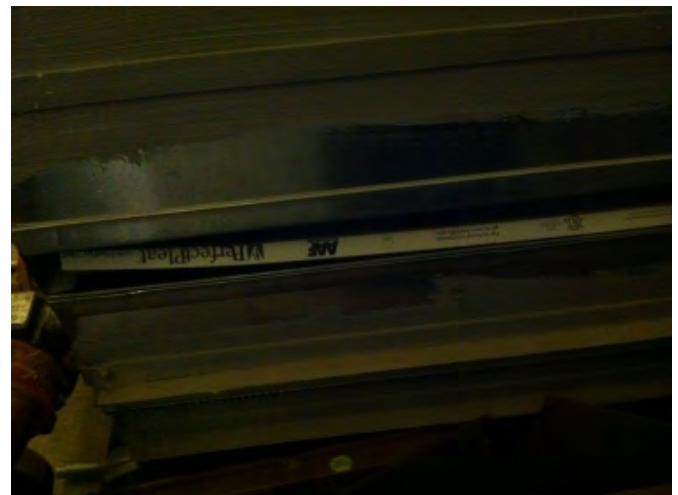
Figure 84. HVAC air handler with missing filter door

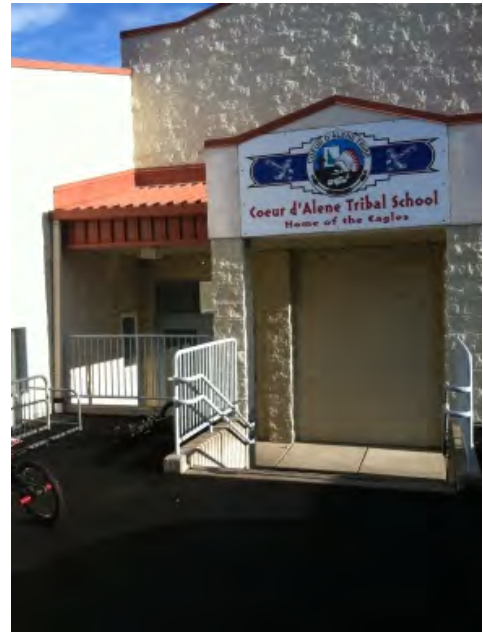
Figure 85. Tribal School entry

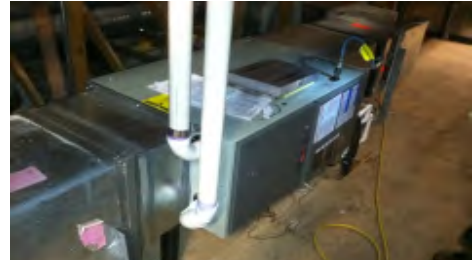
Figure 86. Trane propane furnace/air handlers serving classrooms.

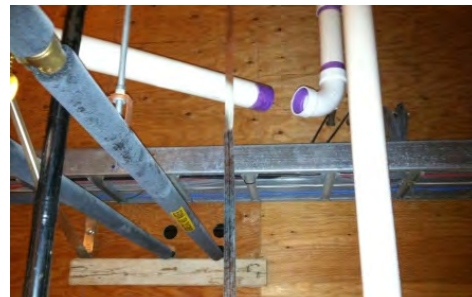
Figure 87. Furnace #F15 combustion air intake line disconnected

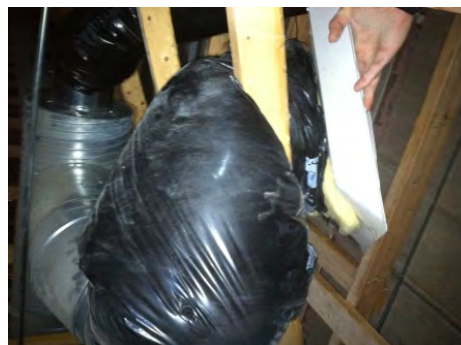
Figure 88. Furnace #F11 disconnected duct blowing into attic

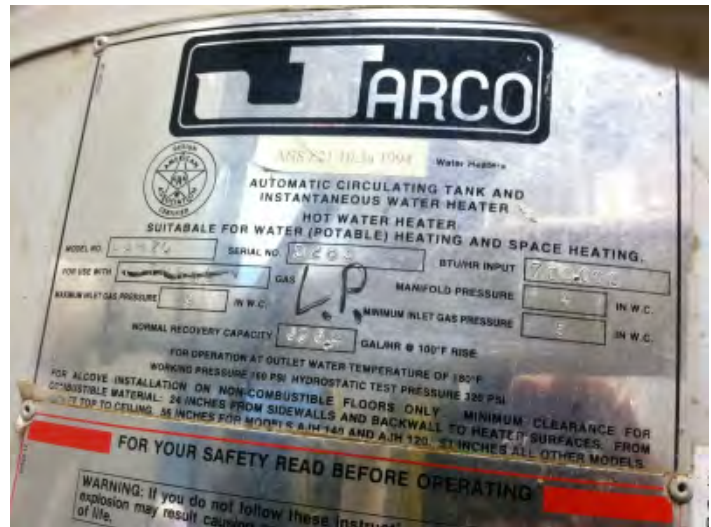
Figure 90. Boiler nameplate specifies natural gas – unknown whether legitimately retrofitted for propane fuel

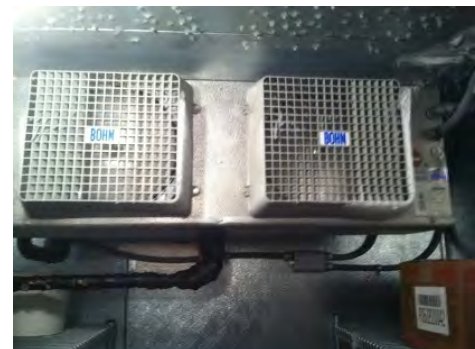
Figure 91. Condensation dripping from ceiling in walk-in freezer.

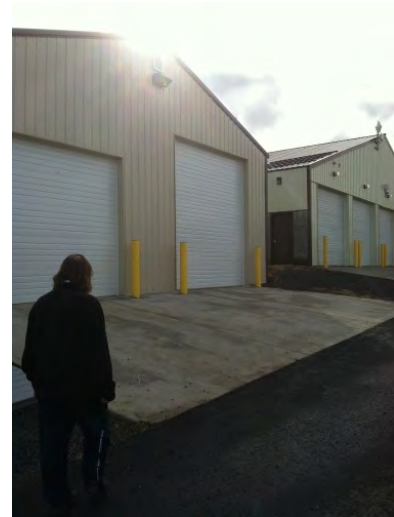
Figure 92. School Bus Garage entrances

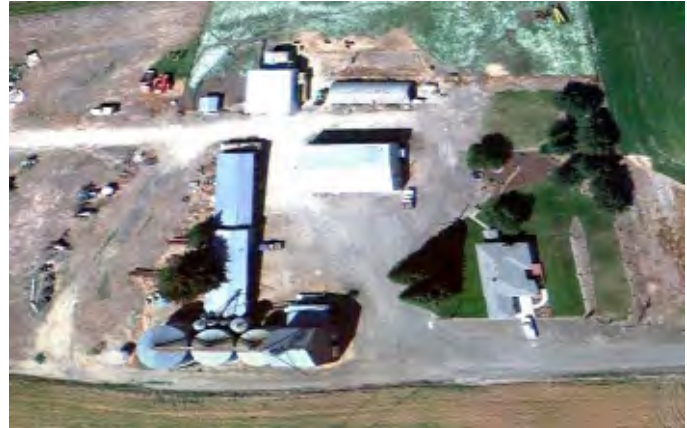
Figure 93. CDA Tribal Farm Complex

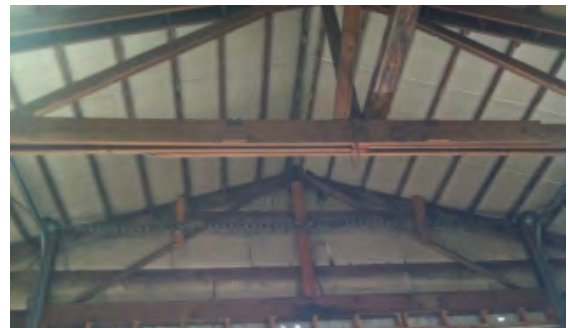
Figure 94. Integrated fiberglass insulation vinyl vapor barrier observed in ceiling and walls.

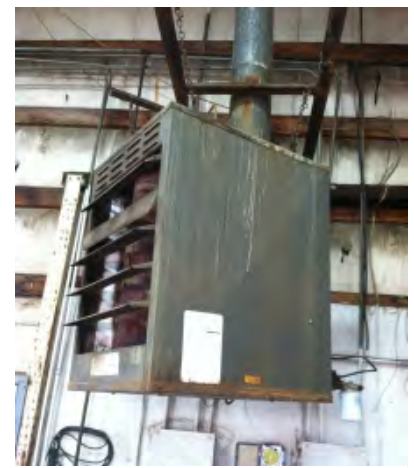
Figure 95. Unit heater with visible corrosion on flue piping and burners.

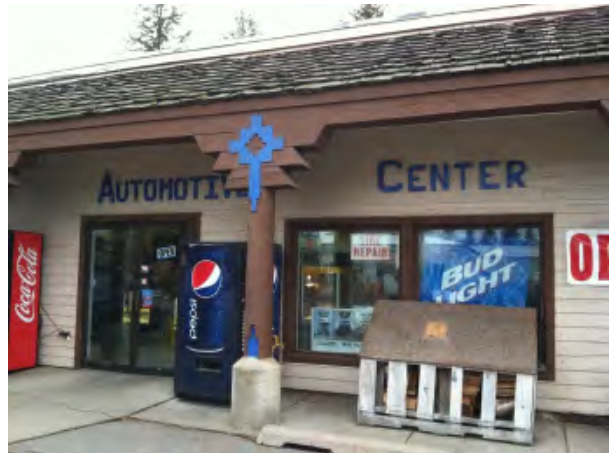
Figure 96. Benewah Auto entry.

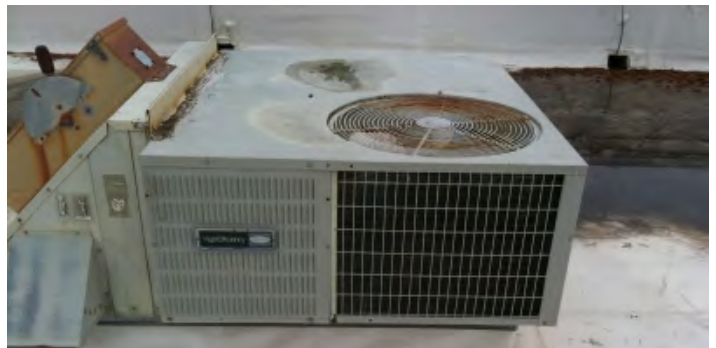
Figure 97. Carrier packaged air conditioner/electric furnace.

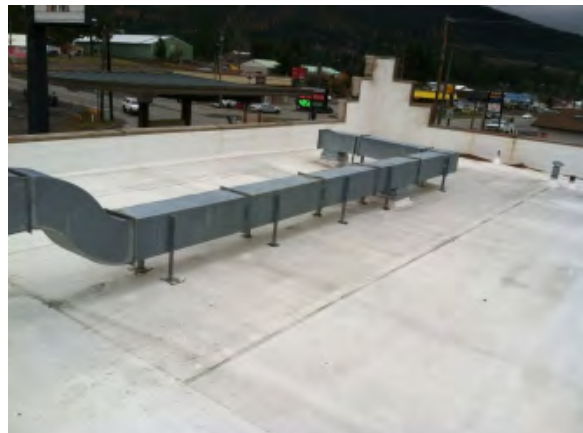
Figure 98. Rooftop HVAC ducting.
