Coeur d'Alene Tribe Energy Efficiency Feasibility Study

Coeur d'Alene Tribal Benewah Medical Center Front Entrance

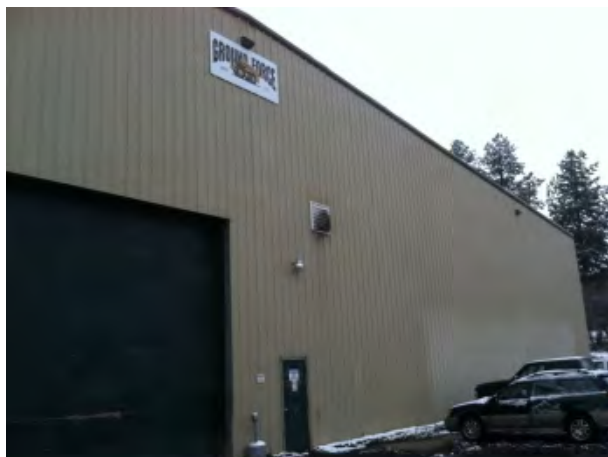
Figure 99. Echelon Plummer entry.

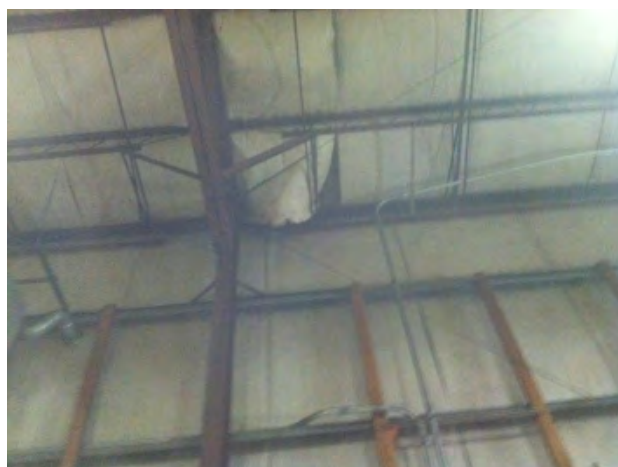
Figure 100. Damaged ceiling insulation noted on interior of structure.

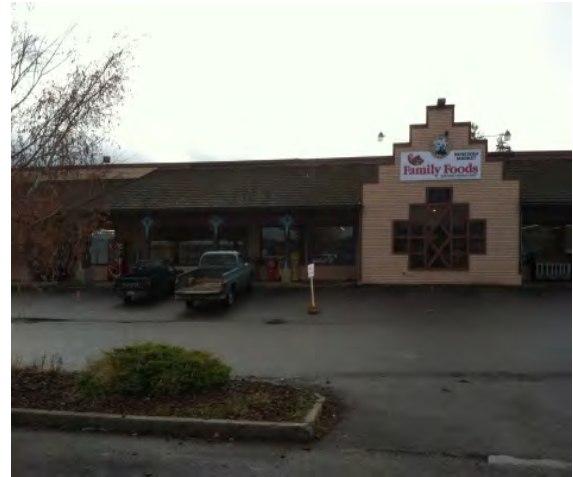
Figure 101. Benewah Market entry.

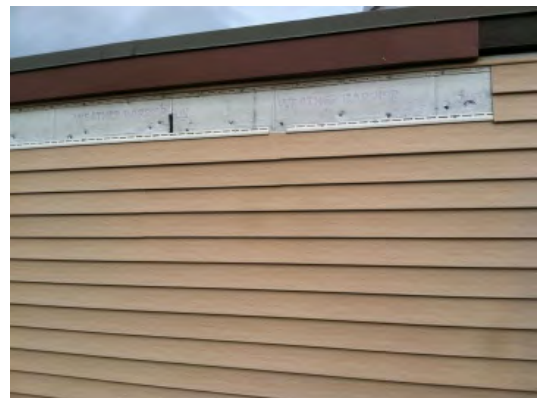
Figure 102. Missing vinyl siding on exterior wall.

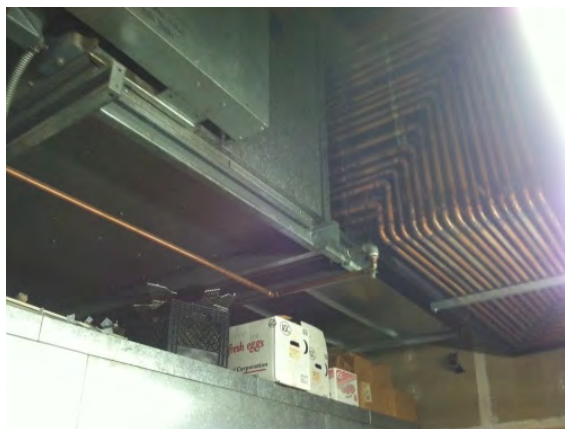
Figure 103. Refrigeration heat recovery system serving building HVAC.

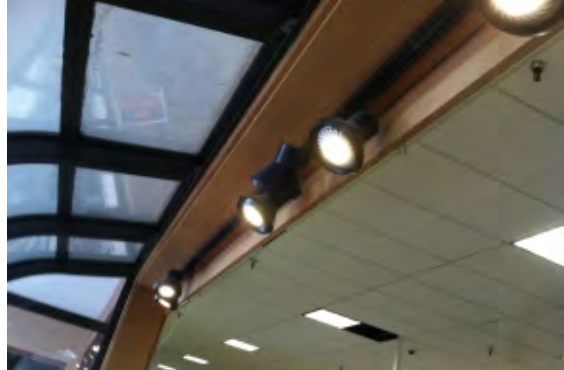
Figure 104. State of the art, extremely energy efficient LED lighting reduces energy costs by 90% compared to incandescent bulbs.

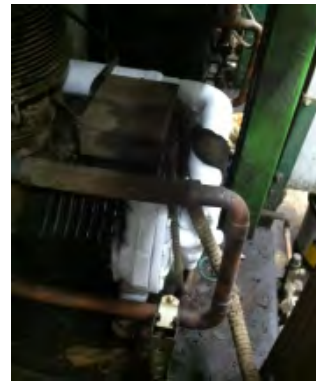
Figure 105. Typical icing observed on refrigeration compressors.

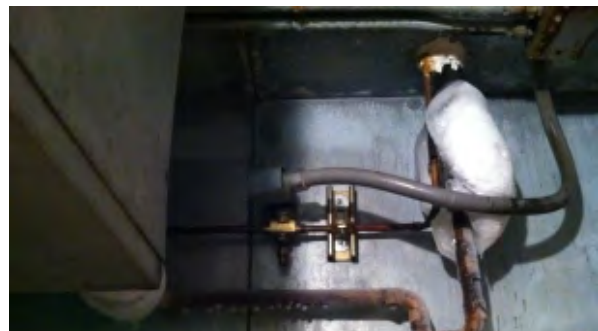
Figure 106. Persistent humidity and ice build-up in game freezer.

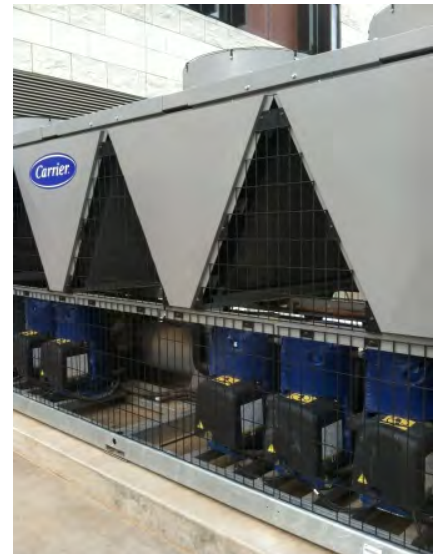
Figure 108. New BMC Chiller

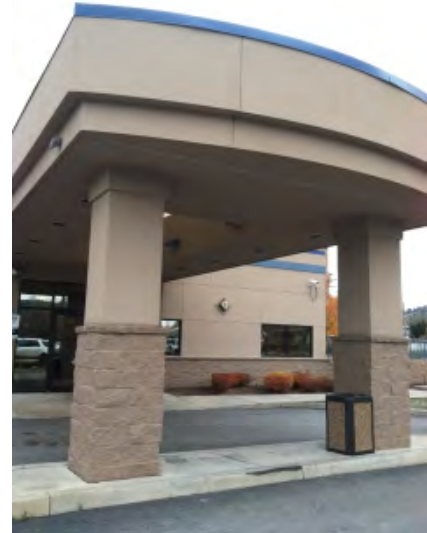
Figure 109. Tribal Wellness Center front entry.

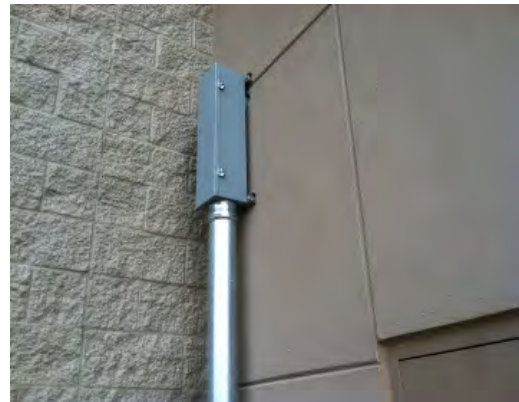
Figure 110. Exterior wall penetration with very poor seal.

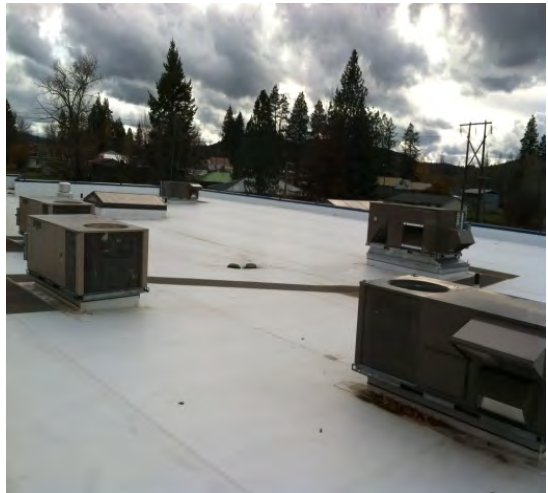
Figure 112. Packaged Heat Pump RTUs.

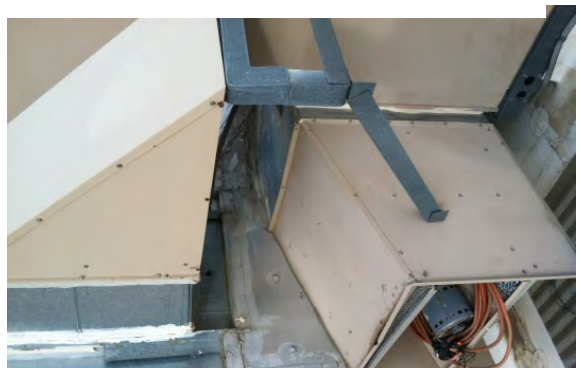
Figure 111. Older York heat pump with economizer disabled

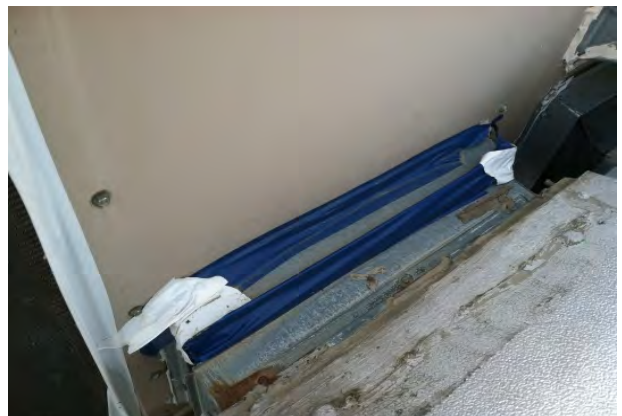
Figure 113. Older York heat pump with compromised duct seals.

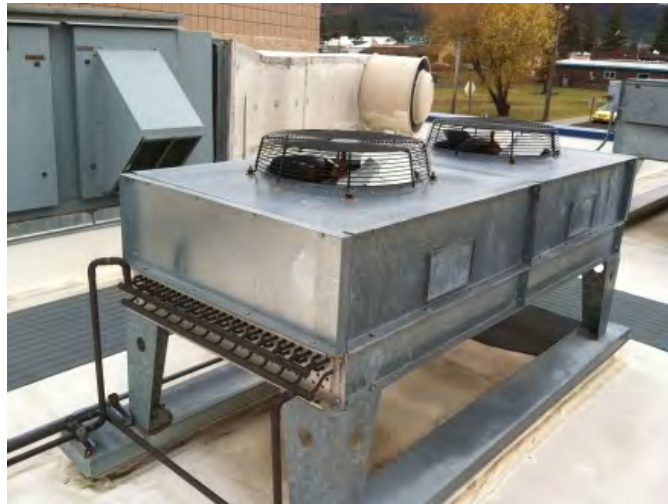
Figure 114. Dectron Pool Energy Recovery Units

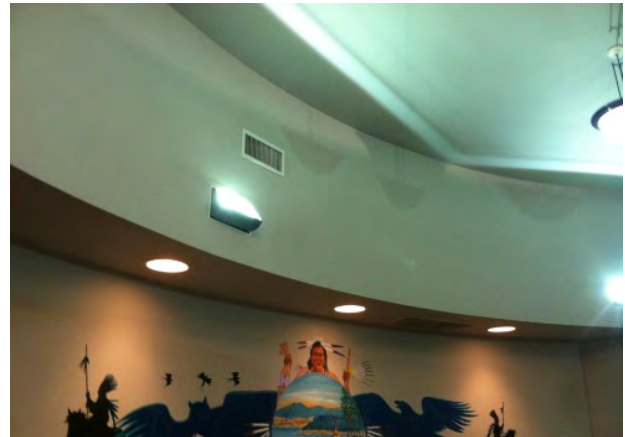
Figure 117. Diverse array of lighting systems at reception area/snack bar

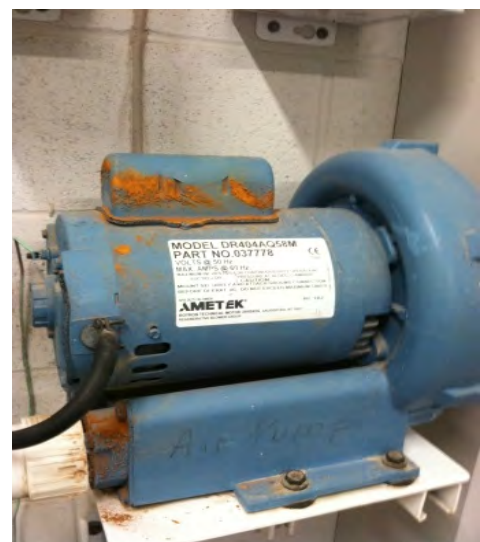
Figure 118. Spa air pump with significant corrosion.

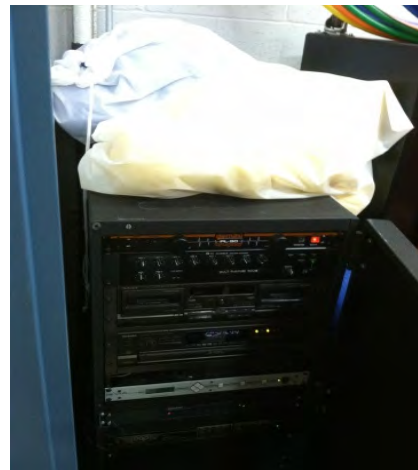
Figure 119. Gym PA audio system consumes 1250 watts "always on".

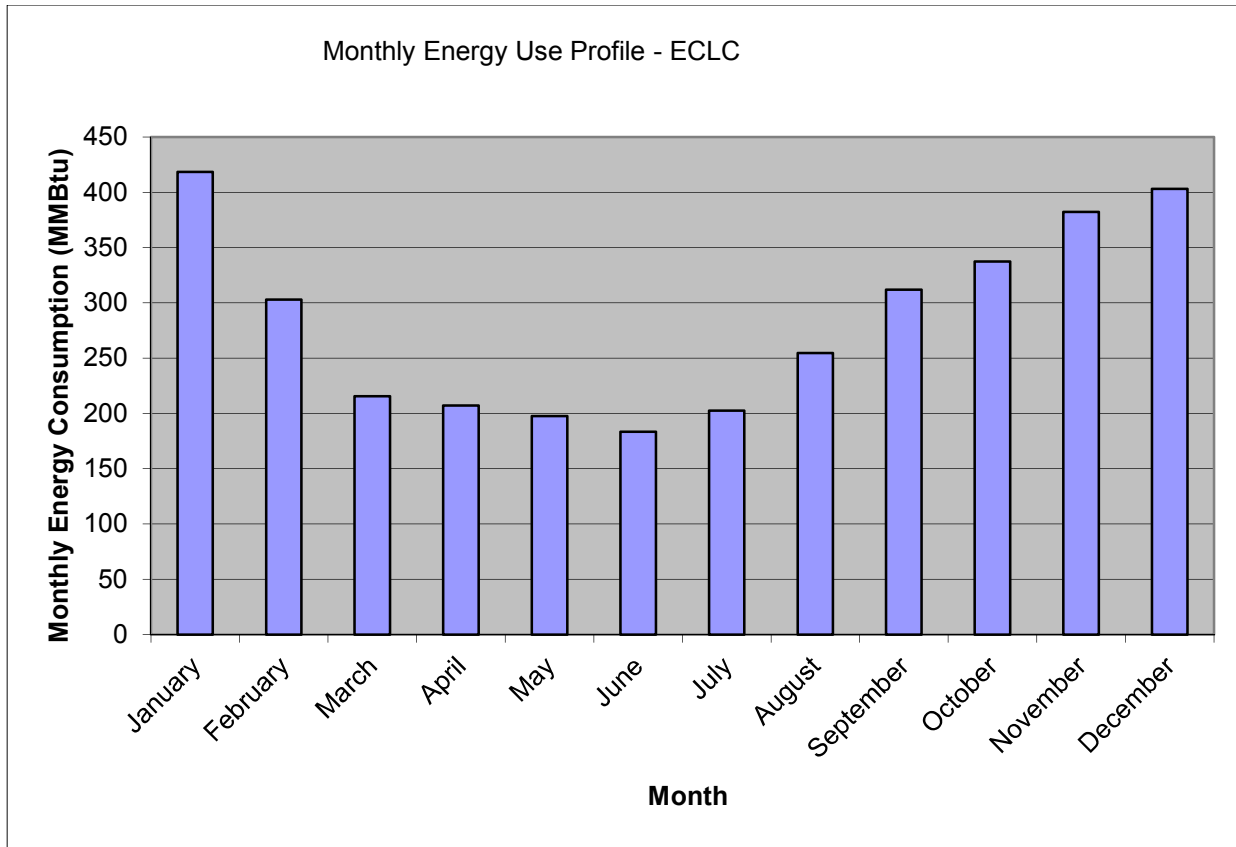
The data provided for the ECLC shows significant variation in billed energy use from month to month correlated to seasonality, with highest energy use attributable to heating during the winter months. It seems unusual however, that energy use would begin to climb in August and continue to increase throughout the fall and into winter. Normally in buildings that do have and run cooling systems there is slightly lower energy use in the milder spring and fall months but that is not in evidence here. Building occupants report generally being too cold during the hotter months when air conditioning is in use, and likewise OE early reported inconsistencies with respect to thermostat programming in the building. Consequently there may be significant energy savings associated with simple optimization of thermostat settings.

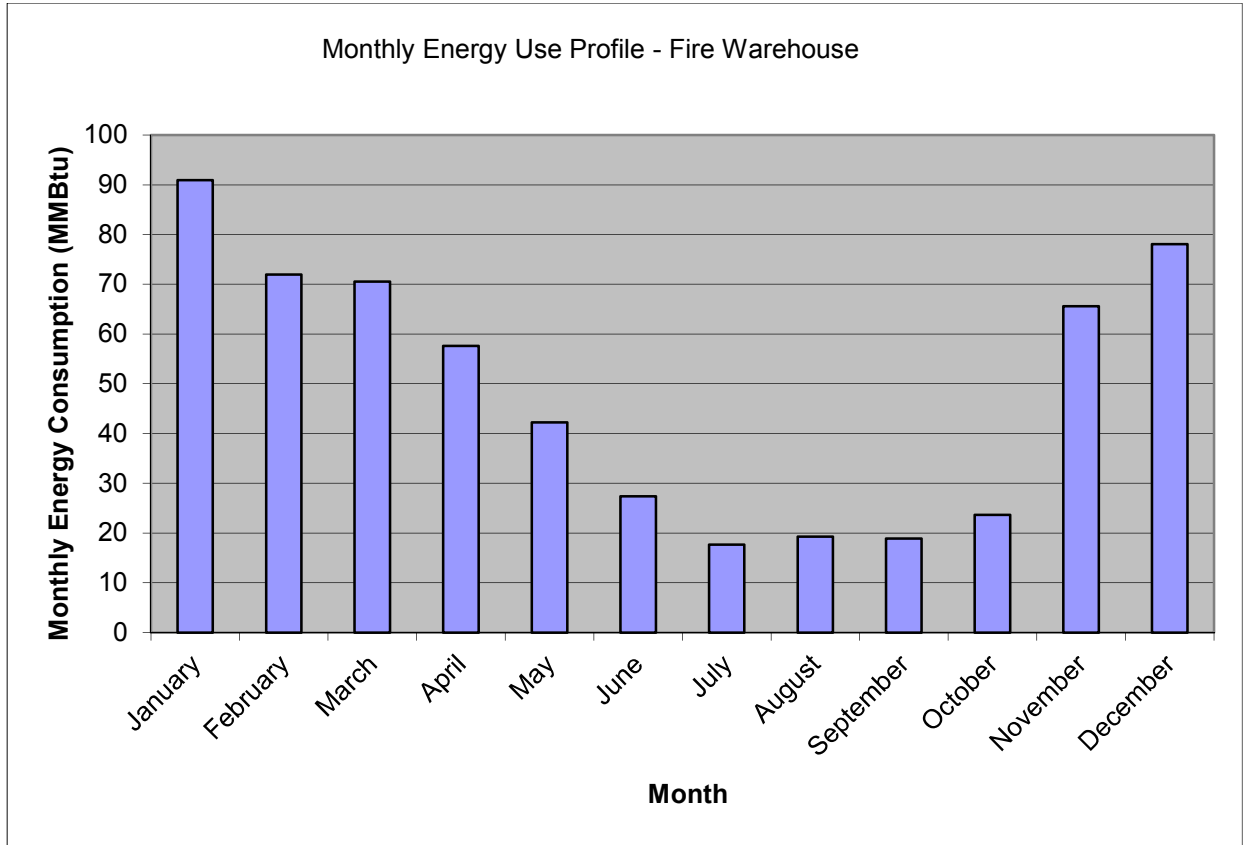
The data provided for the Fire Warehouse shows significant variations in billed energy use from month to month correlated to seasonality, with a net energy use reduction from the base load during spring through the fall and increases in and in winter attributable to heating. There is only a slight increase in summer since the Fire Warehouse has only a couple of small window unit air conditioners that are not used much.

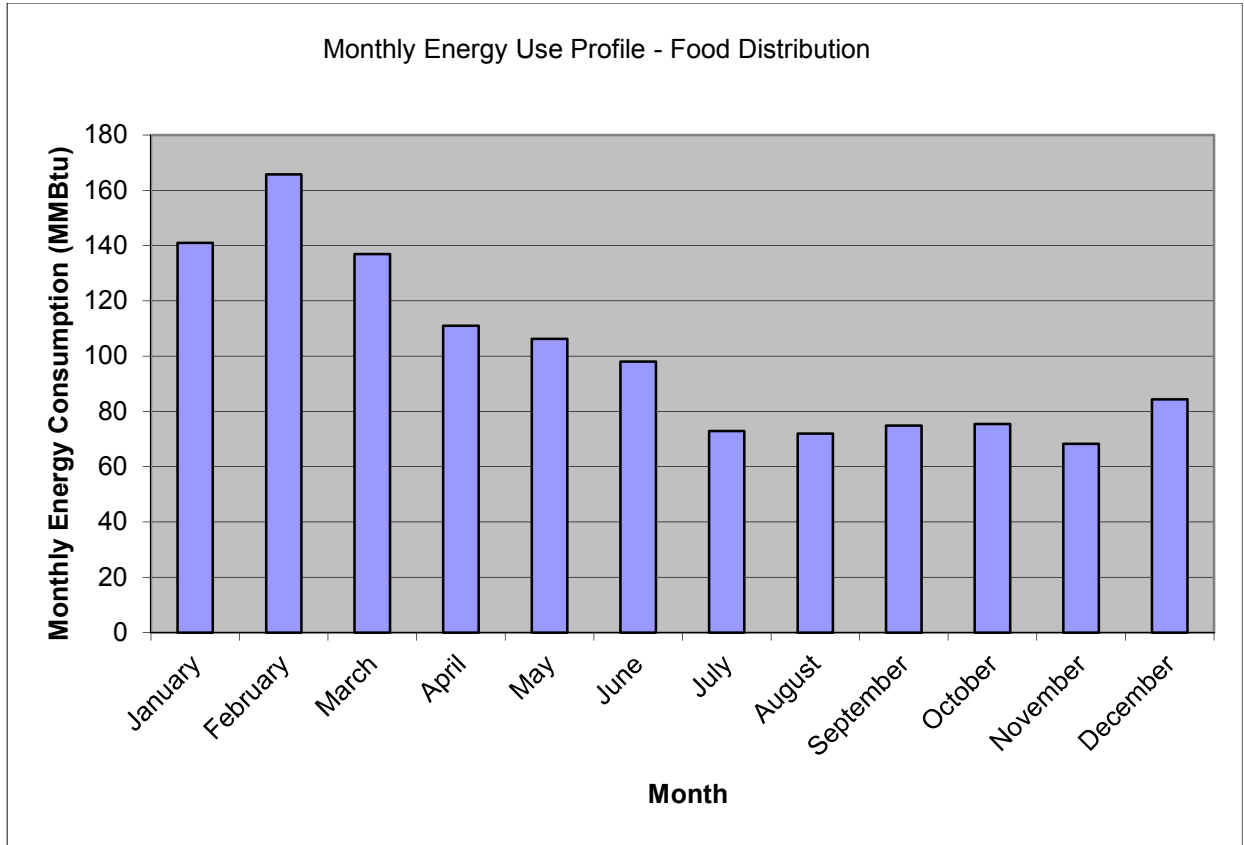
The data provided for the Food Distribution building shows significant variations in billed energy use from month to month correlated to seasonality, with a net energy use reduction from the base load during spring through the fall and increases in and in winter attributable to heating. Summer cooling energy is slight as there is only a single window unit air conditioner serving a small office zone, however it is likely that process refrigeration loads do increase during hotter weather, particularly since the walk-in cooler and freezer units reject their heat inside the conditioned space rather than outdoors.

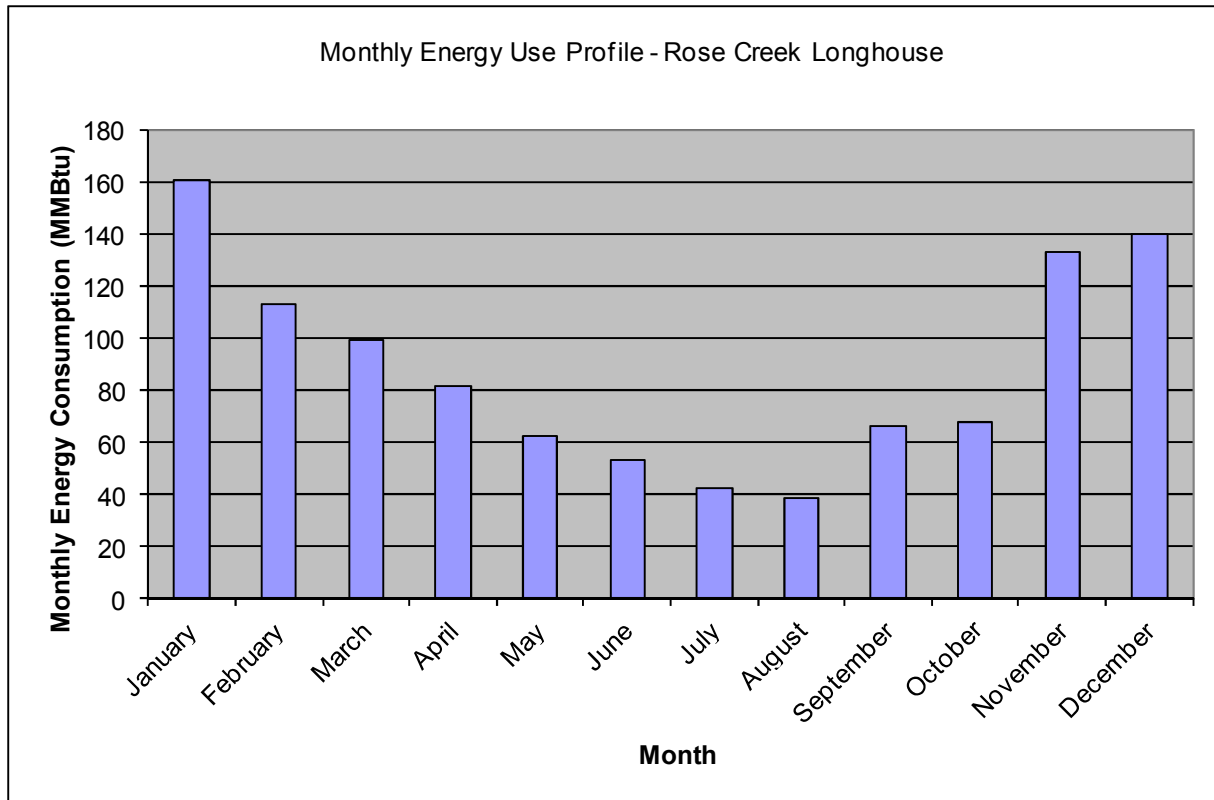
The data provided for the Rose Creek Longhouse shows significant variations in billed energy use from month to month correlated to seasonality, with a significant increase in winter attributable to heating but no corresponding increase in summer attributable to cooling. It is worth noting that the propane fuel consumption data provided appear anomalously high for this building. The fuel delivery data was verified with the vendor, and given that there are no or minimal propane deliveries in the summer months there is no reason to suspect a major leak. It appears that the building is simply heated a great deal during winter months whether it is occupied or not. An aggressive new approach to managing the building is recommended and will likely yield many thousands of dollars in annual savings.

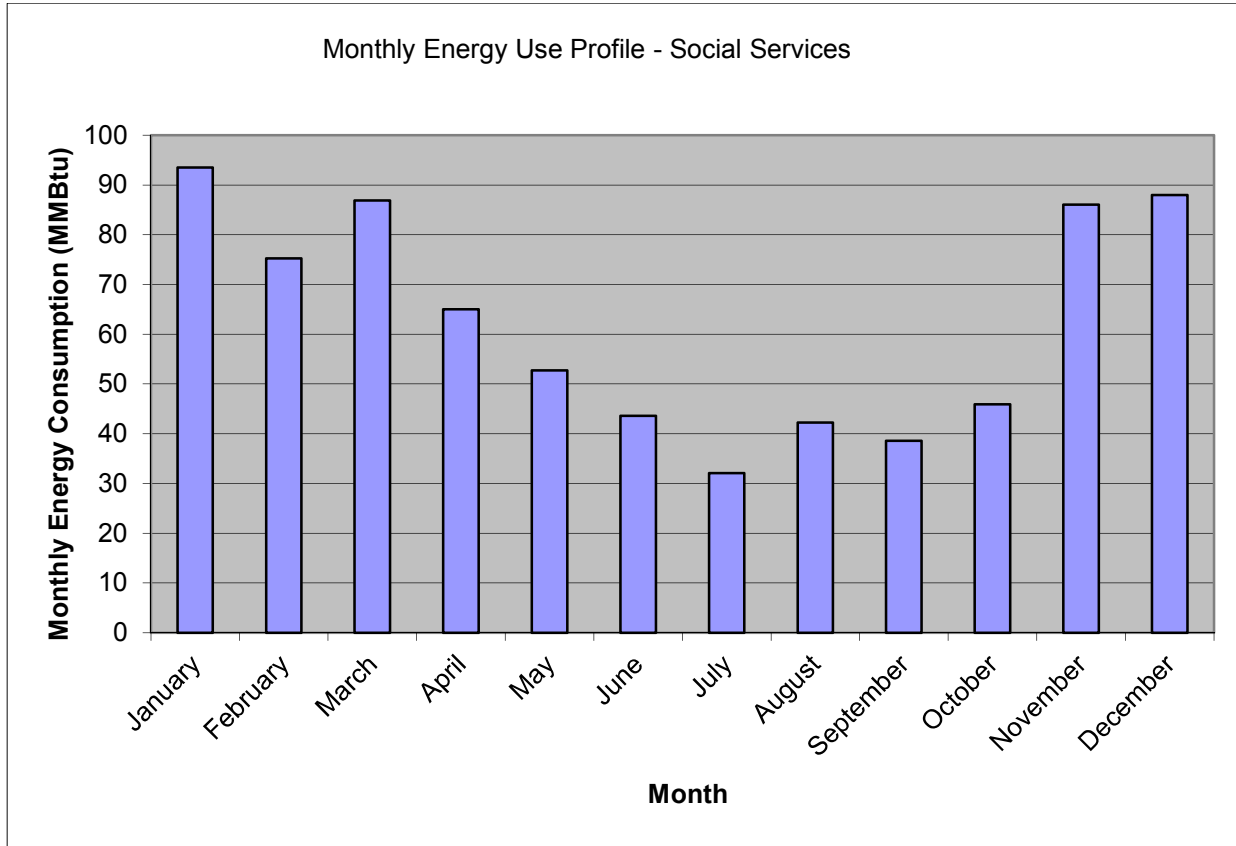
The data provided for the Social Services building shows significant variations in billed energy use from month to month correlated to seasonality, with a net energy use reduction from the base load during spring and fall and increases in winter attributable to heating and slight increases in summer attributable to cooling. It is worth noting that this building's EUI is significantly higher than other nearly identical modular buildings that are used in a similar manner. Assuming the data provided is accurate there is likely some seriously deficient condition in the heating system that warrants further investigation.

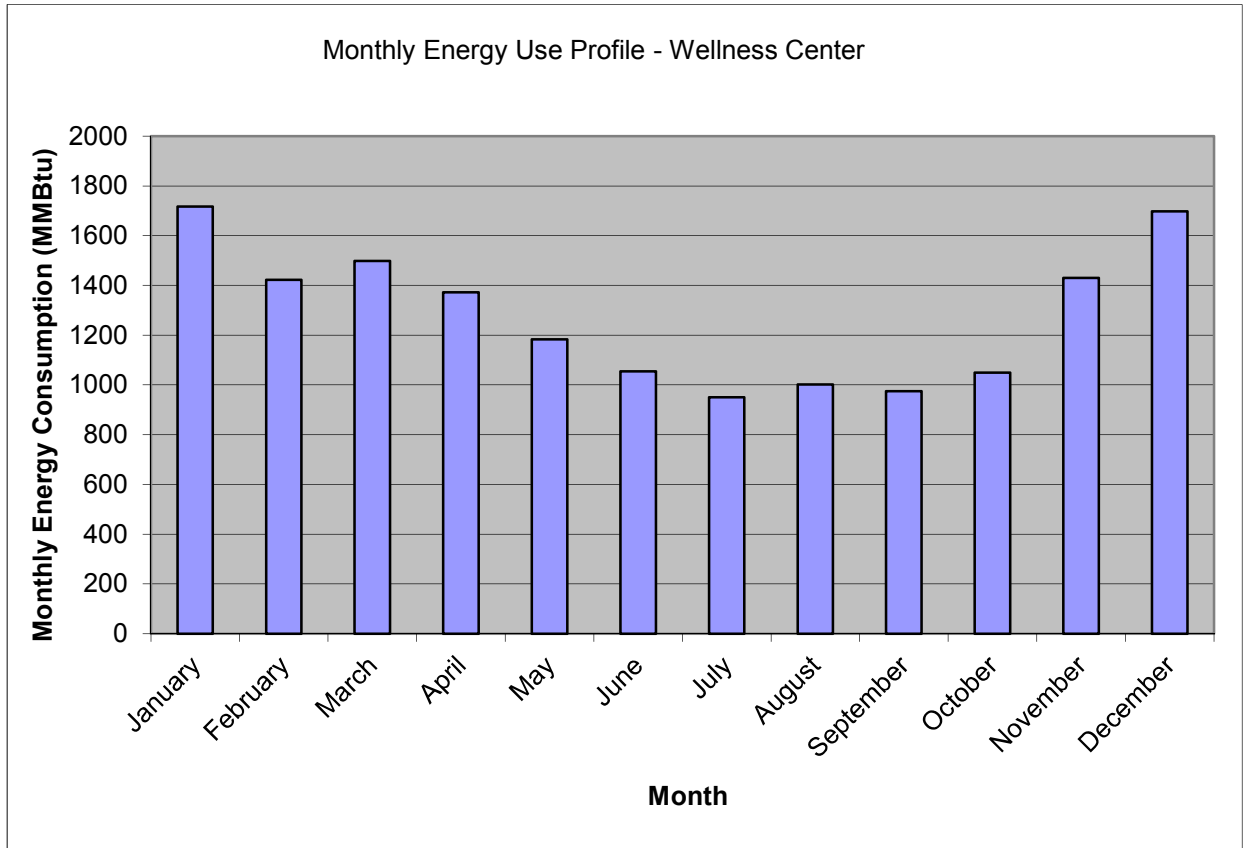
The data provided for the Wellness Center shows significant variations in billed energy use from month to month correlated to seasonality, with a net energy use reduction from the base load during spring, summer, and fall, and increases in winter attributable to heating.

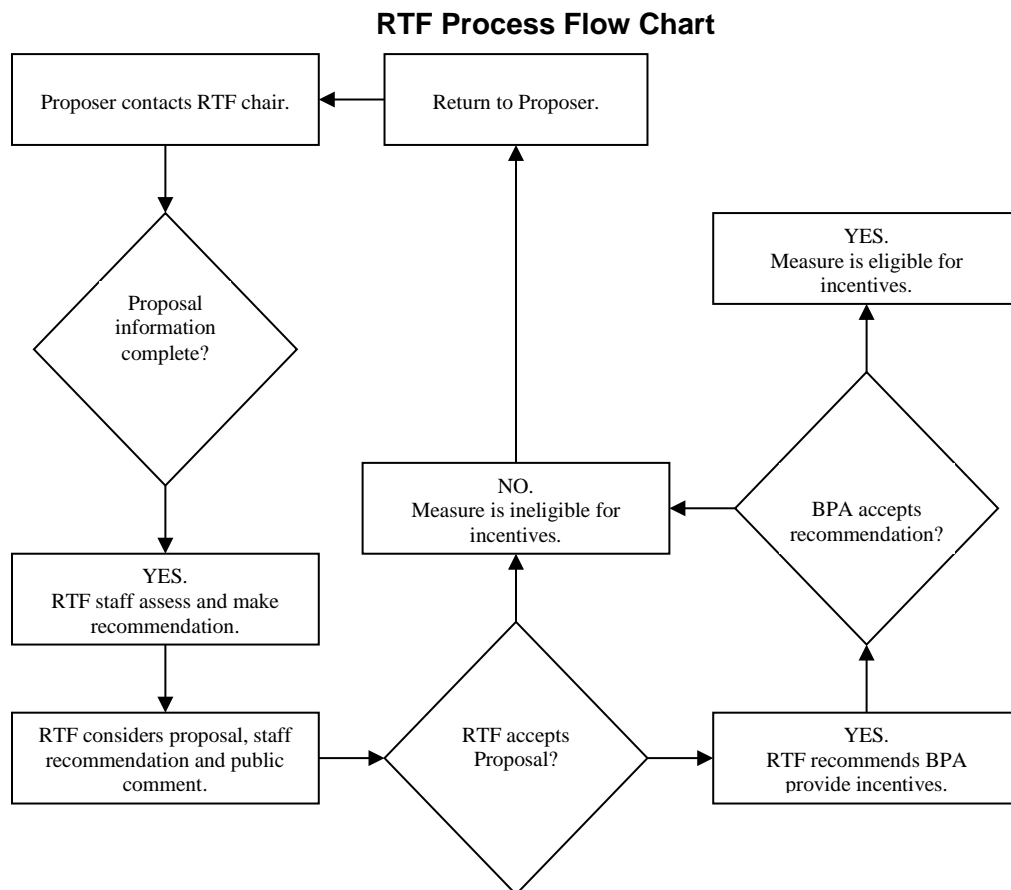
1.1.2 BPA Qualified Measures
