NDE Methods for Certification and Production/Performance Monitoring of Composite Tanks

David McColskey, Marvin Hamstad
NIST-Boulder, CO

Regor Saulsberry, Jess Waller
NASA-JSC White Sands Test Facility

Nondestructive Evaluation and Monitoring Results from COPV Accelerated Stress Rupture Testing

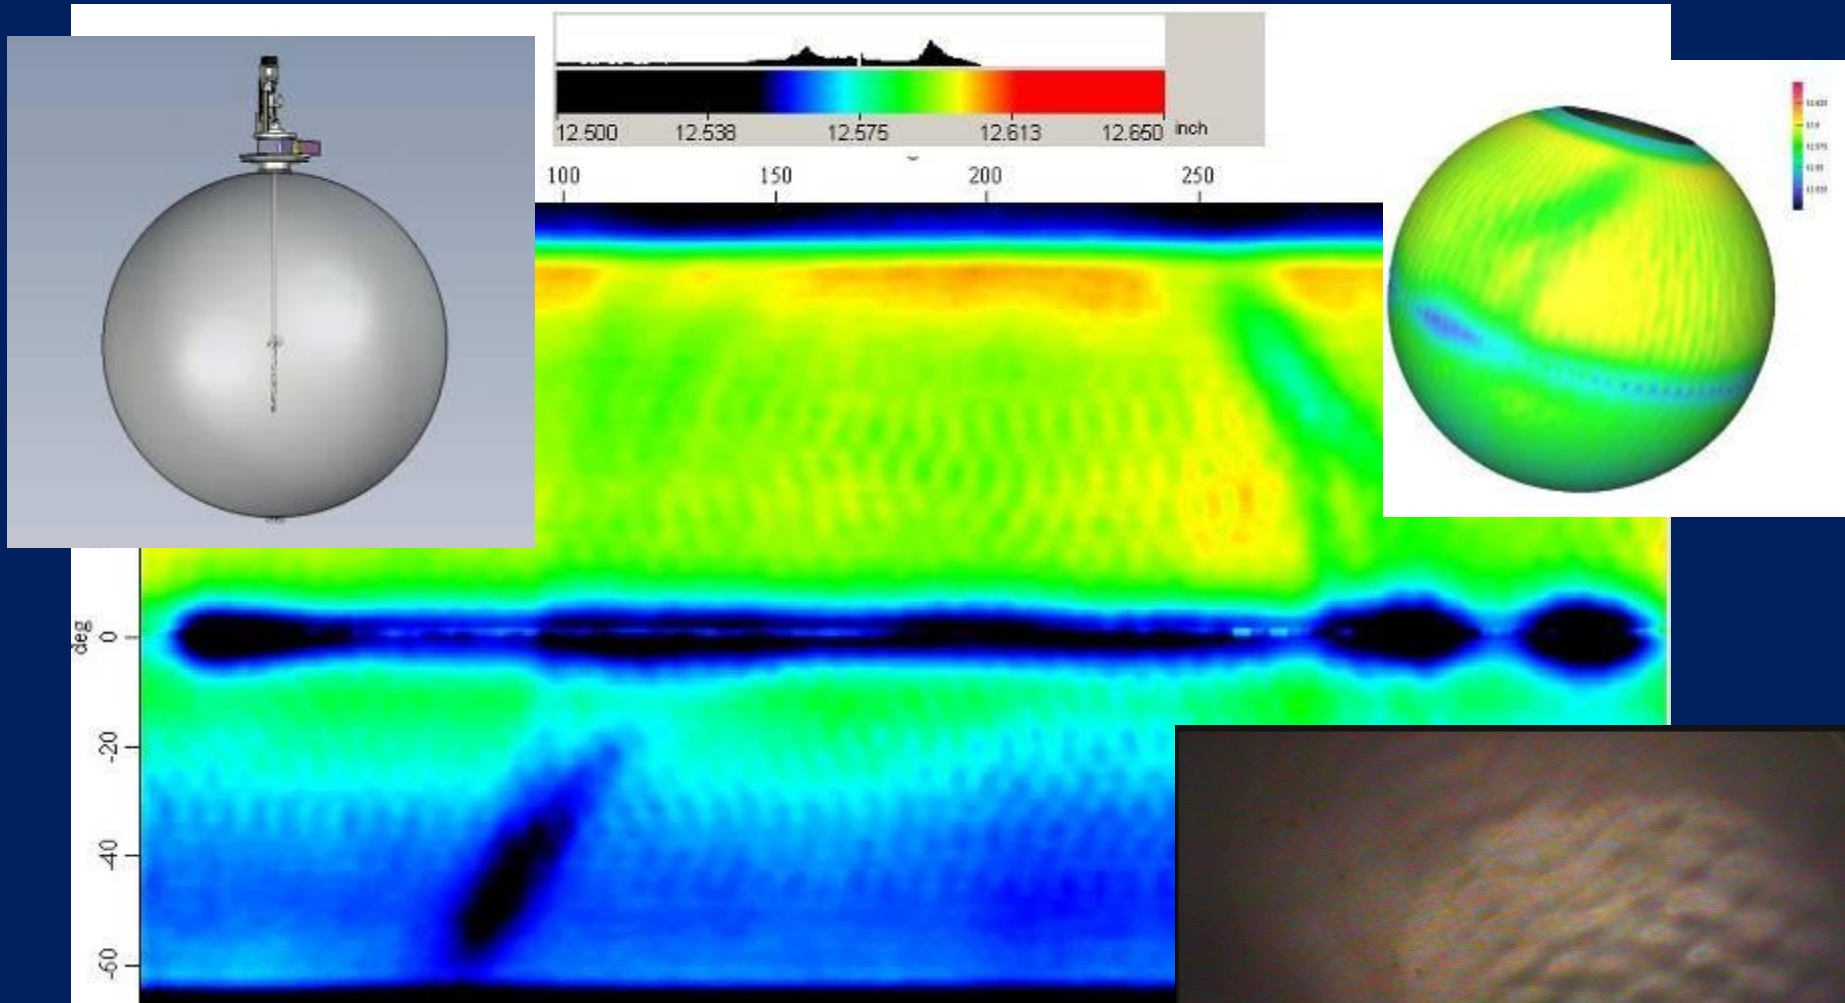
Laser Profilometry Accurately Quantifies Liner Buckling and Other Surface Features

Calibration traceable to National Standard and demonstrated 0.001 in. accuracy/repeatability on 26-in. and better than 0.002 in. accuracy/repeatability on 40-in.

- The large ripples around the girth weld raised a question, but no other observed indications were an issue with planned stress rupture testing
 - Eddy current sensors were placed over the peak of each girth ripple and monitored during pressurization to verify the liner did not flex causing a metallic fatigue concern
 - Decrease of stand-off between the fixed composite surface and liner ripple would indicate a liner buckle and associated air pocket
 - Stand-off remained fixed during pressure cycles, indicating that the indications were not a concern

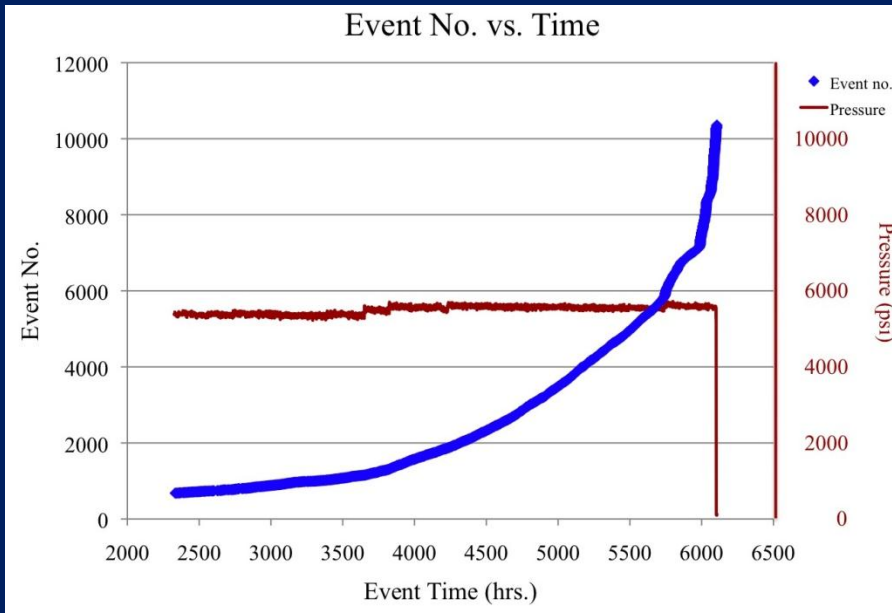
AE Effective in Monitoring Orbiter 40-in. Vessel Stress Rupture Progression to Failure

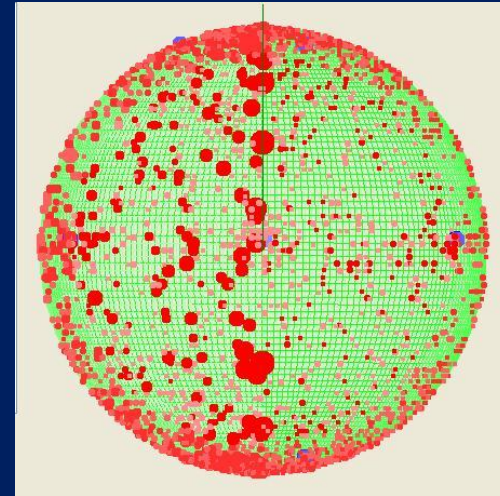
0° view—Front view

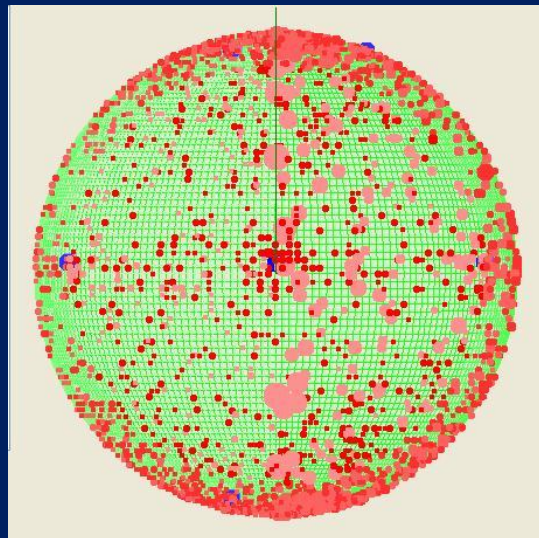
180° view—Back view

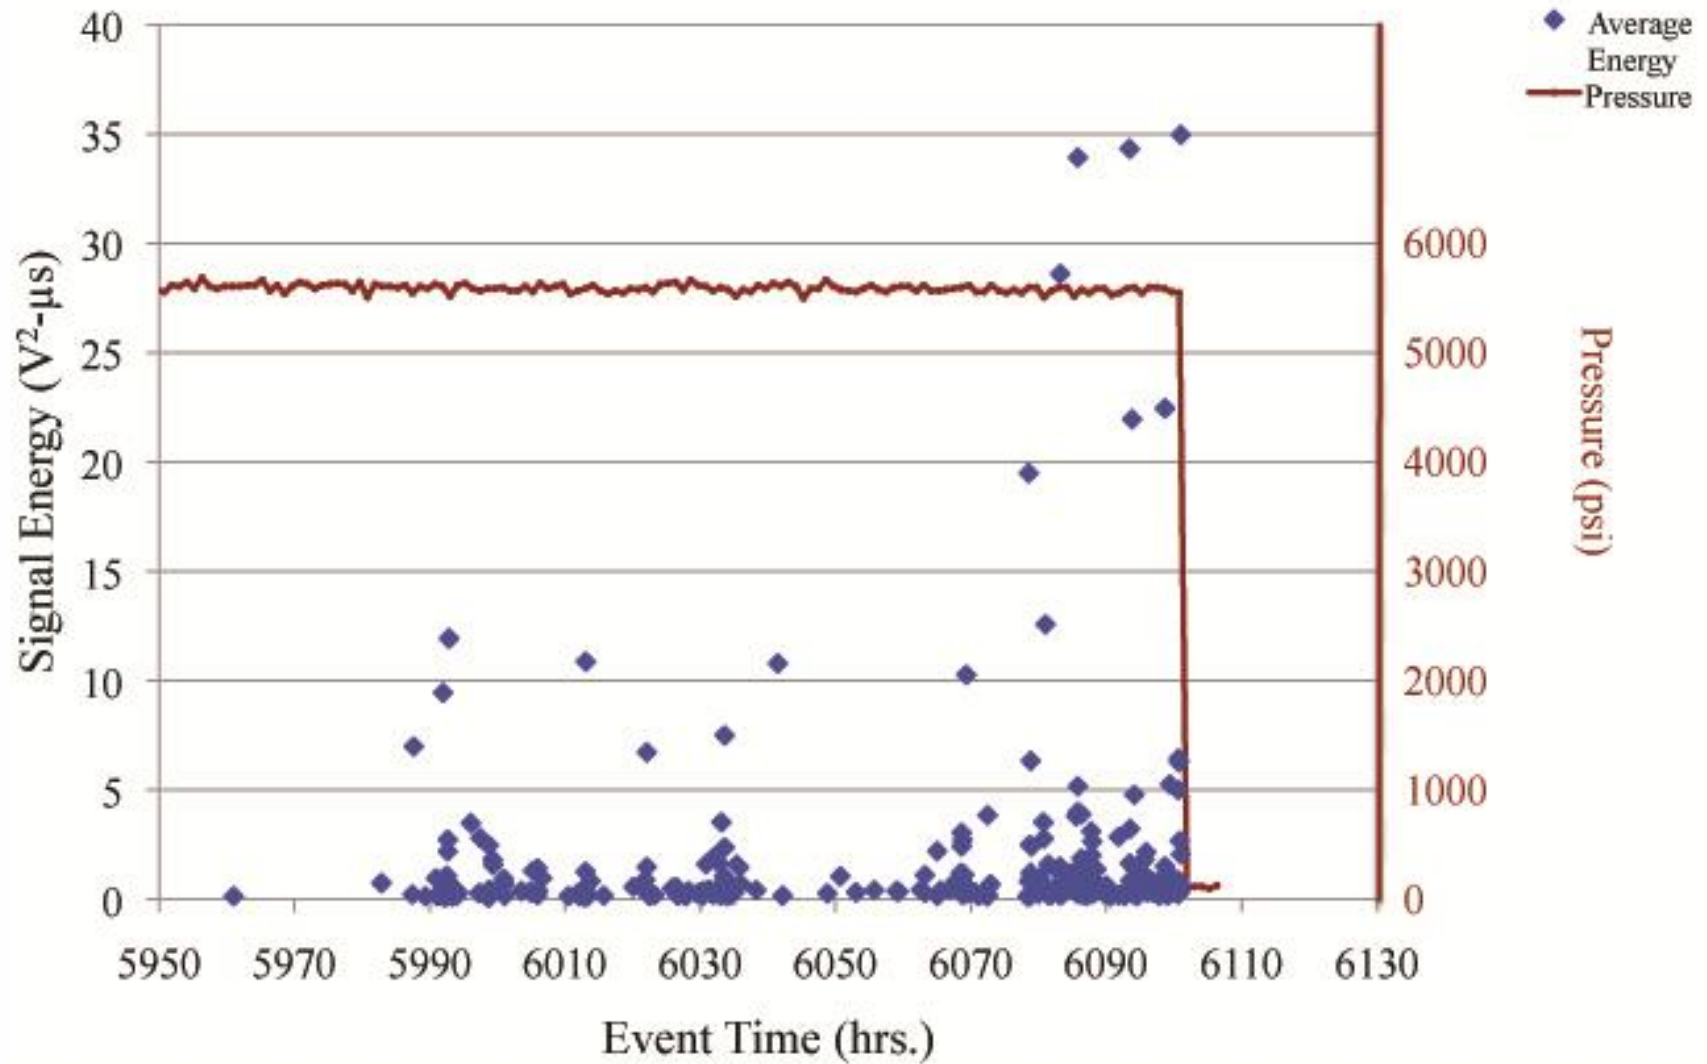
Energetic Signal Levels vs. Time: Final Week

- The first rate increase for large energy, signal events (24 to 96 hours before the end) was approximately 2/hour.
 - The second and final rate increase for large energy signal events (last 24 hours) was approximately 6/hour.

- Event energies rose to very elevated levels during the last 96 hours.
 - High energy events were > 25 times greater than energetic events in the past.

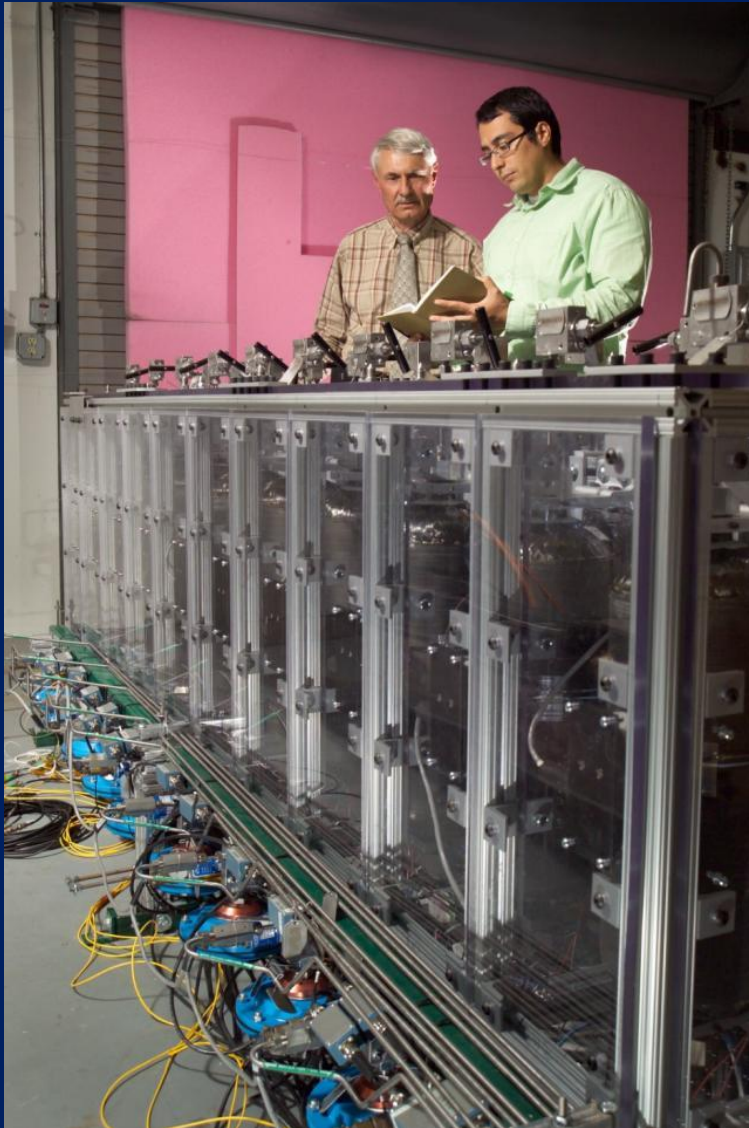
20 carbon vessels and real-time NDE in WSTF Lexan protective enclosure allows inspection while at test pressure

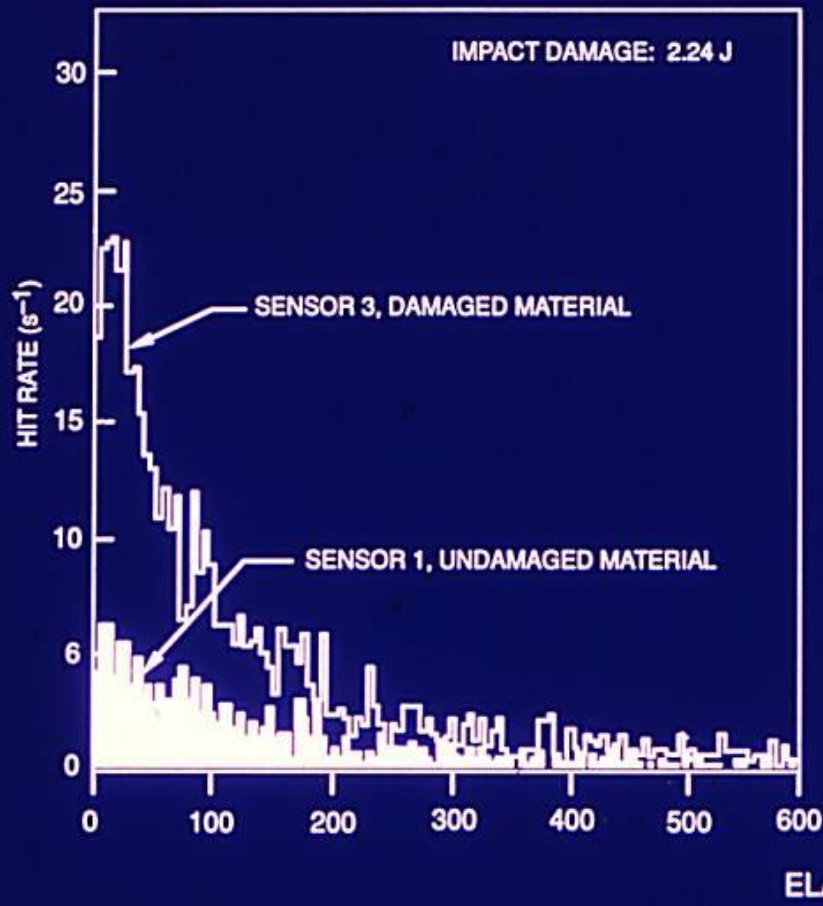
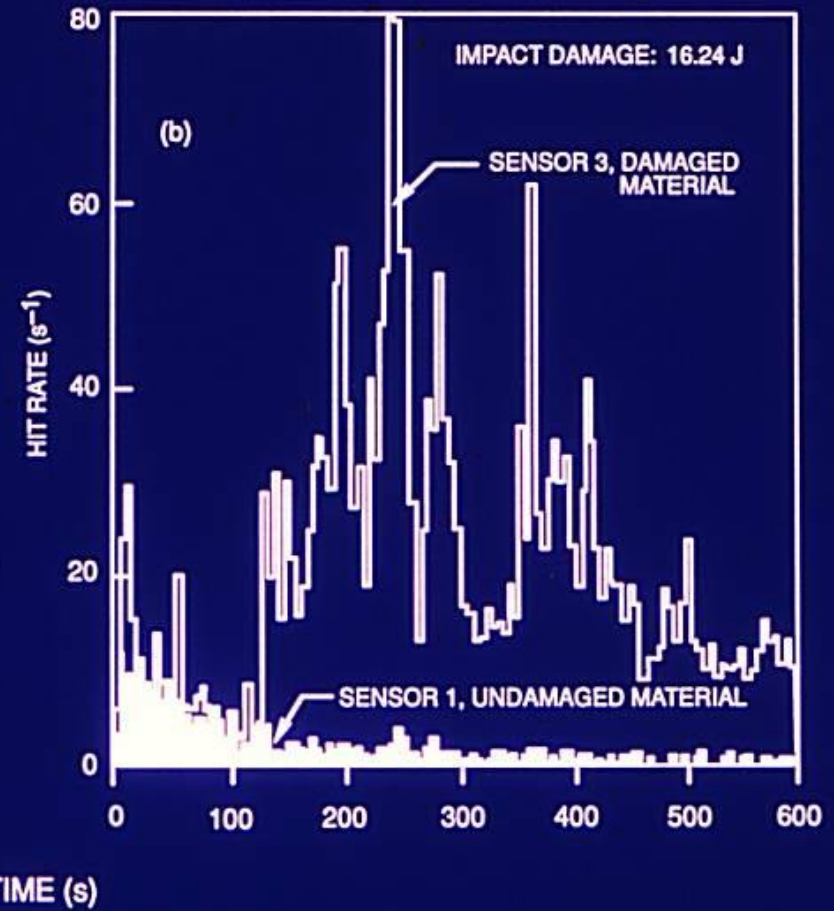
AE during a static hold pressure varied with the time, location and degree of impact damage of Kevlar/epoxy pressure vessels

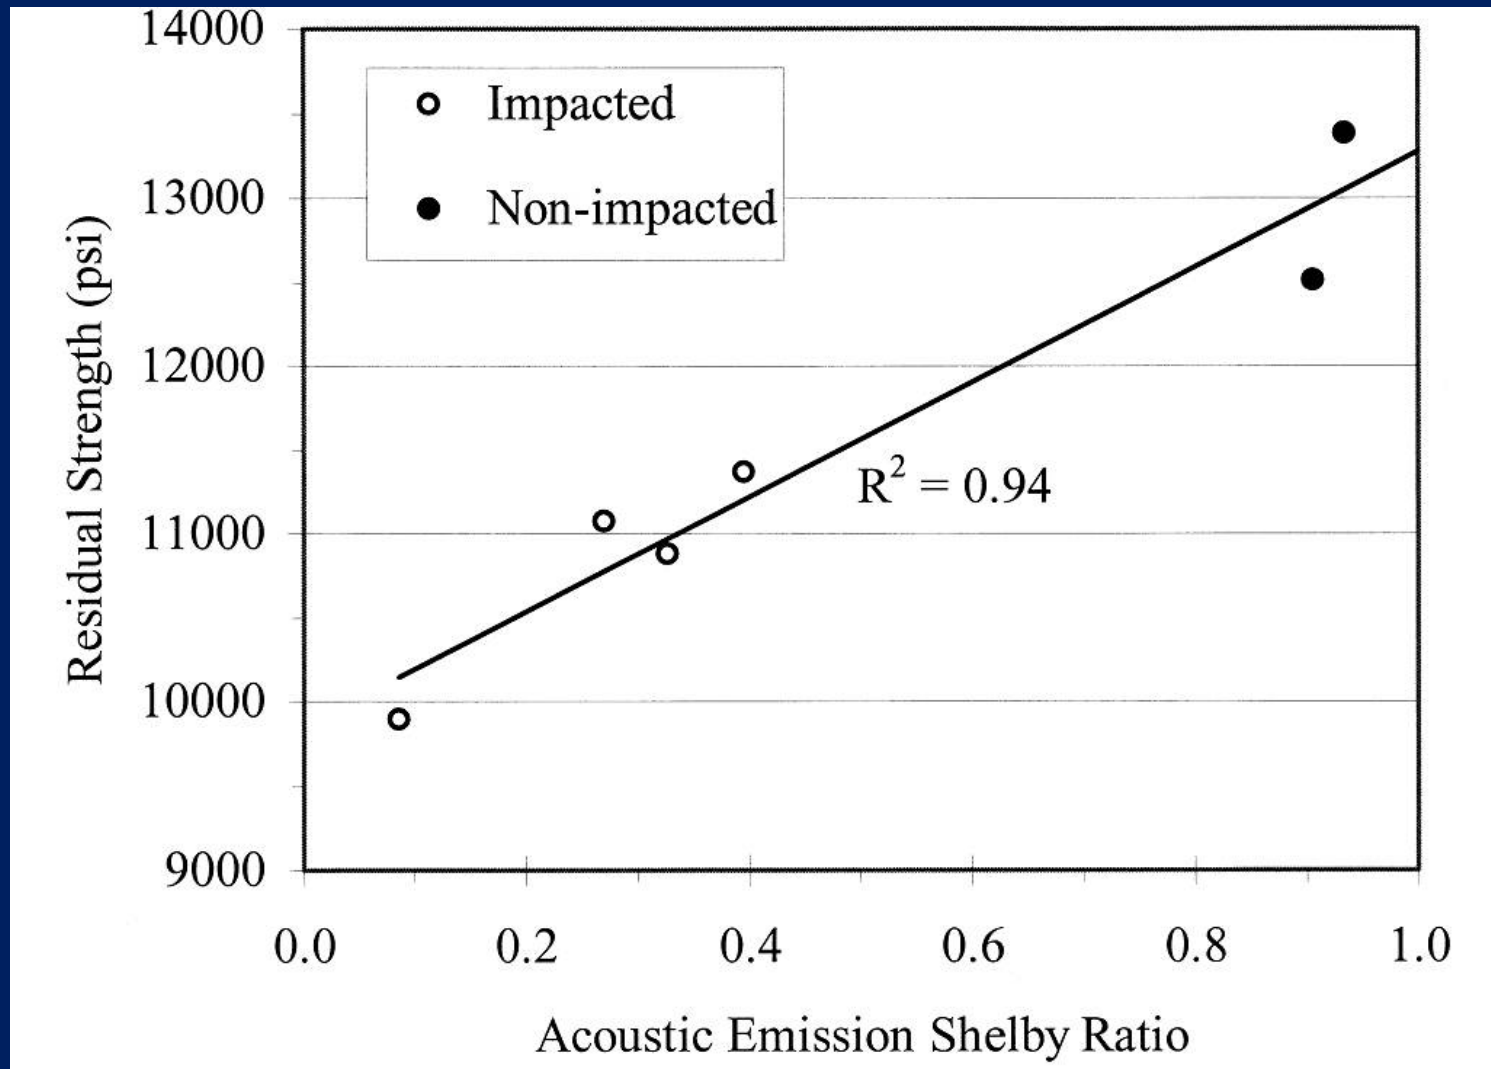
AE from the second de-pressurization (from proof level) of a cylindrical carbon/epoxy pressure vessel correlates with the residual strength, if AE from the region of the impact (eventual failure location) is considered

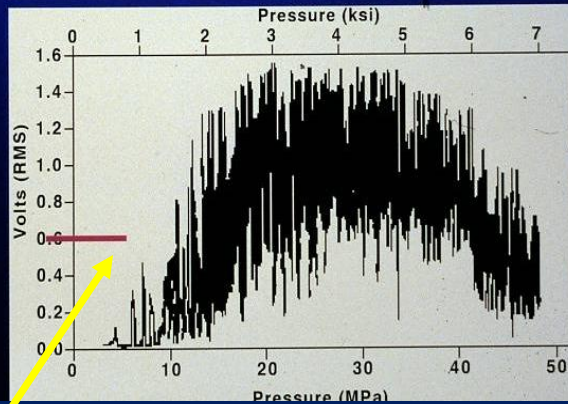
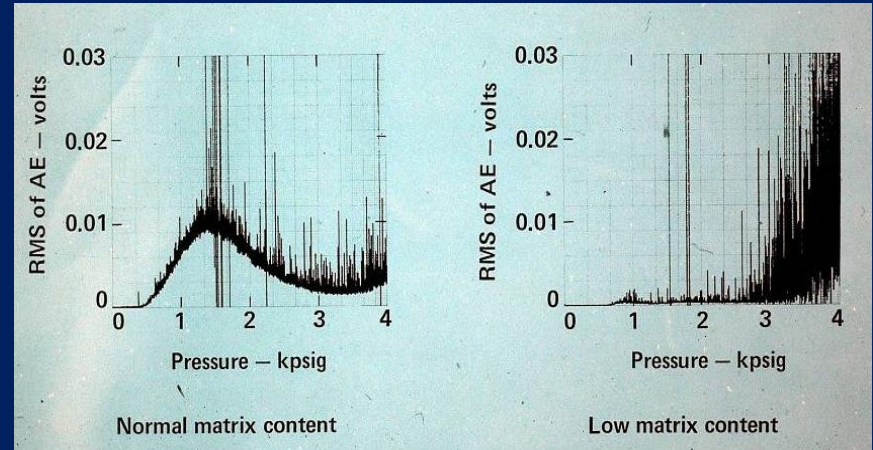
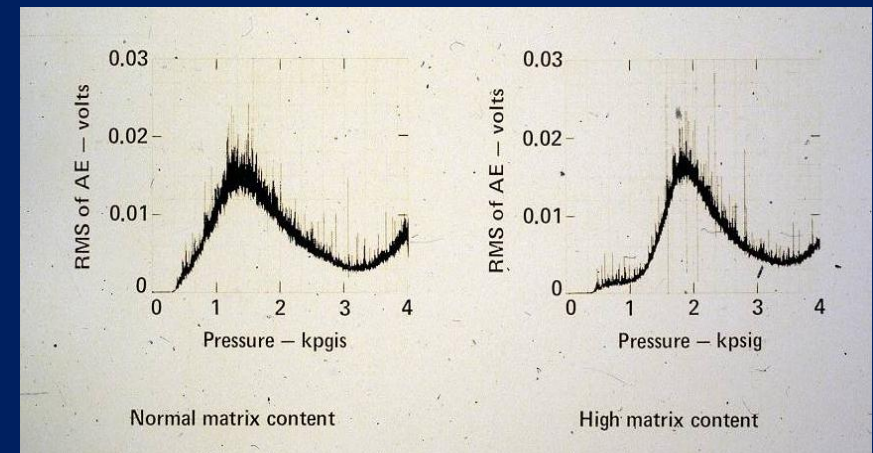
High Resin Content

AE signatures versus pressure during the virgin pressurization (autofrettage or proof test) of COPVs can indicate whether composite has been filament wound correctly

Same level as full scale in top figure

Cases of low and high matrix content
