在用车用缠绕气瓶安全性分析

Safety analysis of in-use vehicle wrapping cylinder

北京市特种设备检测中心

2010.8.10

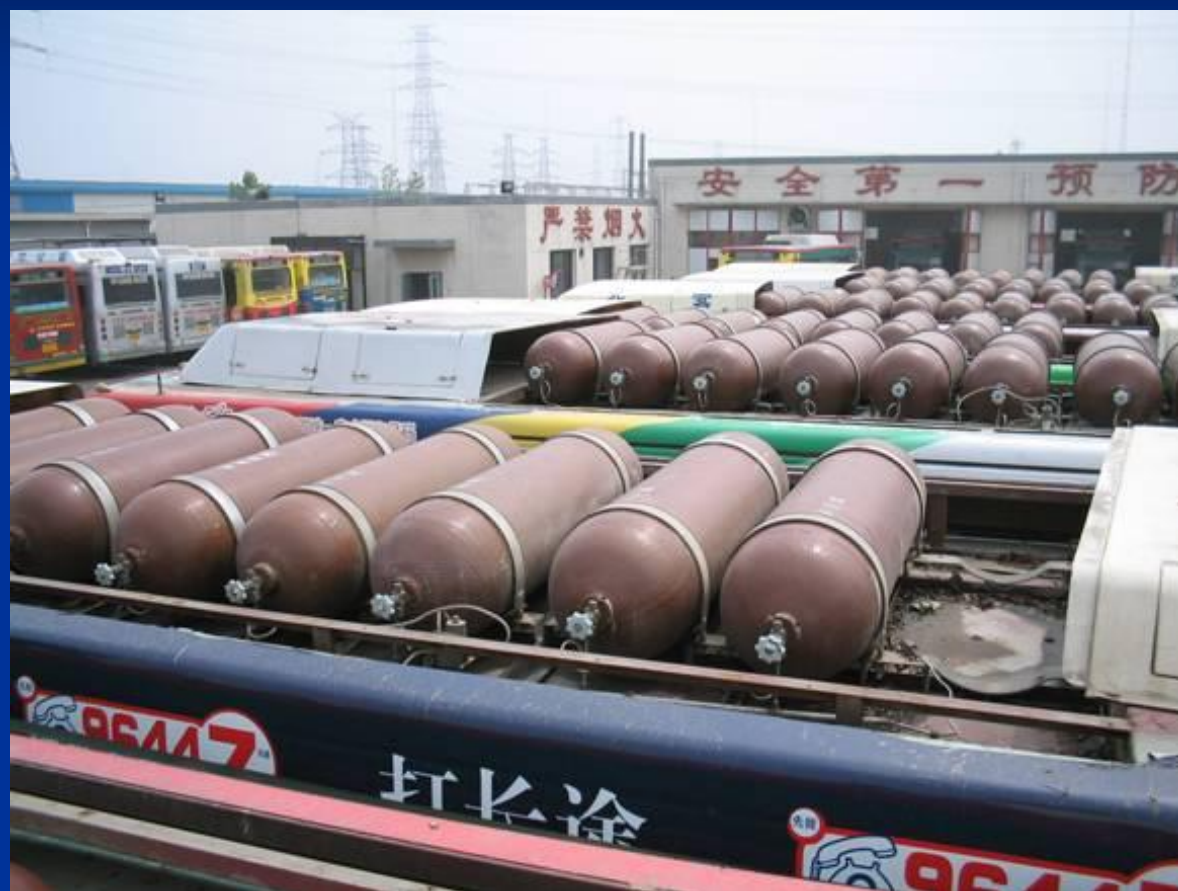
(1) 北京市特种设备检测中心对北京公交总公司使用的车用压缩天然气全复合材料气瓶进行的首次定期检验中，多支气瓶出现外部损伤、泄漏、内胆鼓包、裂纹等问题。

In the first periodic inspection of CNG all-composite wrapped cylinders used by Beijing public transport company , Beijing special equipment inspection & testing center has got the follow data: the defects includes external damage 、 leakage 、 convex 、 cracking etc.

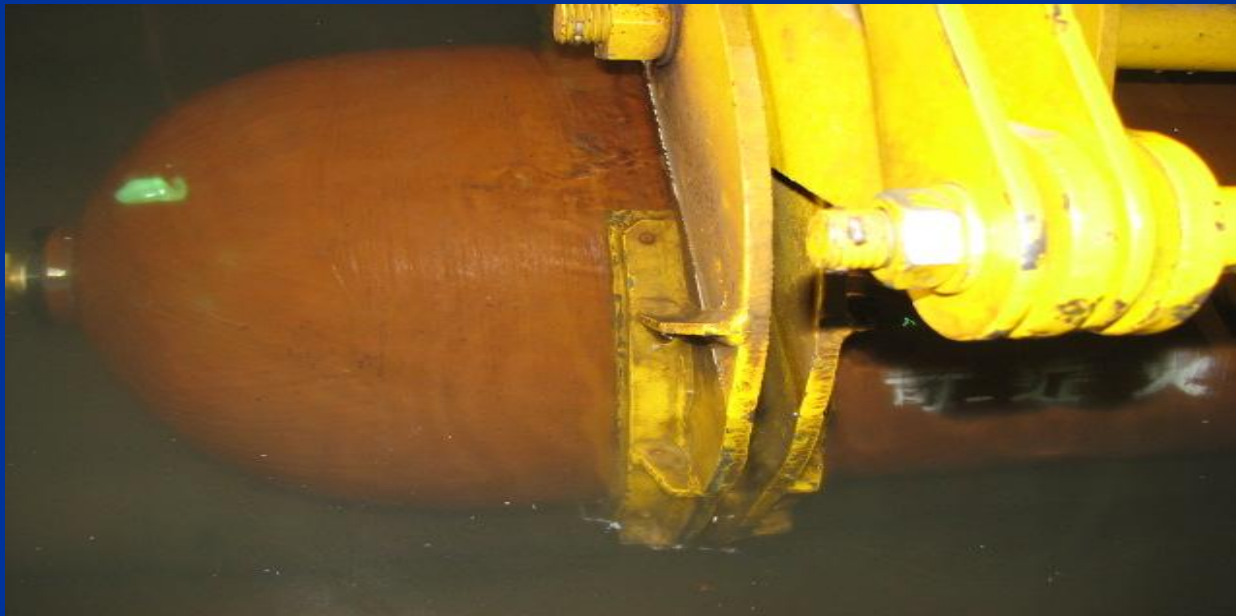
4、气密性试验

Air tightness test

- 试验结果表明：在用气瓶的气密性质量仍处于可靠的安全状态。
- The result shows that the air tightness of the cylinders in use is still safe and reliable.

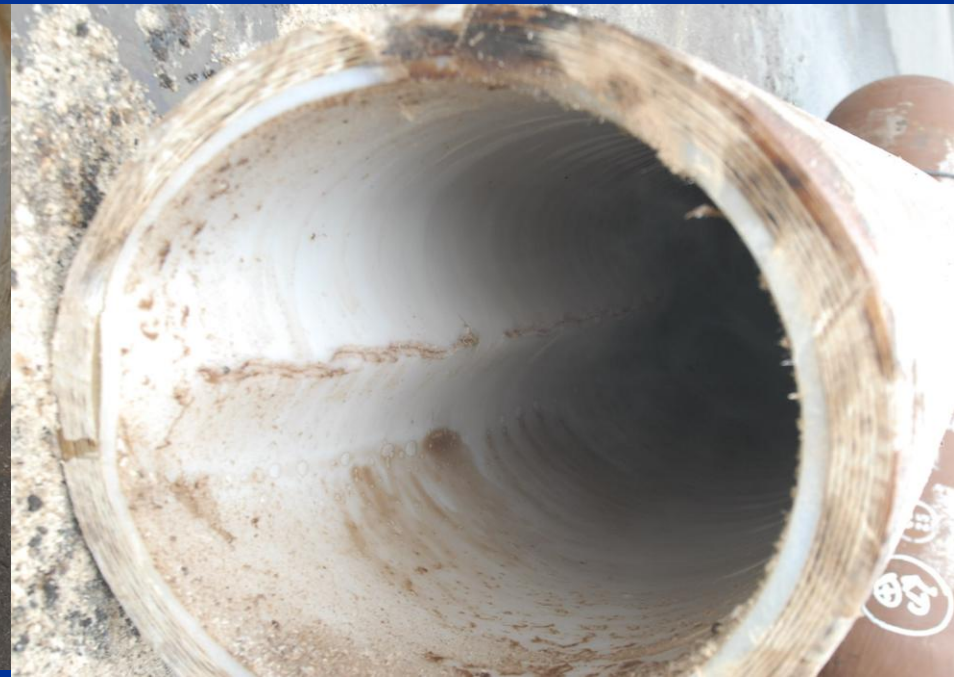
- 内胆出现明显的宏观裂纹
- macro-liner crack

- 多次循环后当变形量超过材料的变形极限时翻转区域内表面或折皱区域即会产生损伤开裂，最终发生泄漏失效，这也就是鼓包最终形成裂纹的过程。
- **After multiple cycles when the deformation exceeds the deformation limit of the material, damage fracture will be occurred and finally lead to leak failure. It is the process from convex hull to the crack formation.**

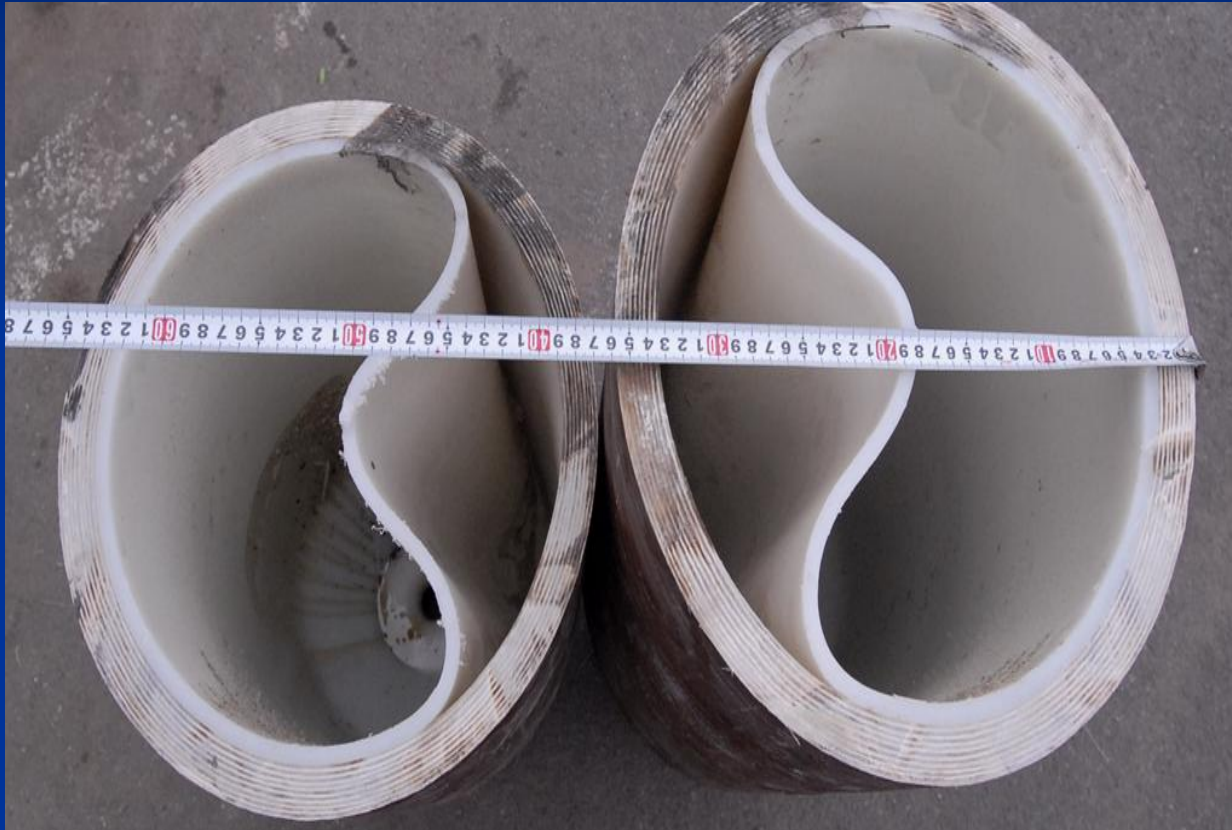
- 内胆形状的改变
- Shape changing of liner layer

④ 气瓶使用过程中的温度变化、充放气过程以及内外材料膨胀系数相差较大的影响会使内胆薄弱部位重复温升—膨胀—失稳—翻转的变形过程，且翻转变形量会增加，

- The temperature fluctuation during the using process of cylinders, inflation and deflation process and the difference of material expansion coefficient between inside and outside of cylinders have influence on the weak part and make it repeat the deformation process of temperature rise — expansion — failure — reversal, and deformation would increase gradually.

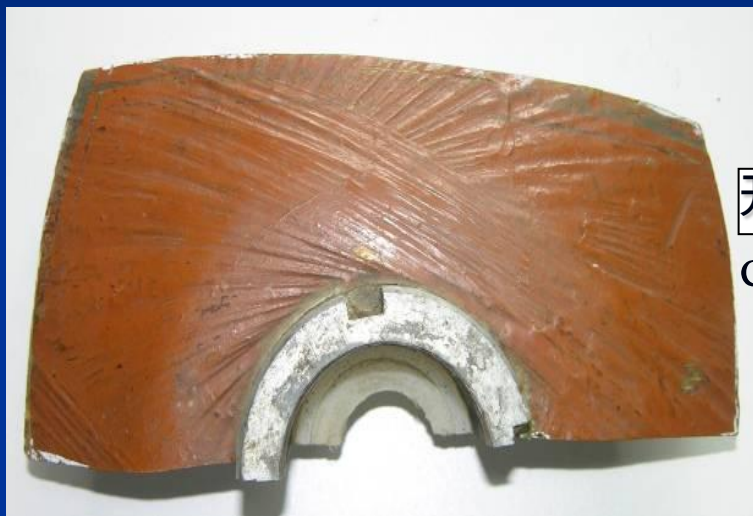
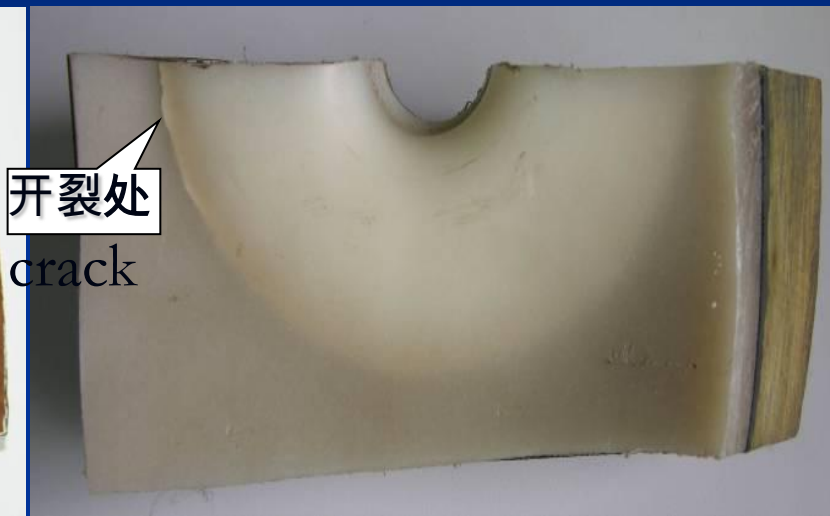
- 内胆与金属接头的封头部位，有明显的裂纹
- **Obvious cracks in liner and the metal joint head**
