Mexican Hat, Utah, Disposal Site

An UMTRCA Title I site

This fact sheet provides information about the **Mexican Hat disposal site**. This site is managed by the **U.S. Department of Energy Office of Legacy Management under Title I of the Uranium Mill Tailings Radiation Control Act of 1978**.

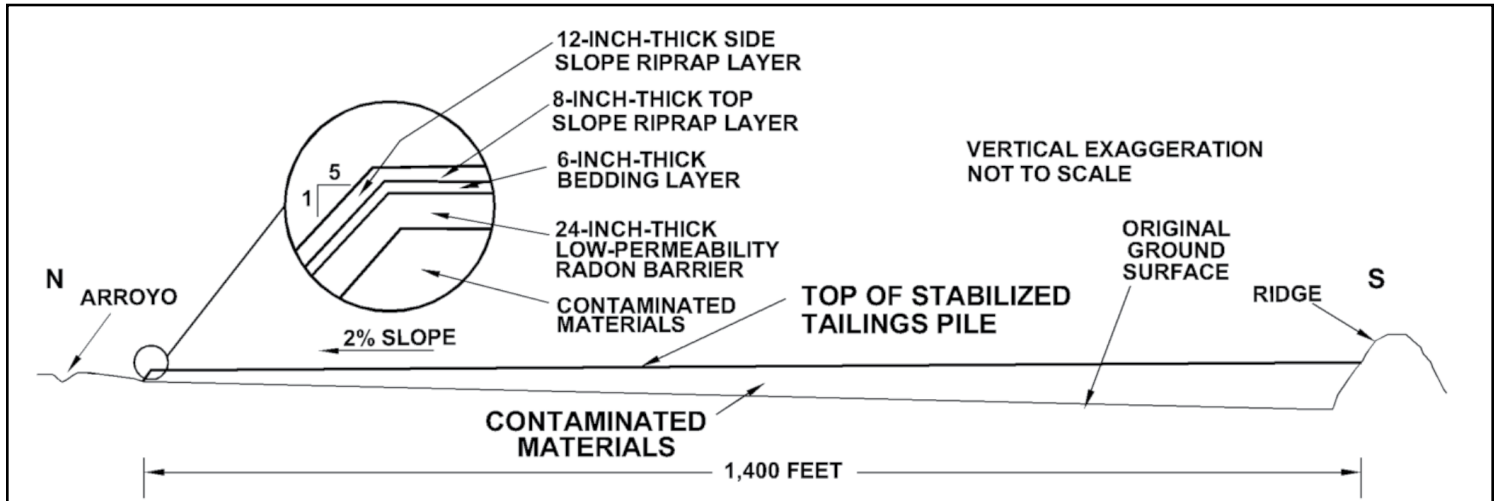
Typical North-South Cross Section of the Mexican Hat Disposal Cell.

The cover is composed of (1) a low-permeability radon barrier (first layer placed over compacted tailings), (2) a bedding layer of sand and gravel placed as a capillary

break, and (3) a rock (riprap) erosion protection layer. The cell design promotes rapid runoff of precipitation to minimize leachate. The cell cover was constructed with a 2 percent grade sloping to the north and east. Runoff water flows down the 20 percent side slopes into the surrounding rock apron and exits the cell via three engineered toe drains that drain into existing arroyos north and east of the cell.

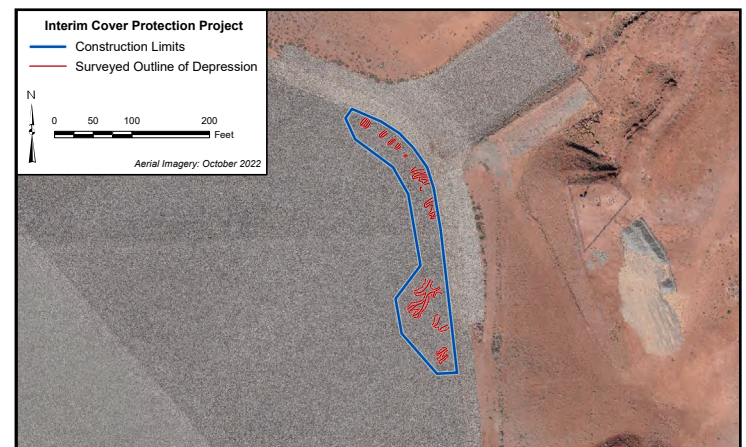
Depression Features on Northeast Side Slope and Approximate Area of Interim Cover Protection Project.

In 2016, multiple subtle depressions were identified in the rock cover along the toe and lower portions of the northeast side slope of the disposal cell. As a result of limited field investigations in 2017 and 2018, erosion into the surface of radon barrier was identified along the lower portions of the north and northeast side slopes of the disposal cell. These observations indicate the disposal cell erosion protection system is not performing as designed. Field observations and supporting radiological scans of the depression features show radioactive materials have neither been released nor exposed, and the disposal cell remains protective of human health and the environment.

and to determine the appropriate corrective measures needed to ensure that the design life of the disposal cell meets the requirements under UMTRCA. A comprehensive interim cover protection project was also performed in 2019, which restored a 20,000 square foot area on the northeast side slope back to the original design specifications to ensure protection of human health and the environment until a final long-term solution is implemented.

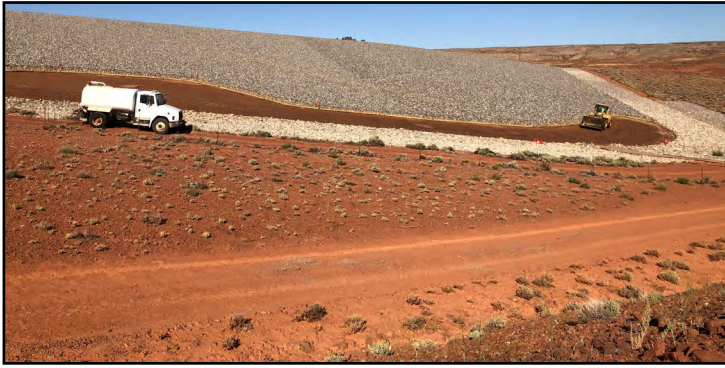
Mexican Hat Interim Cover Protection Project.
