# ***Data Report on Corrosion Testing of Stainless Steel SNF Storage Canisters***

**Fuel Cycle Research & Development**

***D.G. Enos, C.R. Bryan, and K. M. Norman  
Sandia National Laboratories  
September 30, 2013***

**FCRD-UFD-2013-000324  
SAND2013-8314P**

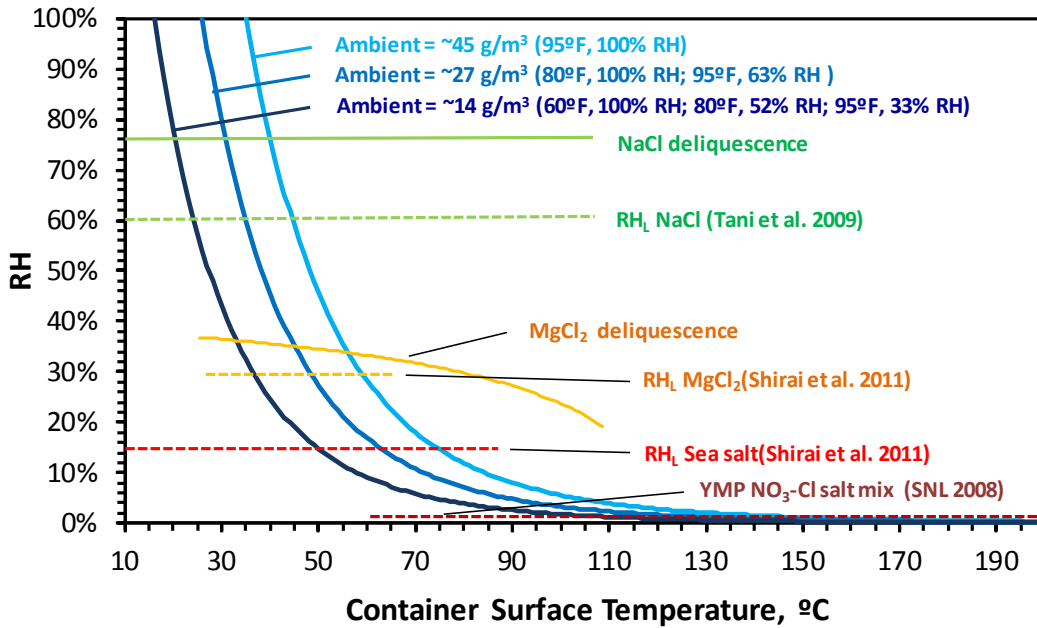
Figure 1. Relationship between RH, surface temperature, and conditions of deliquescence for potentially relevant salt assemblages.

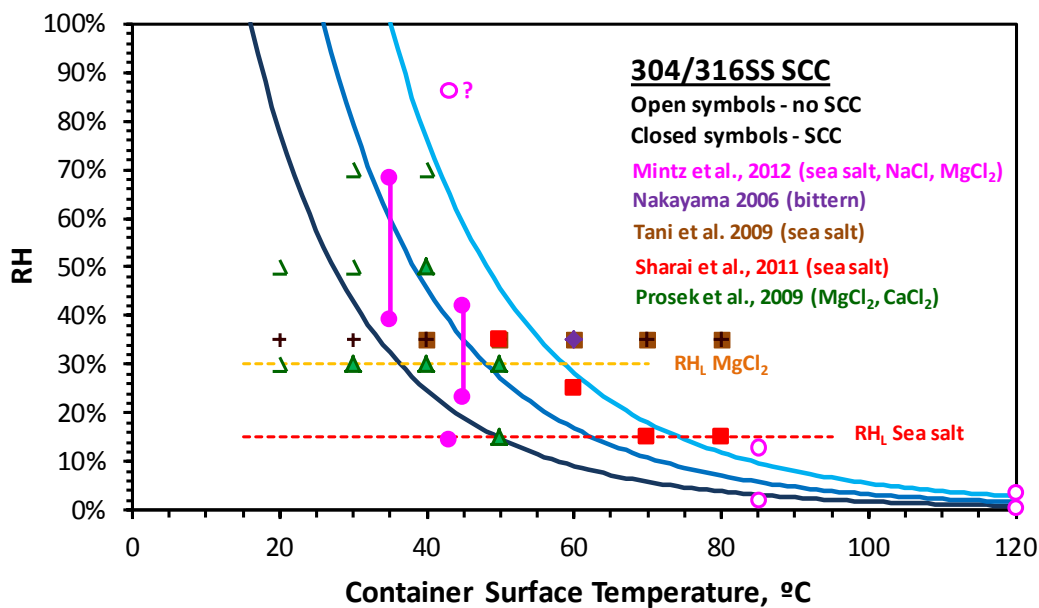
Figure 2. Summary of stainless steel SCC corrosion experiments with sea water components.

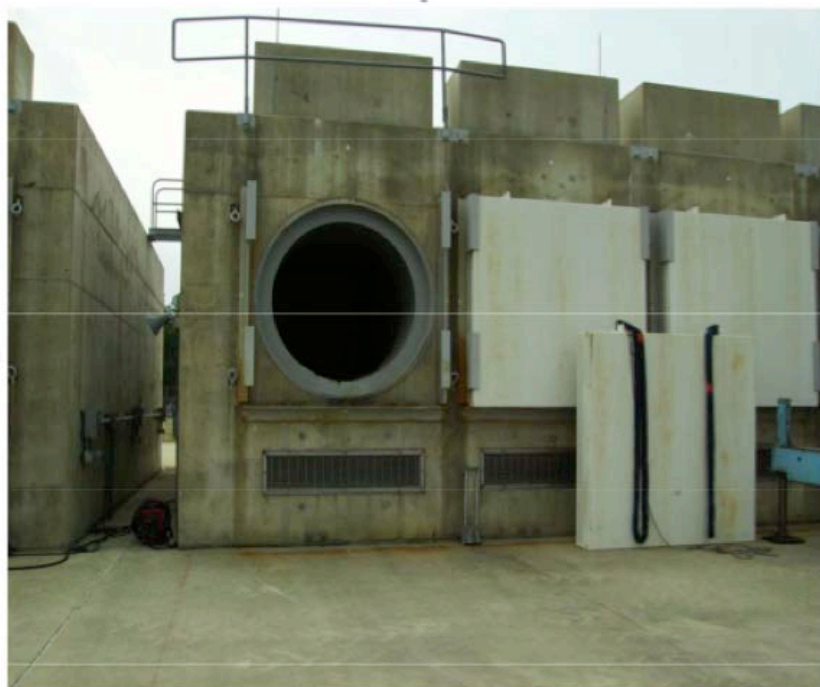
Figure 3. NUHOMS horizontal storage module, at the Calvert Cliffs ISFSI, with doorway open for storage container insertion. The air inlet vent is below the door (Figure 1.2, Suffield et al., 2012).

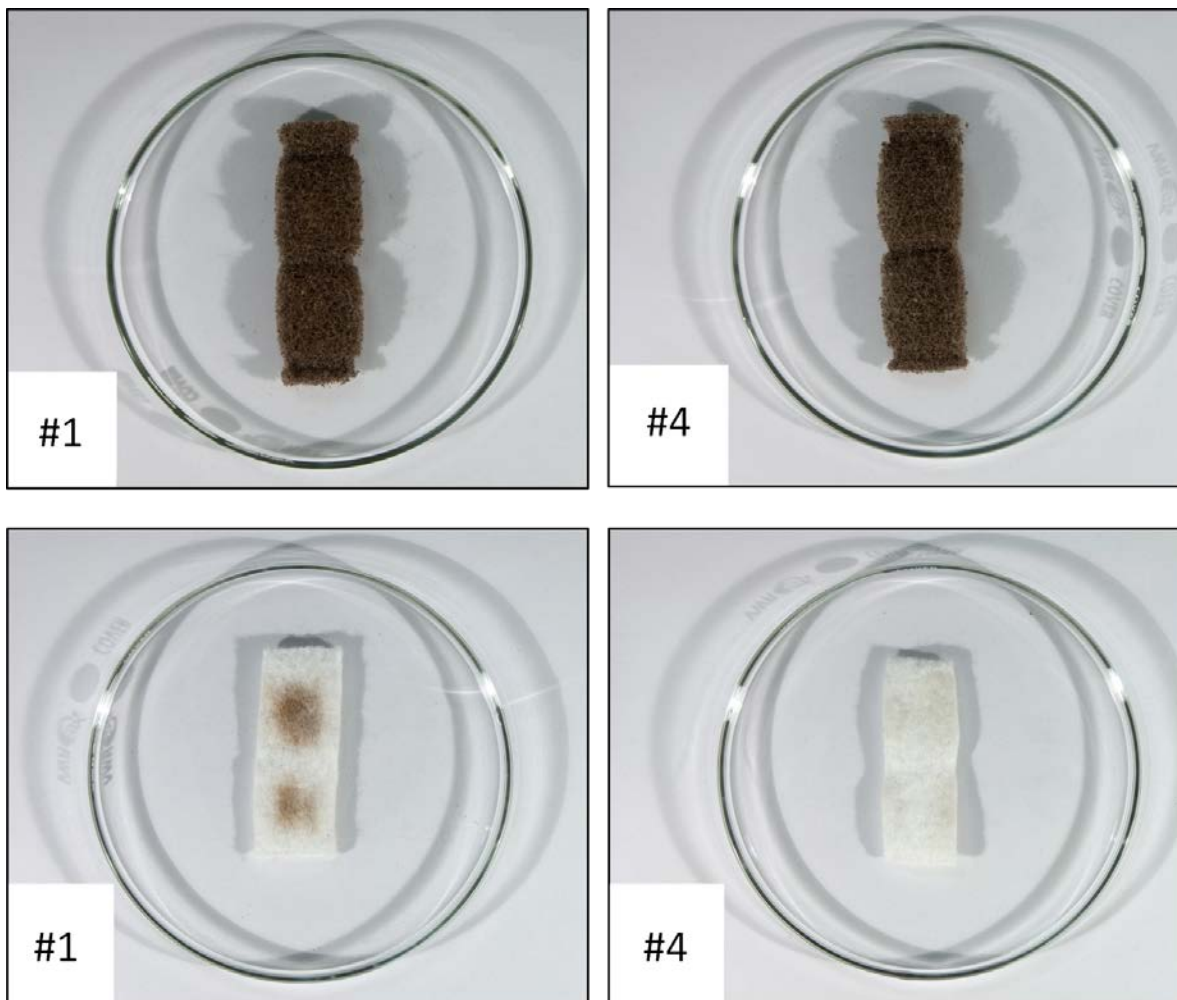
Figure 5. Photographs of the abrasive pads (top row) and filters (bottom row), from samples EPRI #1 and EPRI #4.

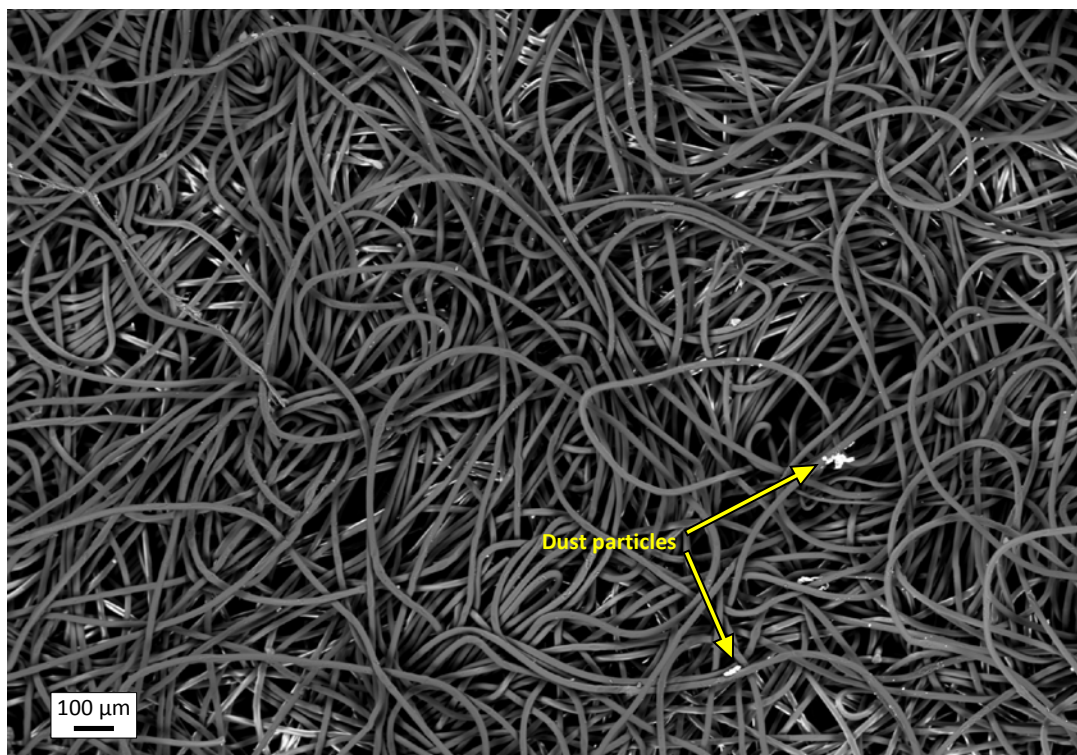
Figure 6. SEM electron backscatter detector (BSD) image of filter blank. The filter consists of polyester fibers, with no binder. The blank has rare dust particles adhering to the fibers.

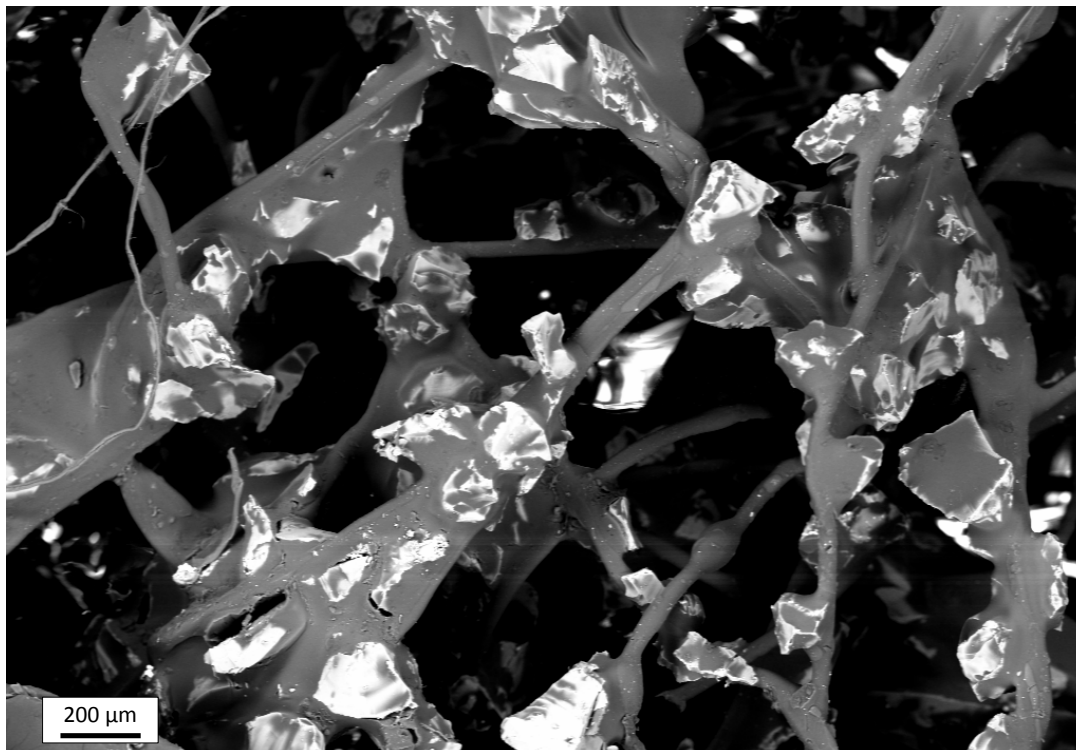
Figure 7. SEM backscattered electron image of the Scotchbrite pad blank, illustrating the presence of the abrasive particles within a polymeric matrix.

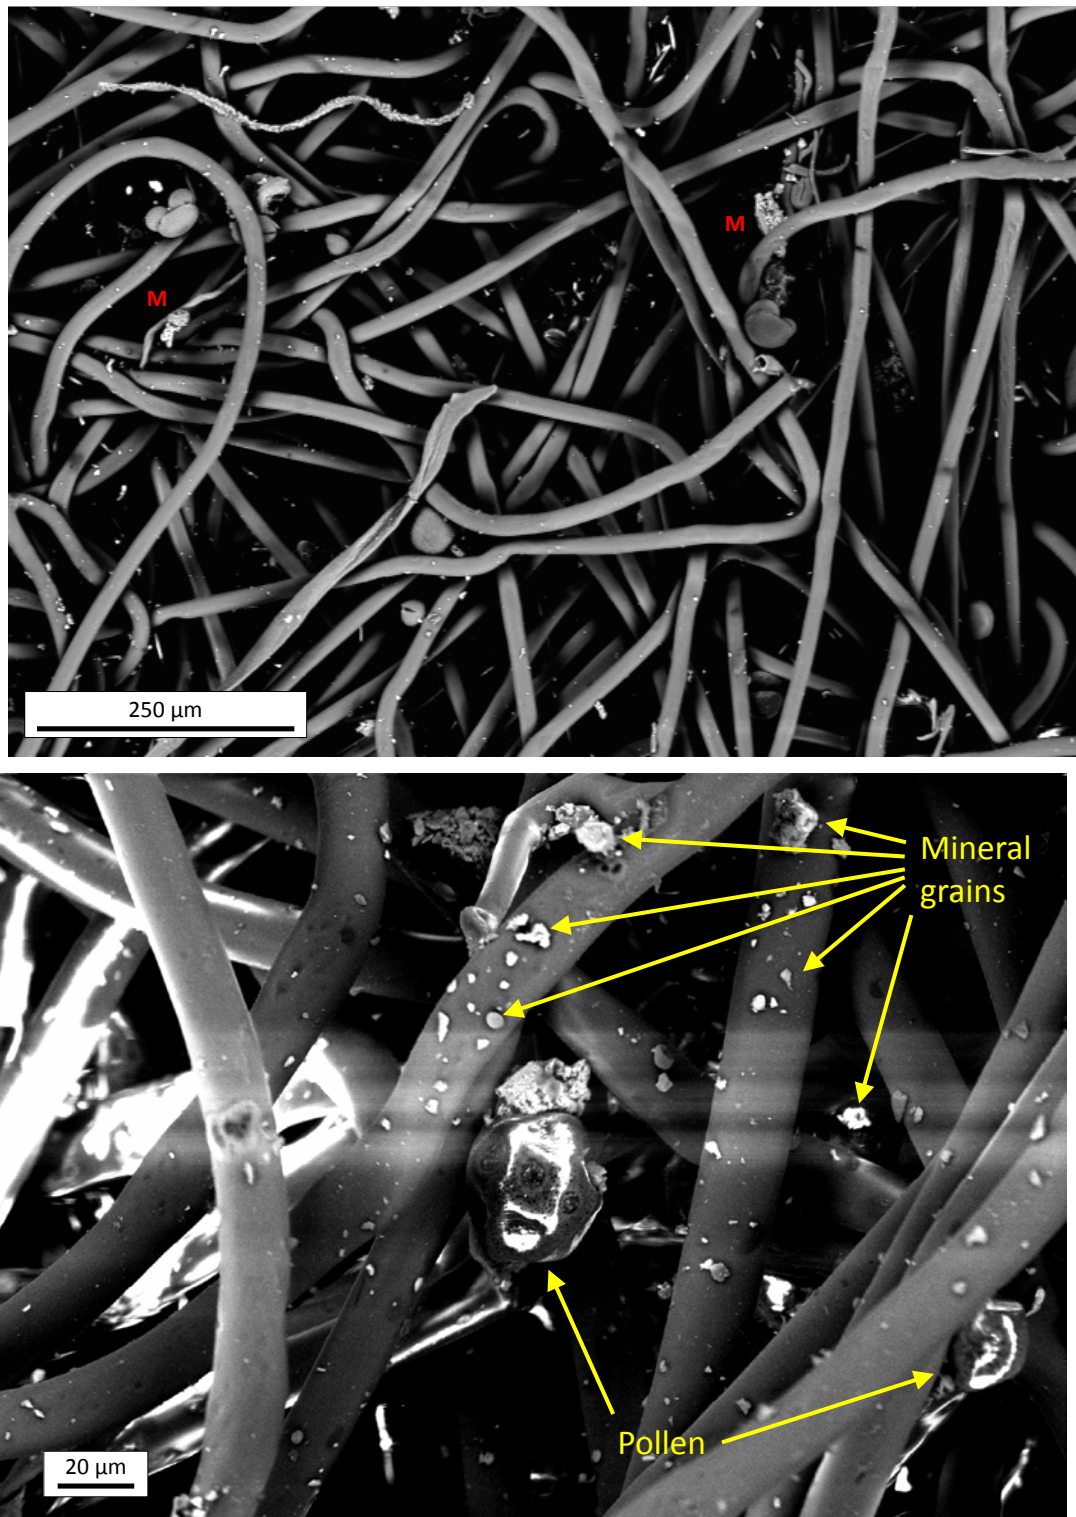
Figure 8. SEM BSD images of EPRI filter #1. A) Low magnification view, showing coarser particles—plant material and composite mineral grains (M)—trapped between filter fibers. B) High magnification view, showing fine dust particles, mostly mineral grains, adhering to the fiber surfaces (blurring and burned-out regions are charging effects).

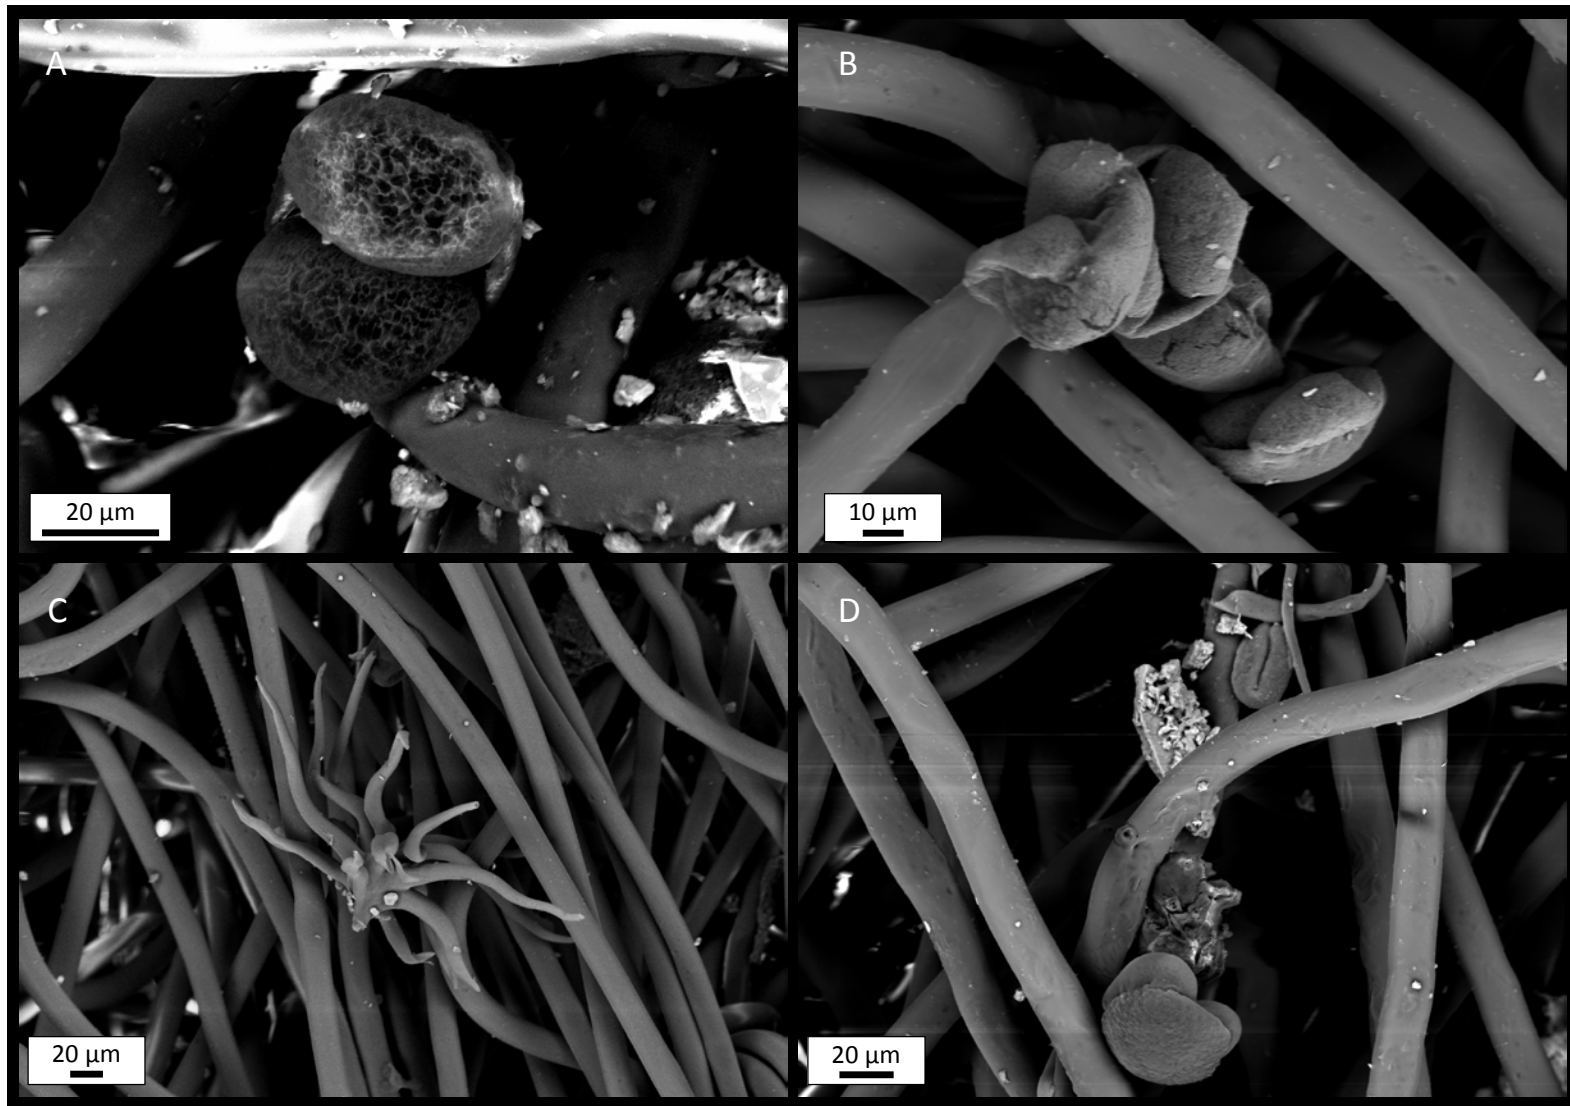
Figure 9. SEM BSD images of coarse particles, mostly biological materials, trapped on EPRI filter #1. A-B) Pollen grains; C) fungal material(?); and D), pollen and a coarse composite mineral grain.

Higher magnification views of some of the coarser materials are shown in Figure 9. Figure 9A is a bilobate pollen grain; Figure 9B shows a cluster of desiccated pollen grains; Figure 9C is a possible fragment of fungal material; and Figure 9D shows three pollen grains with a large composite mineral grain. The SEM survey suggests that the majority of the material on Filter #1 is pollen; this was confirmed by other analyses, as discussed later.

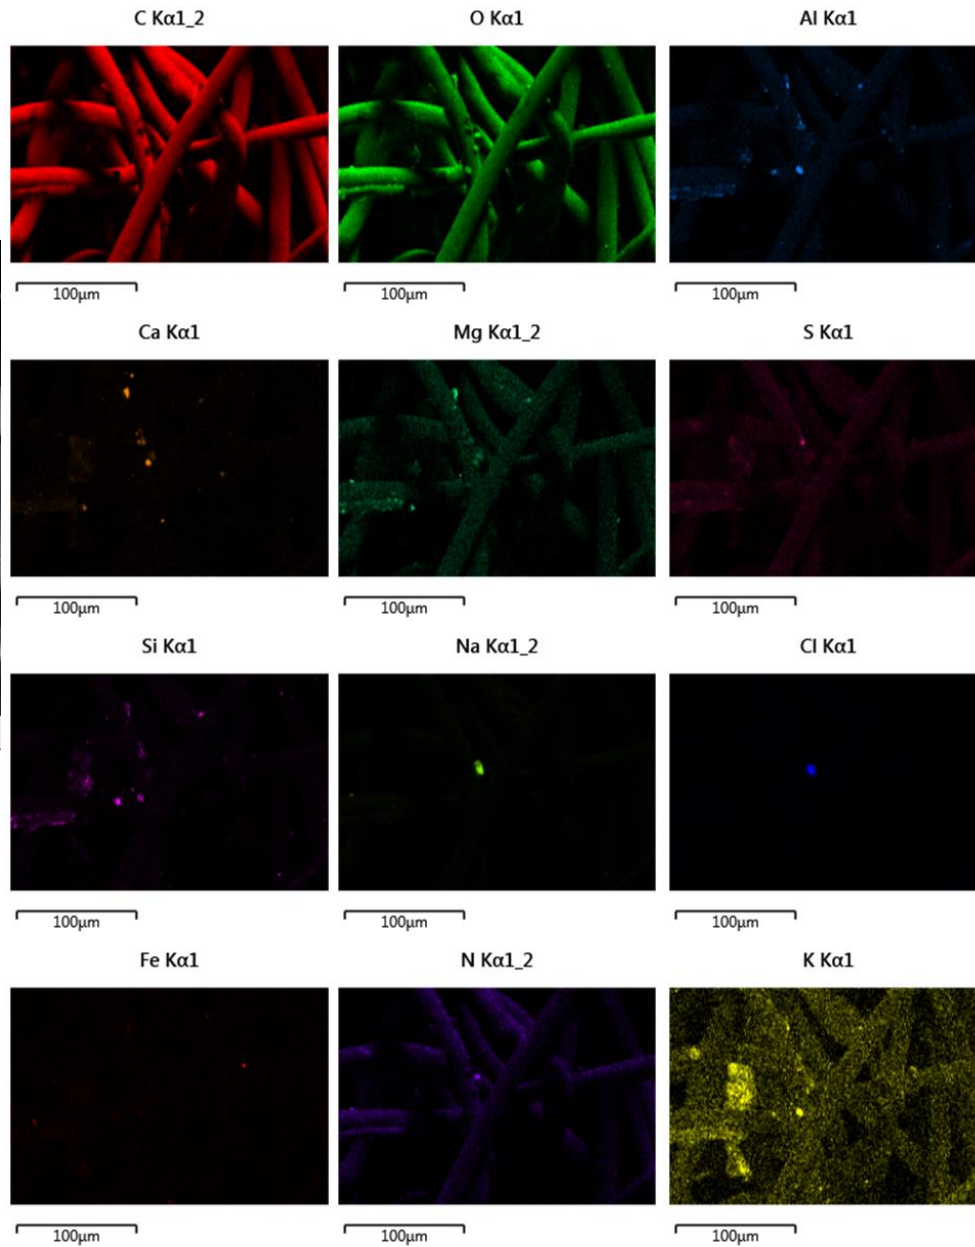
Figure 11. SEM BSD photo, EDS spectrum, and element maps of EPRI filter #1, showing close-up of multicomponent grain in Figure 10.

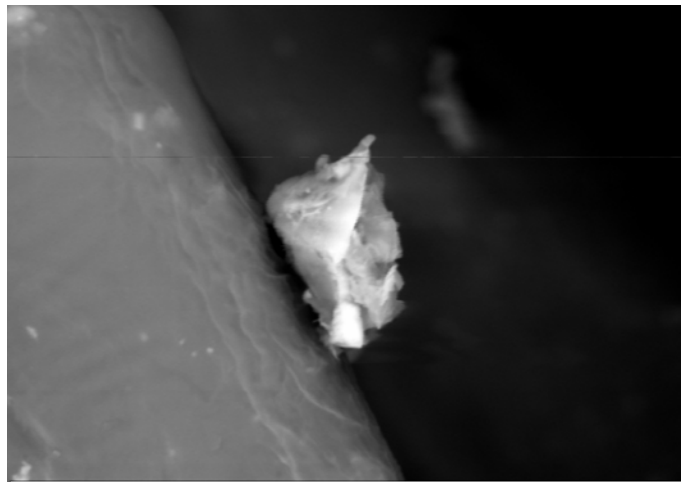
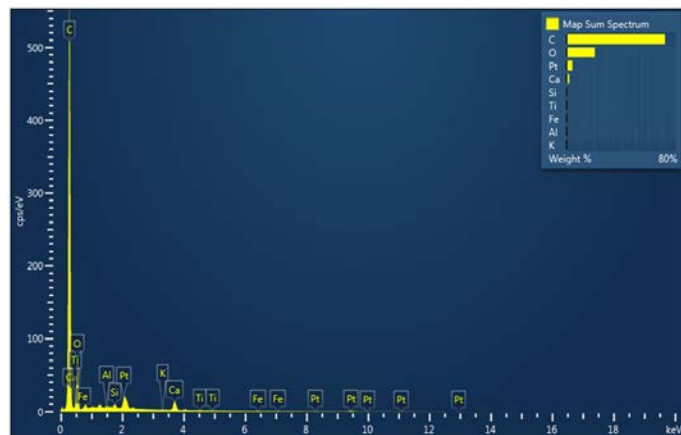
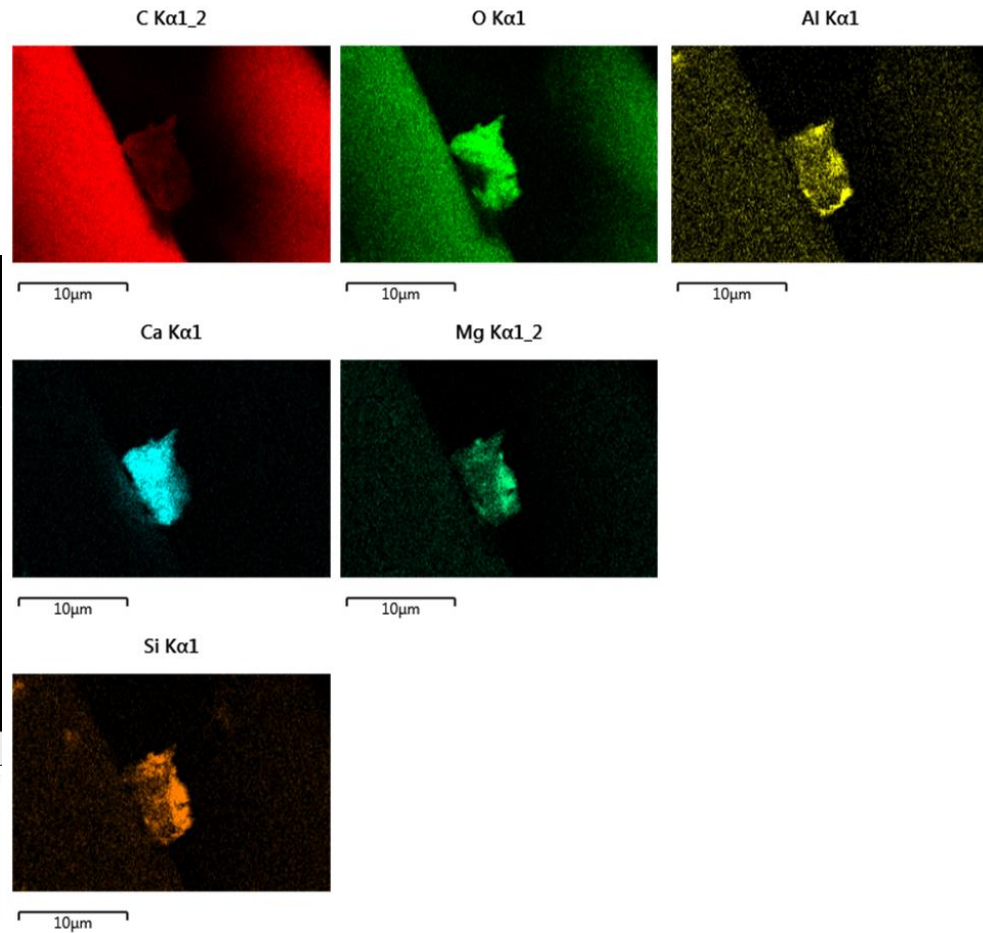
Figure 12. SEM BSD photo, EDS spectrum, and element maps of EPRI filter #1, showing close-up of the multicomponent mineral grain in Figure 9D (Note that pattern of fiber is beam damage).

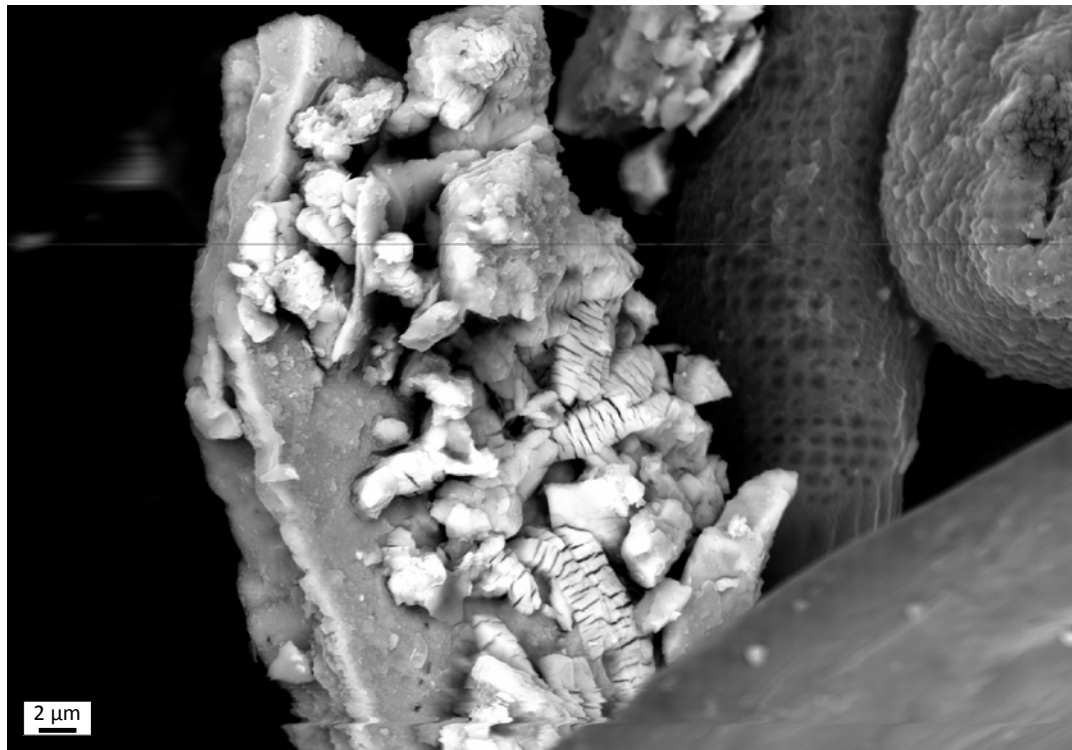
Figure 13. Composite mineral grain on EPRI filter #1. Magnesium-rich grain with desiccated Ca-sulfate crystals on the top, and associated aluminosilicate grains (Note that the pattern on the polyester fiber in the background is beam damage).

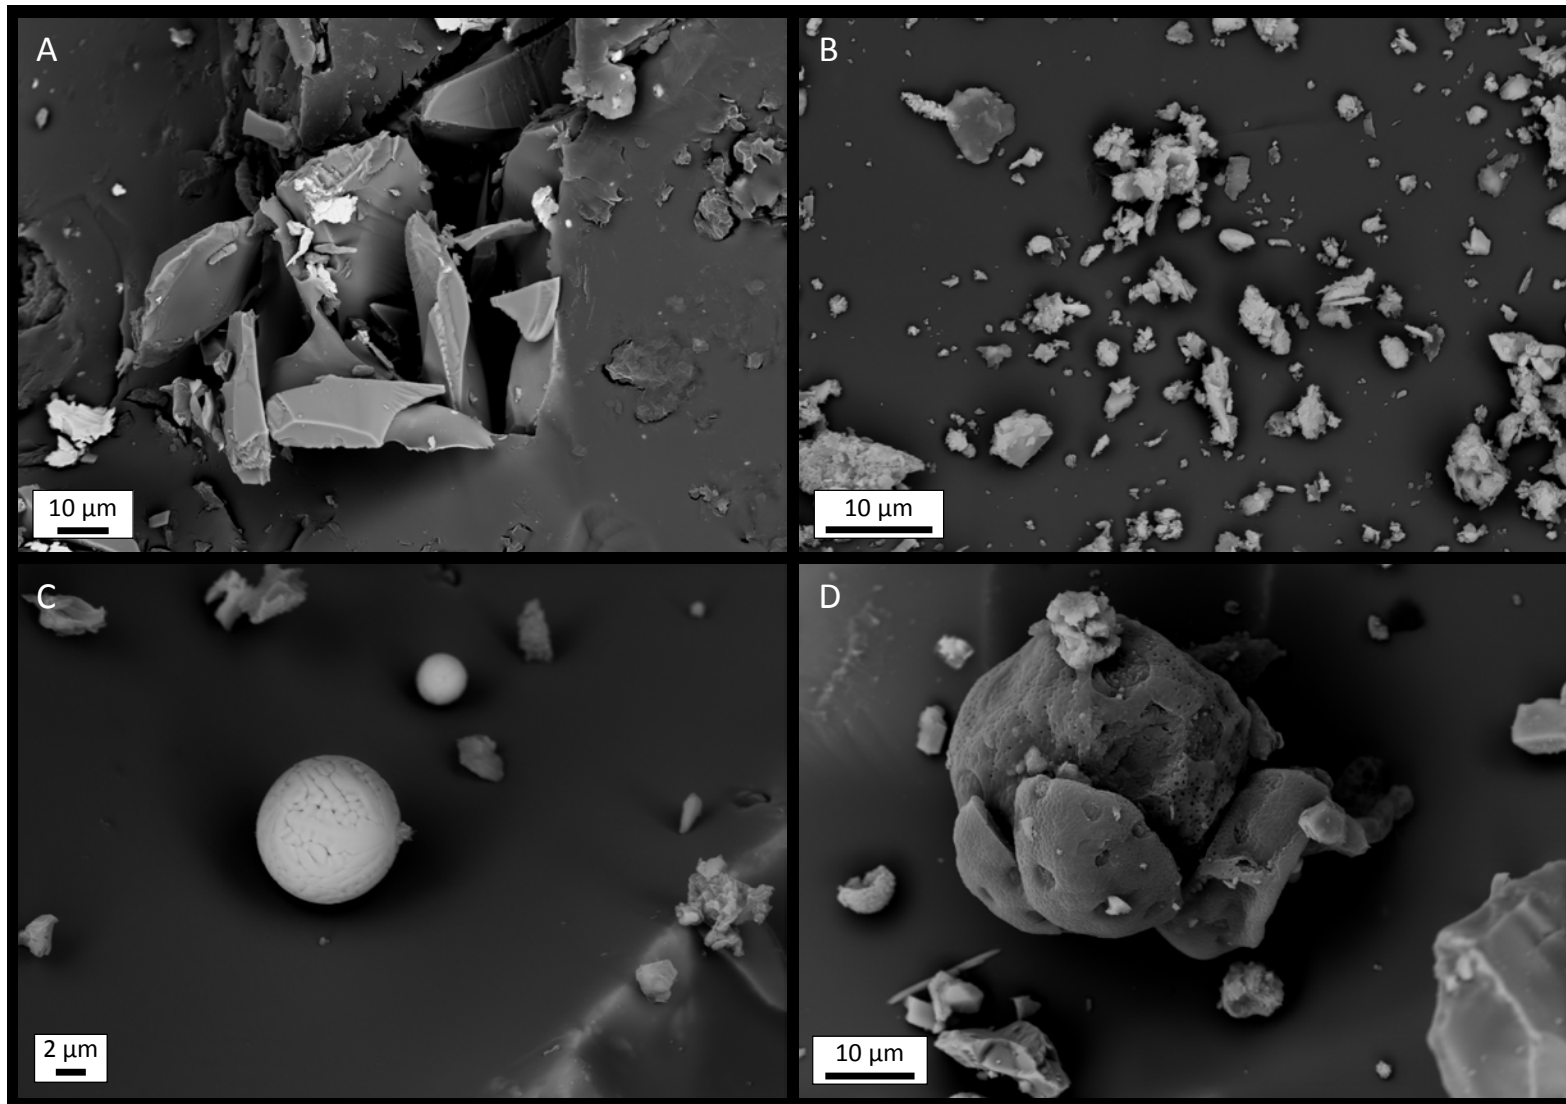
Figure 14. SEM images of EPRI #1 Pad. A) Steel from the storage container adhering to a broken alumina grain; B) dust particles on the surface of the abrasive pad; C) iron spheres (fly ash?); D) pollen fragments on the pad.

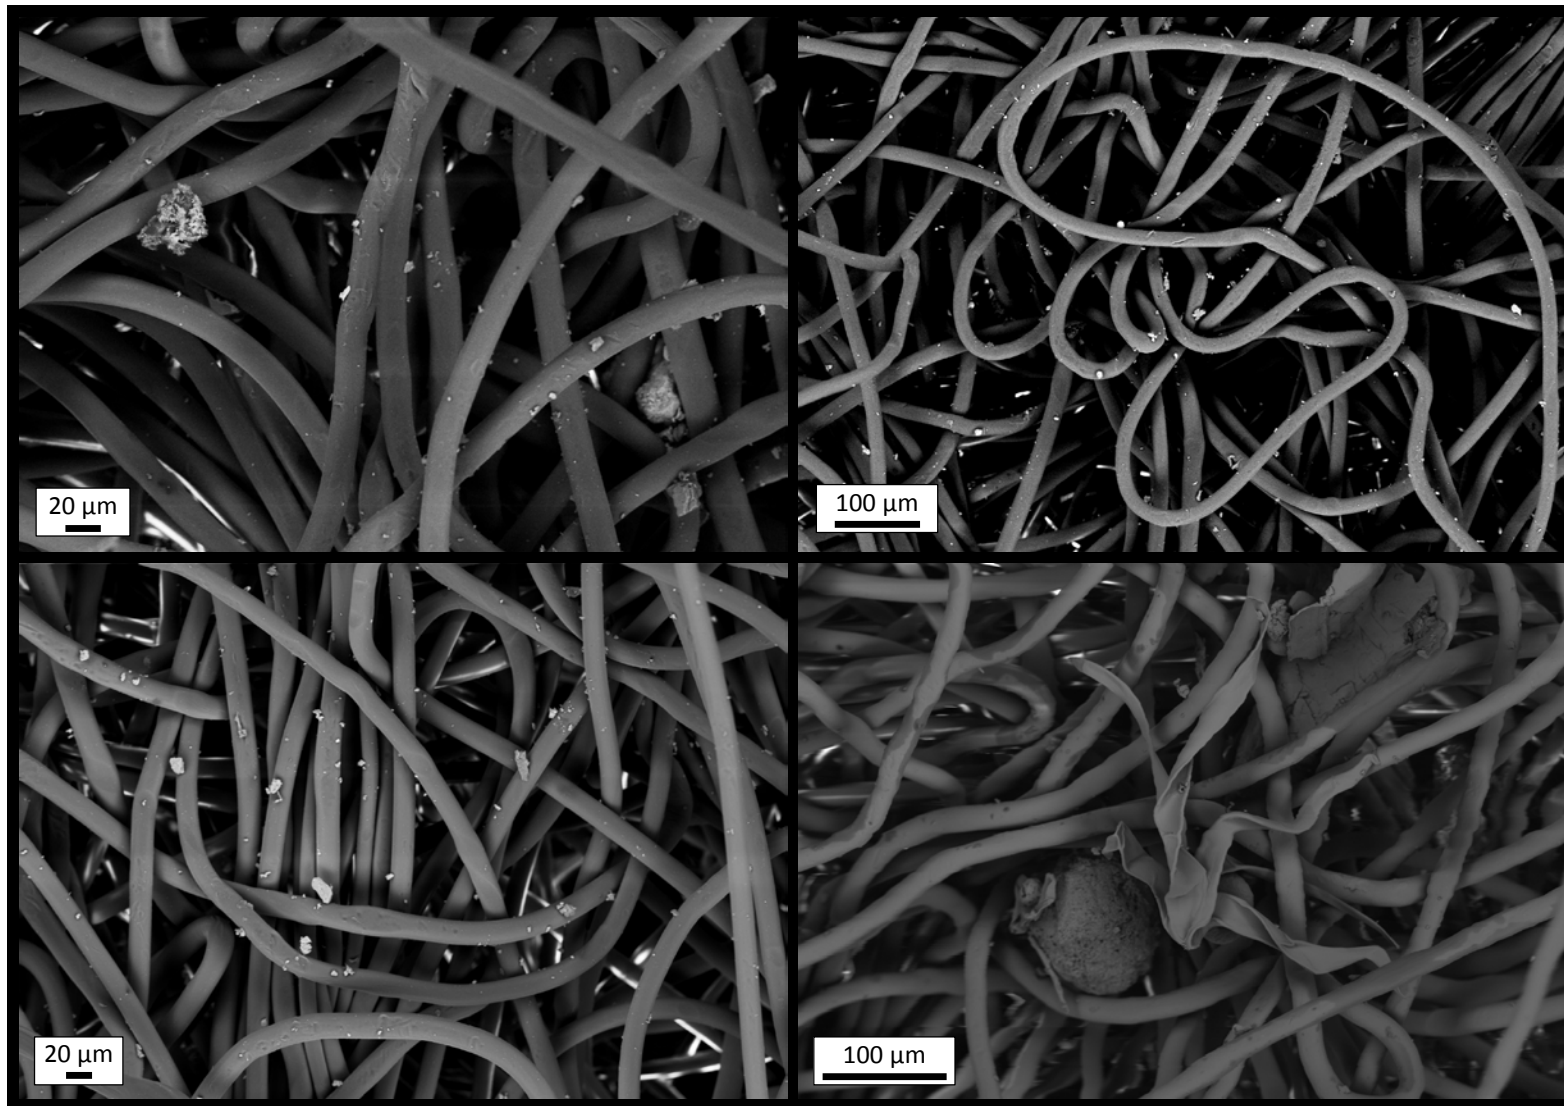
Figure 17. SEM BSD images of EPRI filter #4. A) isolated dust on the filter fibers, and a few large composite grains; B-C) isolated dust on the filter fibers; D) Composite mineral grain (analysis EDS showed it to be primarily calcium sulfate)and organic detritus.

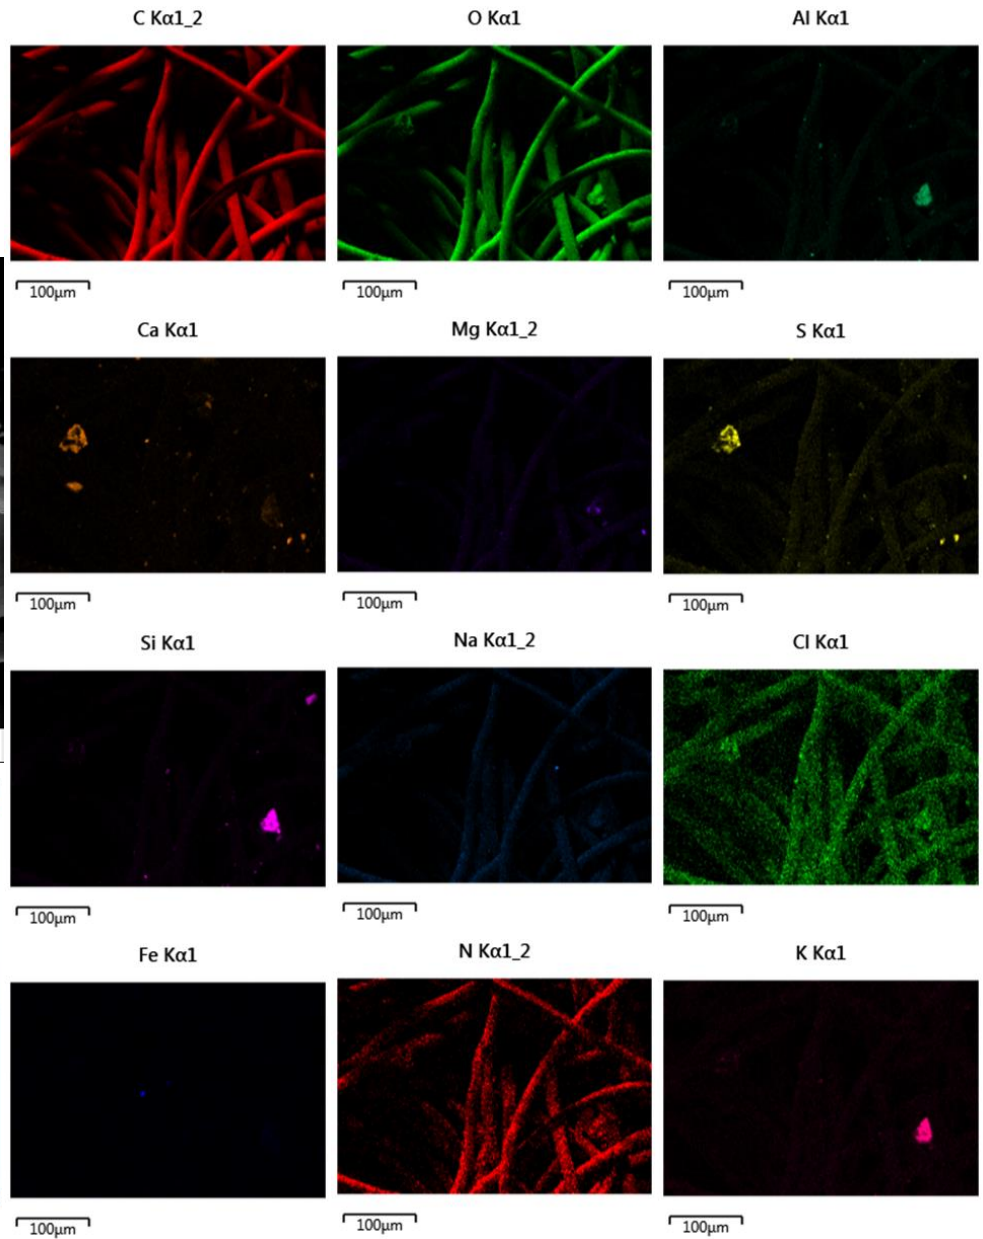
Figure 19. SEM BSD photo, EDS spectrum, and element maps of EPRI filter #4, region 2.

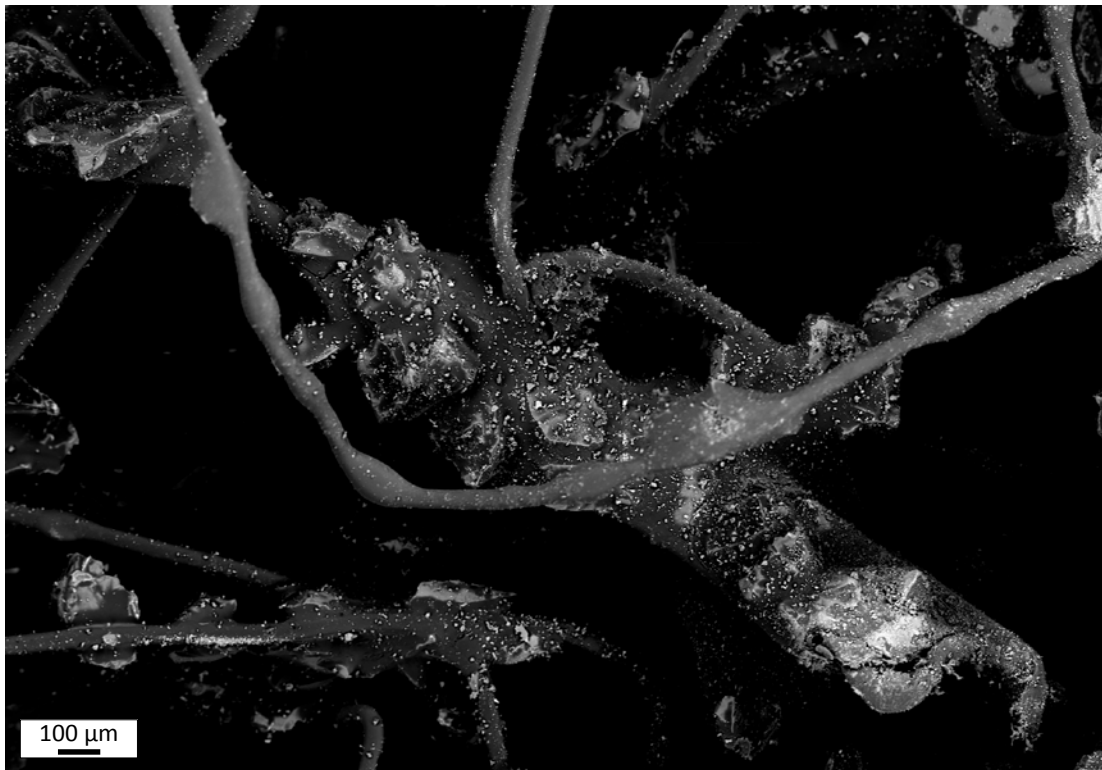
Figure 20. EPRI #4 abrasive pad, heavily coated with dust particles.

Although the EPRI#4 filter was only slightly discolored, the #4 pad was very heavily loaded with fine, inorganic dust particles (Figure 20). It was apparently the lack of pollen that resulted in a lack of visible discoloration on the filter. Figure 21 and Figure 22 show element maps for the filter, and several dominant phases are apparent. Ca-sulfate is a common phase, as is quartz. Minor Na and K aluminosilicates are present, but the dominant aluminosilicate appears to be deficient in mono- and divalent cations—possibly kaolinite. Magnesium is present as a silicate, or possibly a magnesium-aluminum silicate. Chloride and sodium are nearly absent.

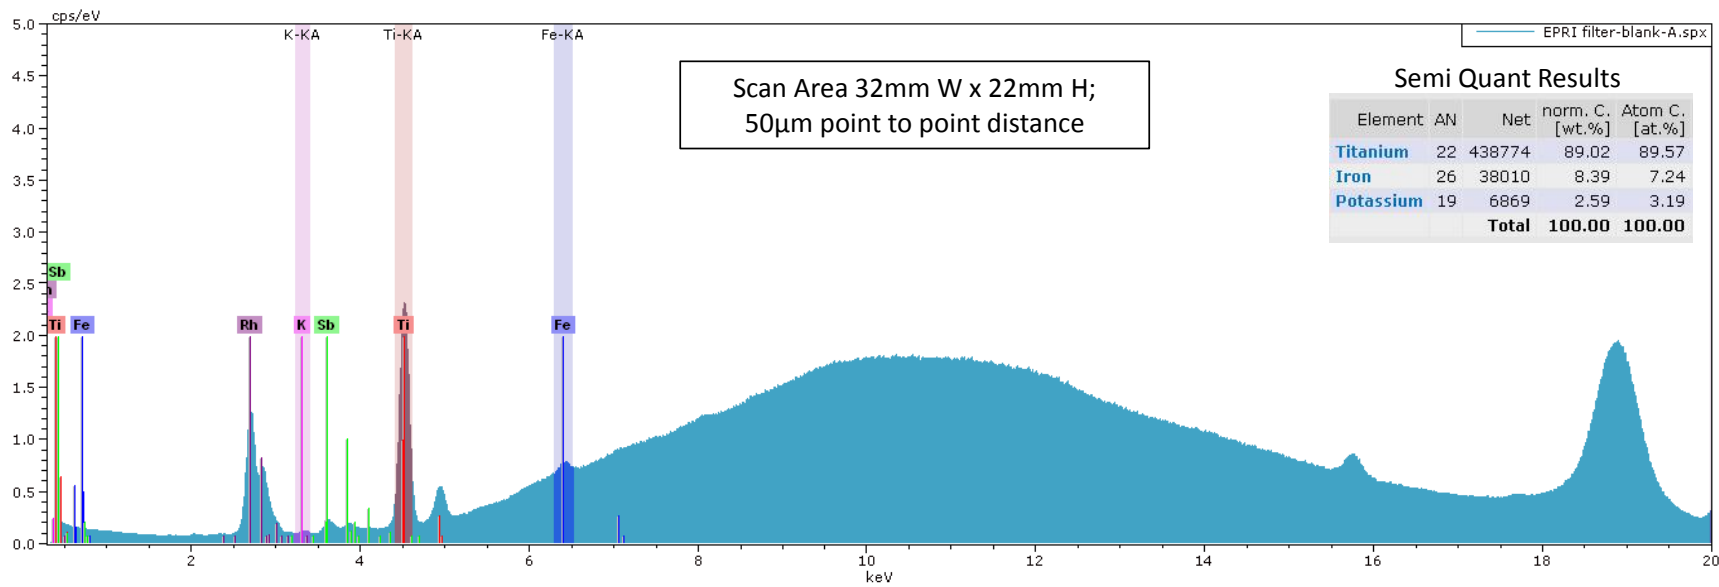
Figure 24. XRD results for EPRI Scotch-brite® pad blank (X-ray spectrum, element maps, and semi-quantitative analytical analysis).

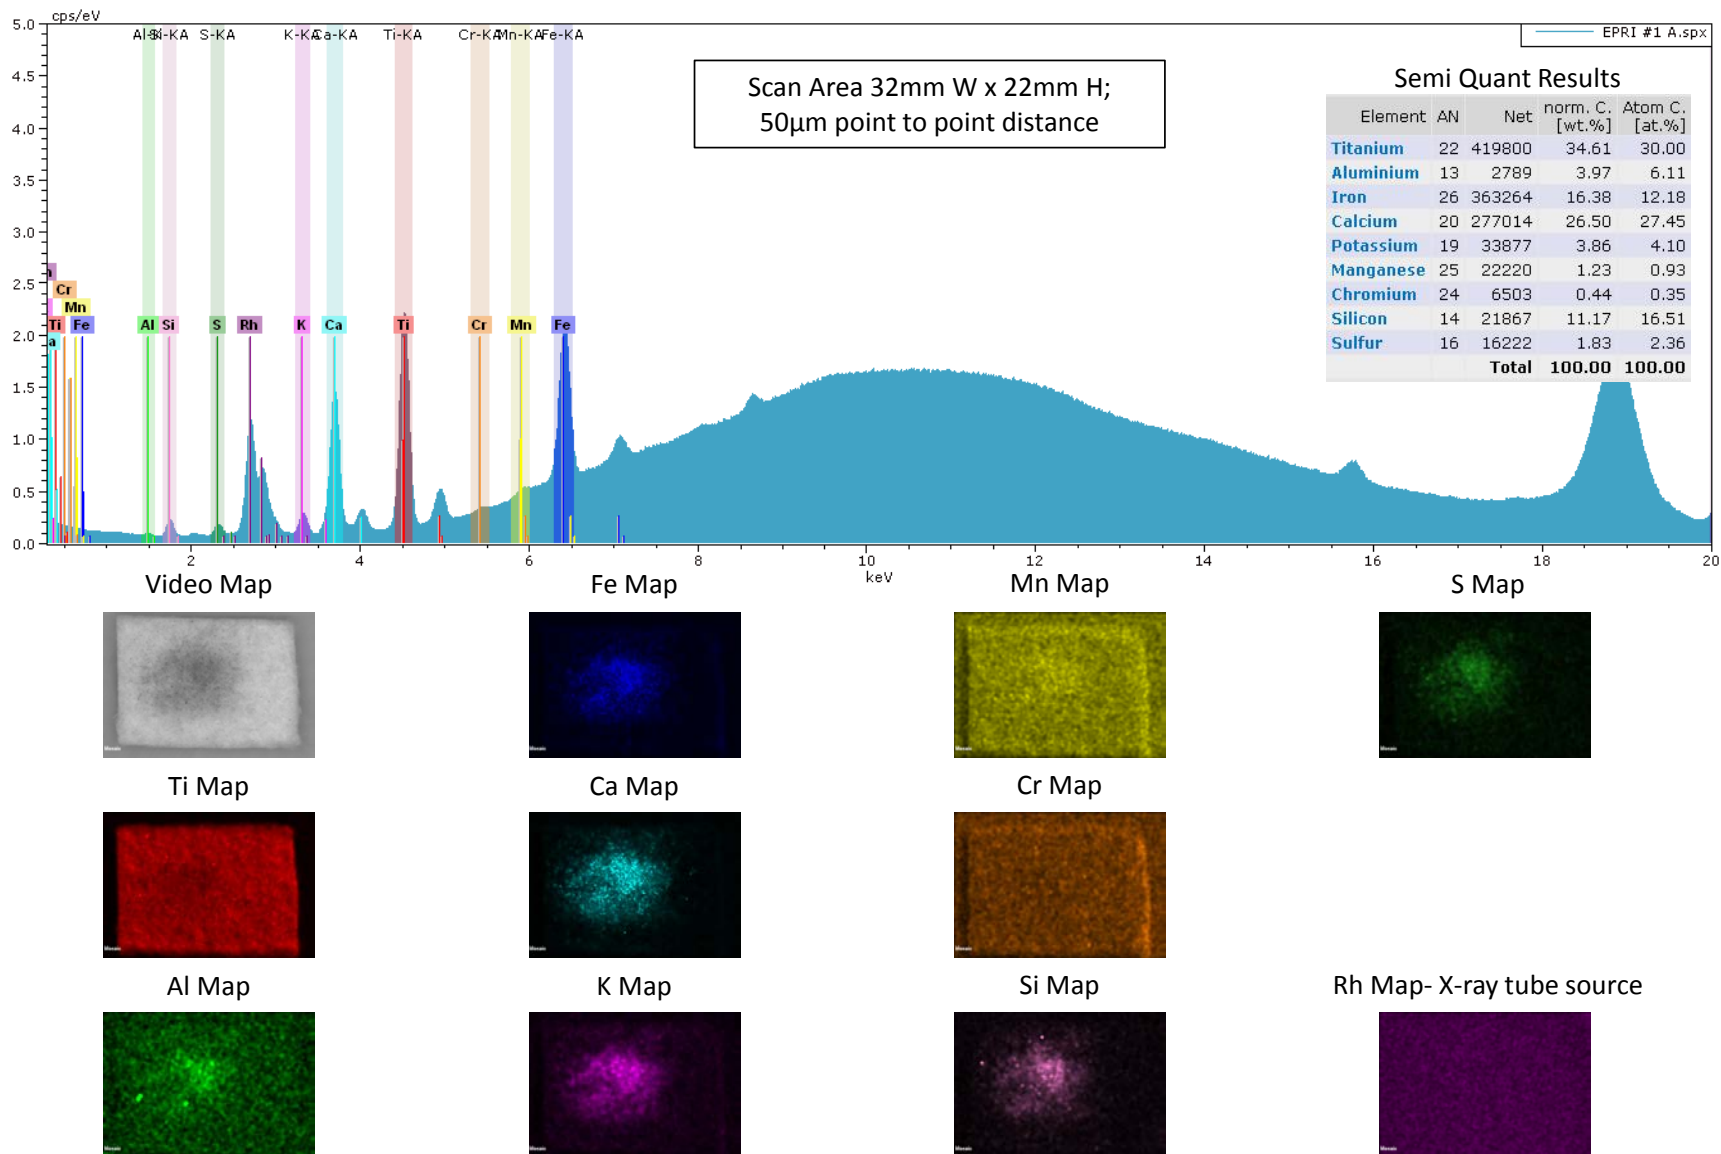
Figure 26. XRD results for EPRI #1 pad (X-ray spectrum, element maps, and semi-quantitative analytical analysis).

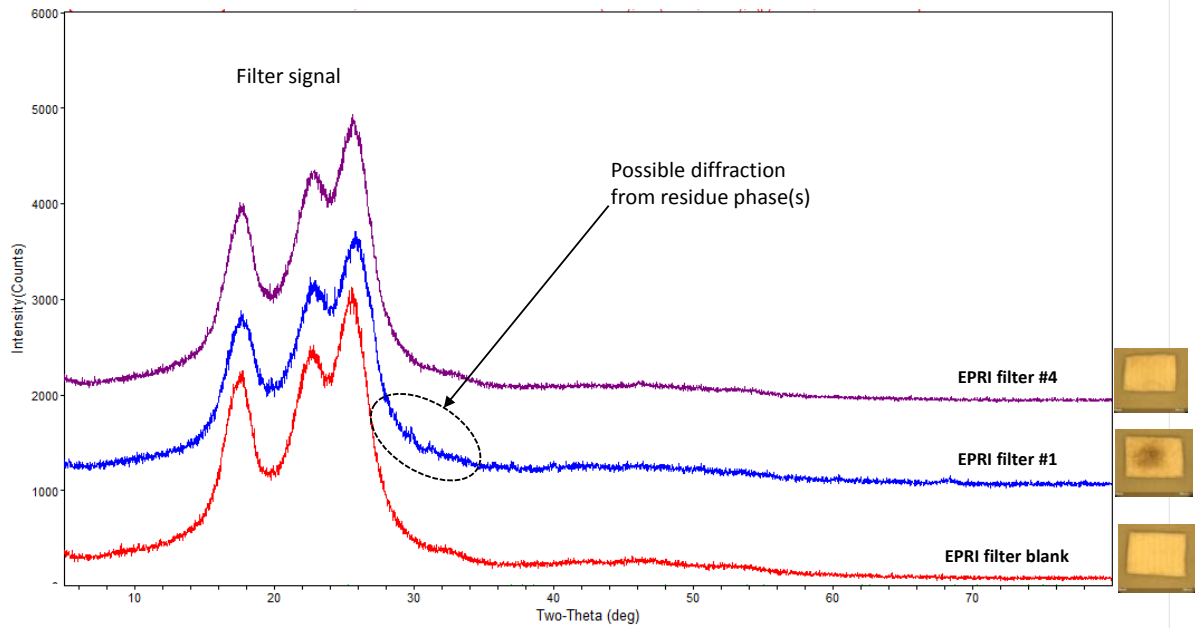
Figure 29. X-ray diffraction patterns for the blank, EPRI #1, and EPRI #4 filters.

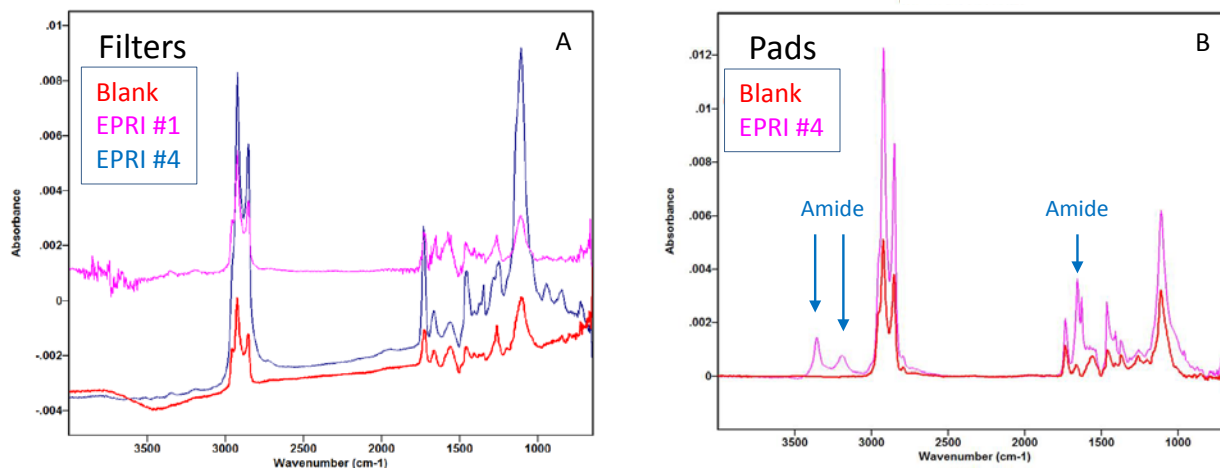
Figure 33. FTIR spectra for the hexane leaches of the EPRI blank and sample filters (A) and Scotch-brite® pads (B). Peaks representing an amide are clearly visible in the EPRI#4 pad sample.

Primary amides are degradation products of proteins, and the amide may represent breakdown of organic matter in the dust due to heat, radiation, or chemical reactions. However, it is more likely that the amide is a contaminant from the filter or pad. Primary amides are widely used in resins and as slip agents and may be present in the cured resin holding the pad together. Moreover, nylon itself is an amide. It was hypothesized that the amide was a breakdown product of the scrubber, exposed by abrasive action (or, when the sample was cut into subsamples with scissors), allowing it to be extracted. To test this, a piece of the blank pad was abraded and leached with hexane; however, the resultant leachate did not contain any detectable amides. Further examination of the analyses showed that the amide was present in low concentrations on all of the filter samples, including the blank. It is possible that the source of the amide contaminant is actually the filters, but it was transferred to the EPRI #4 pad during storage. Or, both the pads and the filters may have absorbed the amide while they were stored, or during shipping. In any case, the presence of the amide on the filter blank strongly suggests it is an artifact, and was not a component in the dust.
