# ***Data Report on Corrosion Testing of Stainless Steel SNF Storage Canisters***

**Fuel Cycle Research & Development**

***D.G. Enos, C.R. Bryan, and K. M. Norman  
Sandia National Laboratories  
September 30, 2013***

**FCRD-UFD-2013-000324  
SAND2013-8314P**

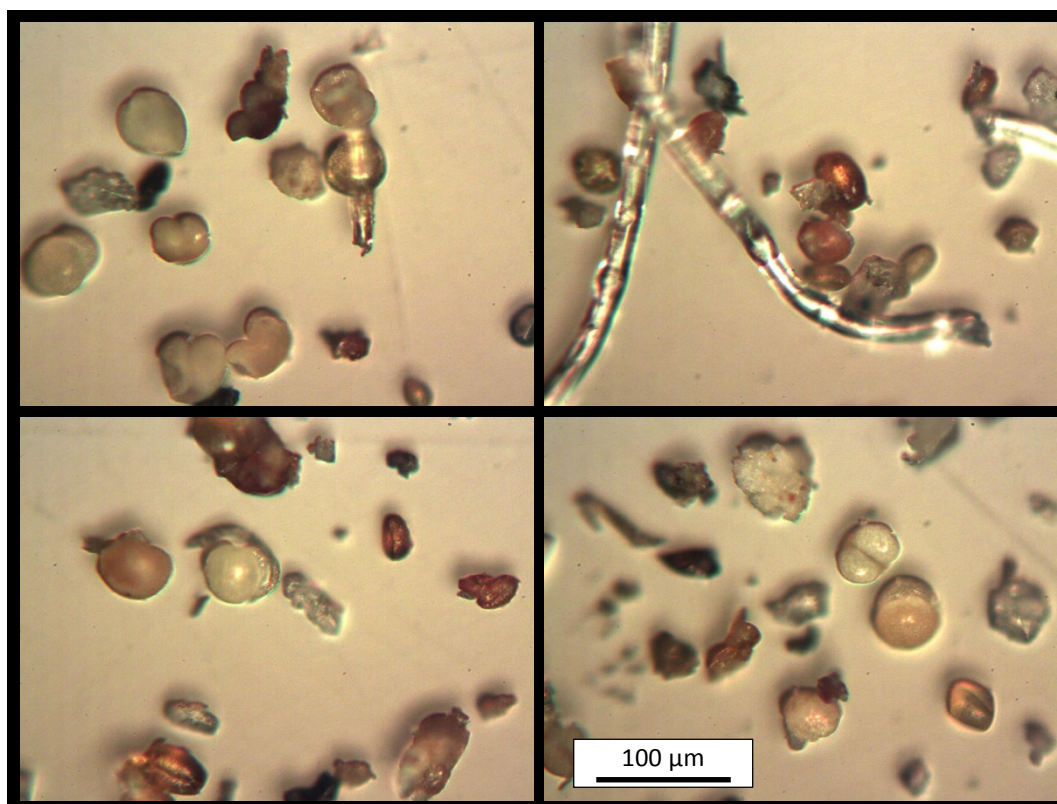
Figure 34. Optical microscope images of dust collected from the EPRI #1 filter for Raman spectroscopic analysis. Large fibers are polyester fibers from the filter.

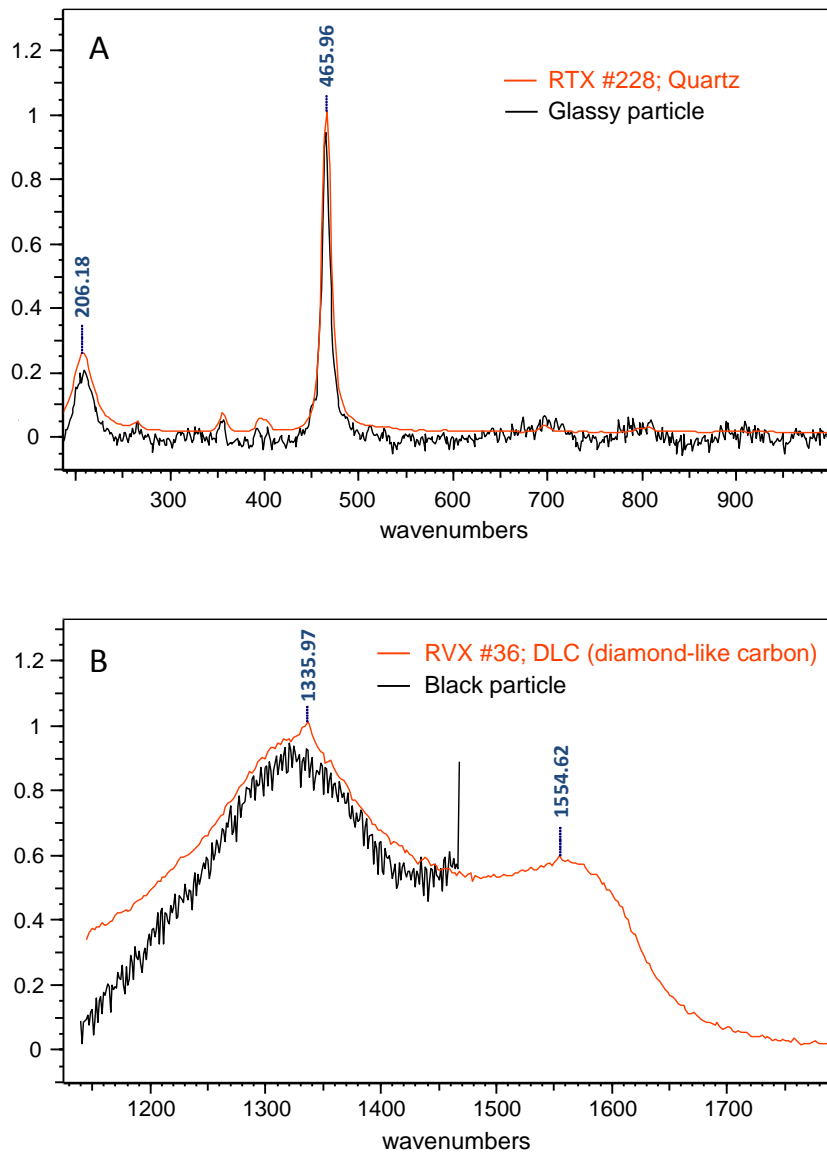
Figure 35. Raw and matching library spectra for dust particles from the EPRI #1 filter. A) quartz; B) soot.

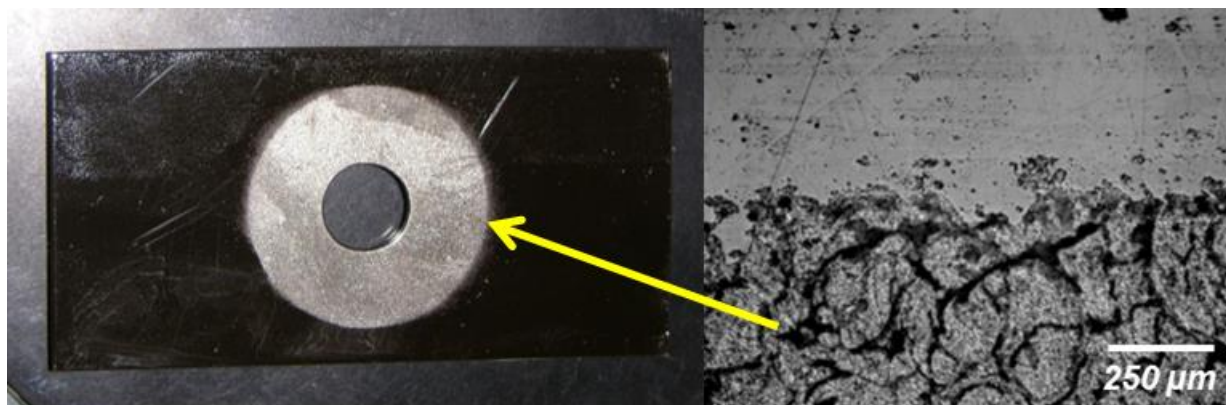
Figure 38. Sample coupon with salt deposit (L) and close-up view of salt layer (R).

Stainless steel test coupons (UNS S30400) from a commercial vendor with dimensions 1" x 2" x 0.0625" and a 0.265" diameter centered hole were mechanically polished to a mirror finish. They were degreased using an alkali detergent and acetone and ethanol solvents, and were rinsed in deionized water and dried. The mirror finish was selected as it facilitates both the formation of a narrow crevice on the surface, as well as the identification of any corrosion that takes place upon completion of the test. Salt layers were deposited on the coupon surface by airbrushing a salt solution in a methanol carrier. ACS reagent grade chemicals were used for the 0.1M salt solution comprised of 50/50 NaCl/KCl and methanol. A region approximately 1.5 inches in diameter was masked on each coupon to define the deposition area via a template (i.e., a shadow mask), and a quartz crystal microbalance placed adjacent to the deposition region was used to monitor the quantity of material deposited. The resulting deposit was a relatively uniform film as shown in bottom half of the right image in Figure 38. Figure 38 shows the salt deposition area on the left and a close-up view of the uniform salt layer on the right. In the right image, the top half of the salt layer was removed to show the contrast between the bare sample surface and the continuous salt layer deposited. Salt was deposited in 50, 100 and 200 $\mu\text{g}/\text{cm}^2$  loadings for experimental evaluation.

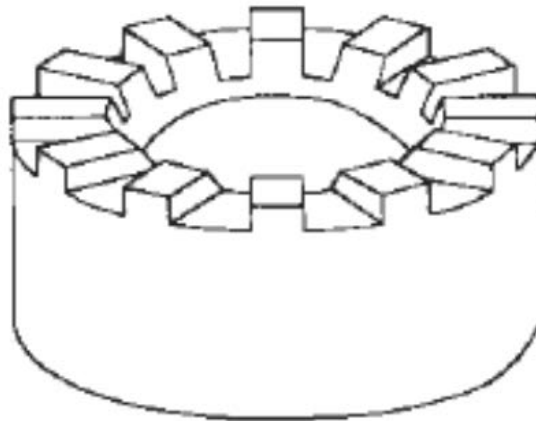
Figure 39. Crevice former representation.

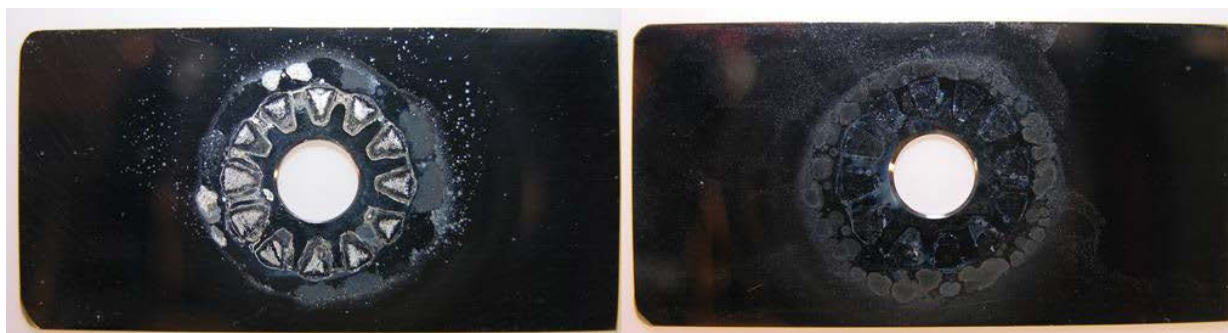
Figure 8. 304SS coupon with 200  $\mu\text{g}/\text{cm}^2$  and 7 day exposure after crevice former removal (L) and rinsing (R).

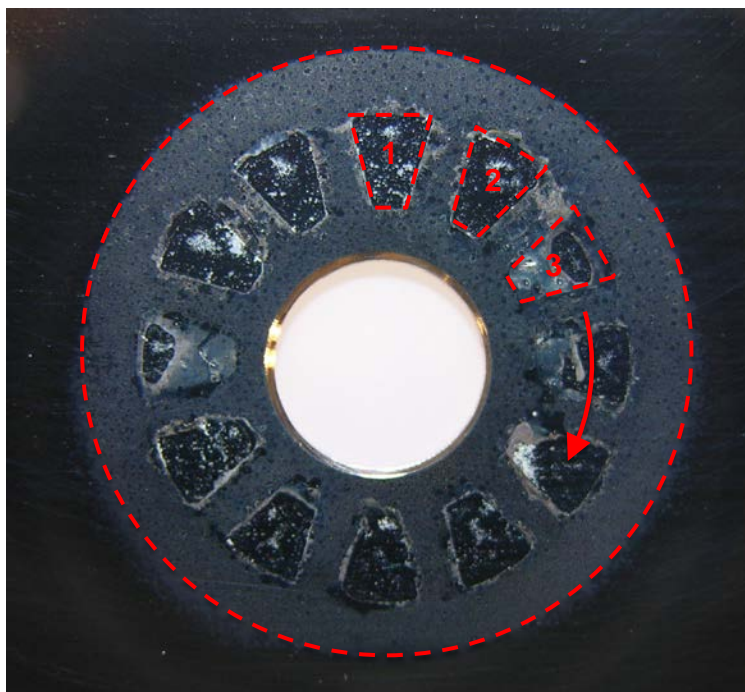
Figure 43. Crevice corrosion site survey location and pattern.

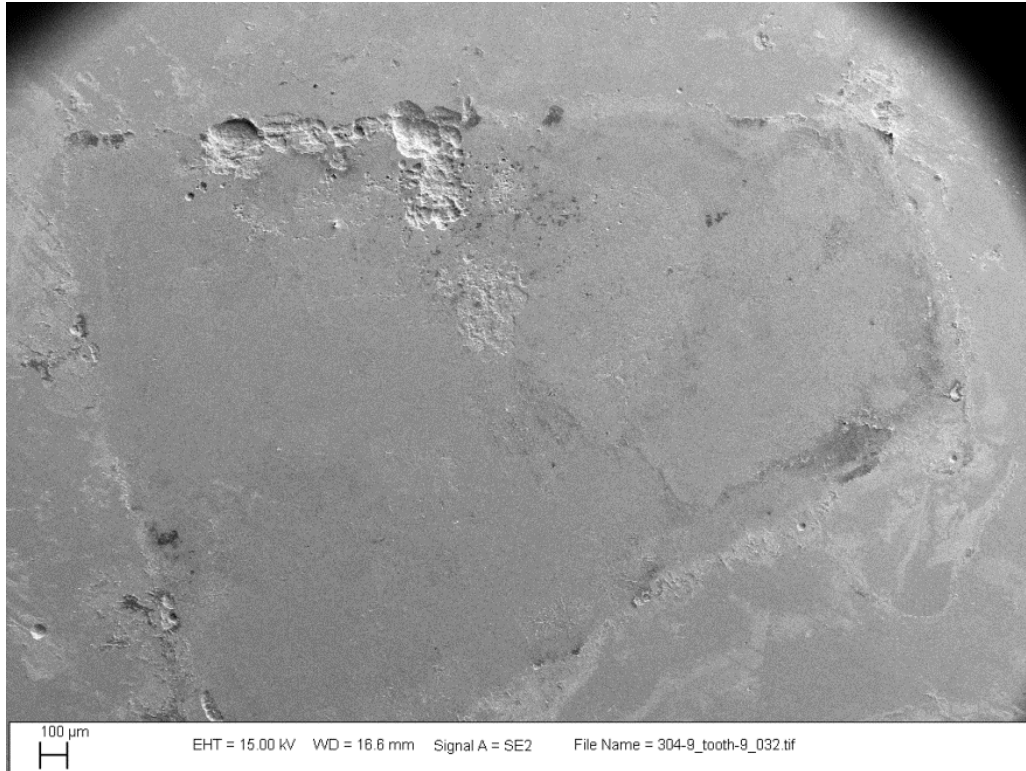
Figure 44. Tooth outline from sample with 100μg/cm<sup>2</sup> salt and 100 days exposure.

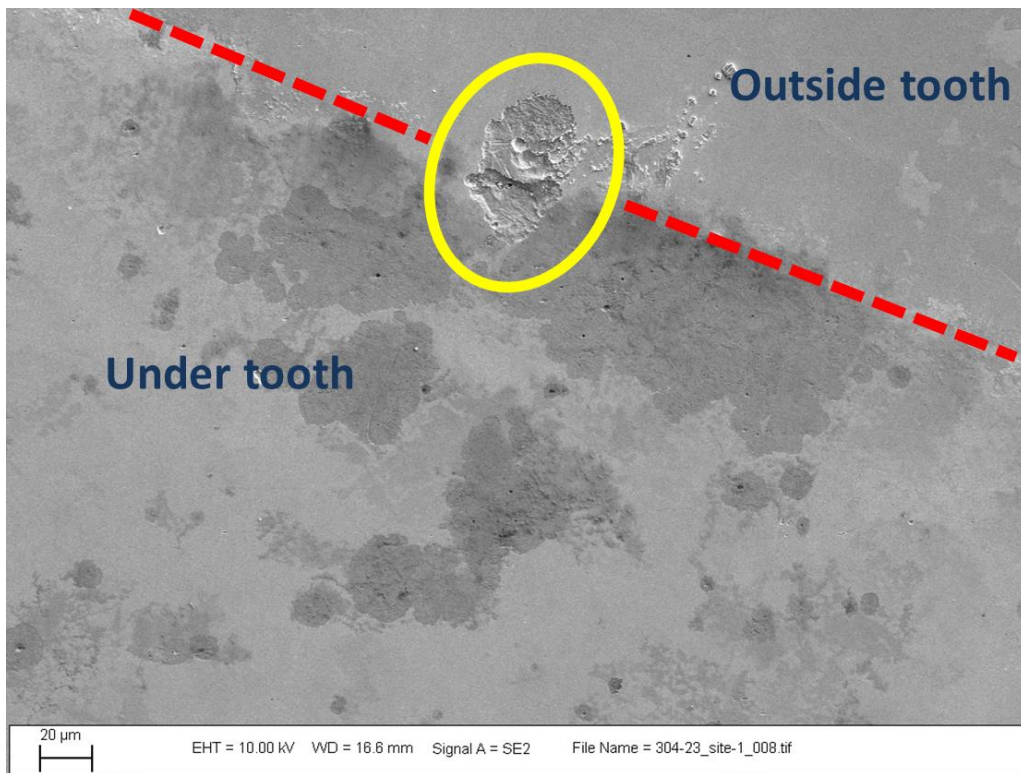
Figure 45. Crevice corrosion in sample with 100μg/cm<sup>2</sup> loading and 50 days exposure.

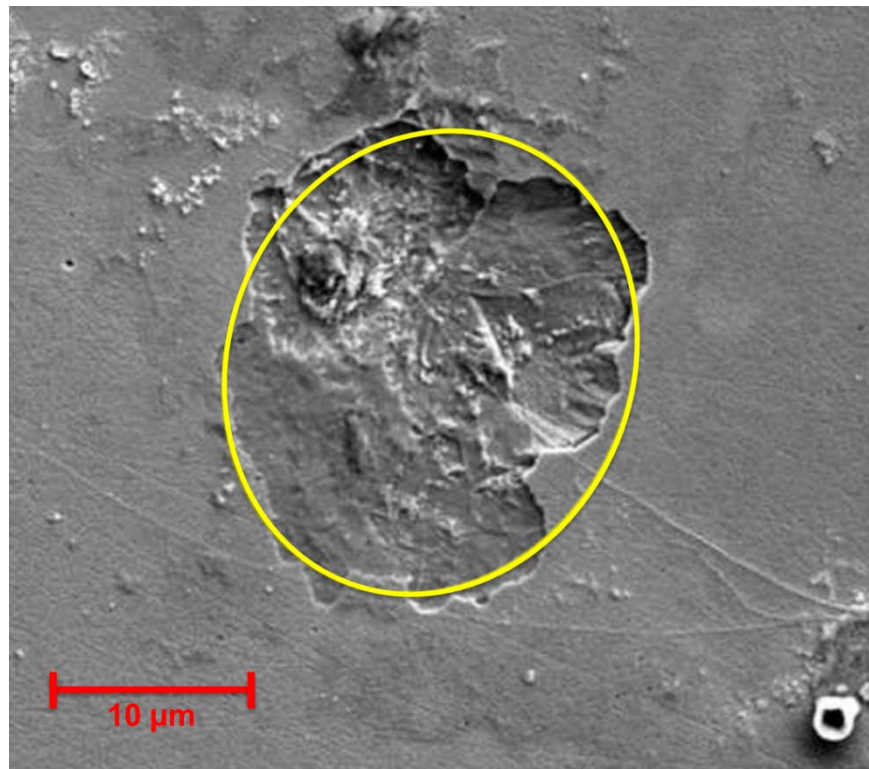
Figure 46. Example of estimating area of a crevice corrosion site.

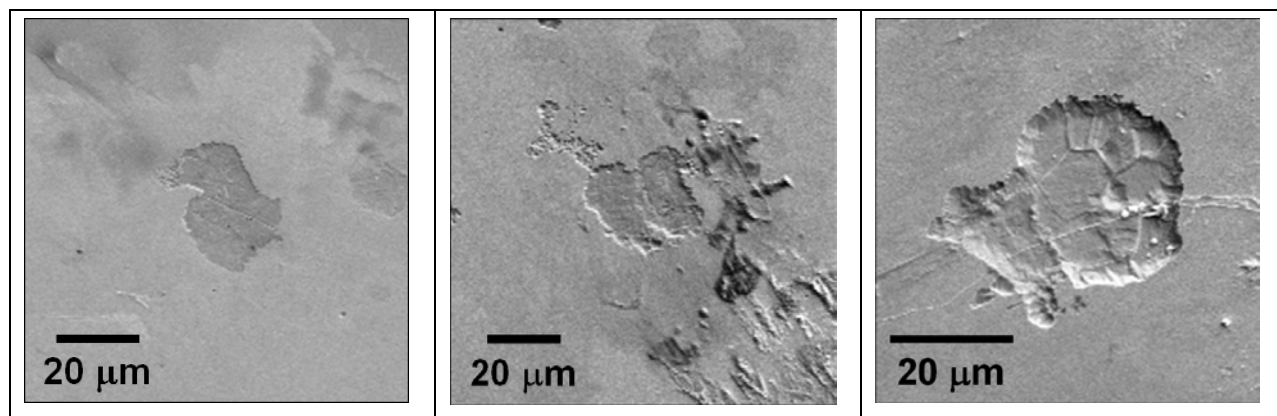
Figure 47. Crevice corrosion sites characterized as very shallow (L), shallow (M), and moderate (R) in depth.

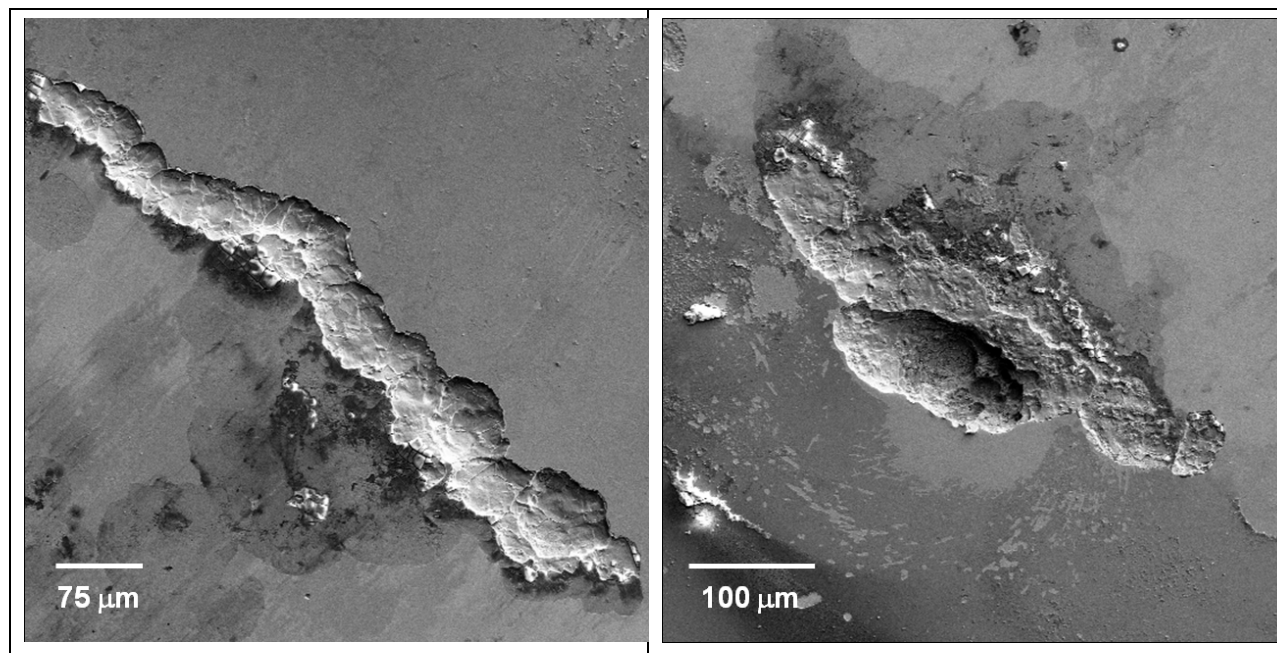
Figure 48. Deep and extremely deep crevice corrosion sites.

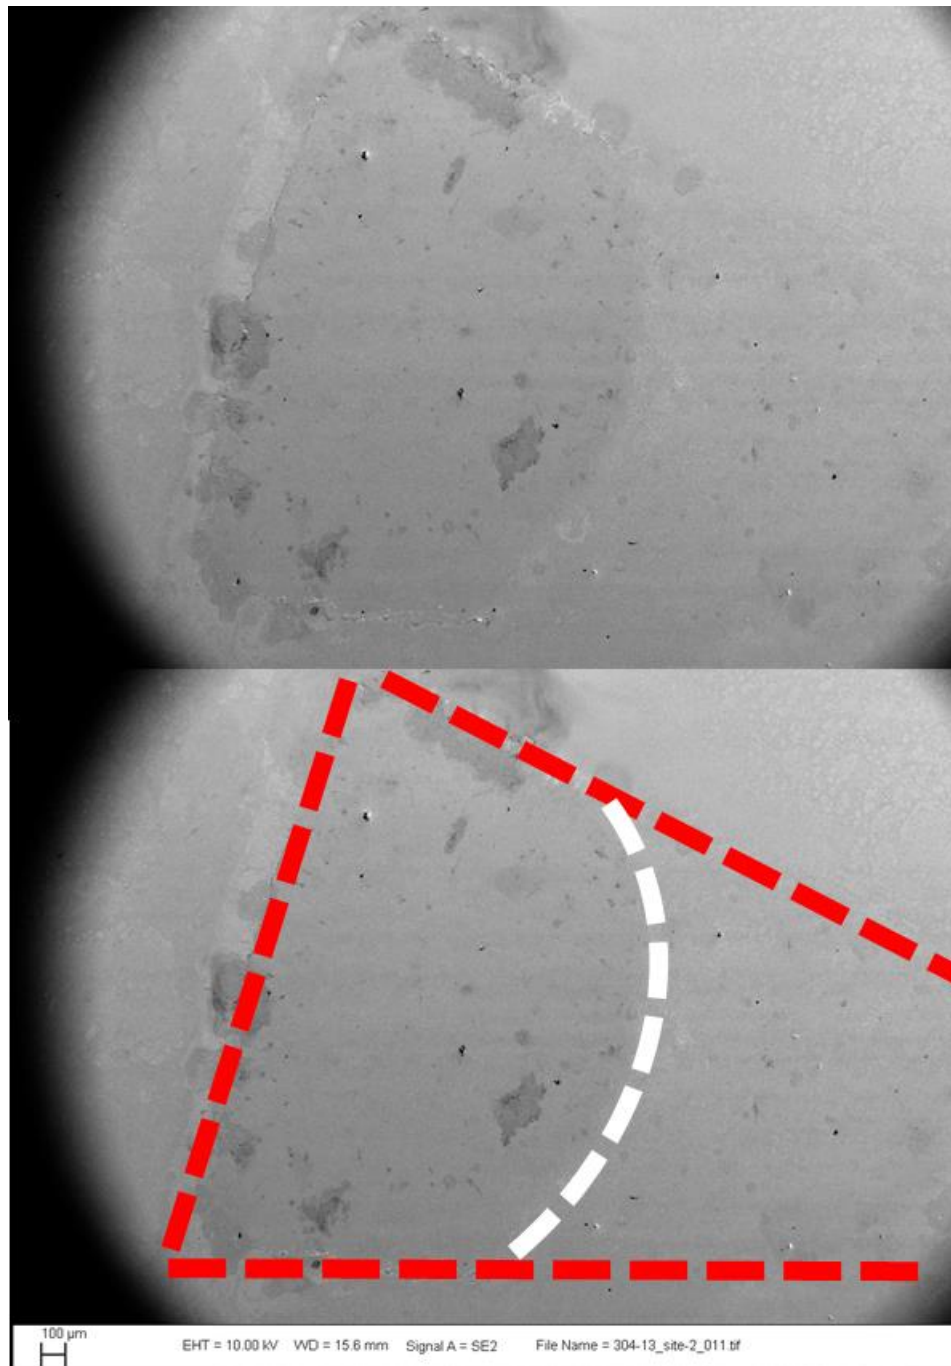
Figure 49. Apparent non-uniform contact of crevice former tooth on sample 304-13 ( $200\mu\text{g}/\text{cm}^2$ , 14 days exposure).

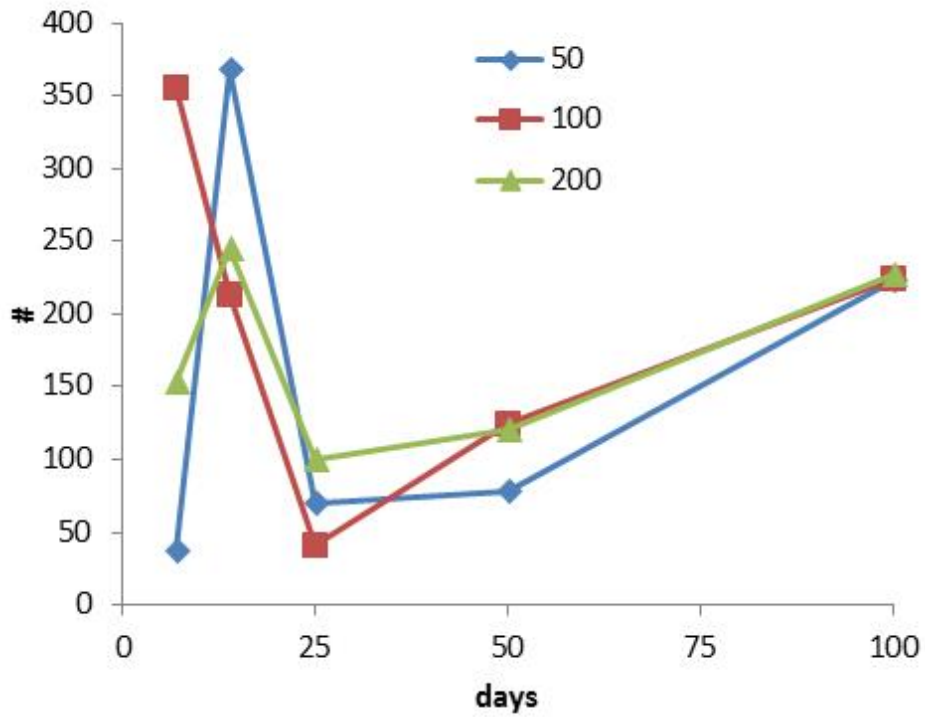
Figure 50. Total sites per sample over time(loadings in µg/cm<sup>2</sup>).

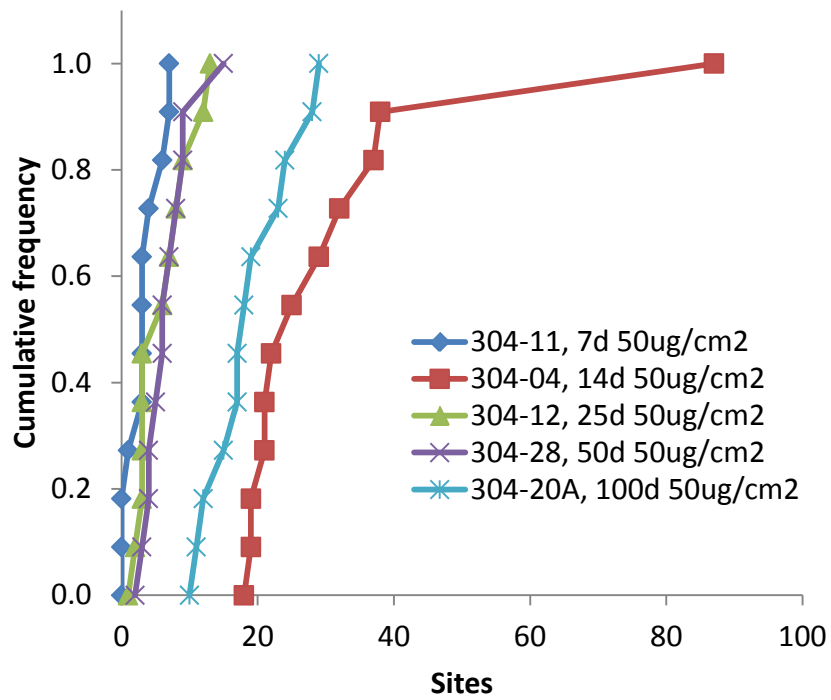
Figure 51. Crevice corrosion sites per tooth over time with 50µg/cm<sup>2</sup> salt loadings.

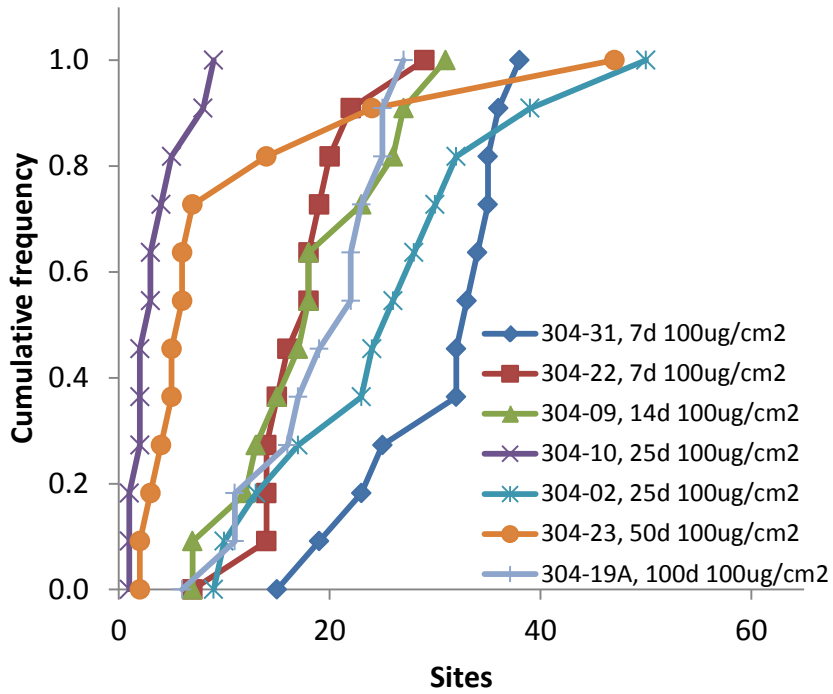
Figure 52. Crevice corrosion sites per tooth over time with 100µg/cm<sup>2</sup> salt loadings.

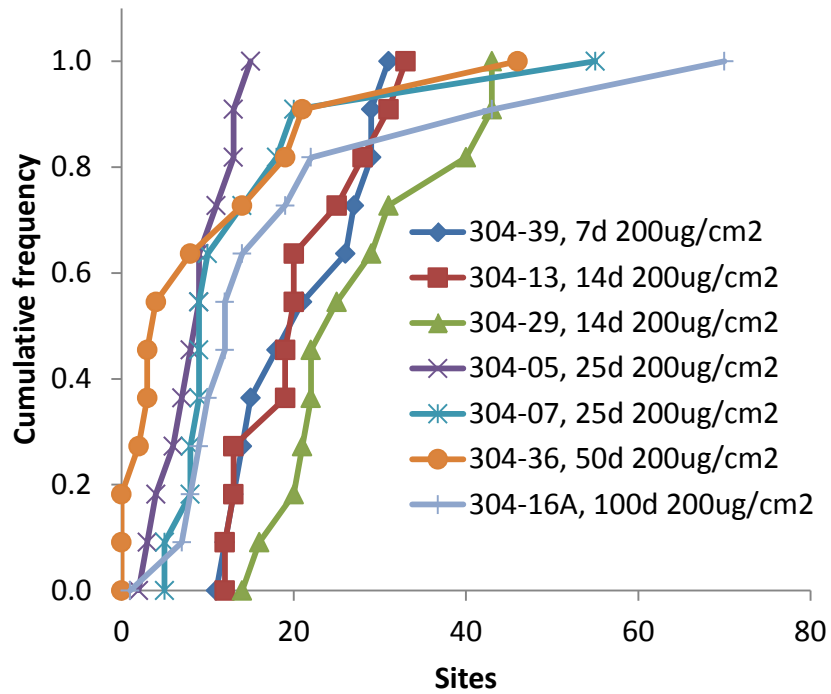
Figure 53. Crevice corrosion sites per tooth over time with 200µg/cm<sup>2</sup> salt loadings.

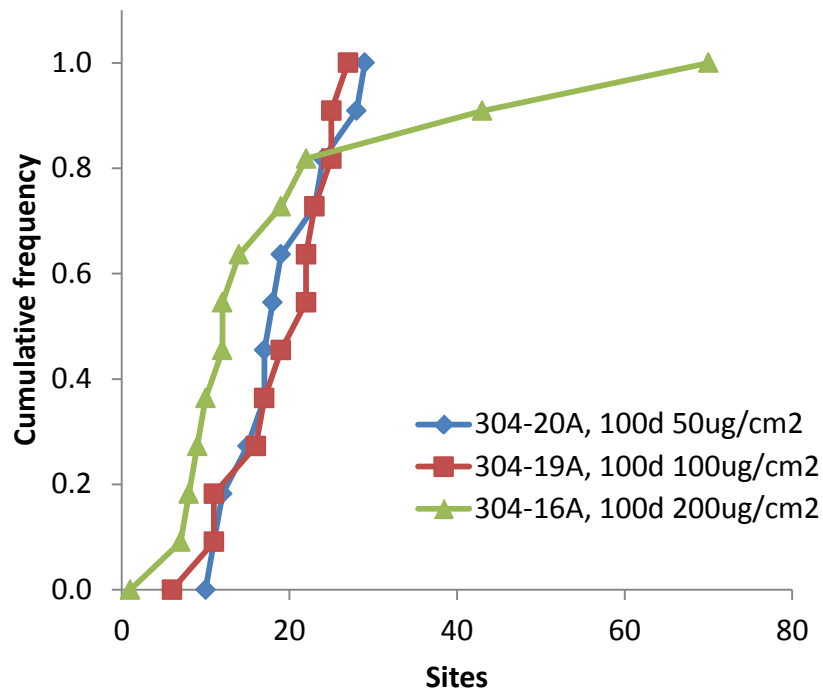
Figure 56. Number of sites per tooth as a function of salt loading from 100 days exposure.

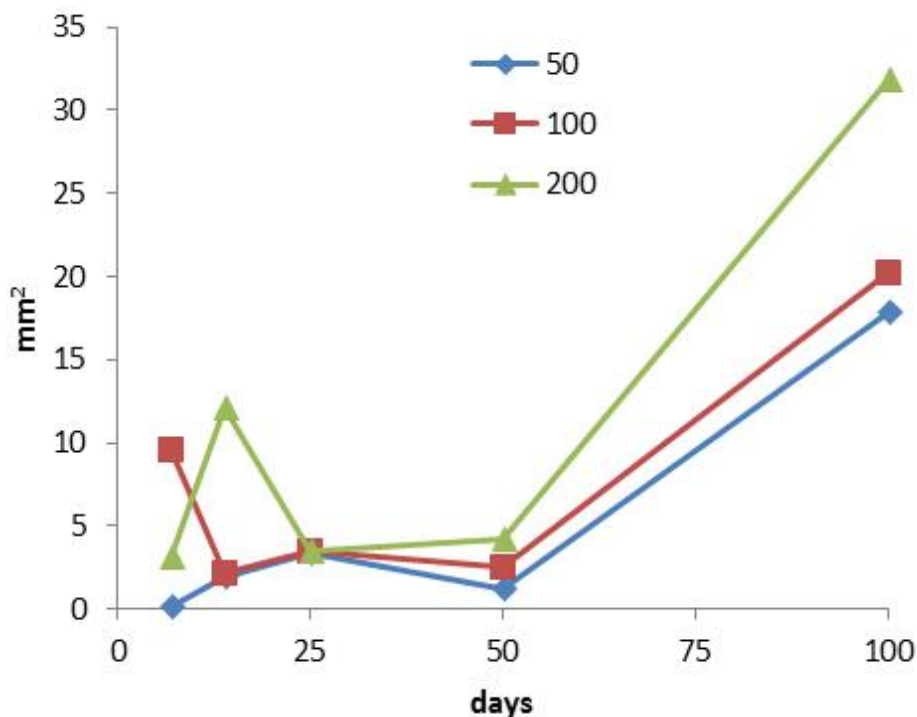
Figure 57. Total area of observed crevice corrosion sites per sample over time (loadings in  $\mu\text{g}/\text{cm}^2$ ).

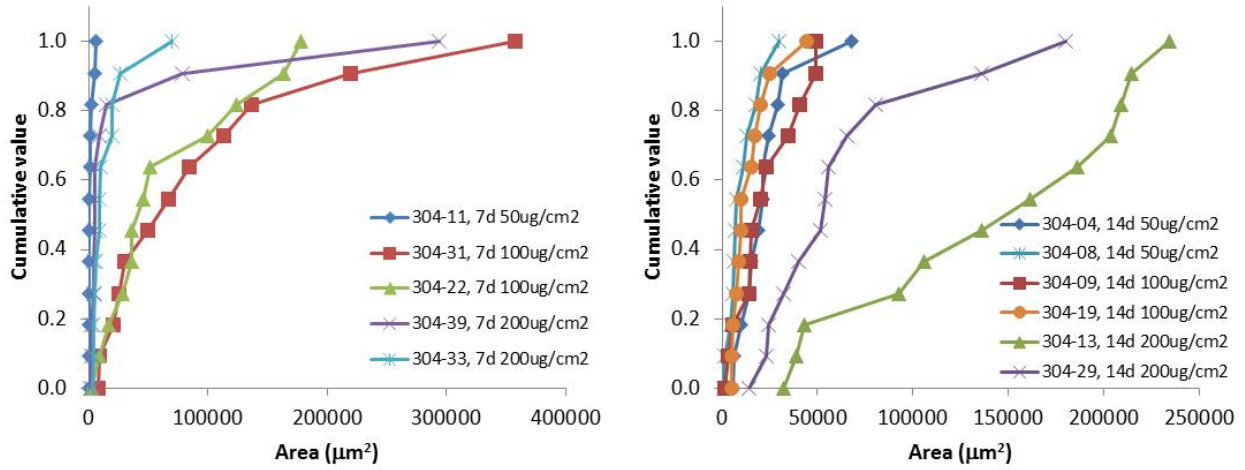
Figure 58. Total crevice corrosion area as a function of salt loading for 7 day (L) and 14 day (R) exposure times.

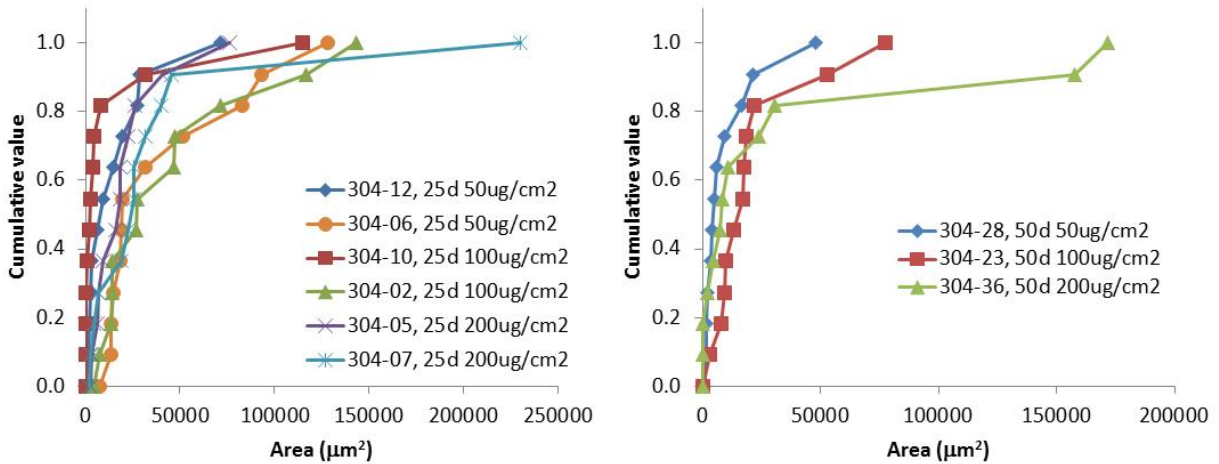
Figure 59. Total crevice corrosion area as a function of salt loading for 25 day (L) and 50 day (R) exposure times.

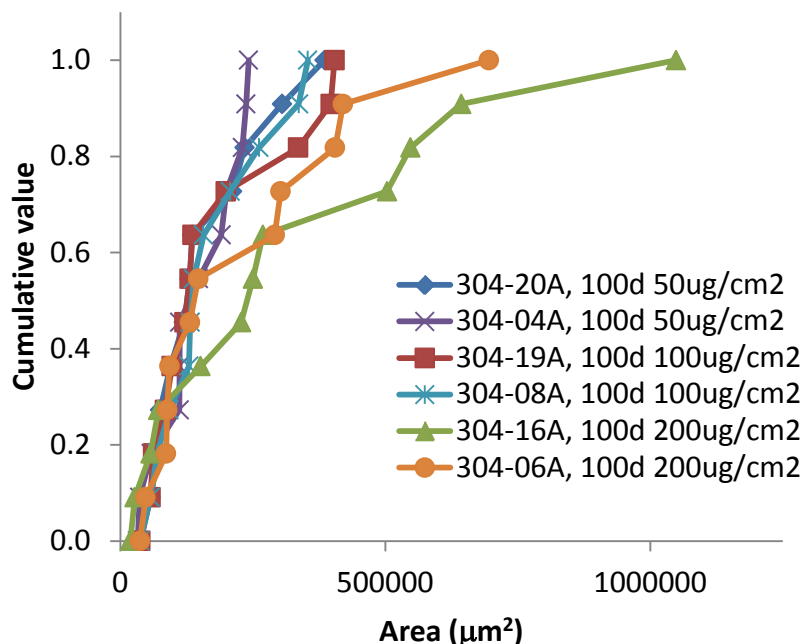
Figure 60. Total crevice corrosion area as a function of salt loading from 100 days exposure.

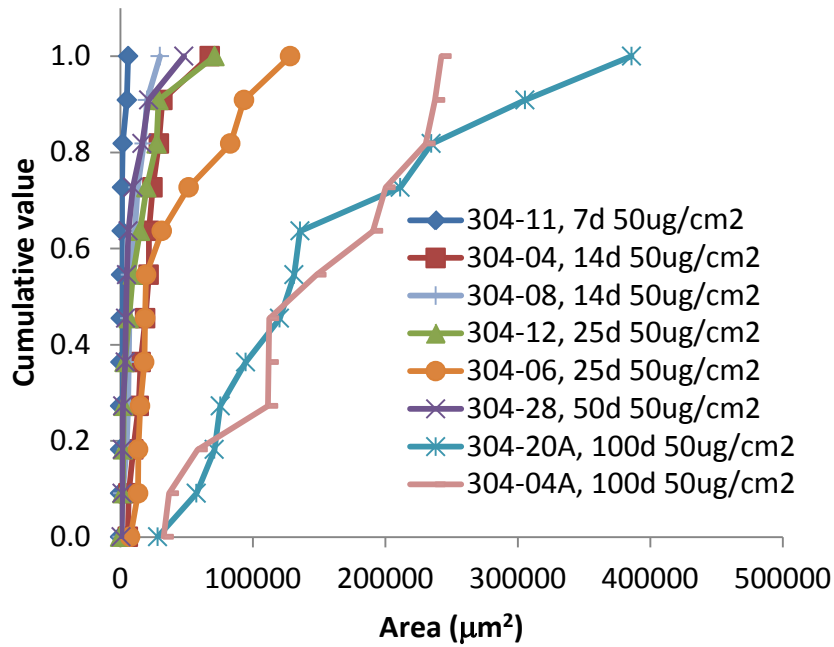
Figure 61. Crevice corrosion area per tooth over time from 50µg/cm<sup>2</sup> salt loading.

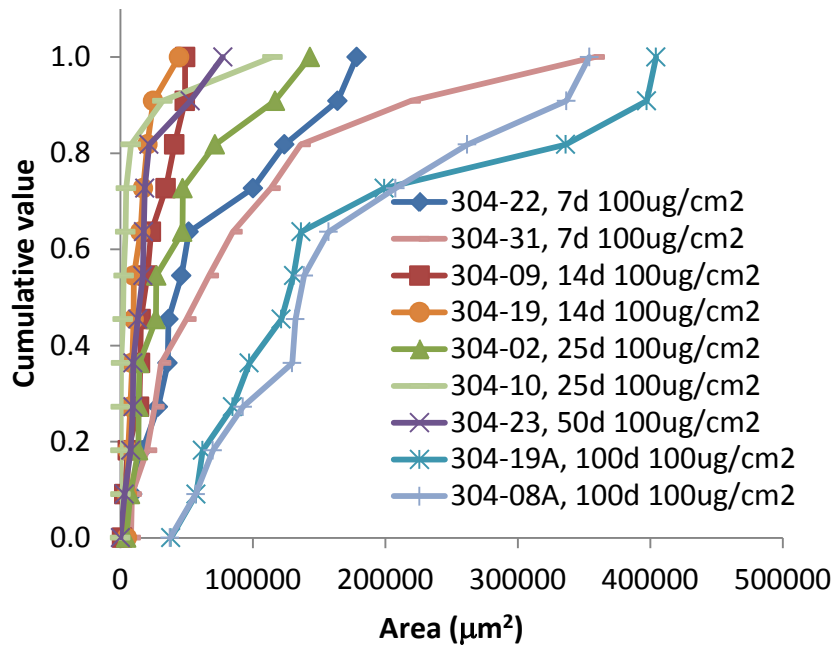
Figure 62. Crevice corrosion area per tooth over time from 100µg/cm<sup>2</sup> salt loading.

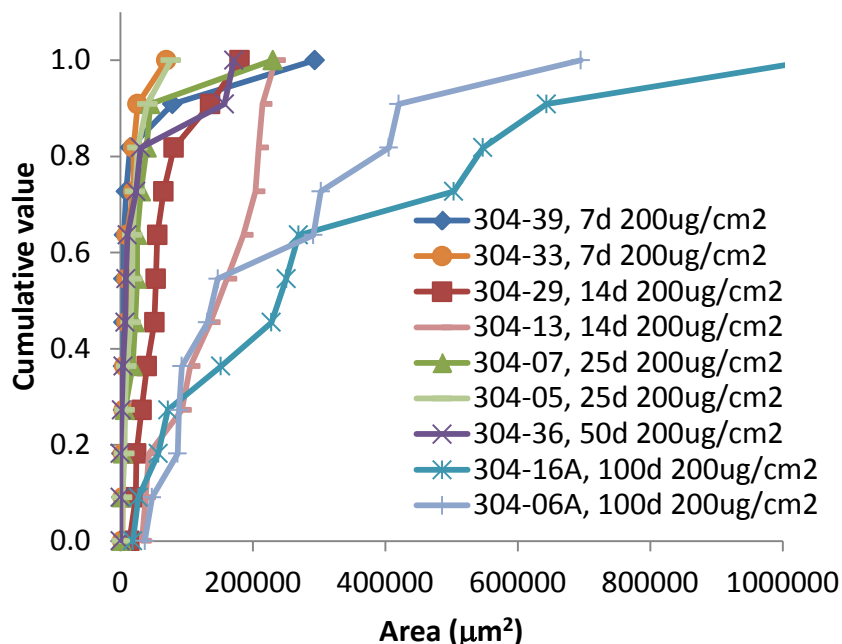
Figure 63. Crevice corrosion area per tooth over time from 200µg/cm<sup>2</sup> salt loading.

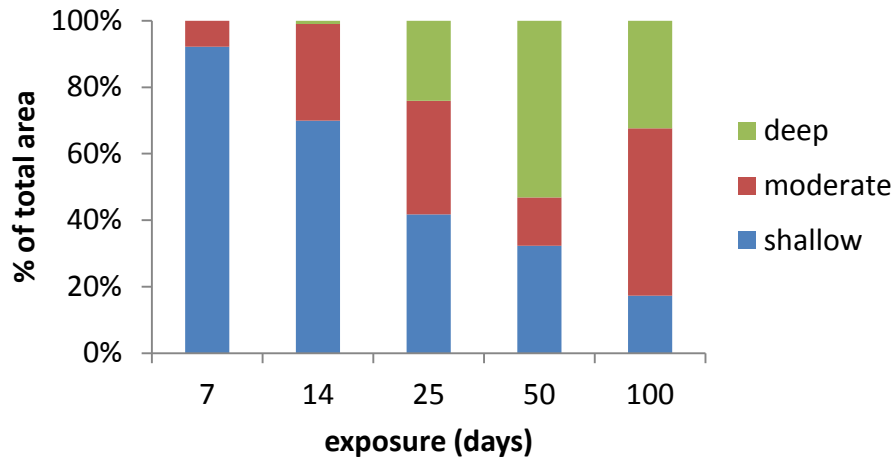
Figure 64. Percentage of corrosion area as a function of site severity for 50µg/cm<sup>2</sup> samples.

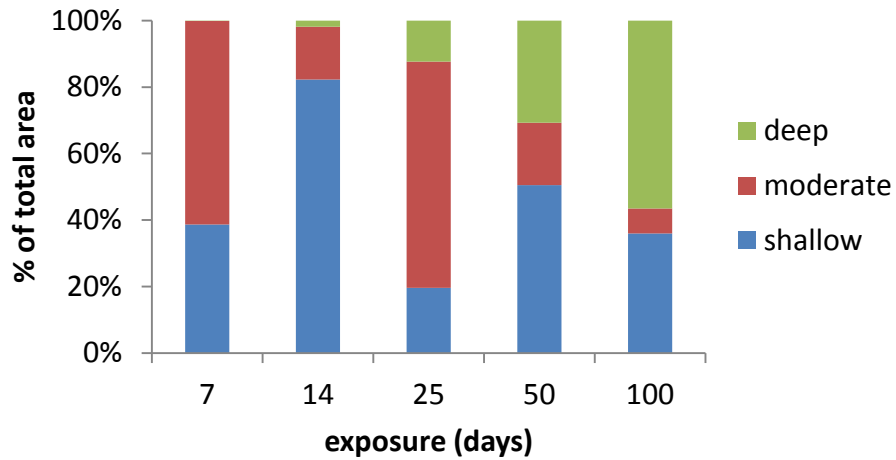
Figure 65. Percentage of corrosion area as a function of site severity for 100µg/cm<sup>2</sup> samples.

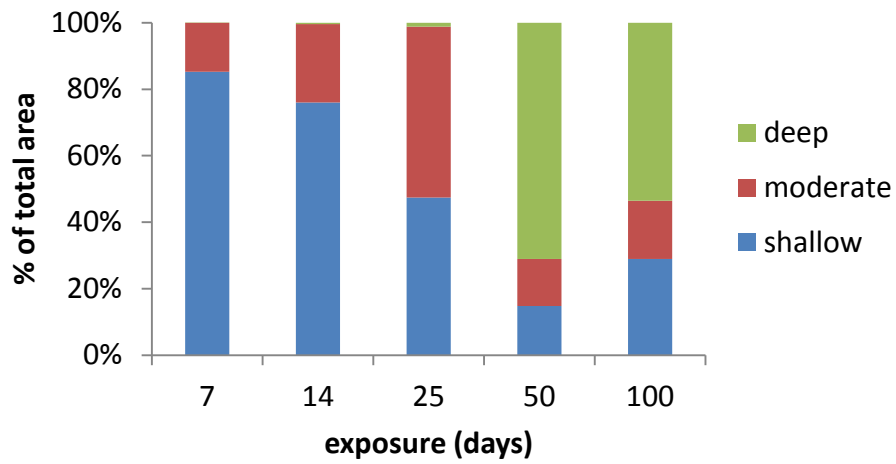
Figure 66. Percentage of corrosion area as a function of site severity for 200 $\mu\text{g}/\text{cm}^2$  samples.

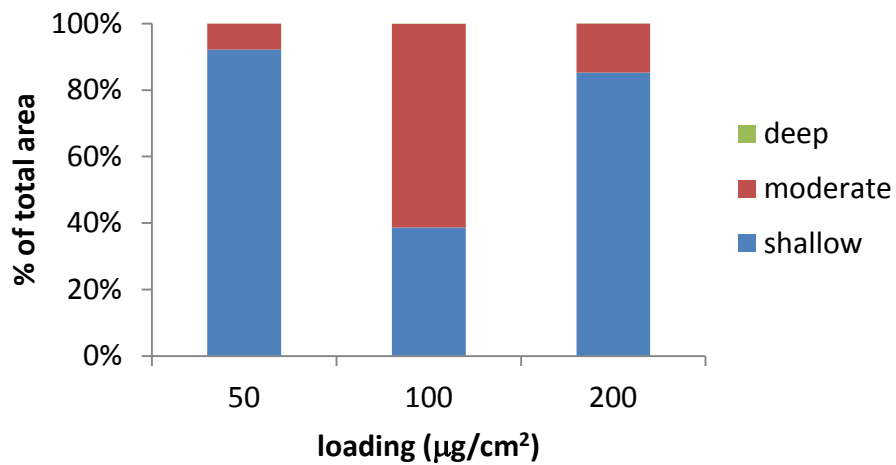
Figure 67. Percentage of corrosion area as a function of site severity for 7 days exposure.

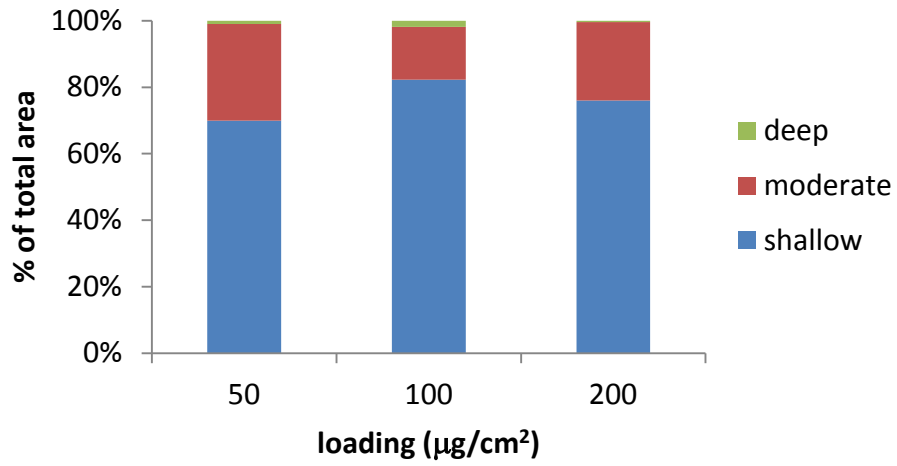
Figure 68. Percentage of corrosion area as a function of site severity for 14 days exposure.

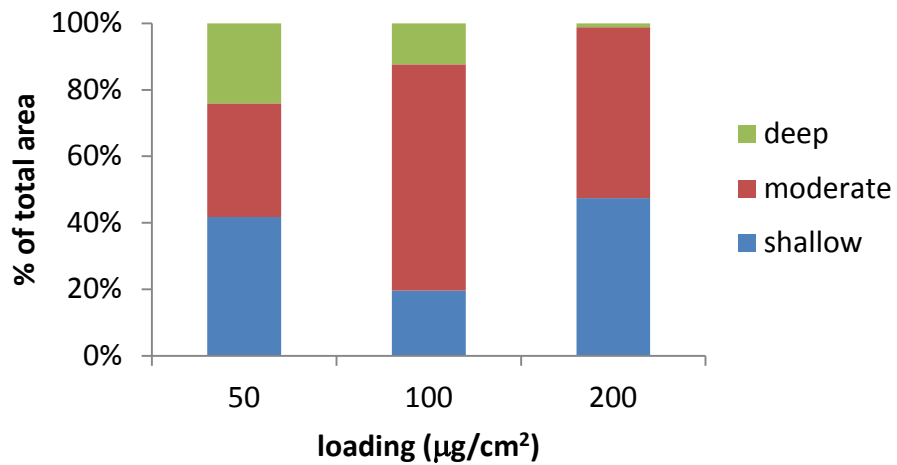
Figure 69. Percentage of corrosion area as a function of site severity for 25 days exposure.

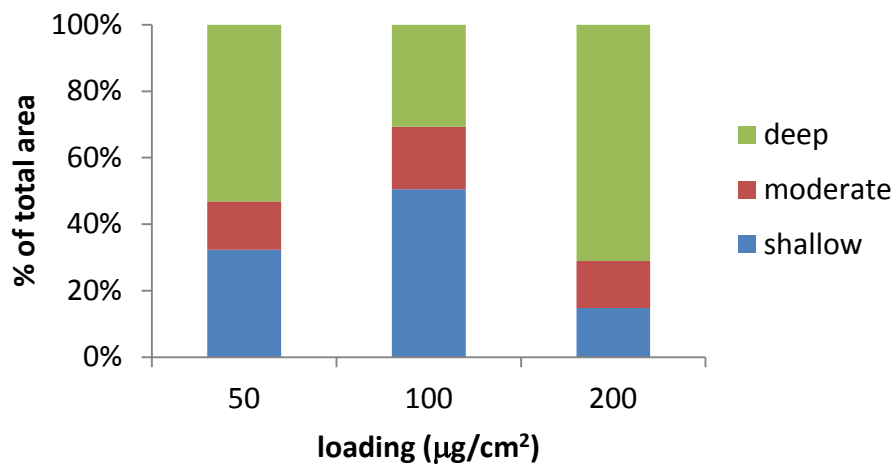
Figure 70. Percentage of corrosion area as a function of site severity for 50 days exposure.

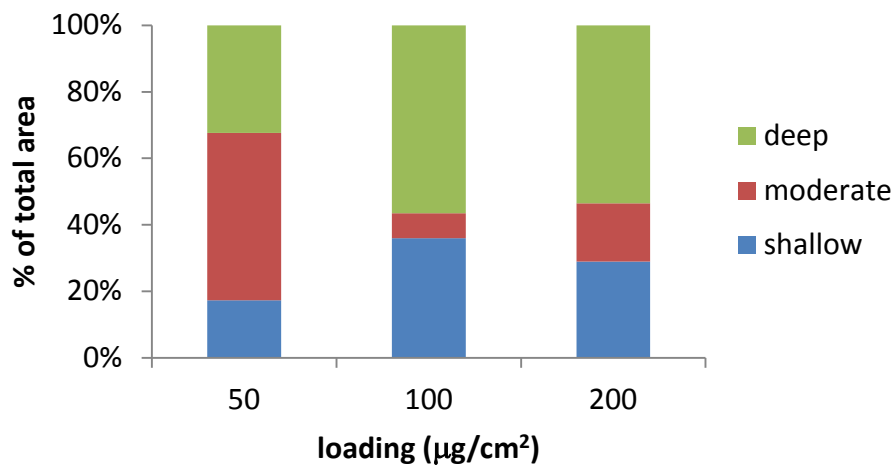
Figure 71. Percentage of corrosion area as a function of site severity for 100 days exposure.
