# ***Normal Conditions of Transport Truck Test of a Surrogate Fuel Assembly***

*Prepared for*  
**U.S. Department of Energy**  
**Used Fuel Disposition Campaign**  
**Paul McConnell, Robert Wauneka,**  
**Sylvia Saltzstein, Ken Sorenson**  
**Sandia National Laboratories**  
**August 29, 2014**  
**SAND2014-20495**  
**FCRD-UFD-2014-000066,**  
**Revision 0.1 (December 15, 2014)**

FCRD-UFD-2014-000066, Revision 0

This report describes a test of an instrumented surrogate PWR fuel assembly on a truck trailer conducted to simulate normal conditions of truck transport.

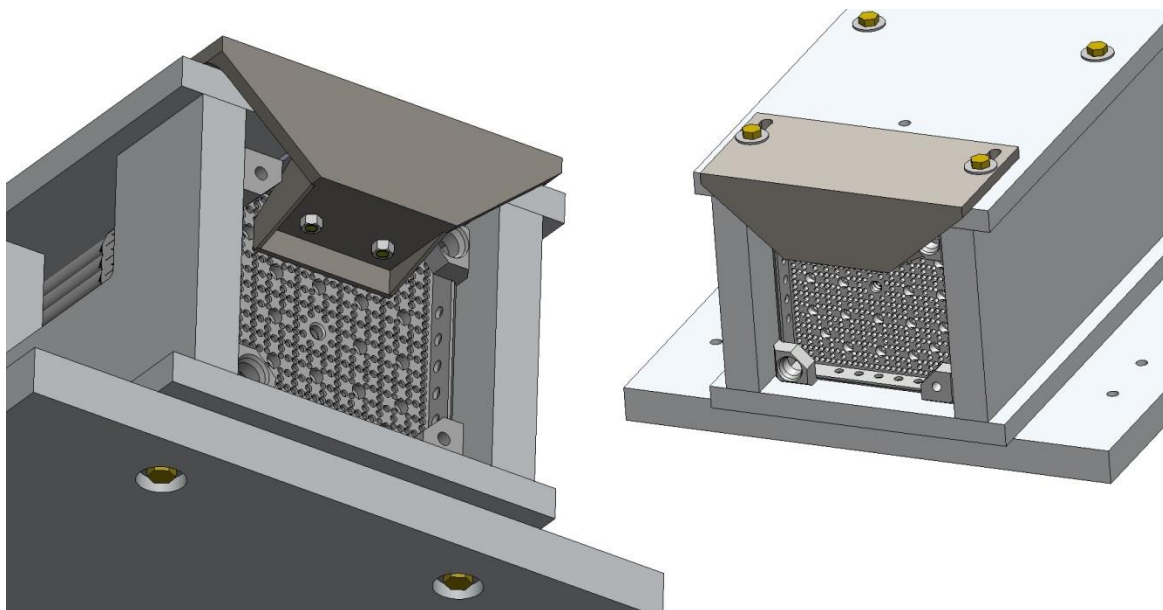
Figure 3.2 Schematic of brackets used to limit possible longitudinal motion of assembly within basket.

In order to ensure that the assembly would not slide forward nor backward out of the basket during the truck test, especially should a hard brake be required during transport, a set of brackets were placed at either end of the basket. These brackets had a lip that was configured below the top plate of the basket that would allow the assembly to slide only 1.25 inch, Figure 3.2.

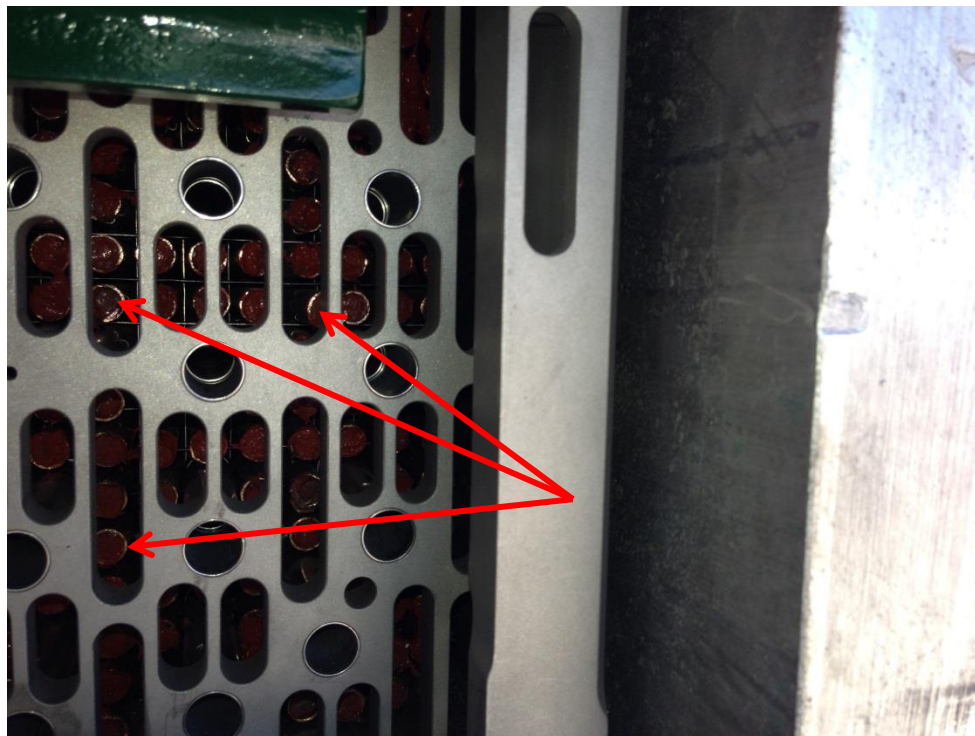
**Figure 3.3 The red arrows point to some of the copper rods that moved longitudinally within the assembly during the truck test.**

Prior to the truck test, a dab of silicone was placed on the edge of these brackets which would contact the assembly if it happened to slide beyond approximately 0.25 inch. Post-test examination revealed that the assembly had not contacted the silicone. It was noted, however, that some of the copper rods within the assembly moved longitudinally during the truck test. Visual examination suggested that the magnitude of this longitudinal motion was less than 0.25 inch (Figure 3.3).

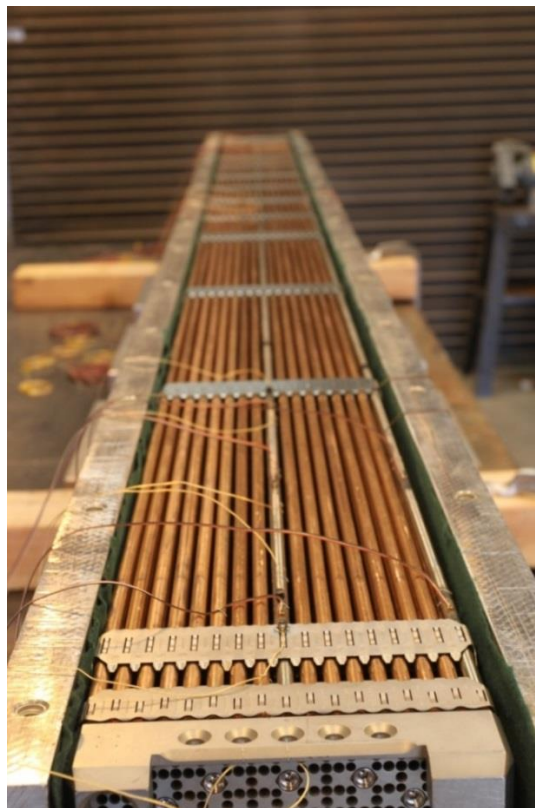
Figure 3.5 Basket / assembly test unit.

Table 3.1 lists the instrumentation. Figure 3.4 shows the location of the strain gauges and accelerometers. Photographs of some of the instrumentation are in Figures 3.5 to 3.9.

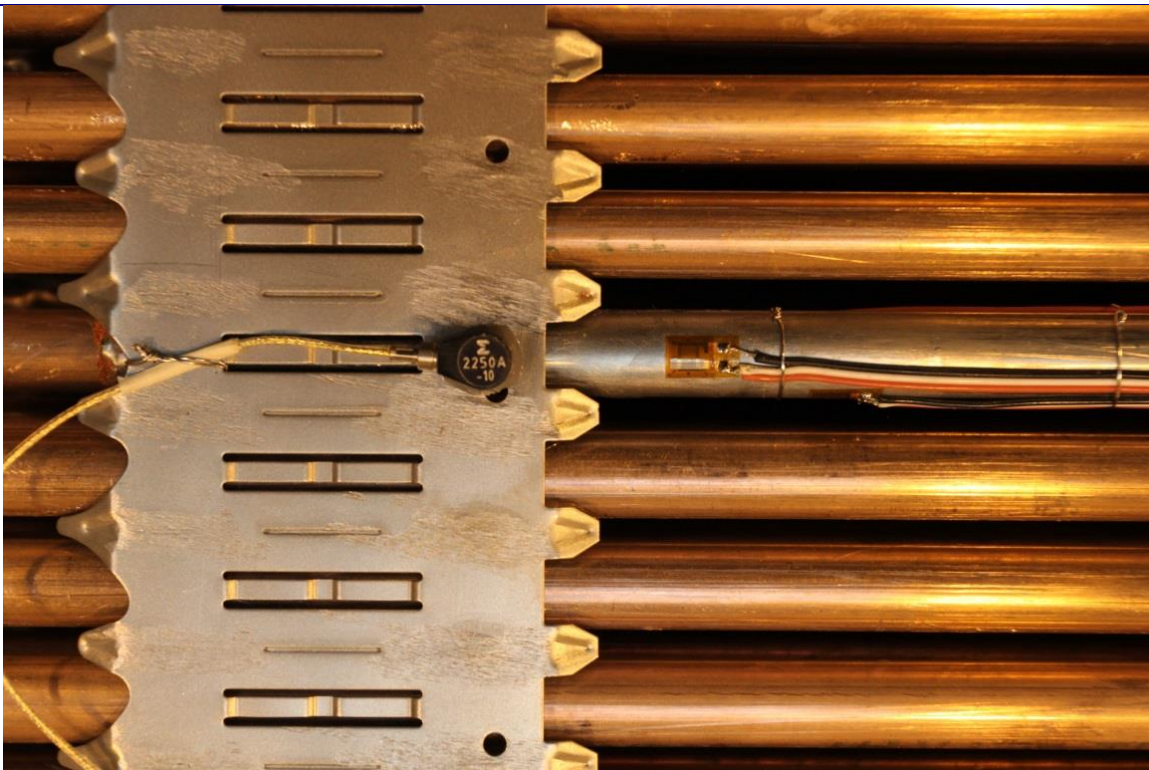
Figure 3.6 Assembly in basket with top plate of basket removed (side plates are visible). This figure shows two Zircaloy-4 rods (center and right edge). Only the center Zircaloy-4 rod was used for the truck test.

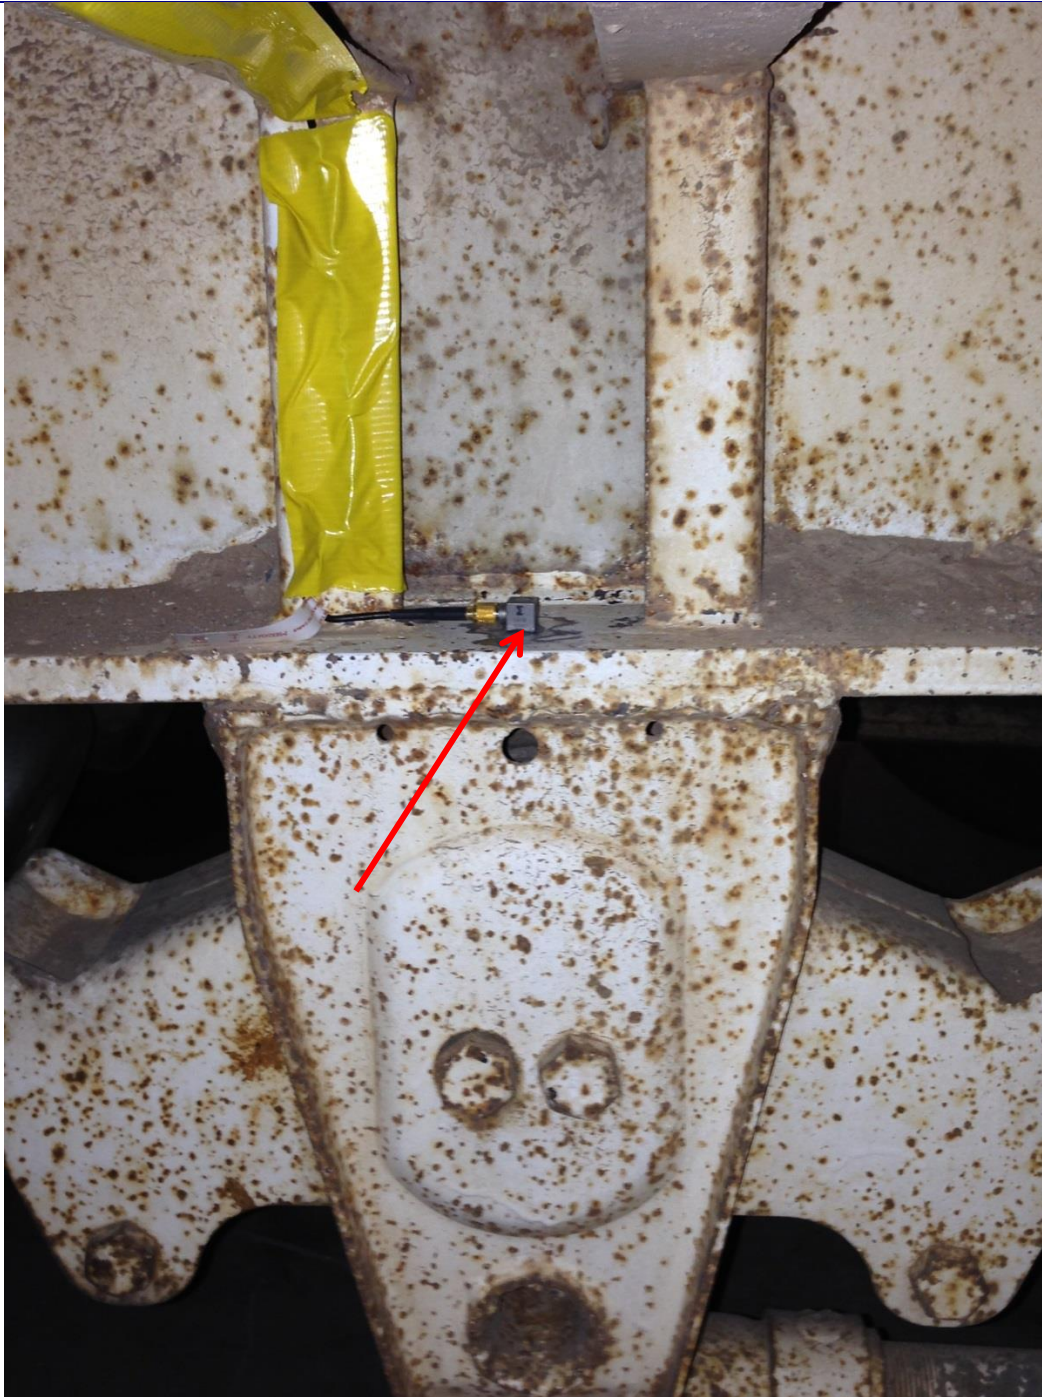
Figure 3.9 Triaxial accelerometer below trailer drop deck above rear axle (see Figures 3.11 and 3.13 and Table 3.1).

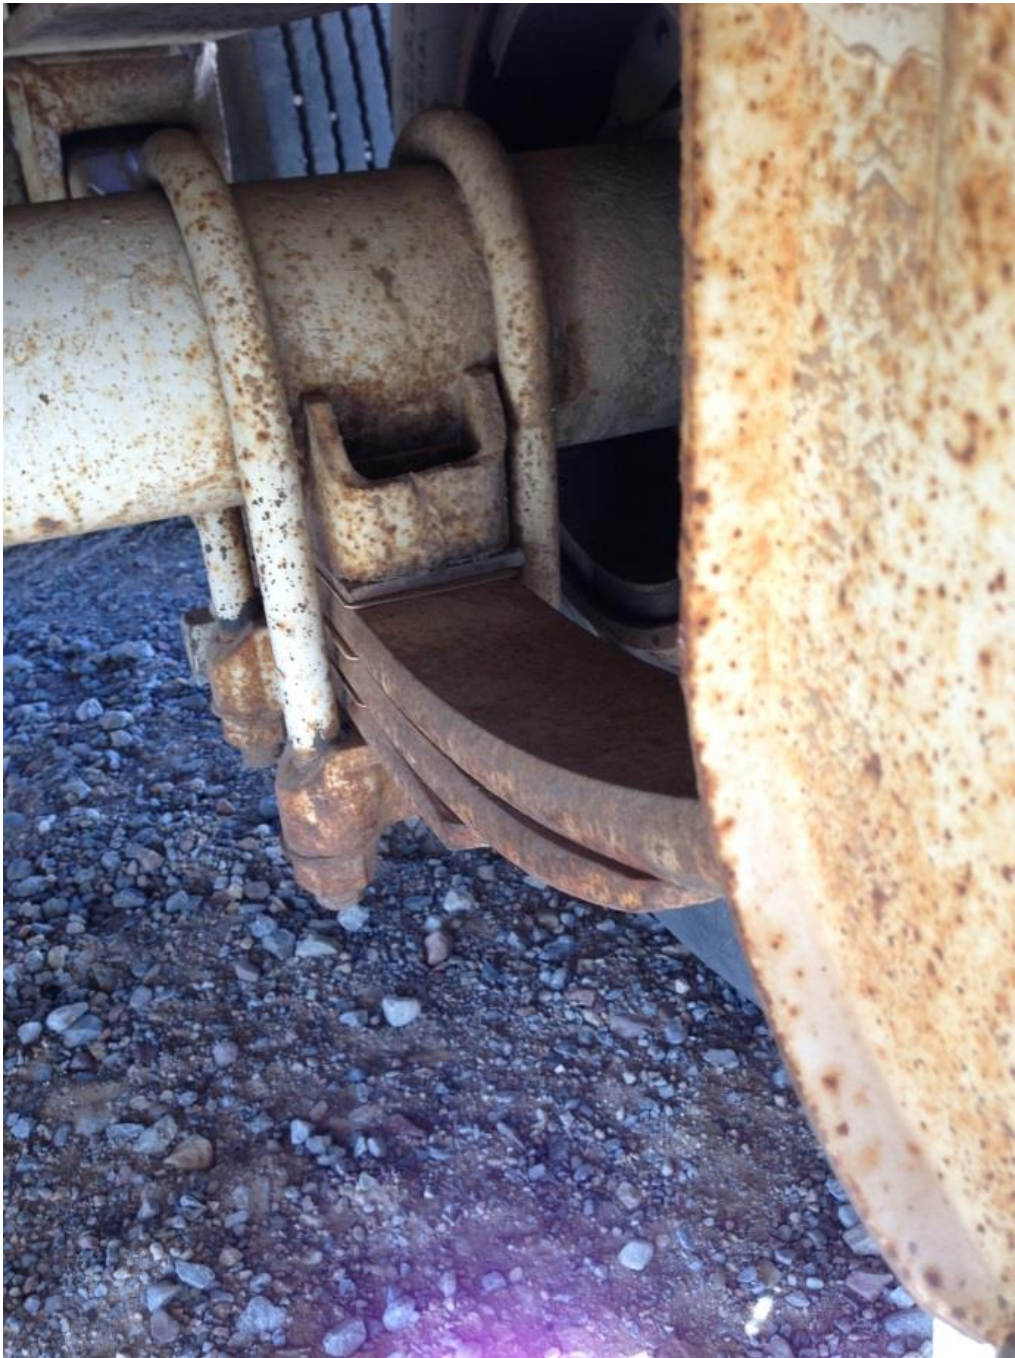
Figure 3.13 Trailer rear spring suspension.

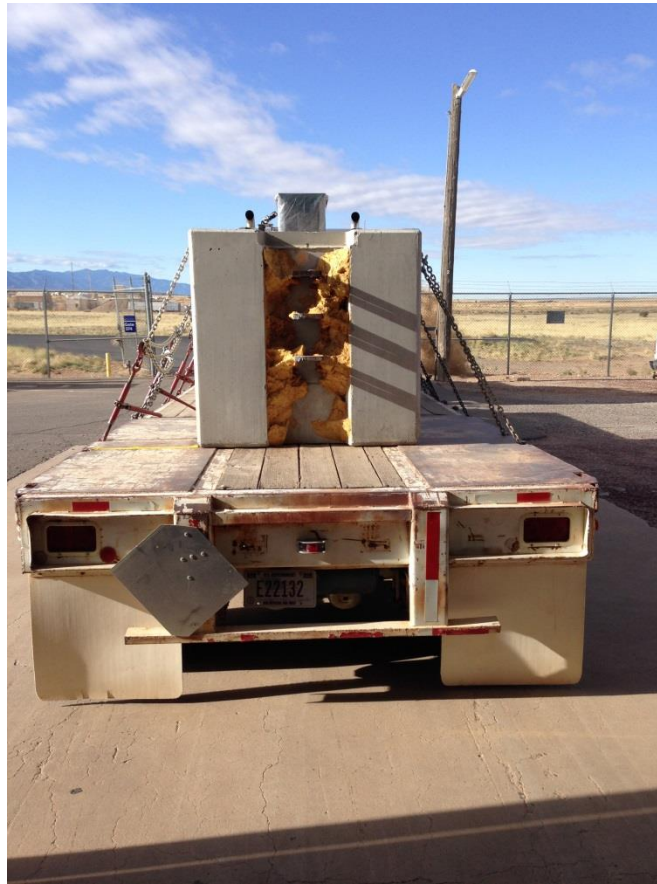
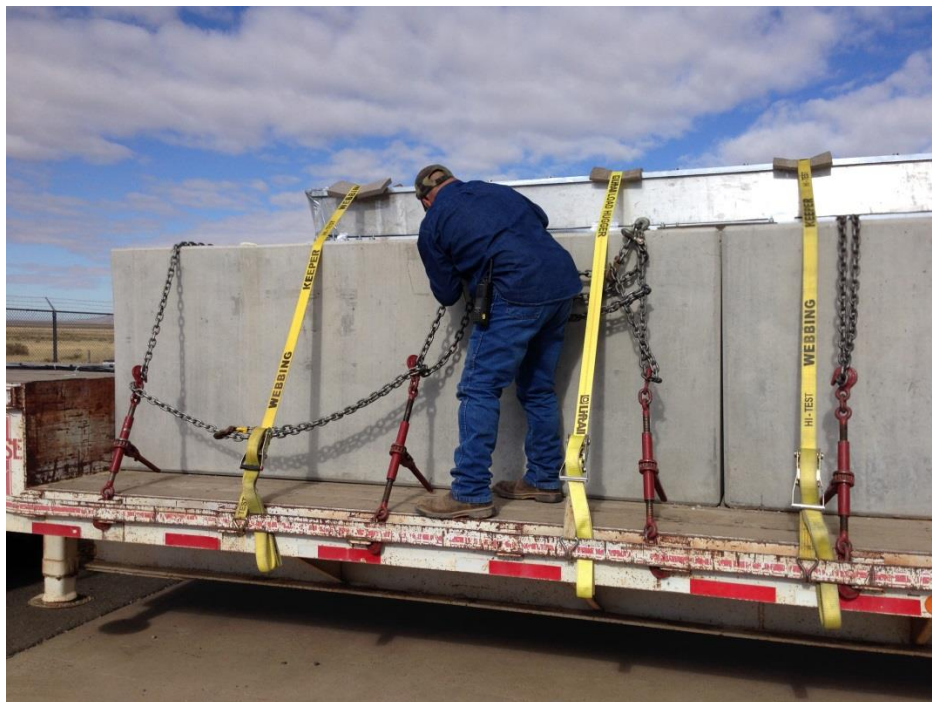
Figure 3.15 Concrete blocks simulating the mass of a truck cask were secured to the trailer. The basket was bolted to the blocks (Figure 3.16).

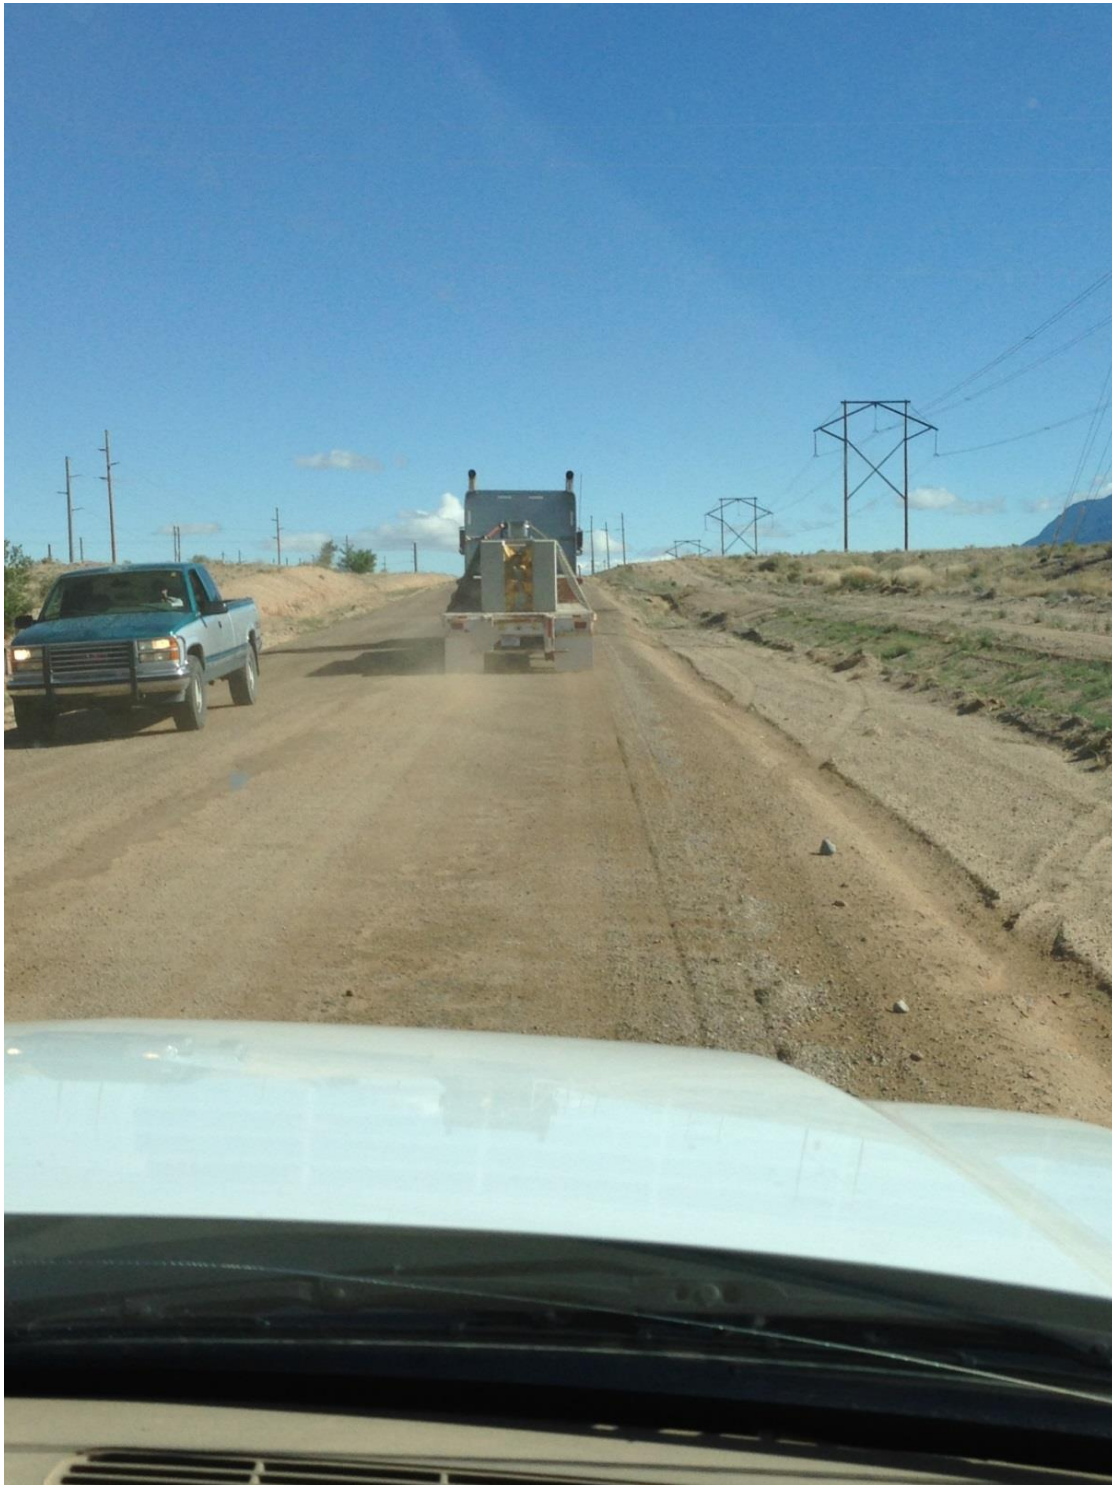
**Figure 4.8 Poleline Road approaching Eubank Contractors' Gate, Segment 1. This potholed, dirt/gravel portion of the truck route resulted in the highest measured rod strains.**

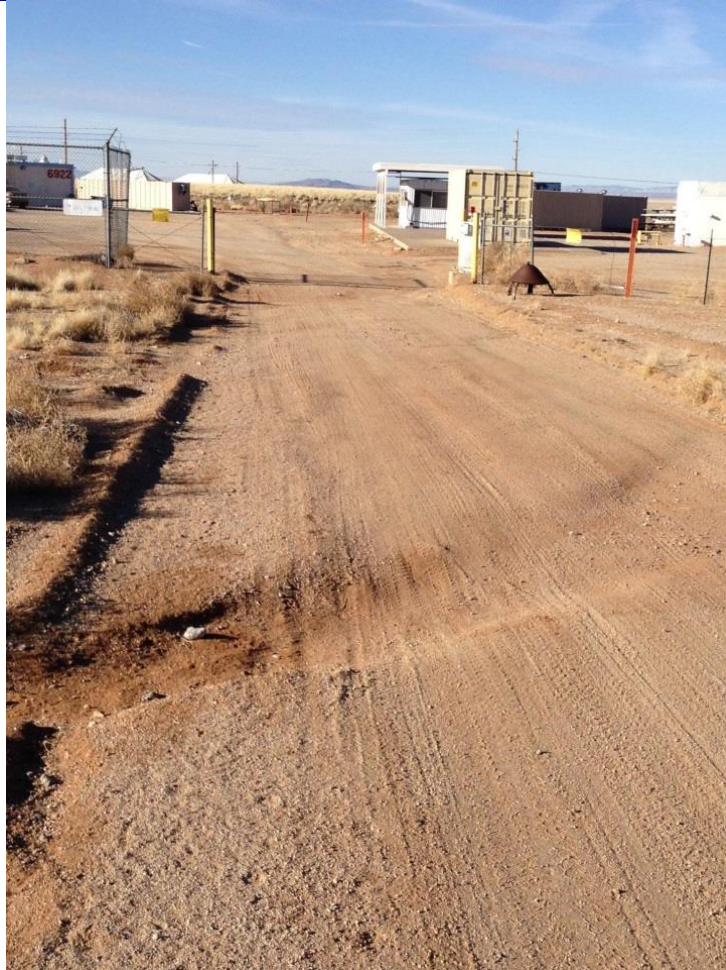
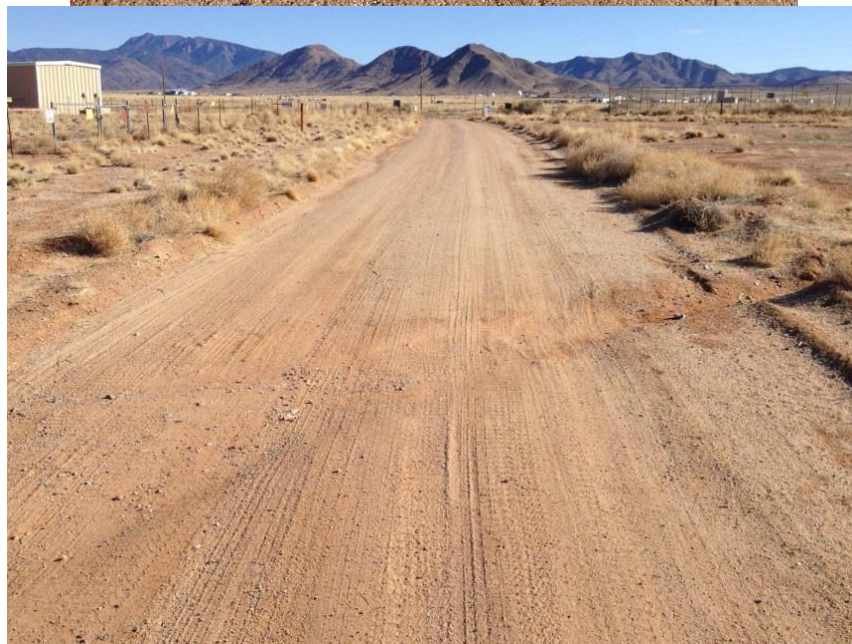
**Figure 4.14** Dirt road into Building 6922 (southwest, top, and northeast, bottom), Area III, end of Segment 5. The trough shown is over 8 inches deep. The truck traveled directly over the deepest portion of the trough.

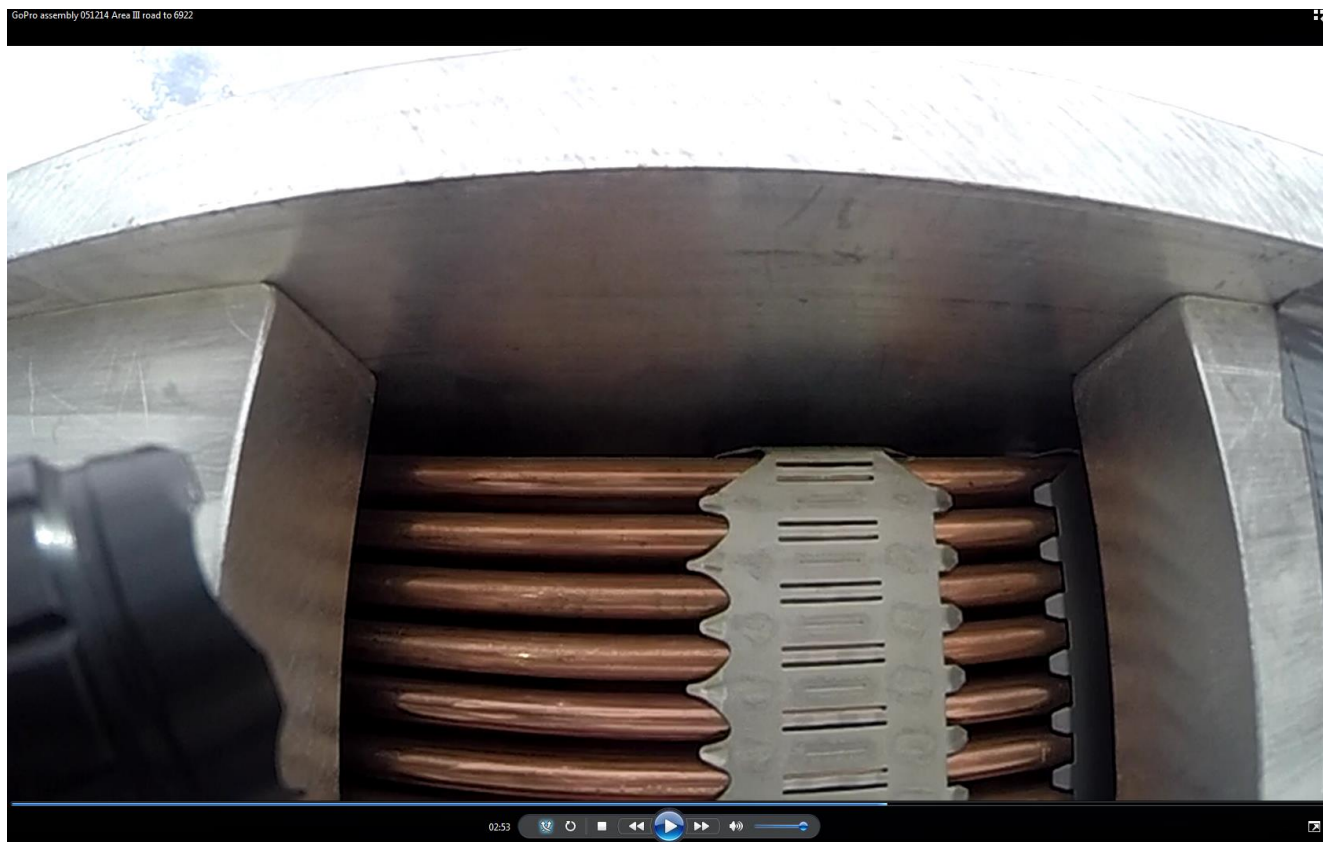
**Figure 5.3** Screen capture of GoPro® .MP4 video file. There was no observed motion of the assembly relative to the inside of the top basket plate or the copper rods relative to one another or relative to the spacer grid in the 4 minute 23 second video (240 frames/second). There was occasionally motion observed between the top edge of the top basket plate relative to the clouds in the sky (note bluish-gray patch in top left corner of figure). The perceived curvature is an artifact of the wide angle view of the video.

A GoPro® HERO3+ camera was attached to the basket (Figure 5.2). A video was taken while the tractor/trailer was driven along the Area III access road (rough asphalt) to Building 6922 (rough dirt). This was done to observe whether the assembly moved relative to the basket or if the rods moved relative to one another. The video was recorded at 240 frames/second. The video speed was subsequently reduced to 30 frames/second. In either version of the video, no motion of the assembly relative to the basket or of individual rods relative to one another was observed (Figure 5.3).

A dab of silicone was placed on top of the assembly spacer grid shown in Figures 5.1 – 5.3 to within about 0.25 inch of the bottom of the top plate of the basket. Post-test examination of the silicone revealed that it had not come into contact with the top plate suggesting that the assembly had not “jumped” vertically during transport.

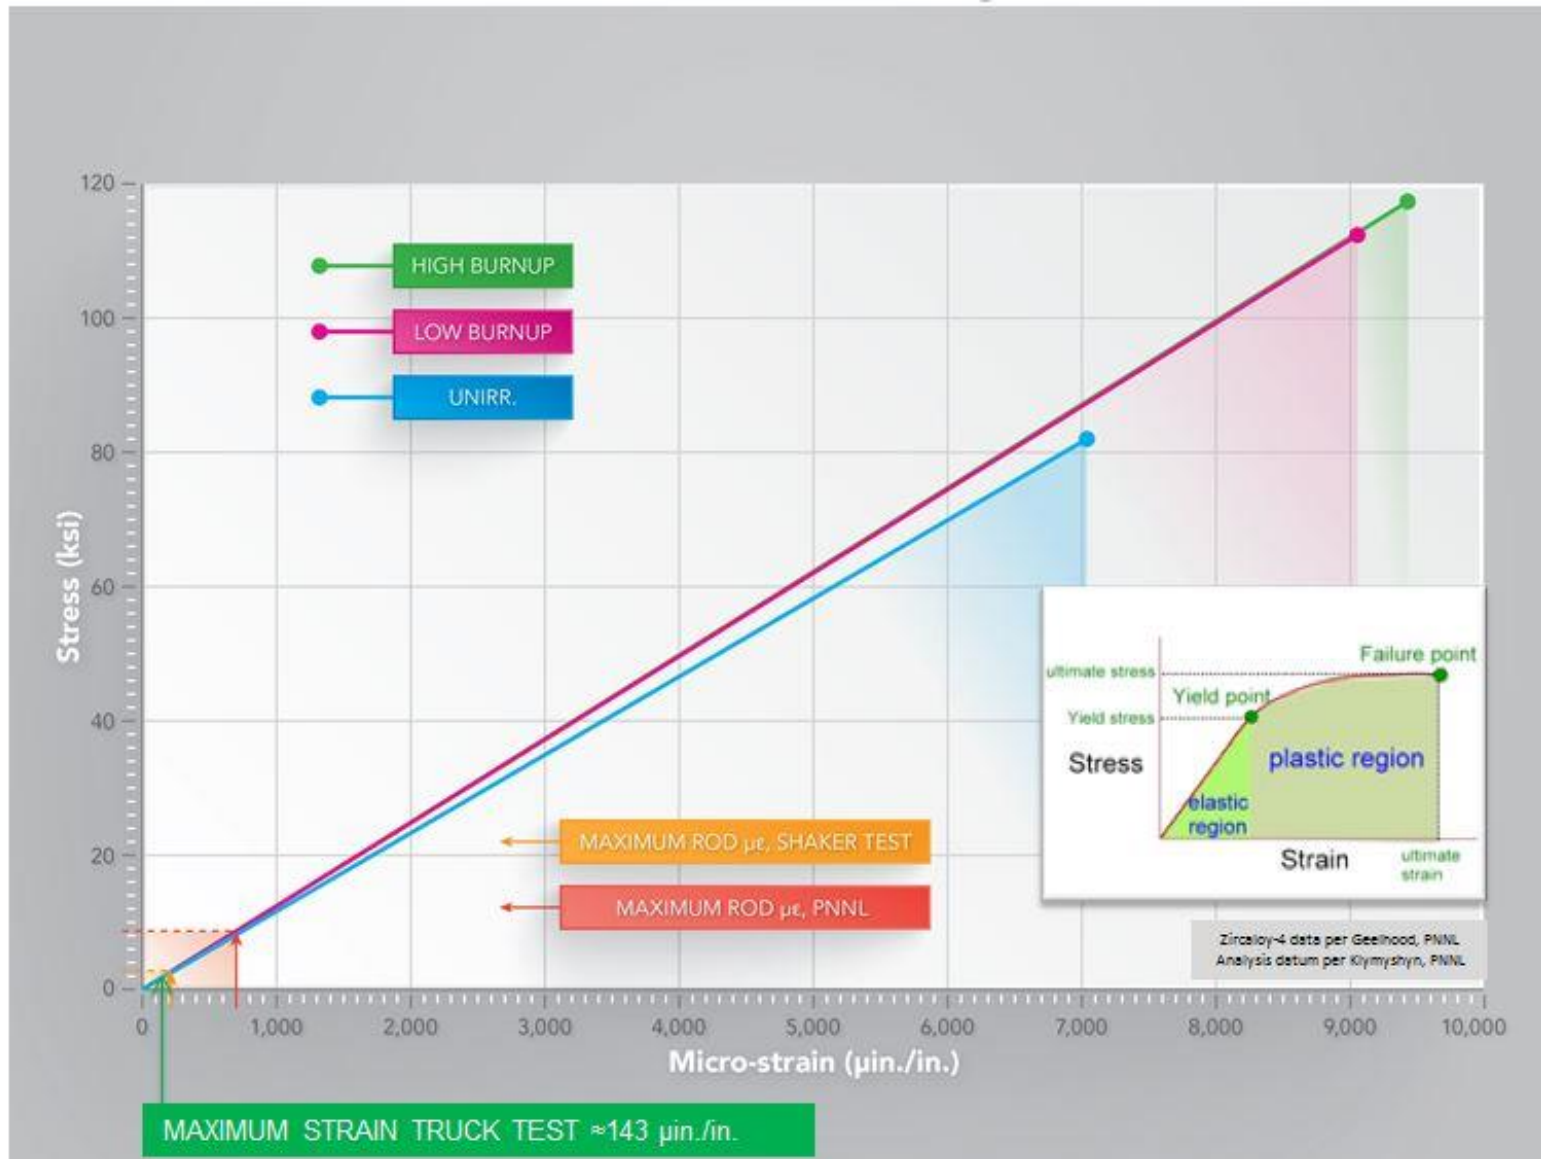
Figure 5.4 Strains on rod measured in truck and shaker tests relative to elastic limit/yield strength of Zircaloy-4.

The stresses<sup>k</sup> corresponding to the maximum experimentally measured strains in both the truck test and the previous shaker tests are approximately 2 - 3 ksi (13.8 - 20.6 MPa) as shown in Figure 5.4, which is a plot of the elastic portion of the stress-strain curves for unirradiated Zircaloy-4 and low-burnup and high-burnup irradiated Zircaloy-4. The figure also shows the maximum strain result from finite element analyses of the shaker tests performed at Pacific Northwest National Laboratory<sup>l</sup>. The figure indicates how low the magnitude of the strains and corresponding stresses were on the Zircaloy-4 rods relative to the elastic limit of unirradiated and irradiated Zircaloy-4. The applied stresses on the rod were low relative to the yield strength of the Zircaloy-4.

The strain data measured during the tests, for shock and vibration loadings, suggest that the axial strains on the rod—and the corresponding applied stresses—are very low in relation to the elastic limit of unirradiated Zircaloy-4 and the estimated elastic limits for low-burnup and high-burnup Zircaloy-4.<sup>r</sup> This suggests that cladding will not fail during NCT via strain- or stress-based failure criteria (Figure 5.4).

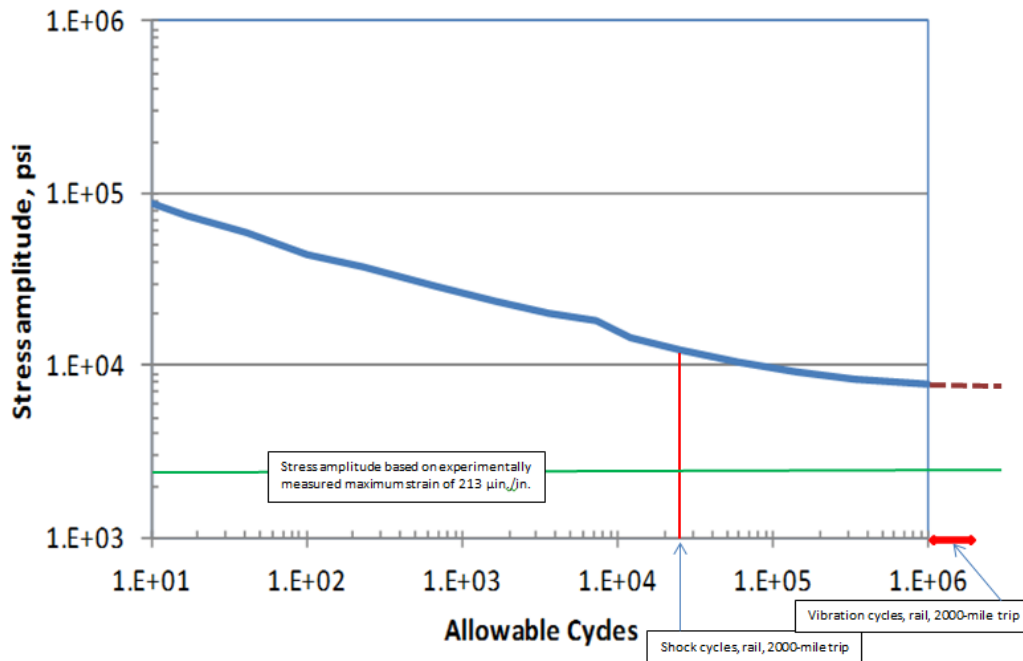
**Figure 5.5 Stress amplitude based upon maximum strain measured in shaker tests relative to irradiated Zircaloy-4 fatigue curve.**

An estimate was made of the number of shocks a rail car may experience in a typical 2000-mile trip and the number of vibrations over the same distance. The number of shock cycles was estimated to be approximately 25000 and the number of vibration cycles was estimated to be approximately 1000000 to 2000000<sup>t</sup>. Based upon the fatigue curve in Geelhood and Beyer relative to the stress amplitude for cyclic loading based upon the maximum strain measured in the shaker tests, it appears that a fatigue crack would not initiate in Zircaloy-4 cladding, Figure 5.5.
