Final Environmental Assessment on the Disposition of Five Signature Properties at Idaho National Laboratory

**U.S. Department of Energy
Idaho Operations Office**

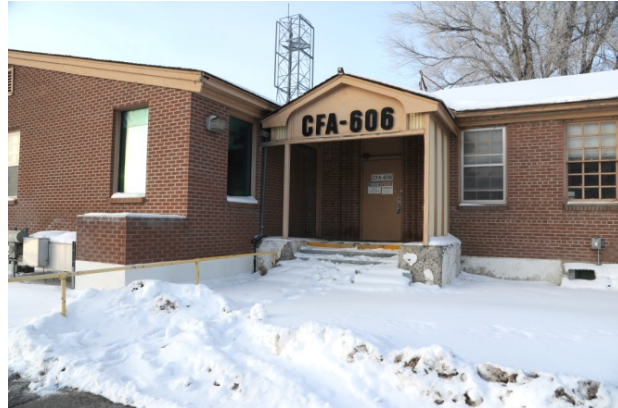
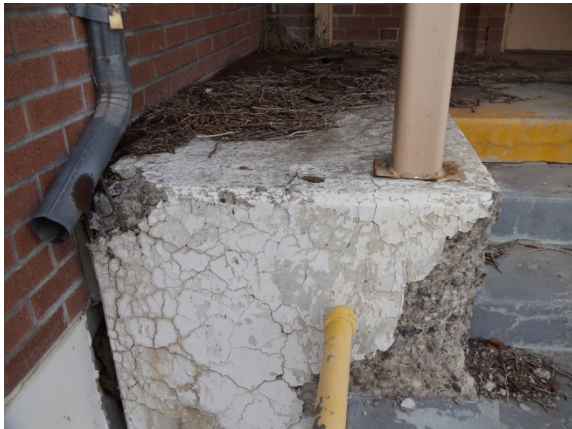
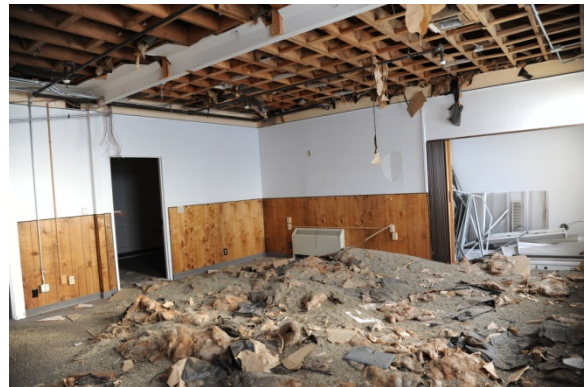
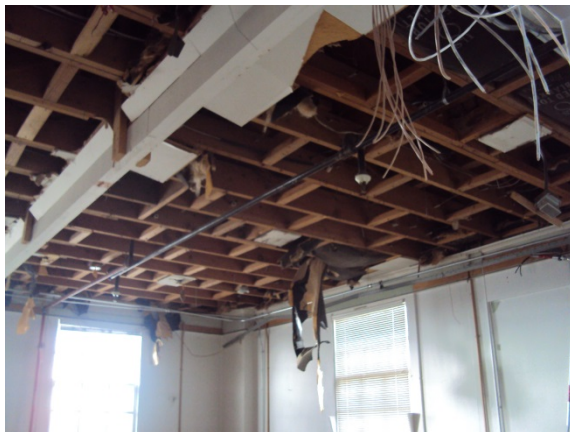
2.1 Marine Barracks – CF-606

CF-606 was constructed in 1943. It is a 5,325 square foot brick one story building with a basement. The building is in a cold and dark condition with all utilities disconnected (hazardous, not compliant with code), and the boiler has been removed. The exterior appears to be in relatively good condition with both the above-grade structure and the basement walls in good condition, with very few settlement cracks. The concrete has significant deterioration around the front entrance, window wells, and basement entrance, possibly from freeze-thaw action and inadequate air entrainment in the concrete. These areas would require repair or replacement.

There does not appear to be significant water damage to the structure itself. There is some cosmetic damage to some basement walls from inadequate caulking around conduit. The interior is significantly damaged; this includes the wall board, paneling, ceiling tiles, flooring, and insulation. The ceilings in some rooms have

collapsed. In addition, numerous health and safety hazards are present throughout the building; these include asbestos, hantavirus from rodent infestation/droppings, mold, and lead based paint.

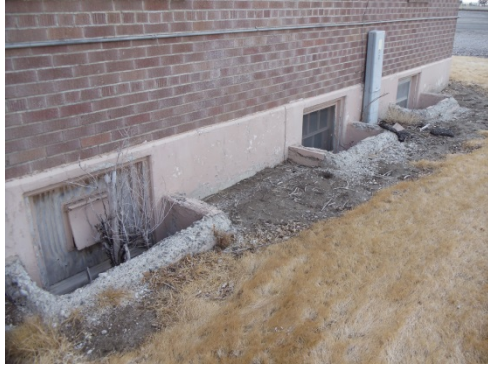
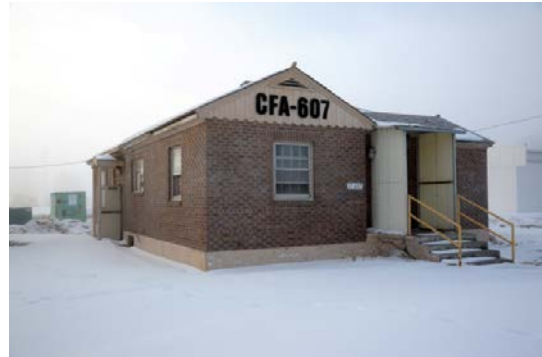
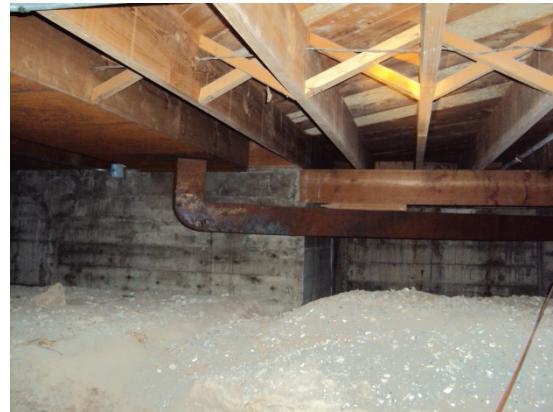
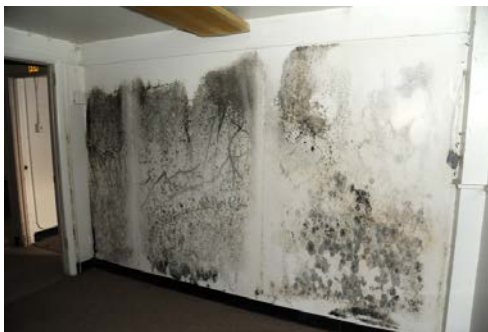
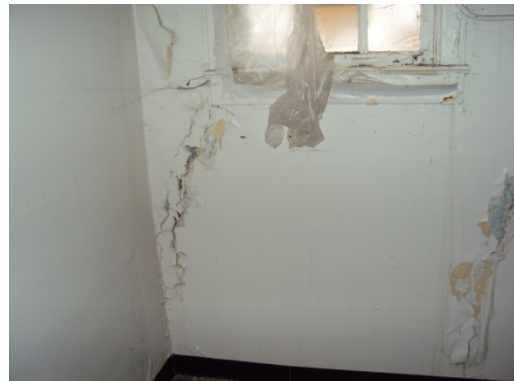
2.2 Scoville Officers Quarters – CF-607

CF-607 was constructed in 1942. It is a 2,228 square foot brick masonry building with 1,396 square feet above grade and 832 square feet below grade. The building is in a cold and dark condition with all utilities disconnected (hazardous, not

compliant with code), and the boiler, although still in place, is not operable. The exterior is in good condition; the basement wall does have structural cracking at several locations. The entrance and window well concrete is deteriorated

and would require replacement. The cedar shake roof is in good condition but requires maintenance such as sealing to prevent deterioration. The exterior wood trim requires painting and caulking maintenance. The windows and exterior doors in this structure will need to be replaced. The floor joists and roof trusses appear to be dry and no evidence of rot was found; both adequately support the loads applied. The interior is generally in poor condition, with a few rooms appearing to be in relatively good condition. The finishes would

need to be removed and replaced throughout, including flooring, ceiling tile, restroom fixtures, etc. There is mold on some walls, and it is assumed to be behind other walls. Numerous health and safety hazards are present throughout

the building; these include asbestos, hantavirus from rodent infestation/droppings, mold, and lead based paint.

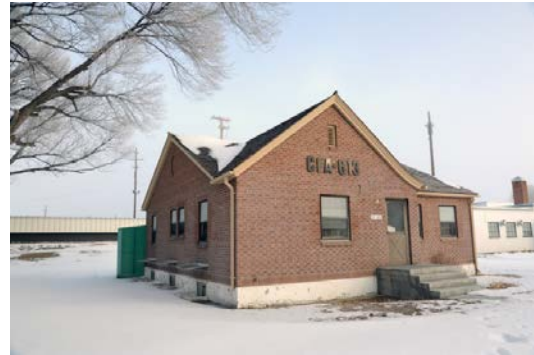
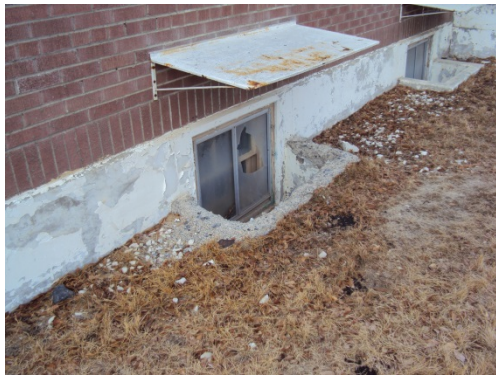
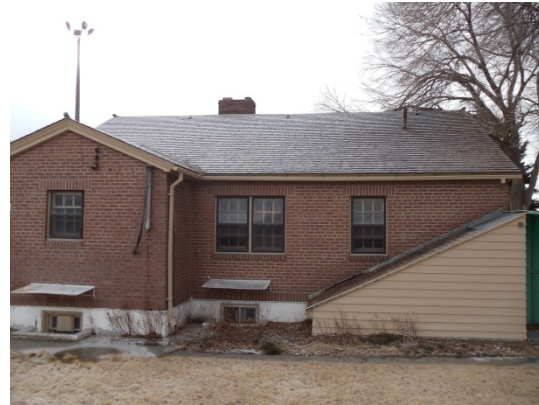
2.3 Bunkhouse – CF-613

CF-613 was constructed in 1942. It is a 2,697 square foot brick building with a concrete foundation and basement. The building is in a cold and dark condition with all utilities disconnected (hazardous, not compliant with code), and the boiler, although still in place, is not operable. In 1994, doors with weather-stripping and automatic door closers were installed to bring the existing smoke resistive walls up to code. The building is in good condition with no signs of structural cracking or excessive settlement noted in the masonry structure or the foundation. The window well concrete and exterior stair wing-wall concrete is deteriorated and should be replaced. The

roof appears to be in good condition. The front steps were replaced several years ago and are in good condition. The interior is in better condition than that of other NPG buildings; however, in some rooms the ceiling appears to be sagging

and near collapse. During the assessment, the sound of rodents in the ceiling was noted. It is unknown what is causing the ceiling to appear to be sagging until further inspections are conducted. Numerous health and safety hazards are present throughout the building; these include asbestos, hantavirus from rodent infestation/droppings, and lead based paint.

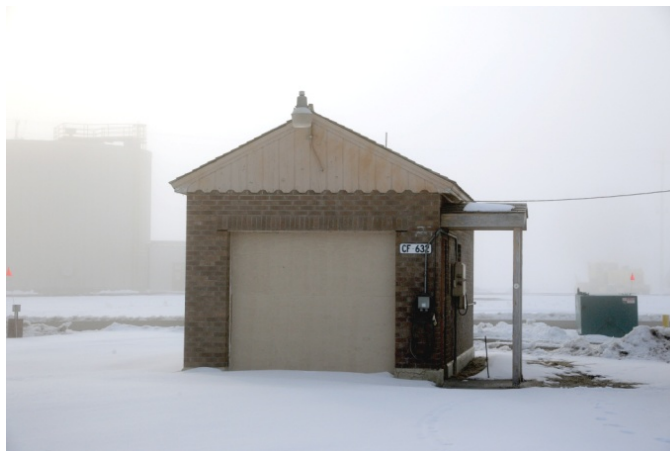
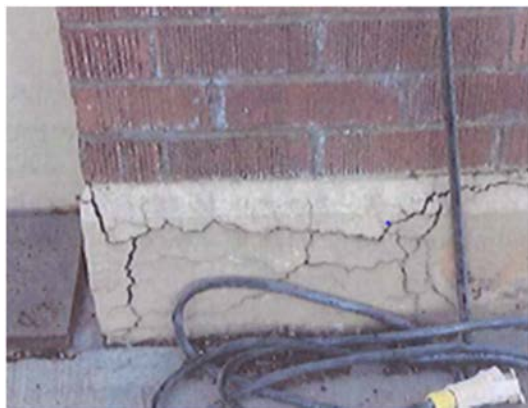
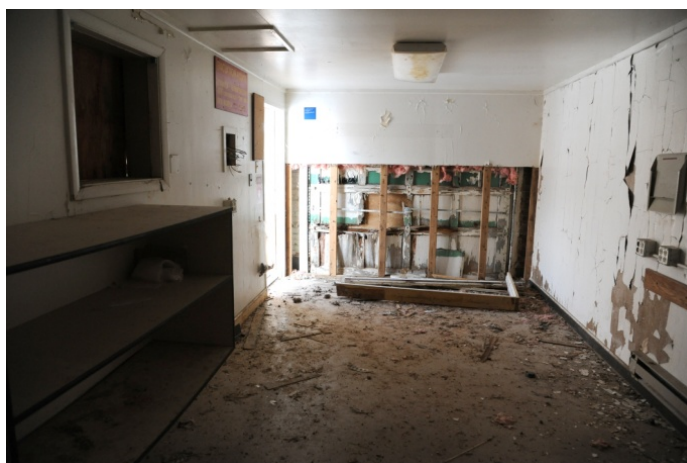
2.4 Single Car Garage – CF-632

CF-632 was constructed in 1945. It is a 300 square foot brick single car garage with a concrete foundation and a concrete pad. The building is in a cold and dark condition with all utilities disconnected (hazardous, not compliant with code). The brick exterior appears to be in relatively good condition. The concrete foundation is deteriorating in several locations. The roof has signs of damage, and the doors need further inspection to verify integrity. The interior is in poor condition, and there are signs of a significant pest infestation problem. Numerous health and safety hazards are present including asbestos, hantavirus from rodent infestation/droppings, mold, and lead based paint.

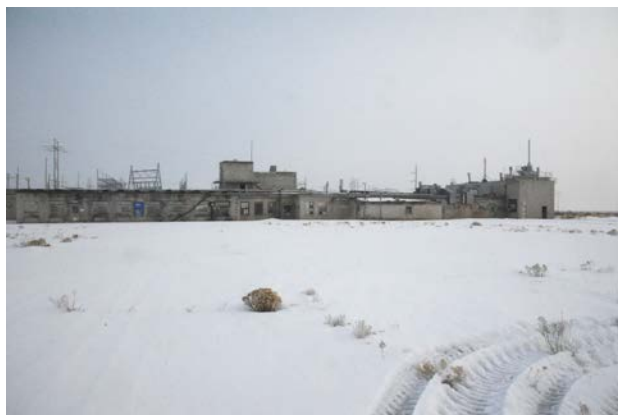
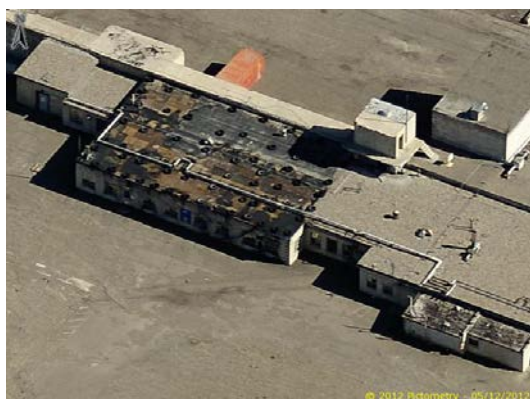
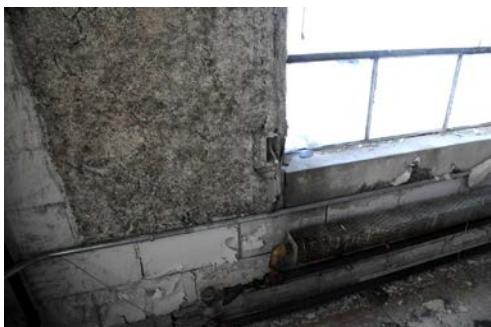
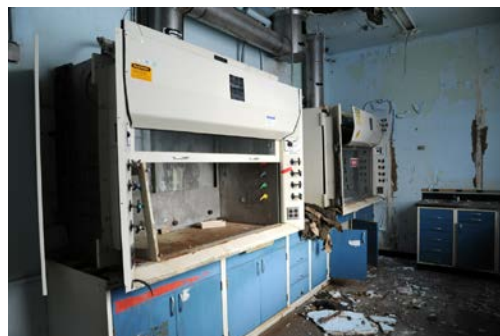
2.5 Ordnance Offices – CF-633

CF-633 was constructed in 1942. It is a 19,833 square foot building with original construction consisting of reinforced concrete that was designed to withstand the blast effect from naval gun testing. An eight foot thick concrete blast wall protected the building from the blast forces. The building has been modified, enlarged, and added on to multiple times over the years and lastly occupied by the INL Health Physics Instrument Laboratory. The additions have used a variety of construction materials and methods such as precast double tees, precast panes, steel joists and decking, timber beams, and concrete slabs. The building is in a cold and dark condition with all utilities disconnected (hazardous, not compliant with code).

The exterior of the building shows significant signs of deterioration. A structural evaluation and analysis was performed in 1996 (LITCO, 1996). The conclusion is summarized as follows:

The portion of the facility located on the south side of the blast wall poses the greatest seismic risk with little margin of safety. Many components of the facility are overstressed, resulting in low

allowable load capacities. The poor condition of the facility is indicative of age and response to the imposed loads. The deterioration of the facility will only

continue at an increased rate. The 1996 report recommends making plans to discontinue use of the facility, which has occurred, and the condition of the facility has only decreased. Based on the analysis performed, use of CF-633 was discontinued.

The interior shows signs of significant deterioration; the condition varies depending on location within the building. The floors, ceilings, and walls all have damage. In several places, water damage has occurred due to leaks from the roof or from ruptured water pipes. Numerous hazards are present throughout the building, these include radiological contamination (fixed), asbestos, hantavirus from rodent infestation/droppings, mold, and lead based paint.

- Retaining the original portions of CF-633, including the concussion wall, observation tower, powder rooms, gantry crane, gun abutments, and railroad tracks. The demolition process will be monitored to ensure that all precautions are taken to
