**Removal Action Completion Report
for Phases I and II of the
X-334 Transformer Cleaning/Storage Building
at the Portsmouth Gaseous Diffusion Plant
Piketon, Ohio**

**U.S. Department of Energy
DOE/PPPO/03-0224&D1**

**Prepared by:
Fluor-B&W Portsmouth LLC, under Contract DE-AC30-
10CC40017**

FBP-ER-RDRA-RPT-0037, Revision 3

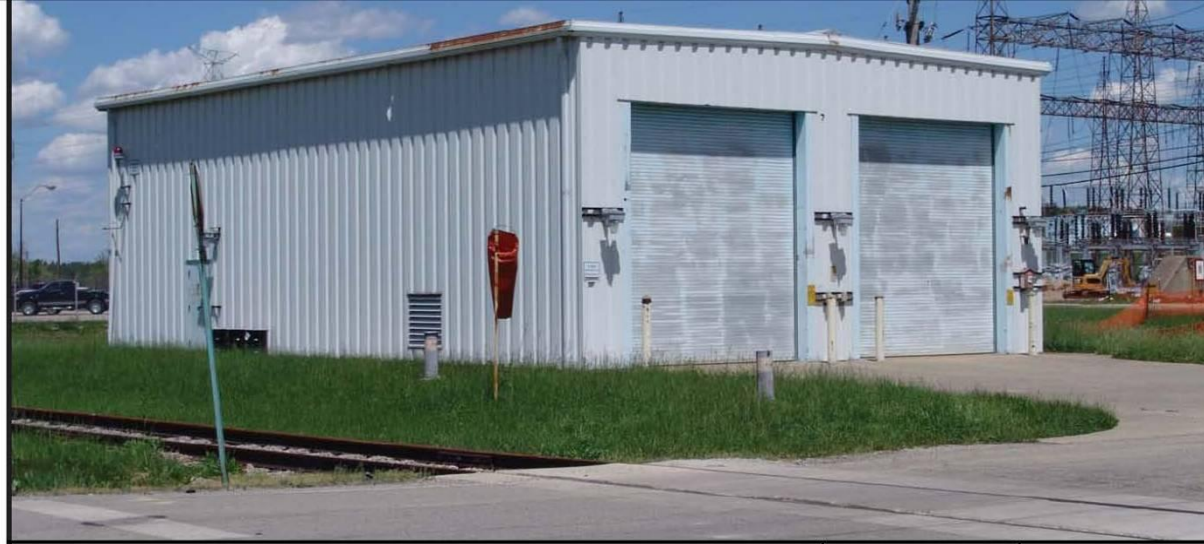
Figure 3. Photograph of X-334 Building before demolition, facing northeast

Built in 1985, the X-334 Building was a 2500 sq-ft, one-story, steel building on a diked concrete slab. The slab sloped towards a blind sump located in the north central part of the slab. The building housed storage tanks containing polychlorinated biphenyl (PCB) oils and PCB-contaminated kerosene. Liquids recovered in the sump were pumped to a storage tank pending their final disposition. Previous operations included repair of electrical equipment from the X-530A and X-533A Switchyards and the X-600 Steam Plant. The facility was used for this purpose from its construction through the middle of 1994. A 2000-gallon fiberglass reinforced plastic underground storage tank was installed in 1985 outside of the southeast corner of the building. The tank, formerly used to store kerosene, was removed on August 19, 2003, in accordance with the State of Ohio's underground storage tank regulations. The Ohio Bureau of Underground Storage Tank Regulations issued a No Further Action letter on March 8, 2004. In

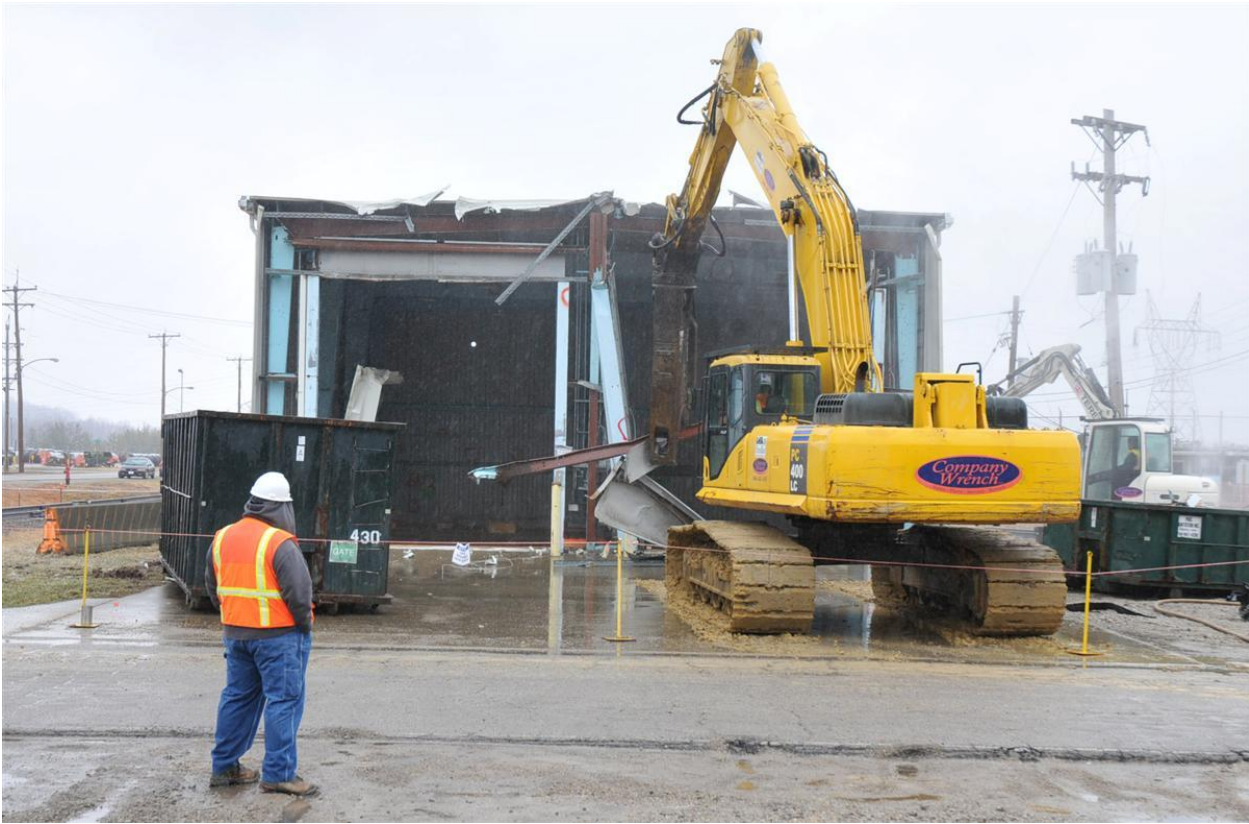
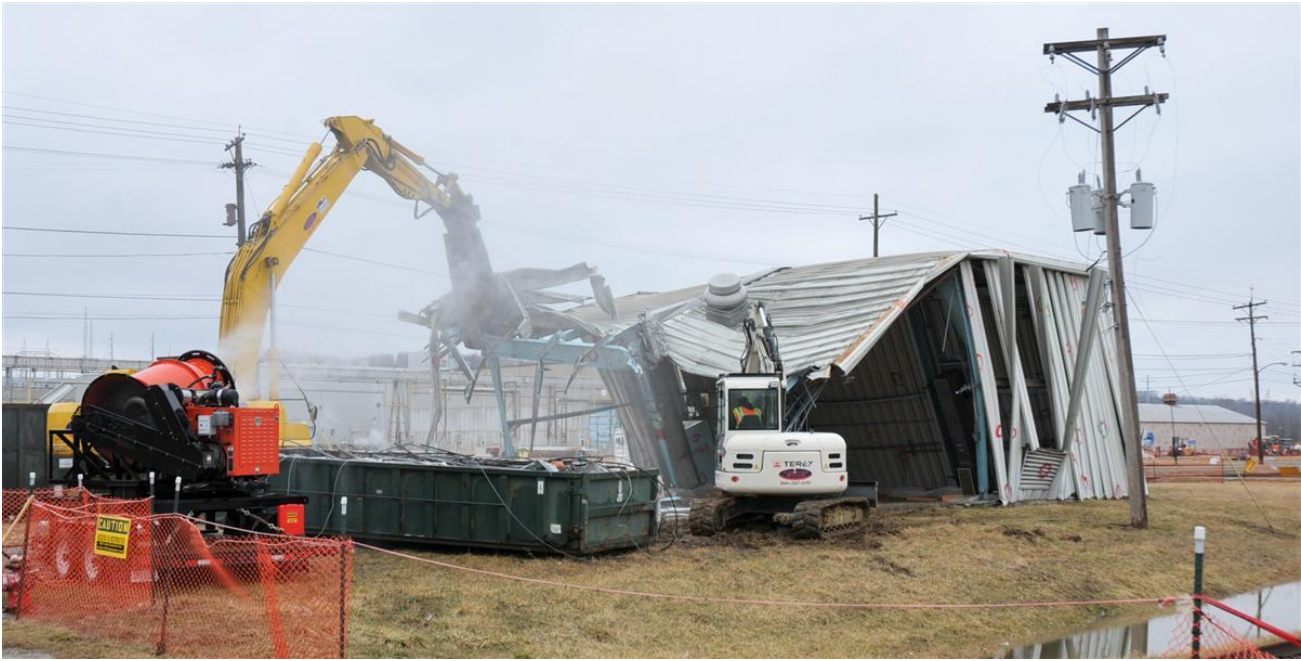
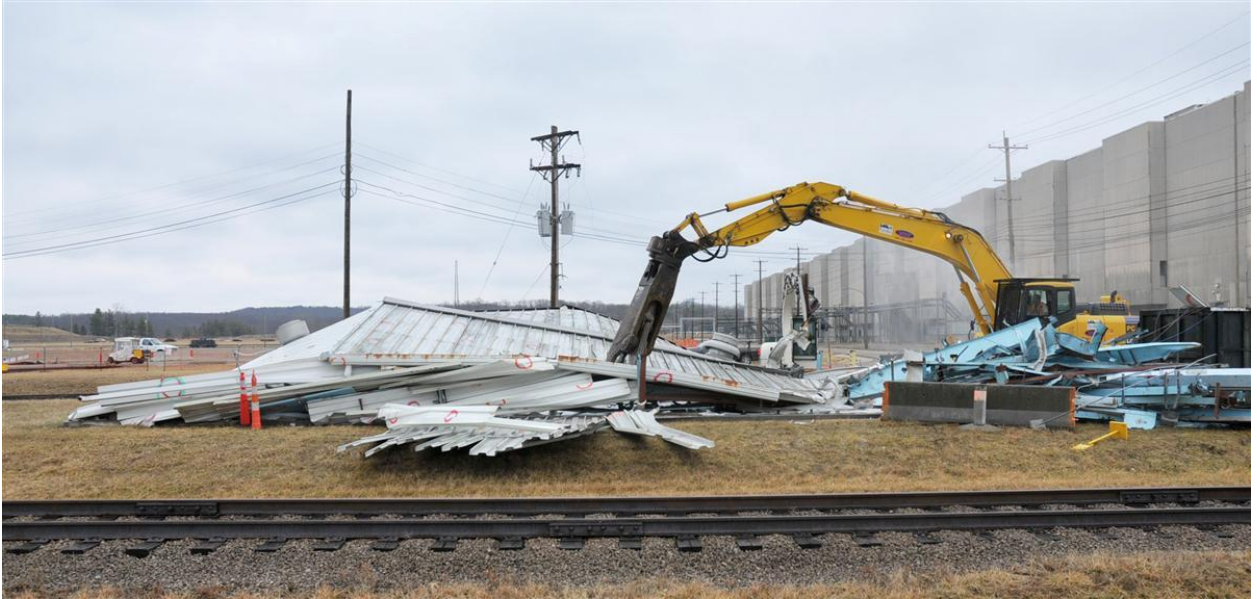
Photo 5. X-334 Building demolition

Photo 6. X-334 Building demolition

Photo 7. X-334 Building demolition

After the slab was covered with poly sheeting and plywood (see Section 1.5), controlled demolition of the X-334 above-grade structure was performed by positioning equipment and waste/recycling containers strategically to maximize demolition rates, minimize the distance between debris and containers, and prevent unsafe conditions. Demolition of the above-grade structure was completed in a manner such that the underlying slab was not cracked or otherwise damaged. Excavators were used to demolish the building frame and walls and shear the rubble to reduce it to a manageable size. The X-334 Building structural steel, steel siding and other demolition debris were loaded into containers and disposed. (See Table 2.) During Phase I, water was sprayed to minimize fugitive dust emissions.

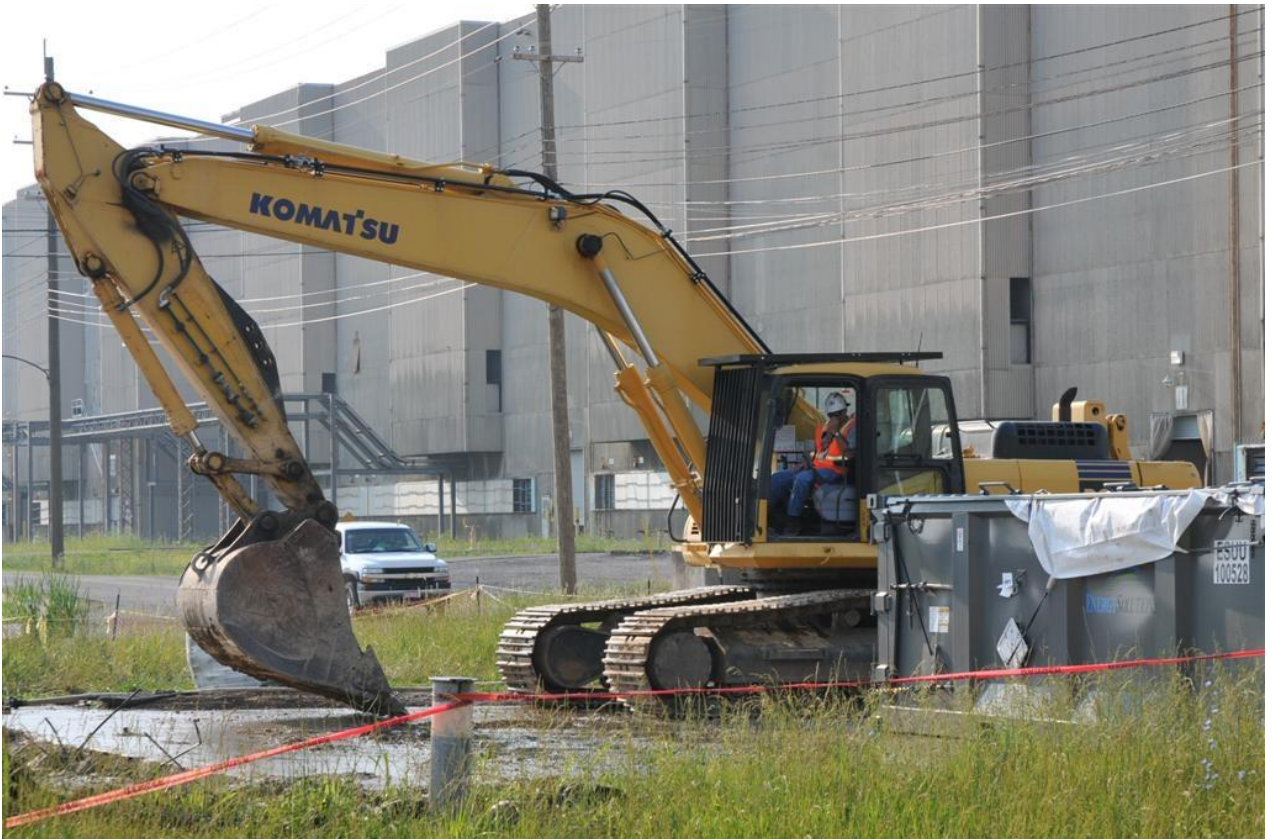
Photo 8. Slab removal

An excavator equipped with a power chisel was used to break the X-334 concrete slab, and an excavator equipped with a concrete processor was used to size reduce the concrete pieces. The processed concrete was then loaded into containers for disposal. Small quantities of soil which adhered to the slab were managed with the concrete.

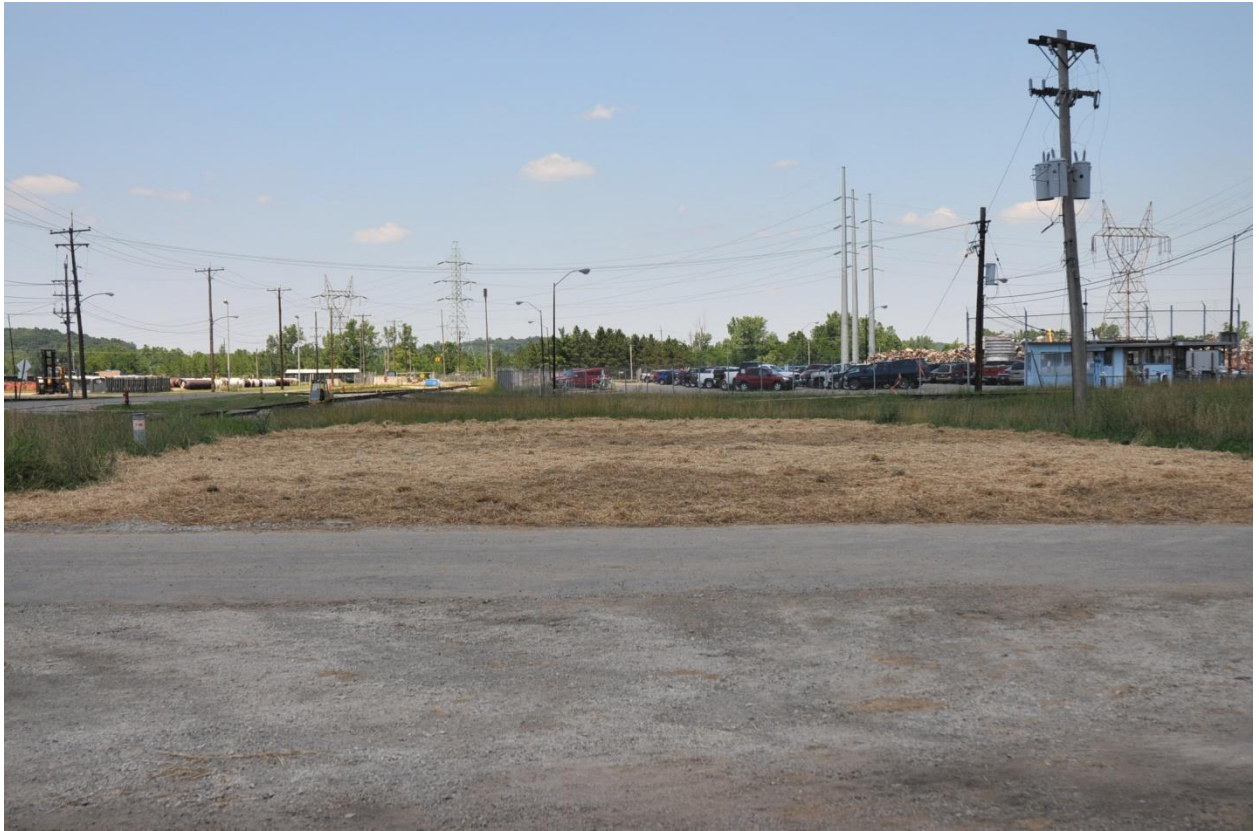
Photo 9. Former X-334 Building site

Following completion of the Phase II demolition activities, the site was re-contoured to promote natural drainage and prevent pooling of stormwater. The site was then seeded and mulched with straw to promote rapid growth of grass cover.
