## LED Lighting in a Performing Arts Center

**Host Site:** University of Maryland,  
College Park, Maryland

# University of Maryland Wall Washer Retrofit LED Modules Replace Halogen Lamps in a Performing Arts Center

PNNL-24437

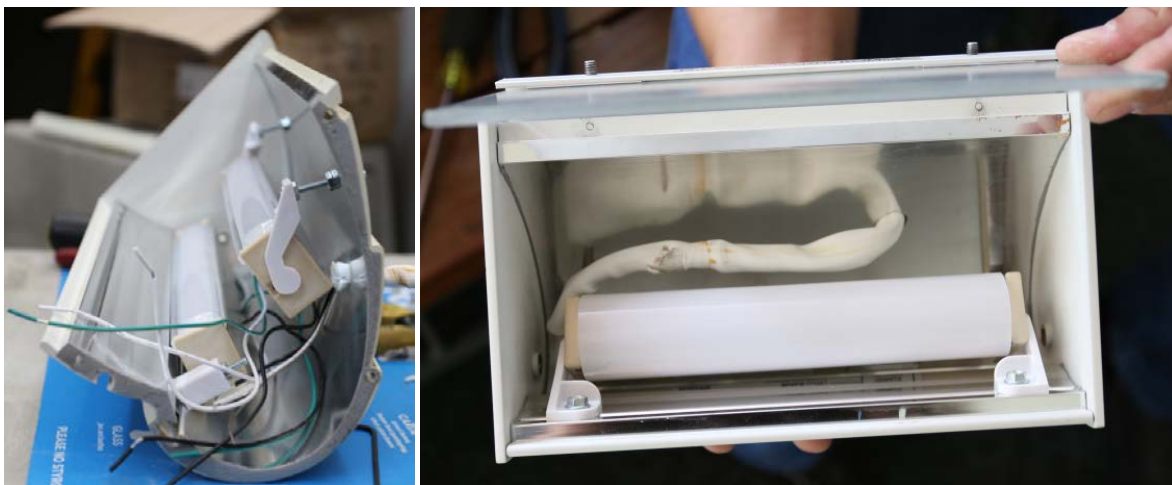
**Figure 2. LED Modules in Existing Wall Washer Housings.** The left image is a side view of the large wall washer housing with two LED modules and the right image is a front view of the small wall washer housing with one LED module.

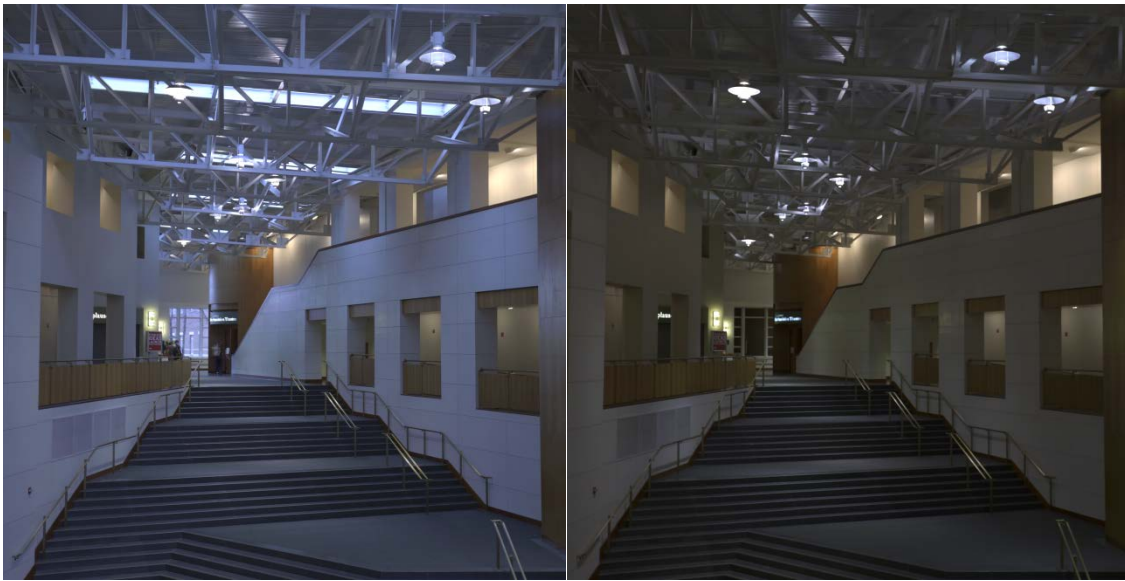
**Figure 4. Interior View of the UMD CSPAC Atrium.** The wall washers illuminate the hallways that line the atrium during the day (left) and evening (right) as well as some surrounding areas. The brightness of the hallways is faint during the day compared to the daylight washing the main walls of the atrium; however, in the evening these perimeter hallways play a more dominant role in the visual appearance of the space.

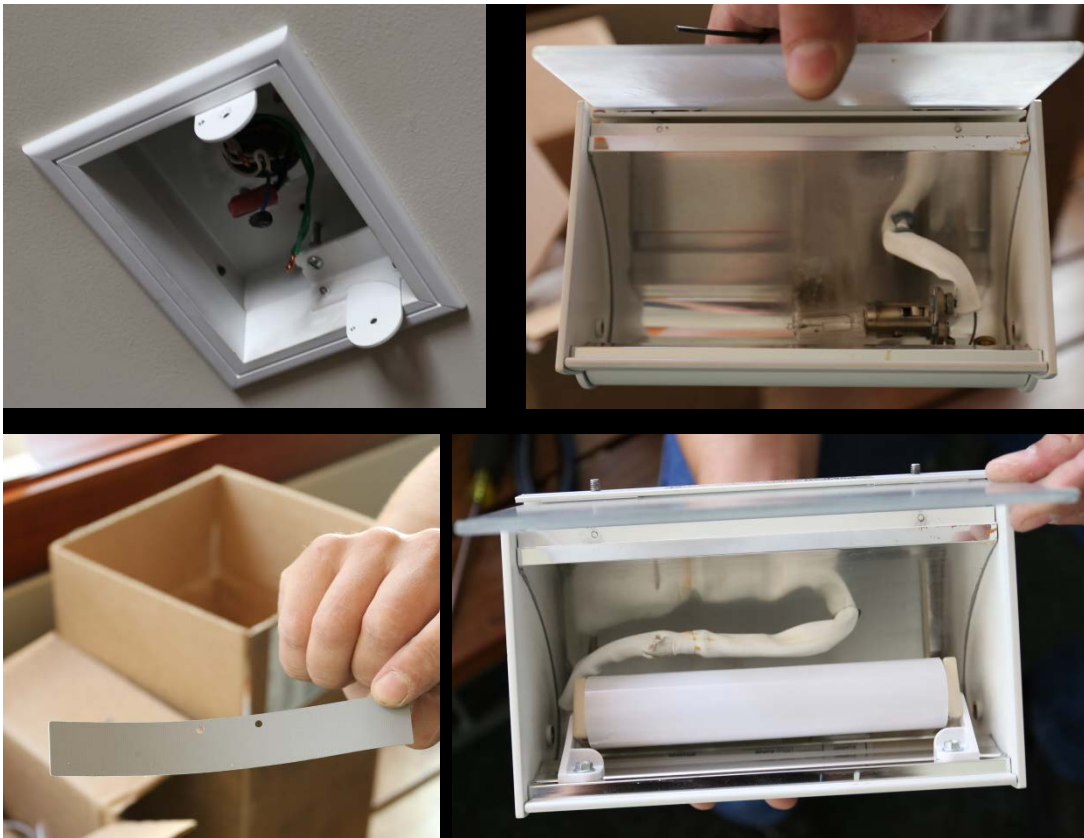
**Figure 5. Retrofit of Small Wall Washer from Halogen to LED Module.** The trim and mounting frame remained in the ceiling (top left), and the adjustable luminaire housing was removed (top right) so the halogen lamp and socket could be replaced with the LED module (bottom right). A thermal pad (bottom left) was to be attached to the module.

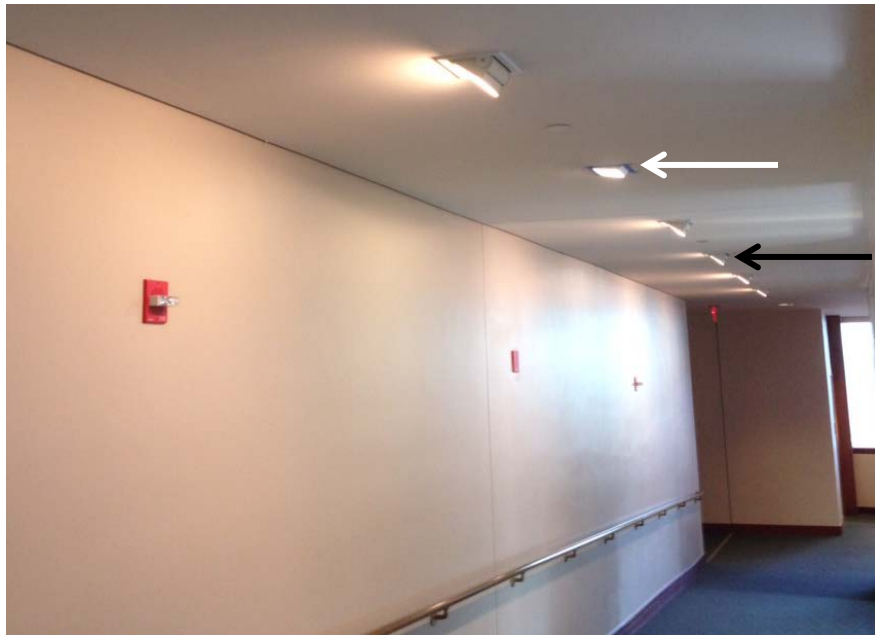
**Figure 6. Initial Mock-up of the LED Wall Washer (white arrow) and the 6 in. LED Module (black arrow) with the Existing Halogen Wall Washers (no arrow).** The dimming level was 30%. The LED wall washer did not provide light near the top of the wall, or distribute the light as widely on the wall, when compared to the halogen and LED module wall washers.

The mock-up compared the LED wall washer, LED module, and the existing halogen wall washer. UMD Facilities Management coordinated the mock-ups and from the beginning sought feedback from key CSPAC staff. The LED module had two financial advantages over the LED wall washer. First, the initial cost of the LED module was one-third the cost of the LED wall washer. Second, the LED wall washer was slightly smaller than the existing halogen wall washer, so patching the ceiling or fabricating custom trim plates would have been necessary—adding considerable cost and the risk of noticeable repair marks on the ceiling. In order to justify the cost difference, the LED wall washer needed to perform better than the LED module in the visual evaluation of the distribution of luminous flux, glare, and color. The side-by-side mock-up of some of the options is shown in Figure 6.

The 17 W complete LED wall washer did not provide light near the top of the wall, or as widely on the wall as the halogen lamp or LED module in the existing wall washers. The distribution of light was similar between the 150 W halogen and the 10 W 6 in. LED module. The 10 W LED module provided less light on the ceiling than the existing halogen; however, it was barely noticeable and in some cases might be preferable. The 8 W 4 in. LED module did not provide enough light on the wall, so the 10 W 6 in. LED module was selected. There was a 13 W 8 in. LED module option that would have provided more light on the wall, but it was too long for the existing small wall washer housing. Although the 10 W LED module did not provide as much light on the wall as the 150 W halogen lamp, it was considered similar enough to be acceptable by UMD Facilities Management staff as well as key CSPAC staff.

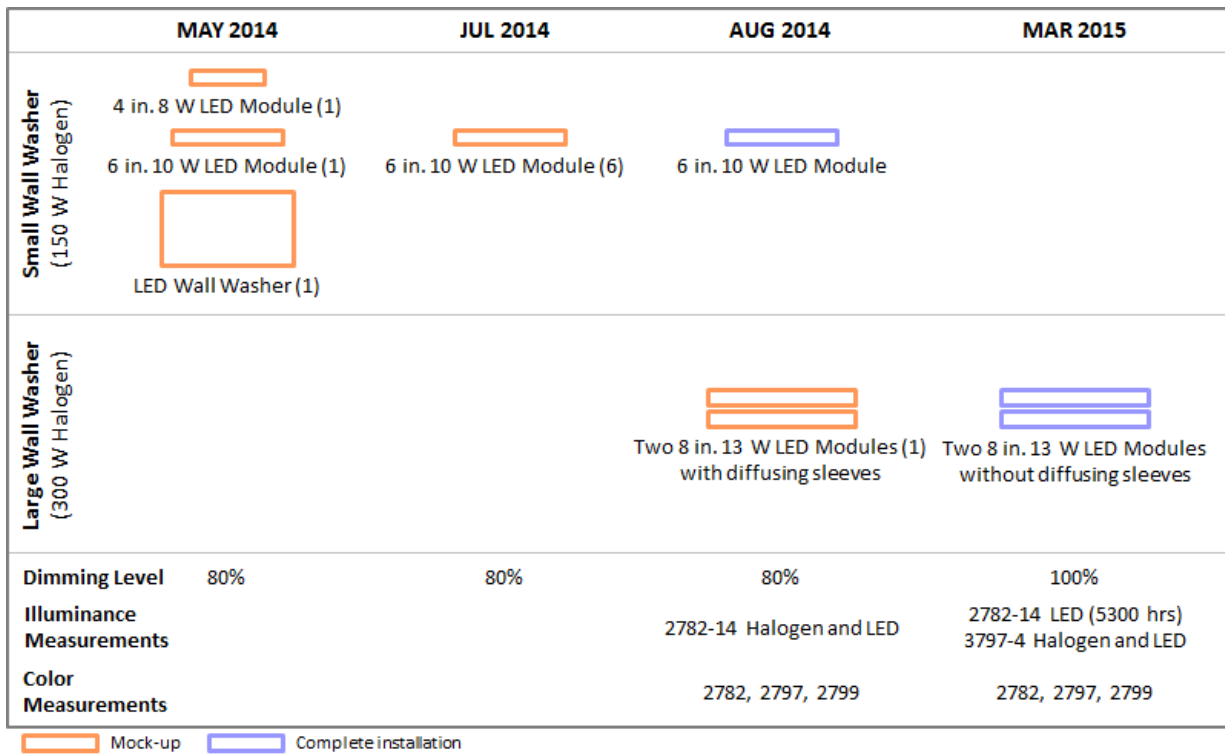
**Figure 9. UMD CSPAC Wall Washer Retrofit Timeline: Mock-up, Installation, and Measurement.** After potential alternatives to the incumbent halogen wall washers were assessed, the selected options were mocked-up in various stages, delineated above by the orange outline. The installation was completed for the small wall washers in August 2014 and for the large wall washers in March 2015, shown by the purple outline. The numbers in parentheses indicate how many of a given option were installed for the mock-up. The bottom third of the figure lists when and where the illuminance and color measurements were completed, and the dimming level at the time of measurement.

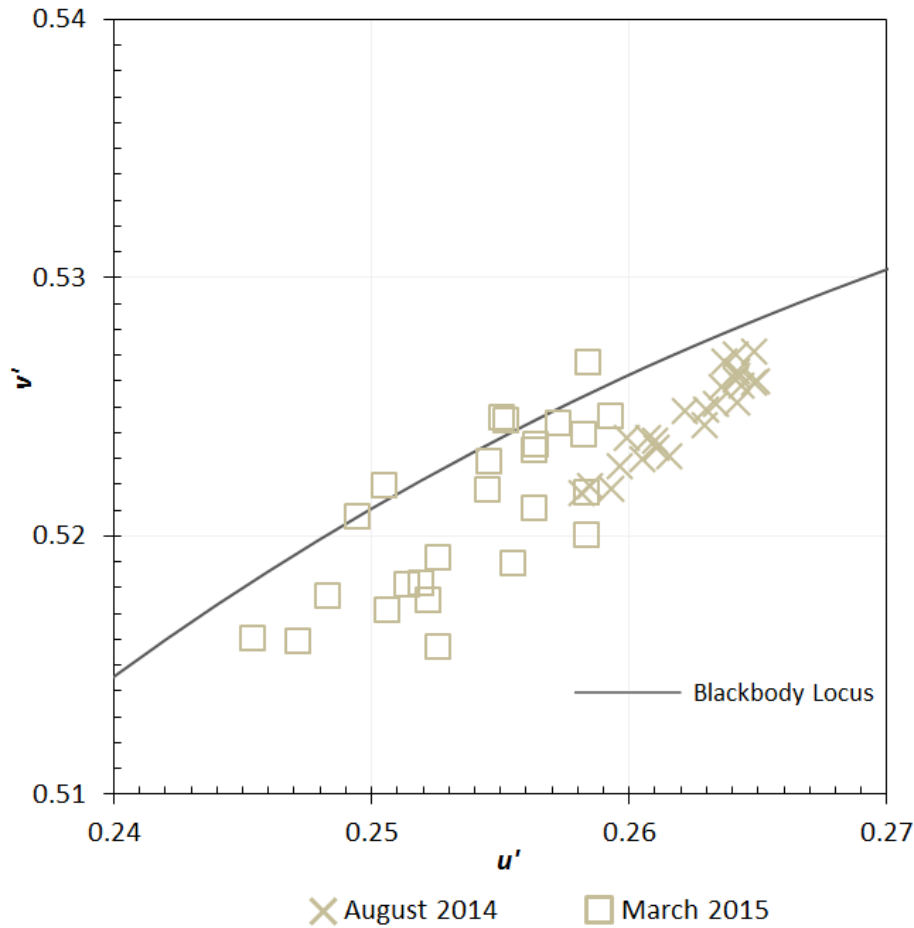
**Figure 13. Small Wall Washer Chromaticity Coordinates Plotted on 1976 CIE UCS ( $u',v'$ ) Chromaticity Diagram.** The diagram shows the chromaticity coordinates of the light exiting 25 wall washers in three different areas on the second floor, measured in both August 2014 and March 2015. In August 2014, 18 of the modules had just been installed, 6 had been operating for 700 hours, and 1 had been operating for 1600 hours—the differences due to mock-ups prior to the full retrofit of the small wall washers. In March 2015, the wall washers had been operating an additional 4600 hours since the August 2014 measurements. Three of the 50 plotted points are based only on one recorded measurement, and the remaining points are an average of two to three SPD measurements per wall washer.

coordinates in the International Commission on Illumination (CIE) 1976 uniform-chromaticity scale (UCS) chromaticity diagram ( $u',v'$ ), which are plotted in Figure 13. Each plot of the ( $u',v'$ ) chromaticity coordinates is an average of two or three SPD measurements of a given wall washer.

In August 2014, 18 LED modules in hallway 2782 and area 2799 were installed. In hallway 2797 six LED modules had already been operating for 700 hours, and one had been operating for 1600 hours. These differences in operating hours were due to the mock-ups that occurred in May and July 2014. When the second set of SPD measurements were recorded in March 2015, the wall washers had been operating an additional 4600 hours since the August 2014 measurements.<sup>3,4</sup>

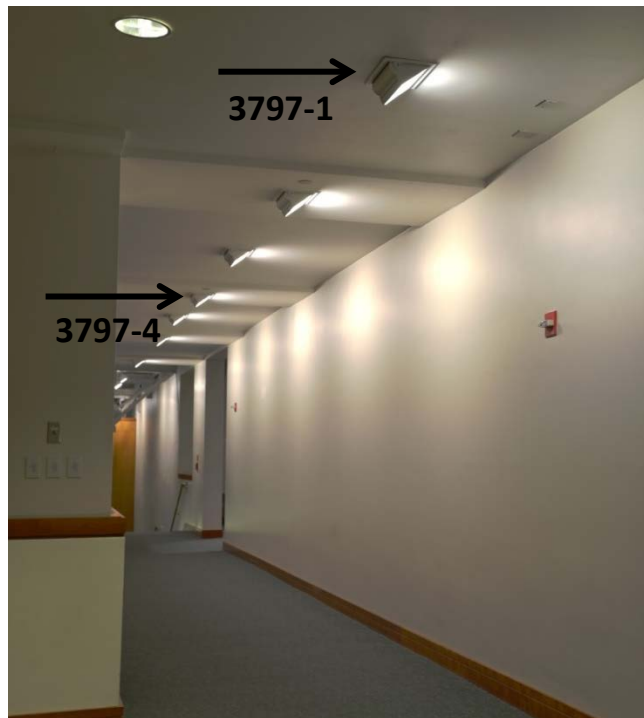
**Figure 14. Hallway 3797 Photograph: LED Initial.** The photograph shows the seven large wall washers in the foreground, with additional large wall washers over the stairs, illuminating the background. Wall washer 3797-1 was installed in August 2014, and the remaining wall washers in 3797 were installed in March 2015. Illuminance measurements were recorded for the wall and floor areas near 3797-4.

The day following the halogen measurements, the retrofit of the 300 W halogen lamp to two 13 W LED modules was completed for the large wall washers in area 3797, shown in Figure 14, and in the evening measurements were recorded following the same method used the prior evening. The measurements are detailed in Figure 16.

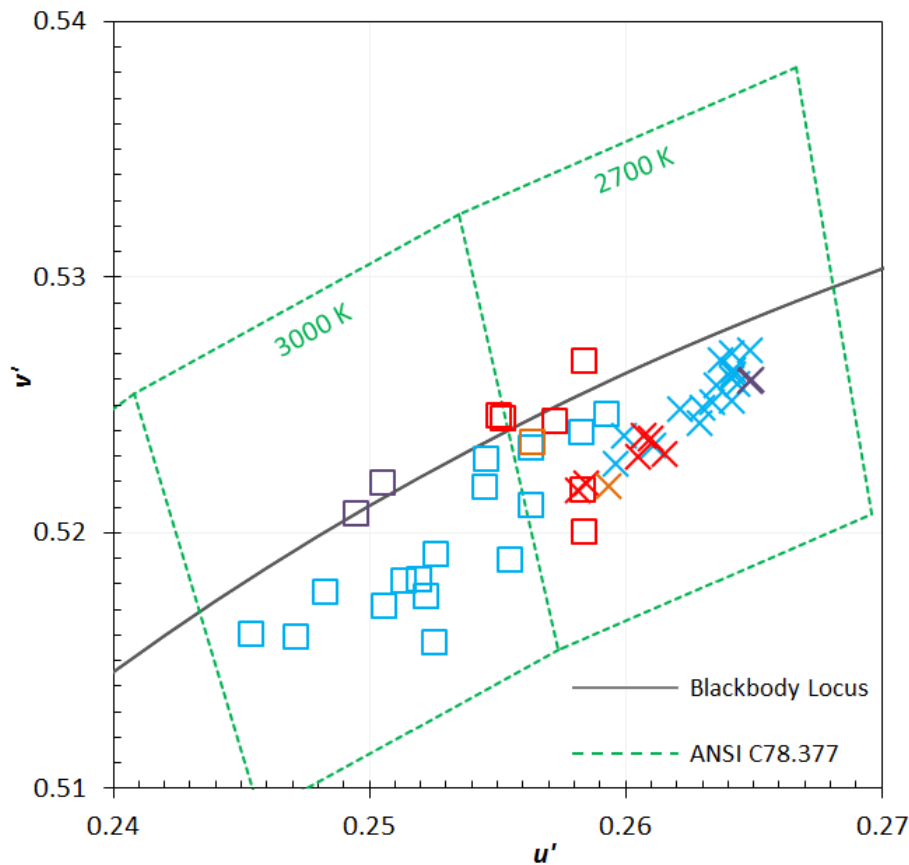
August: × 2782 (Initial)    × 2799 (Initial)    × 2797 (700 hr)    × 2797-3 (1600 hr)  
 March: □ 2782 (4600 hr)    □ 2799 (4600 hr)    □ 2797 (5300 hr)    □ 2797-3 (6200 hr)

**Figure 19. Small Wall Washer Chromaticity Coordinates Plotted on 1976 CIE UCS ( $u'$ ,  $v'$ ) Chromaticity Diagram: Measurements shown by CSPAC Area.** The diagram shows the chromaticity coordinates of the light exiting 25 wall washers in three different areas on the second floor, measured in both August 2014 and March 2015. In August 2014, 18 of the wall washers had just been installed, 6 had been operating for 700 hours, and one had been operating for 1600 hours—the differences due to mock-ups prior to the full retrofit of the small wall washers. In March 2015, the wall washers had been operating an additional 4600 hours since the August 2014 measurements. The ANSI-defined areas for LED products rated at 3000 K and 2700 K are also shown.

Further analysis of the chromaticity coordinates of the light exiting the 16 wall washers reveals a trend that is dependent on the area of CSPAC, shown in Figure 19. Wall washers in areas 2782 and 2799 are generally shifting toward blue, while wall washers in area 2797 remain relatively stable. Further investigation of the installed LED modules in these areas revealed that although the 6 in. LED module labels installed in these wall washers had the same product specification, the dates on the labels were different. The LED modules installed in wall washers 2797 in May and July 2014 are dated 2013, and the modules installed in wall washers 2782 and 2799 in August 2014 are dated 2012.
