LED Performance Under Tough Conditions

Three DOE Gateway applications show how LED luminaires respond to rigorous outdoor environments

BY JAMES BRODRICK

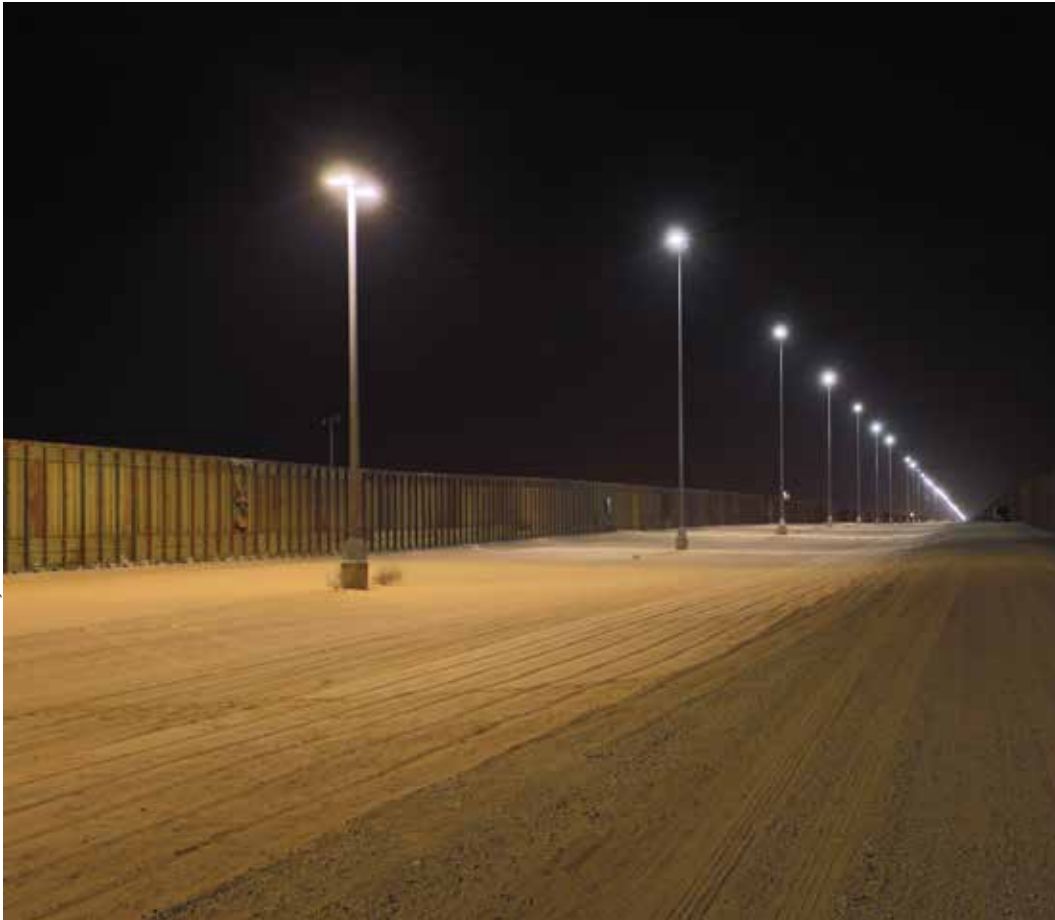
Photo: Pacific Northwest National Laboratory

Yuma, AZ—the site of an LED installation in extremely high temperatures.

The luminaires in the Yuma Sector Border Patrol Area are subjected to high temperatures almost on a 24/7 basis. During the daytime, they're often exposed to high ambient temperatures and direct solar radiation, and then when those two factors begin to subside at sunset, the luminaires turn on and generate their own internal heat. Between the initial measurements taken in February 2014 and the 7,000-hour measurements taken in Septem-

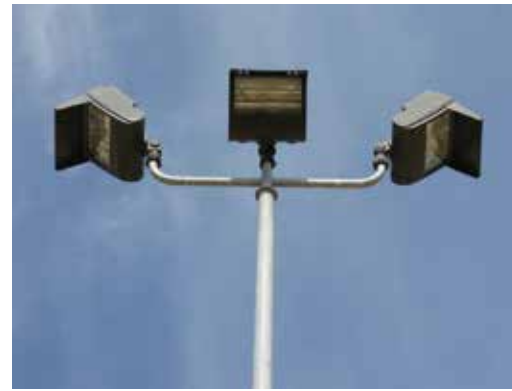
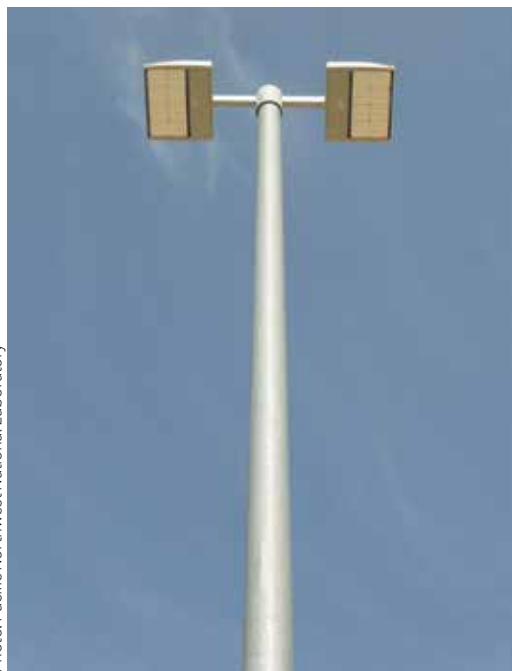
Photo: Pacific Northwest National Laboratory

Quartz metal halide fixtures (top) were replaced by LED luminaires (two per pole) on the U.S.-Mexico border.

Two LED luminaires were installed on each of three poles on the U.S.-Mexico border in February 2014 as part of a trial installation, with a December 2014 Gateway report describing how the LED system equaled or bettered the QMH system in terms of both uniformity and illuminance, when comparing the initial output of the LED system and the maintained output of the QMH system. This initial trial was intended as a short-term test before proceeding with the complete installation of more than 400 luminaires. Although unexpected delays in the full installation have prevented the detailed evaluations originally planned, the six installed LED luminaires continue to be monitored. Illuminance measurements were recorded in February 2014, after installation; in September 2014, at about 2,500 hours of operation; in March 2015, at about 5,000 hours of operation; and in September 2015, at about 7,000 hours of operation.

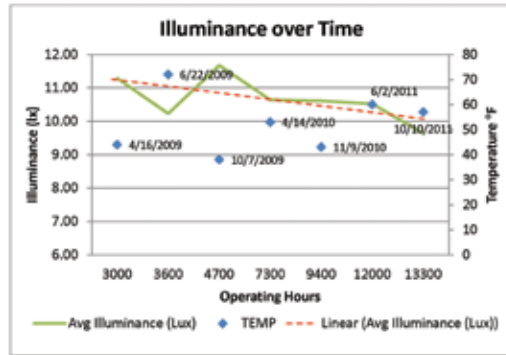
Figure 2. Average illuminance levels from the MMS.

During the 10,000 hours of operation that the MMS was used, there was a 10 percent decrease in measured average ground illuminance (Figure 2), which reflects the cumulative impact of multiple factors whose relative contributions can’t be determined from the illuminance data alone.

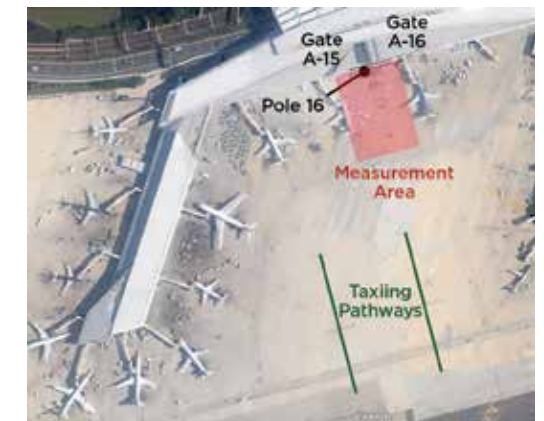
An aerial view of Terminal A, where the trial LED installation took place in the apron area immediately in front of Pole 16.

to reduce maintenance and light pollution and increase safety. To minimize the complexity and cost of installing the new lighting system, PHL chose to replace the existing high-pressure sodium (HPS) luminaires on a one-for-one basis with an LED luminaire for a trial installation in the apron area at one of six concourses. An initial trial installation of three luminaires, conducted in October 2014, led to recommended improvements in the system design and evaluation procedures. Consequently, a second trial installation was conducted in May 2015 and provided a better solution, which, if fully implemented, would bring energy savings of between 24.5 percent and 51.5 percent, depending on the mix of high- and medium-output LED luminaires installed.
