# Integrated Waste Treatment Unit Status

Jack Zimmerman  
Deputy Manager  
Idaho Cleanup Project  
Feb. 23, 2017

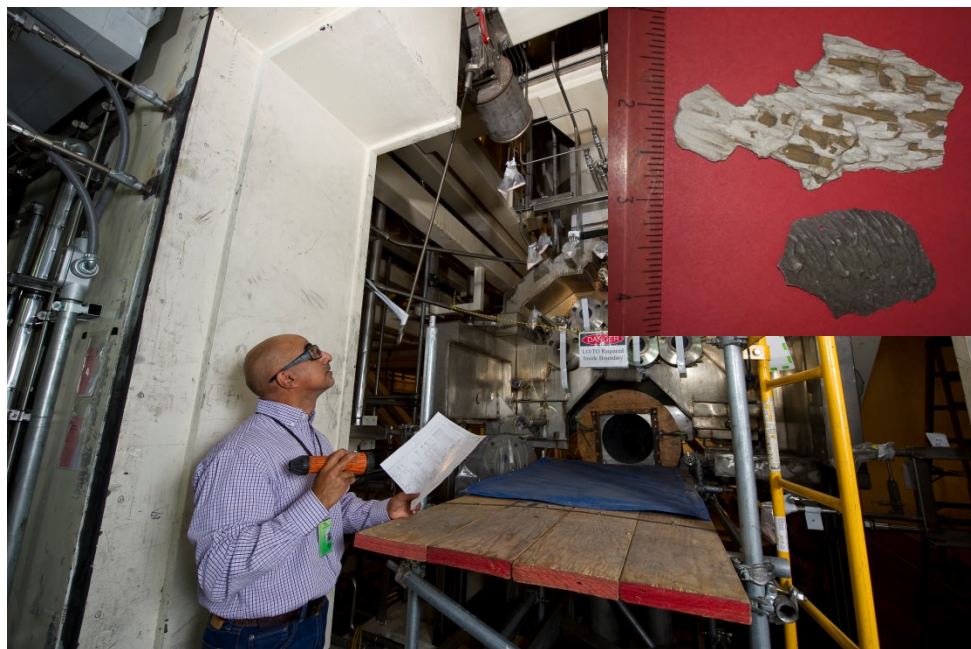
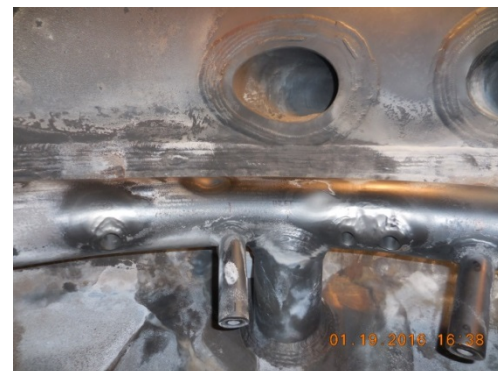
- Chemical/physical – mainly associated with the fluidization process and wall scale in the Denitration Mineralization Reformer.
- Mechanical/equipment – in relation to the auger-grinder and ring header.

- Fluidization studies in conjunction with chemistry studies (on product and scale) identified modifications and process changes to improve fluidization, stabilize process control and address slow waste feed conversion to product.
- Particle size control is critical for stable operations.
- Waste feed droplet studies complete. Results to be evaluated regarding optimal waste feed rate for adequate product conversion.

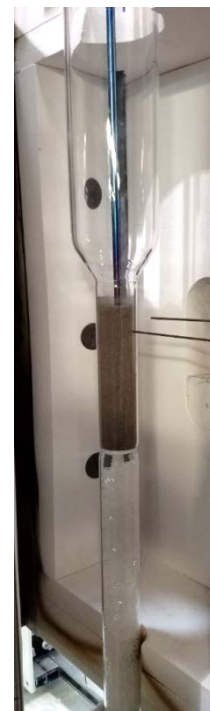
- Hazen 2-inch pilot plant testing and supporting test confirm addition of CO<sub>2</sub> ensures stable bed with no sand castle formation.
- Hazen 18-inch DMR pilot plant was delivered last November and began Phase 2 heat-up in January.

Process Skid (left) and Fluidizing Vessel (right) at Hazen, Colo. test facility.

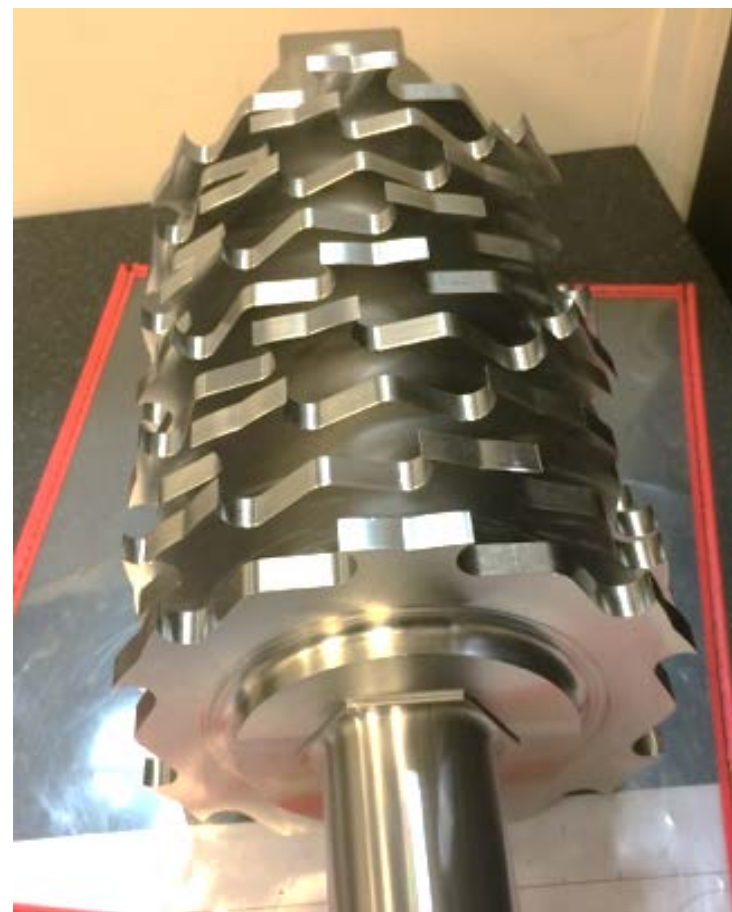
- Auger-grinder failure mechanism (from May 2016 simulant run) evaluation complete.
- Test results indicate steam forms a cementitious material that locks up the auger-grinder.
- Purge strategy very important.
- Developed design, completed fabrication of prototype unit, and installed in DMR.

Prototype SST components to be used for testing.

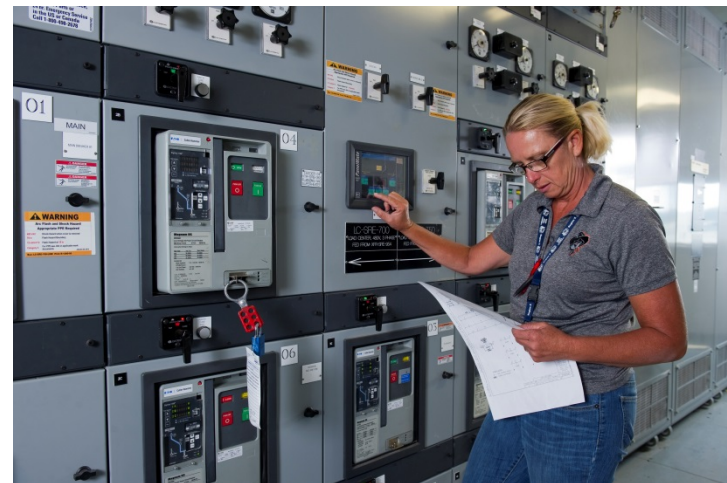
- Extent of condition plant review conducted by Fluor Idaho complete. Plant review identified required modifications for balance of plant. Modifications have been prioritized and sequenced into Phase 2 project plan.
- Complete IWTU facility mods including manway installation and ring header repair.
- Conducted auger-grinder design development tests.
- Conduct IWTU simulant runs
  - Validate auger-grinder design under plant conditions; fluidization improvements, operating and recovery operations.
