Decontamination and Decommissioning Overview/ Materials and Fuels Complex Pressure Excursion

Citizens Advisory Board Brief
March 14, 2012

MFC-766 Sodium Event

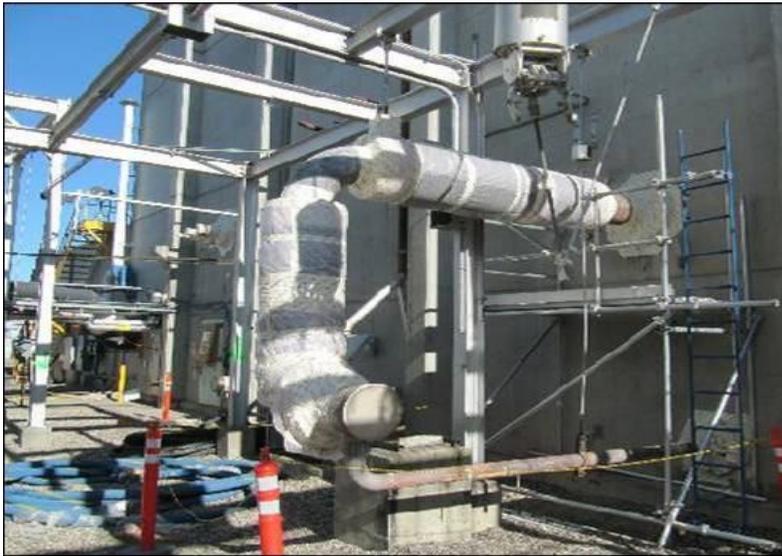
Before Water Hammer

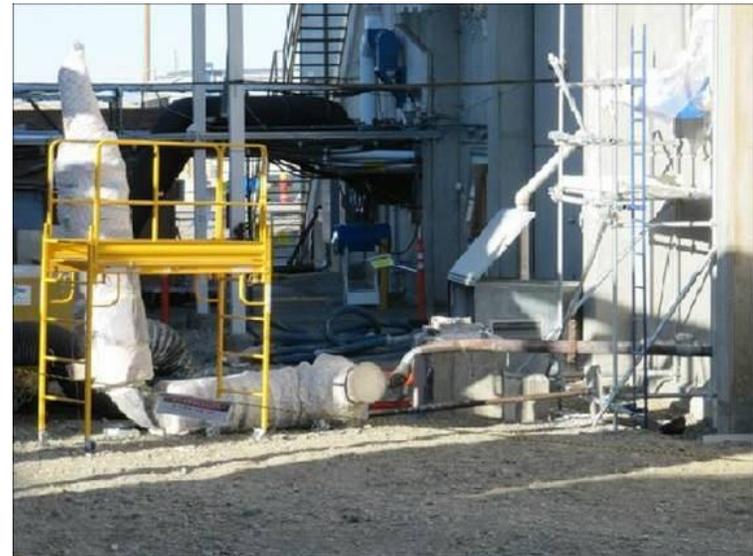
After Water Hammer

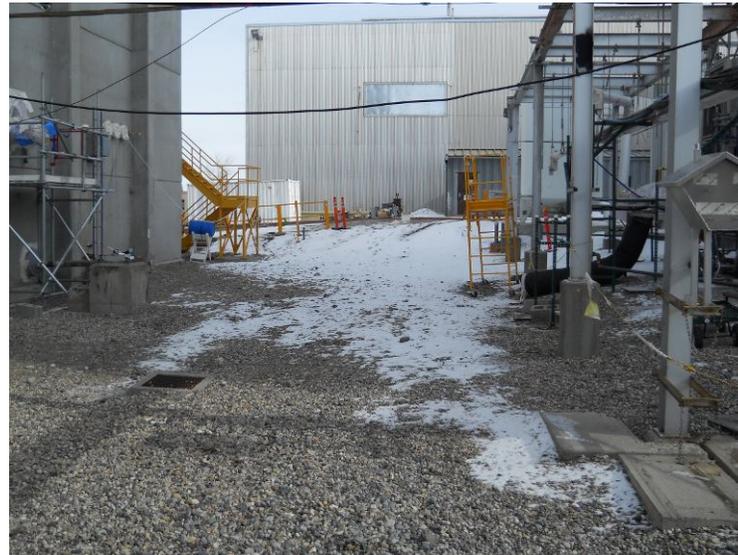
Current

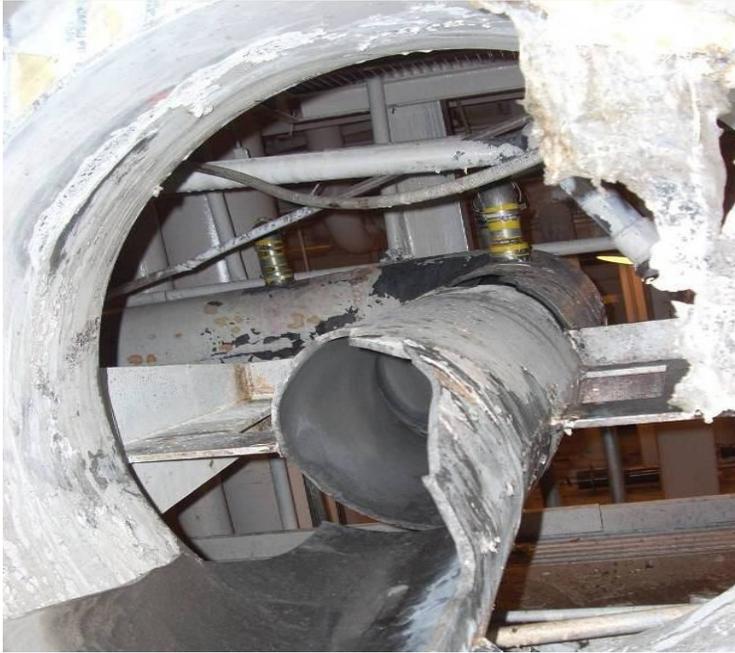
12-inch Pipe at South Exterior Wall of MFC-766

After Pipe Breach

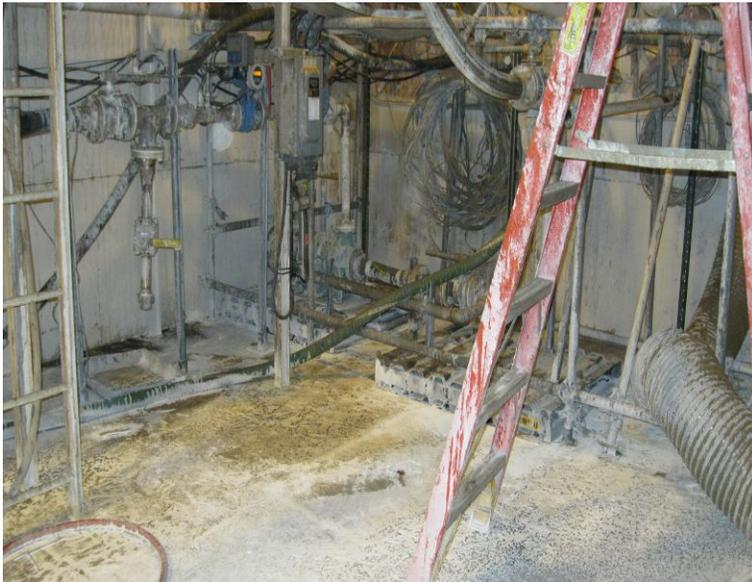
Caustic Solids in Eastside Secondary Containment

MFC-766 caustic solids before pressure washing
