Moab UMTRA Project
Crescent Junction Disposal Cell Interim
Completion Report Addendum - K

Revision 0

December 2021

U.S. Department
of Energy

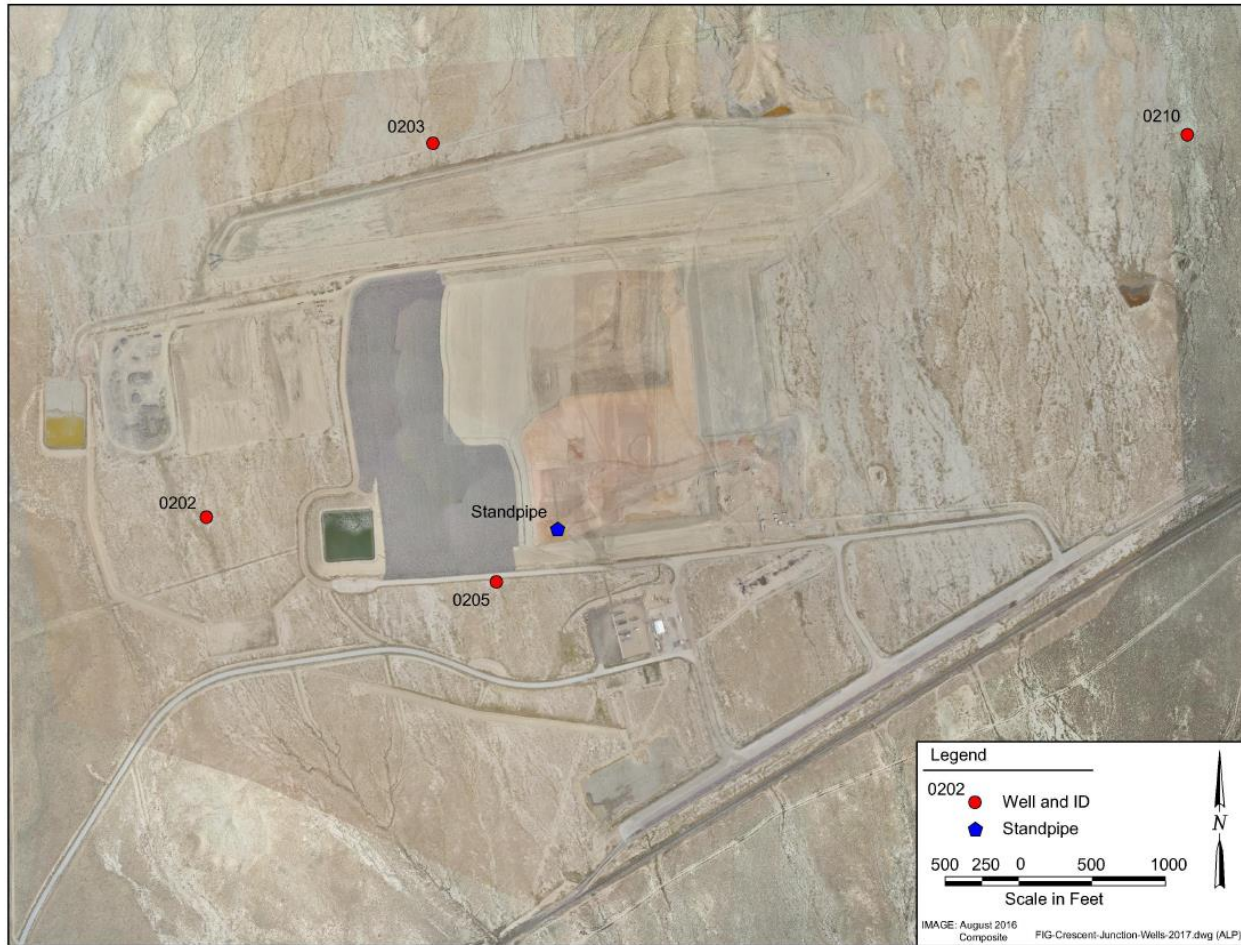
Figure 6. Locations of Monitoring Wells and Standpipe

One short-term recovery test (from 0205) was completed to determine the water source and recharge rates. Analysis of the December 2020 recovery data collected indicated the recharge rate was 0.029 gpm, which is within the historical range of recharge rates measured at this location.

Water level, precipitation, recovery test data, along with the analytical results continue to suggest that the groundwater source is surface runoff flowing off the cover, and not associated with leakage from the disposal cell.
