**Moab UMTRA Project  
Crescent Junction Disposal Cell Interim Completion Report  
Addendum E**

**Revision 0**

**December 2015**

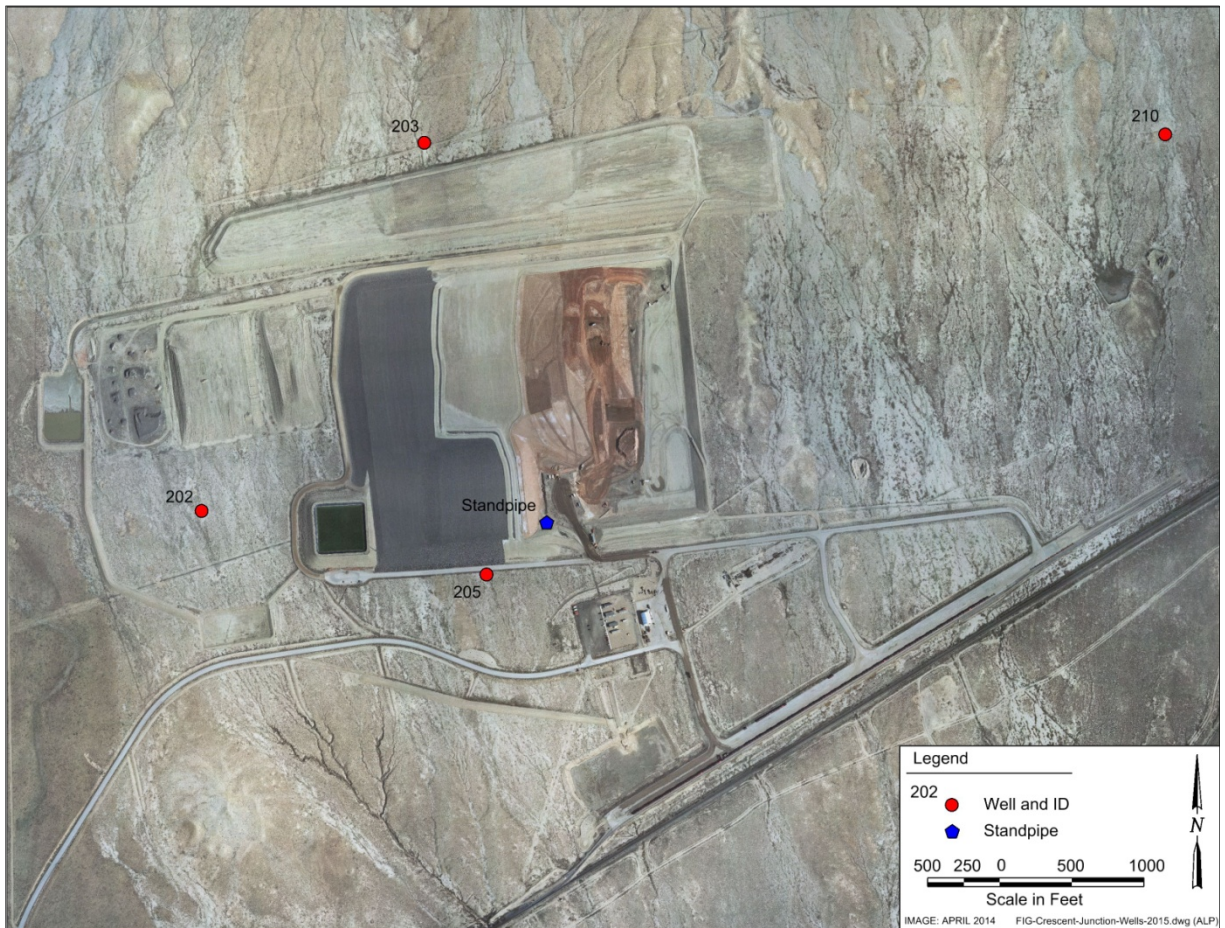
Figure 7. Locations of Monitoring Wells and Standpipe

Four wells were monitored for the presence of ground water outside of the disposal cell footprint (see Figure 7). Results of the monitoring are shown in Table 13. Water was encountered in one of the wells for the first time since monitoring was initiated in late 2011. On June 29, 2015, it was noted that the bottom of well 0205 had dropped 6 ft in elevation and approximately 11 ft of water was present. This well was sampled in July for anions, cations, inorganics (ammonia, nitrate/nitrite, and total dissolved solids), and select radiological constituents (gross alpha, gross beta, Ra-228, and Ra-226). Based on the radionuclide concentrations, the water recharging well 0205 does not appear to be associated with the disposal cell.

Between July 21 and September 30, the recharge rate for well 0205 gradually decreased from 0.20 to 0.04 gallons per minute. During an investigation to determine if the well was recharging from one discrete zone or throughout the borehole, a fracture at 60.2 ft below top of casing was noted. This fracture appears to be a significant contributor to the recharge. A report will be prepared describing actions taken since the water was discovered and short-term recovery test data and analytical data associated with samples collected from this well.
