Moab UMTRA Project
Crescent Junction Disposal Cell Interim Completion
Report Addendum F

Revision 1

December 2017

U.S. Department
of Energy

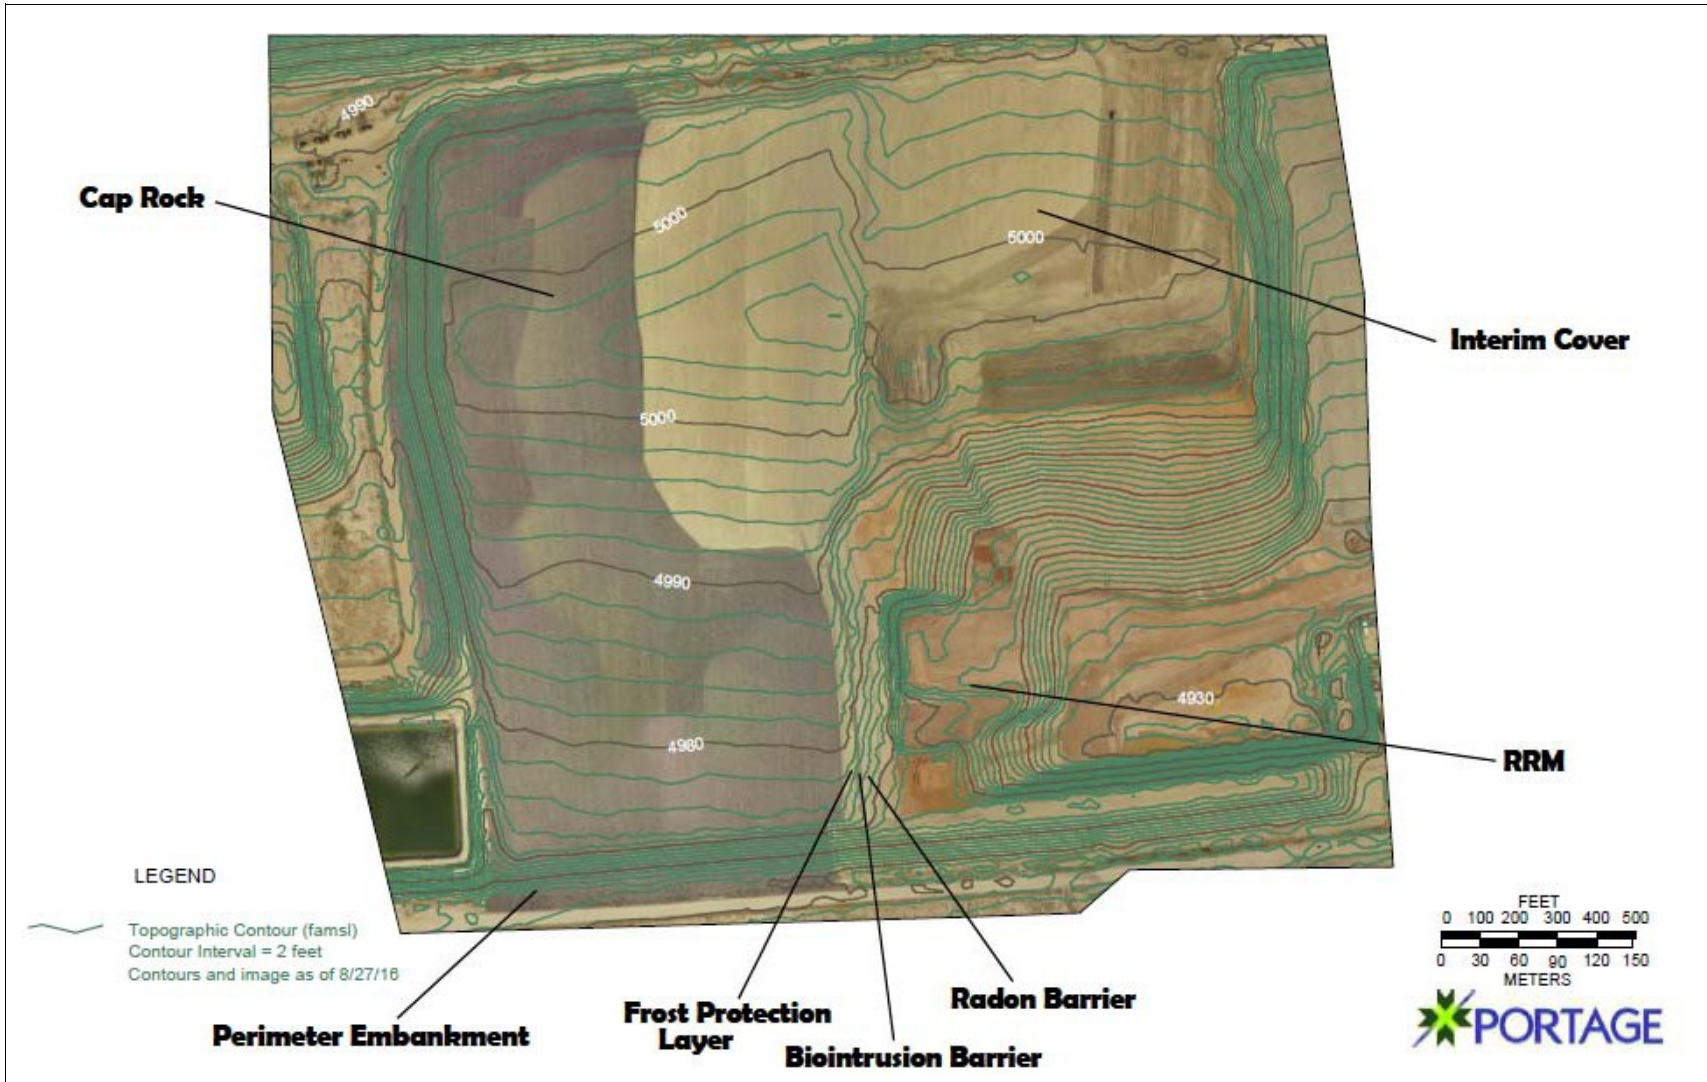
Figure 3. General Extent of Cover Layers

The Critical Review provides key technical information about the disposal cell construction. This section contains tables summarizing inspections or tests for cell excavation, embankment construction, RRM placement, and cell cover material placement as appropriate for the report period. The tables reference the criteria and material testing procedures used to verify cell excavation and placement of each type of material were performed in accordance with design specifications or drawings and with Addendum E of the RAP, “Remedial Action Inspection Plan” (RAIP). The distribution survey associated with each material type is also included in this section, as appropriate. Figure 3 shows the general extent of cell cover layers as of the end of this Addendum period, and Figure 4 shows the extent of Phase 3a excavation and the southern perimeter embankment.

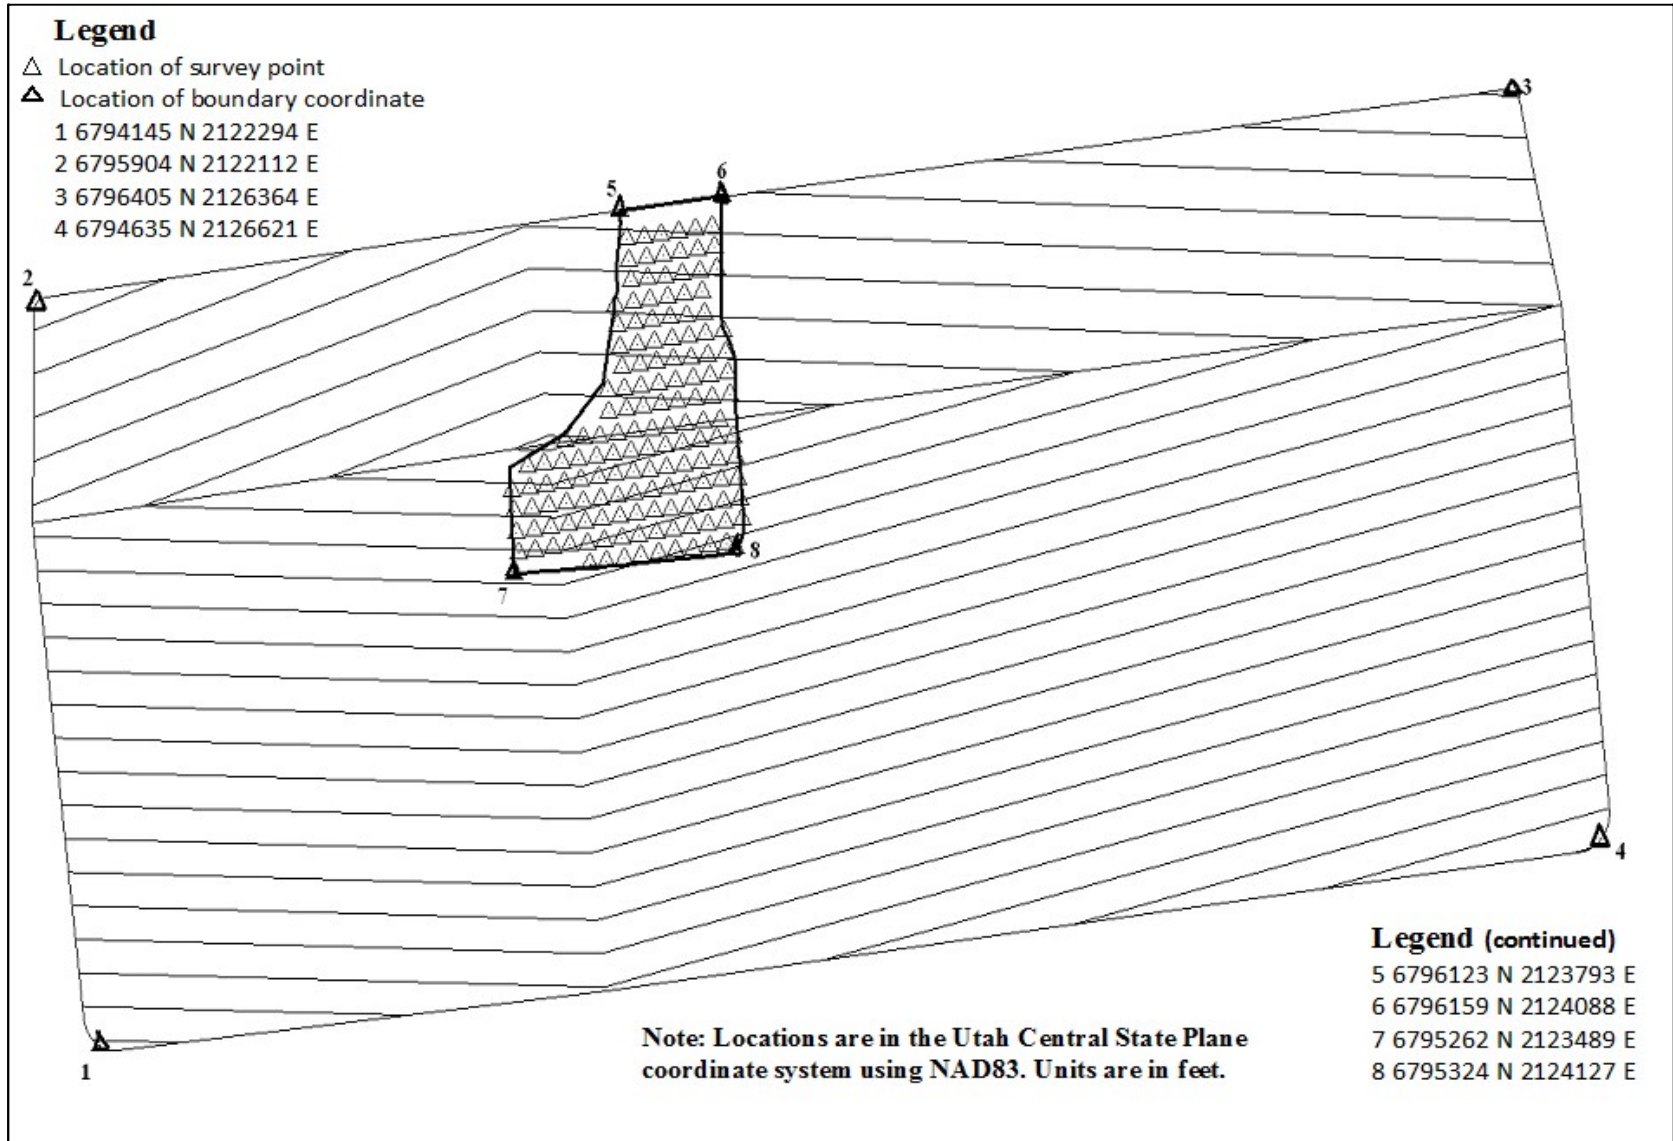
Figure 6. Distribution of Survey Points to Verify Compliance with Interim Cover Specifications

The inspection and testing for the interim cover is shown in Table 7. The distribution of survey points is shown in Figure 6. The standard proctor test results summary, lift approval summary, one lift approval package, and buyoff surveys for the interim cover are provided in Appendix A3.

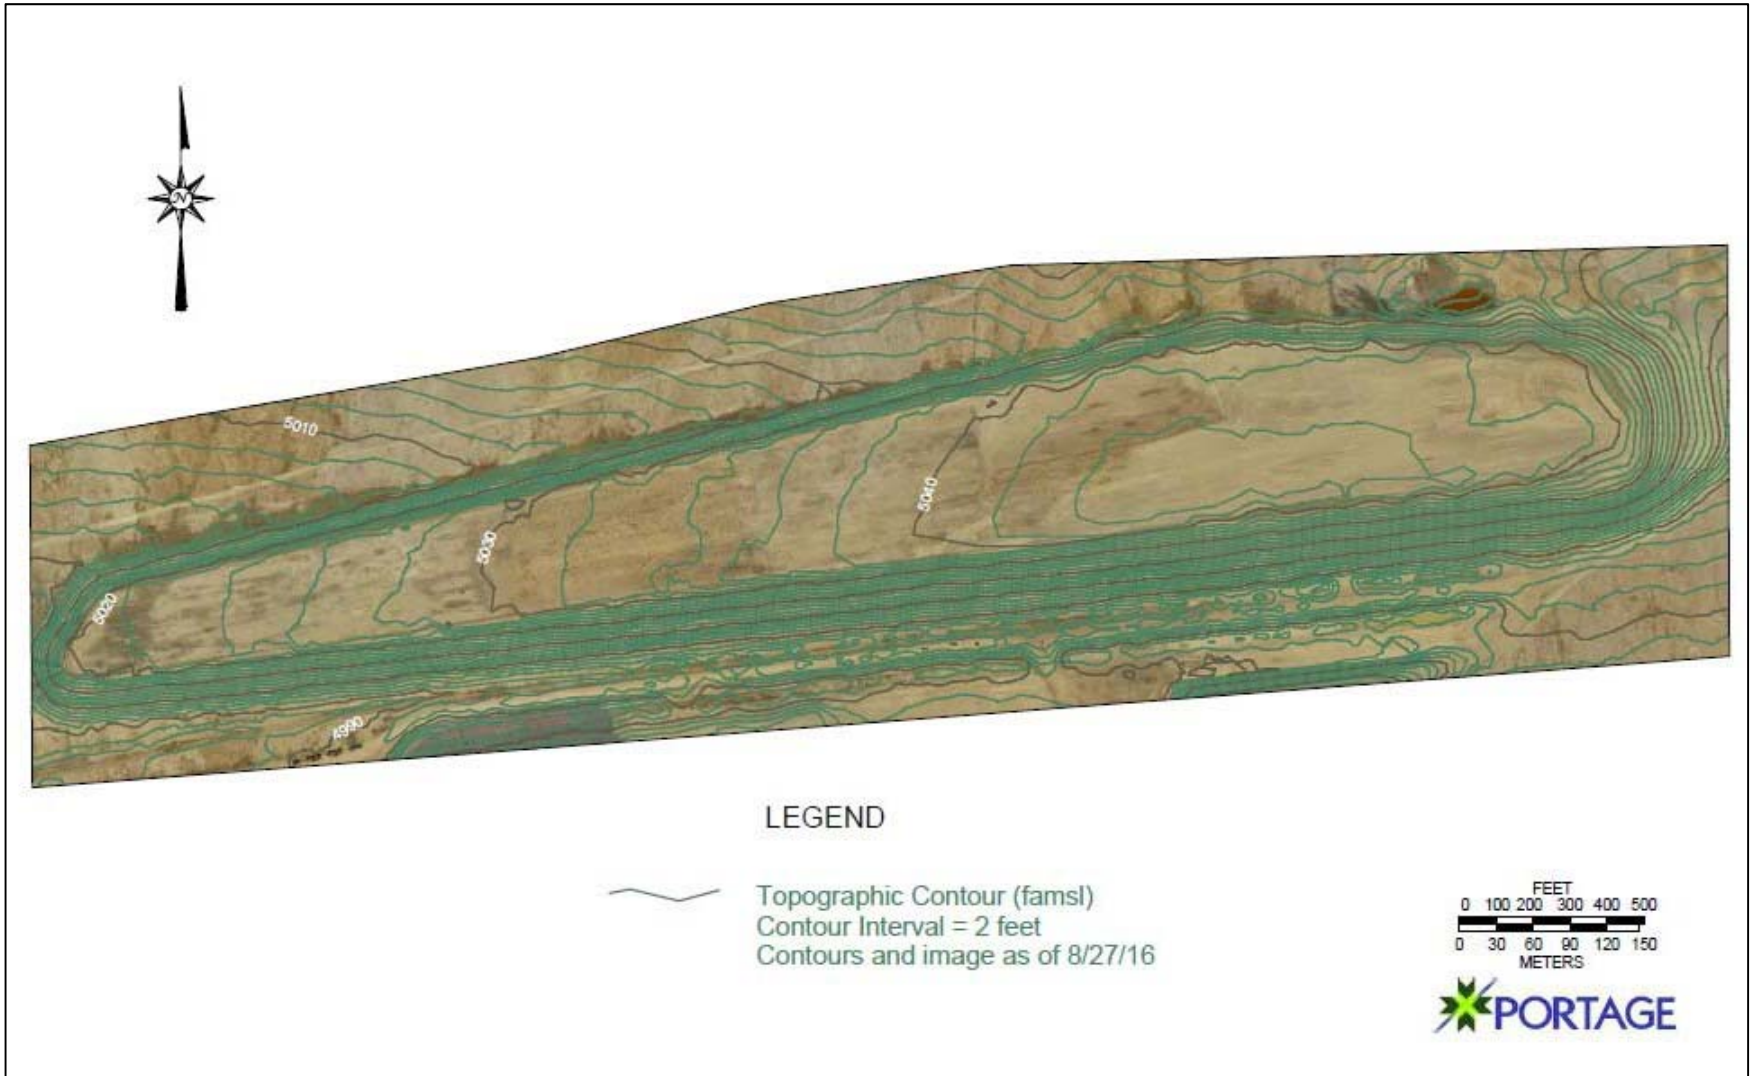
Figure 7. Topographic Surface of Spoils Embankment

During this report period, 495,000 yd³ of material excavated for Phase 3a of the cell was used to extend the spoils embankment to the east. The inspection and testing for the spoils embankment can be found in Table 10. The standard proctor test results summary, lift approval summary, and one lift approval package for the spoils embankment are provided in Appendix A8. Figure 7 shows the topographic surface of the spoils embankment as of the end of this Addendum period.

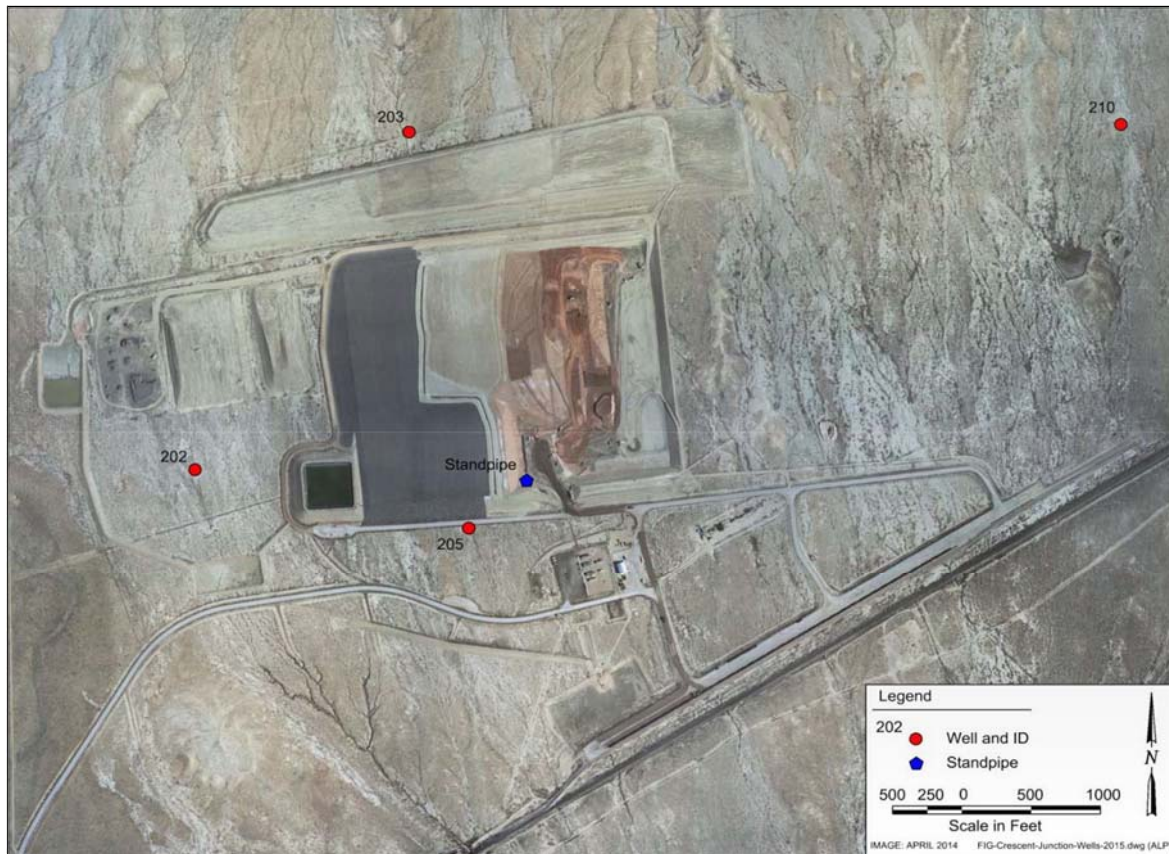
Figure 8. Locations of Monitoring Wells and Standpipe

The results of monitoring of the one existing standpipe (see Figure 8) during this period for the presence of free liquids in the disposal cell, are shown in Table 13. It was not possible to access the standpipe in July 2016 due to site conditions. No additional standpipes were installed during this period.

Four wells were monitored for the presence of ground water outside disposal cell footprint (see Figure 8). Results of the monitoring are shown in Table 14, with wells 0203 and 0210 dry throughout this report period. Water was first encountered in well 0202 during monitoring in early February 2016, with only 0.2 ft present.
