# West Valley Demonstration Project Decommissioning Status

**Bryan Bower**  
Department of Energy

Quarterly Public Meeting  
February 26, 2014

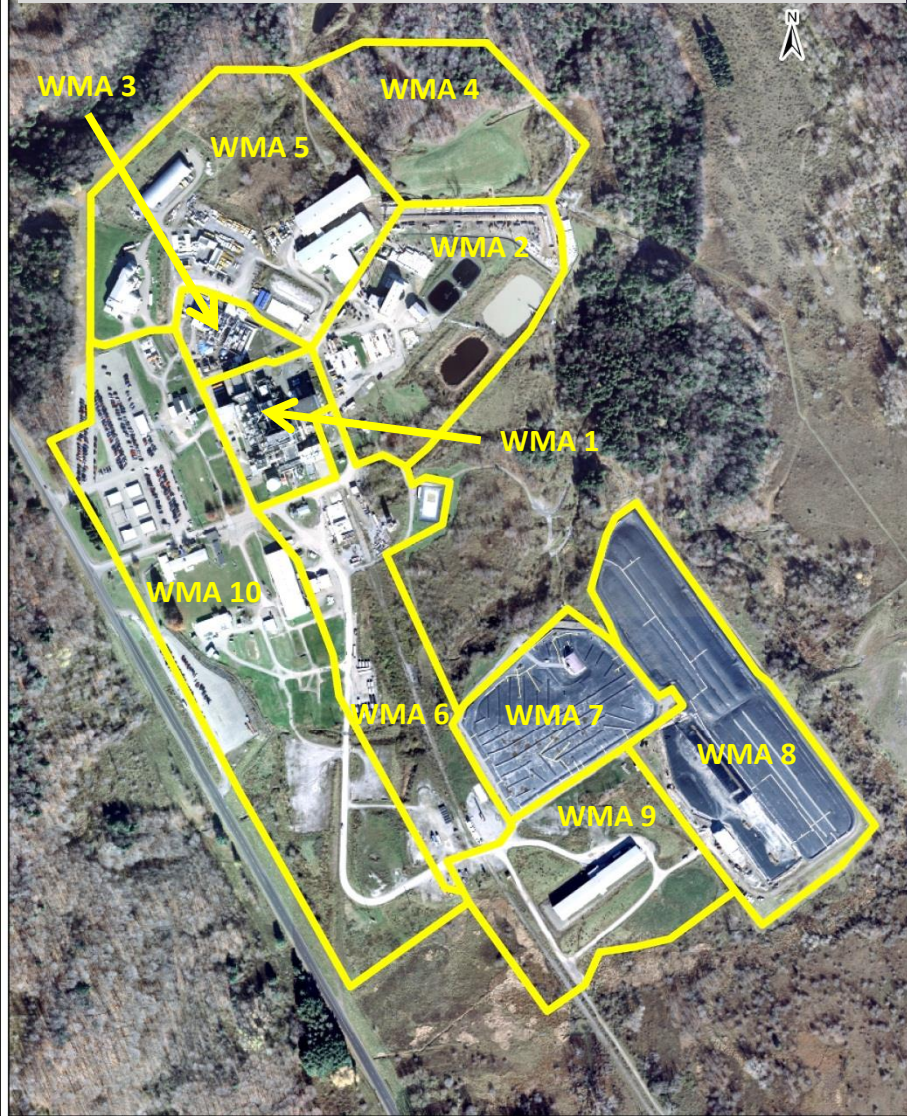
Orthoimage of the West Valley Demonstration Project

The *Final Environmental Impact Statement for Decommissioning and/or Long-Term Stewardship at the West Valley Demonstration Project and Western New York Nuclear Service Center* addresses the developed portion of the site in 10 waste management areas (WMA)

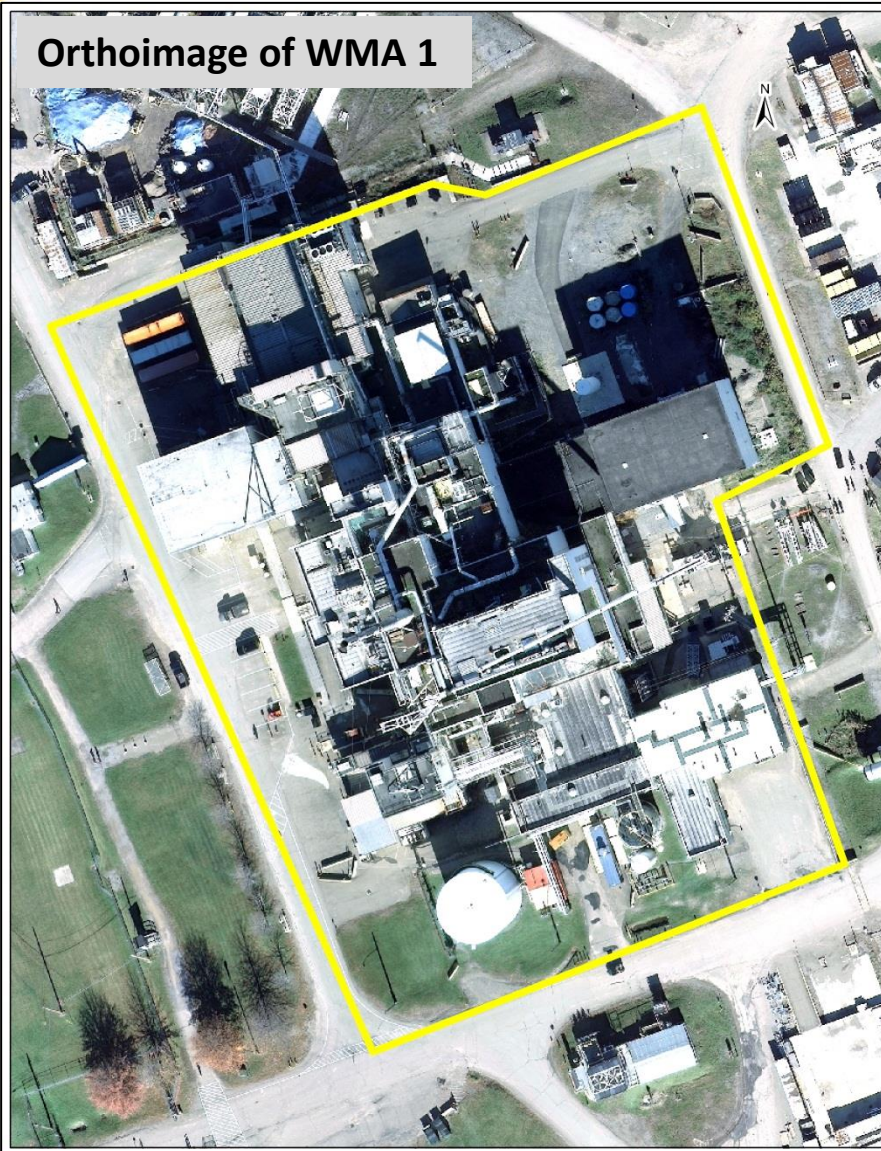
Orthoimage of WMA 1

- Main Plant Process Building (MPPB)
- Plant office building
- Vitrification Facility
- Load-in/Load-out Facility
- Utility Room
- Fire Pump House
- Water storage tank
- Laundry
- Fuel Receiving and Storage

| Facility | January 2014 Status | Planned for End of Phase 1 Facility Disposition | Planned for End of Phase 1 Decommissioning |
|---|--|---|--|
| Main Plant Process Building | Removed:<br>86% of contaminated vessels<br>84% of piping and conduit<br>95% of asbestos | Demolished to grade | Removal of below-grade structures and source area of the plume |
| Vit Facility | 99% decontaminated: contaminated equipment removed, floor cleaning & electrical isolations underway; cold chemical building demolished to the slab | Demolished to the slab | Removal of below-grade structures |
| Fuel Receiving & Storage | Vent building demolished; pool drained and cleaned; surface & airborne contamination remain | Remains in place | Removal of above- and below-grade structures |
| Plant Office Building | Rooms emptied, asbestos removal underway | Demolished to grade | Removal of below-grade structures |

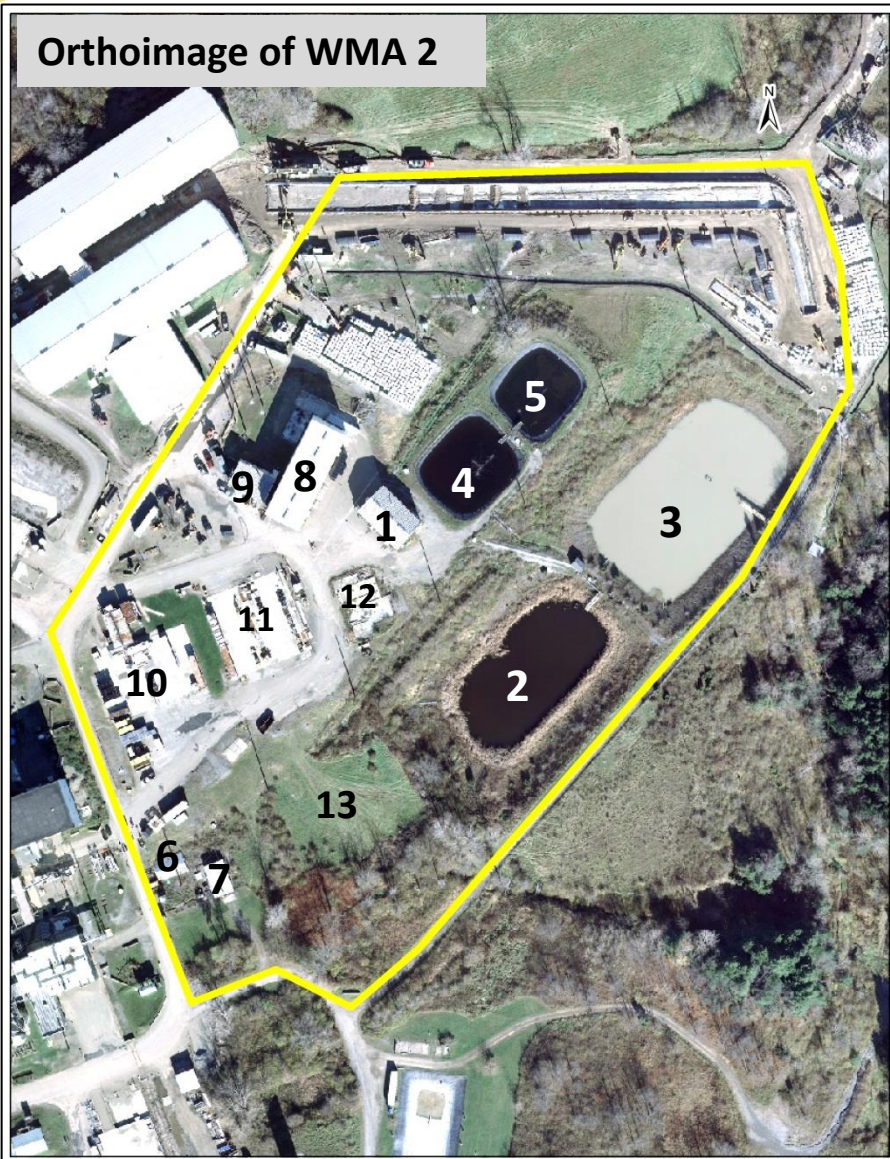
Orthoimage of WMA 2

1. Low-Level Waste Treatment Facility 2 (LLW2)
2. Lagoon 2
3. Lagoon 3
4. Lagoon 4
5. Lagoon 5
6. Old interceptor
7. New interceptors
8. Vitrification Test Facility
9. Vehicle Repair Shop
10. Test and Storage Building
11. Maintenance Shop
12. O2 building
13. Lagoon 1 area

| Facility | January 2014 Status | Planned for End of Phase 1 Facility Disposition | Planned for End of Phase 1 Decommissioning |
|--|--|---|---|
| Low-Level Waste Treatment Facility 2 & Lagoons 2, 3, 4 & 5 | Operational | Operational | Removal; installation of hydraulic barrier wall |
| Old & new interceptors | Operational | Operational | Removal |
| Vitrification Test Facility | Operational | Facility & foundation removed; area restored | NA |
| Vehicle Repair Shop<br>Test & Storage Building<br>Maintenance Shop | Facilities removed, foundations remain | Facilities removed, foundations remain | Removal |
| O2 Building | Facility removed, foundation remains | Foundation removed; area restored | NA |
| Lagoon 1 | Inactive | Inactive | Removal |

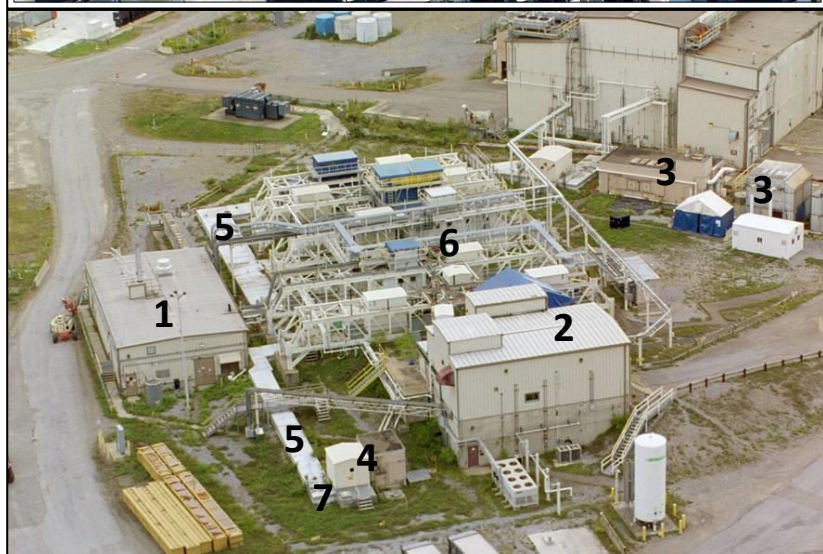
# WMA 3

1. Permanent Ventilation System building
2. Supernatant Treatment System support building
3. Equipment shelter and condensers
4. Con-Ed building
5. High-Level Waste (HLW) transfer trench
6. Two underground, 760,000 gallon carbon steel tanks: 8D-1 and 8D-2
7. Two underground, 14,300 gallon stainless steel tanks: 8D-3 and 8D-4

- Tank & Vault Drying System (T&VDS) installed and operational in December 2010
  - Status of tank liquids
    - Tank 8D-1 – all liquid evaporated
    - Tank 8D-2 – all liquid evaporated
    - Tank 8D-3 – all liquid evaporated
    - Tank 8D-4 – 4,630 gallons of liquid/sludge remain
  - Status of vaults and containment pans
    - Tank 8D-1 vault liquid is below level indicator (<2 inches and may be dry)
    - Tank 8D-2 vault liquid is below level indicator (<2 inches and may be dry)
    - All liquid in containment pans of tanks 8D-1 and 8D-2 evaporated
    - Tank 8D-3/8D-4 vault liquid evaporated
- At the end of Phase 1 decommissioning the T&VDS will be operational; tanks and their support structures will remain in place

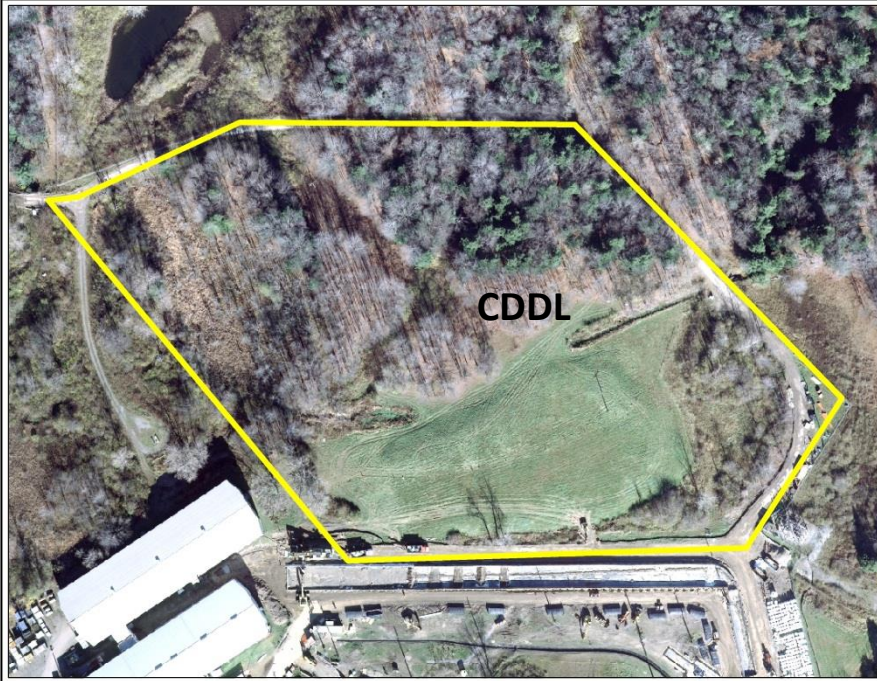
**Orthoimage of WMA 4  
Construction & Demolition Debris Landfill**

- CDDL is inactive
- Monitoring and maintenance will continue through Phase 1 decommissioning

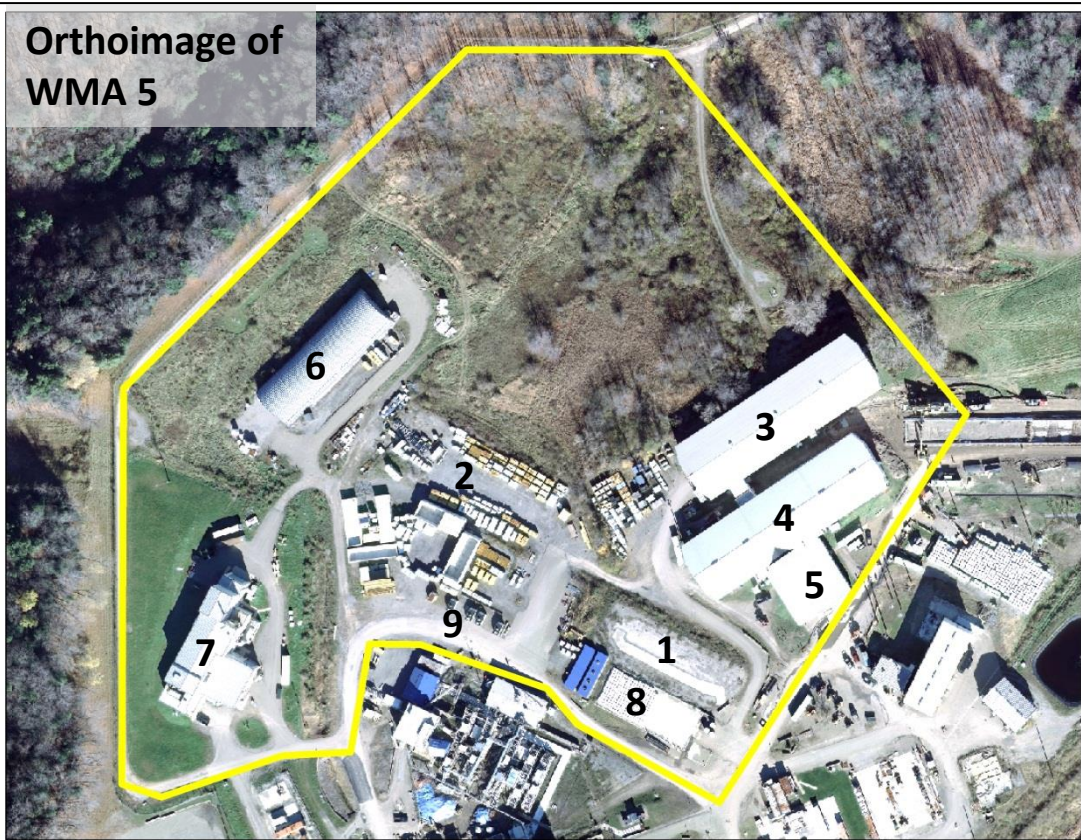
Orthoimage of  
WMA 5

1. Lag Storage Area 1
2. Lag Storage Area 2
3. Lag Storage Area 3
4. Lag Storage Area 4
5. Shipping depot
6. Chemical Process Cell  
Waste Storage Area
7. Remote-Handled Waste  
Facility (RHWF)
8. Lag Storage Building
9. Four Hazardous Waste  
Storage Lockers

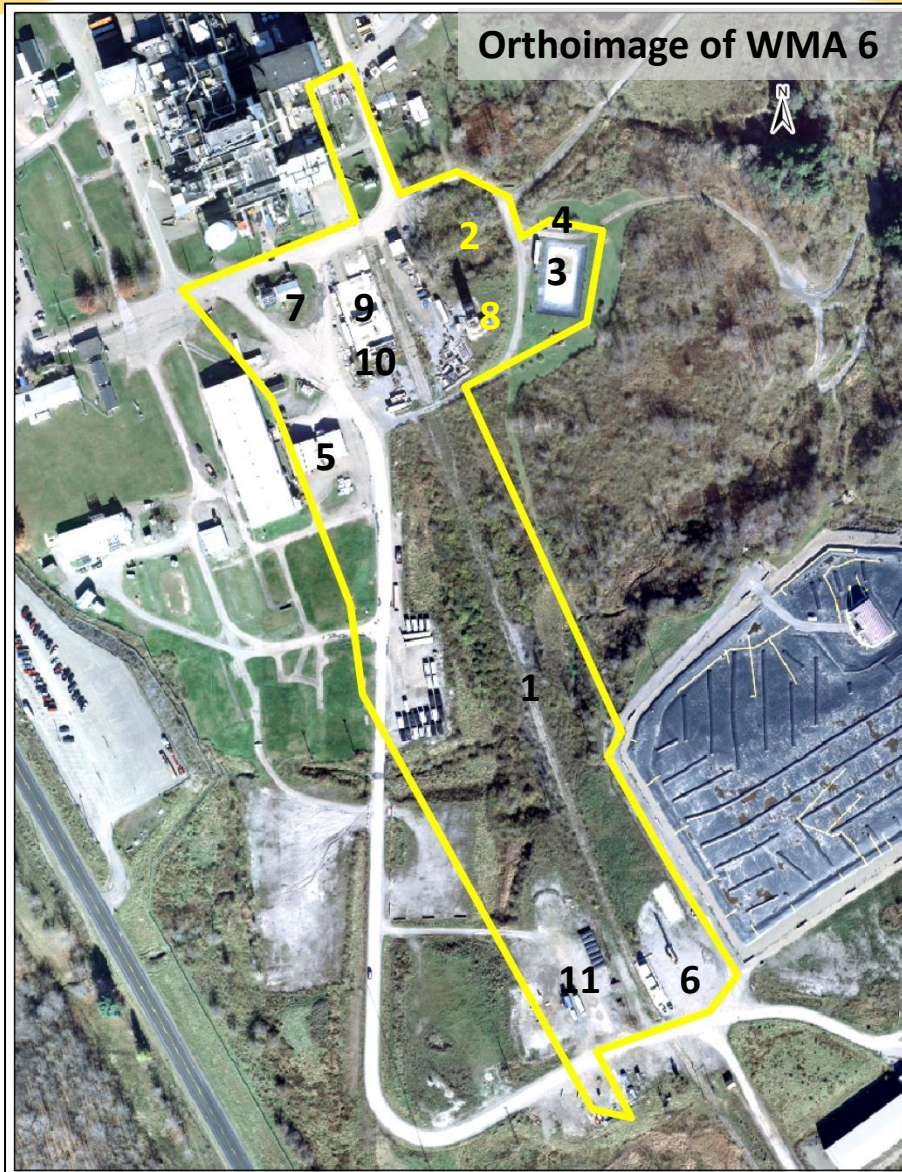
Orthoimage of WMA 6

1. Rail spur
2. Demineralizer sludge ponds (inactive)
3. Equalization basin
4. Equalization tank
5. Sewage Treatment Plant
6. Low-level waste rail packaging and staging area
7. Cooling tower
8. Two waste tank farm test towers
9. Old warehouse
10. Product Storage Area
11. HLW storage pad

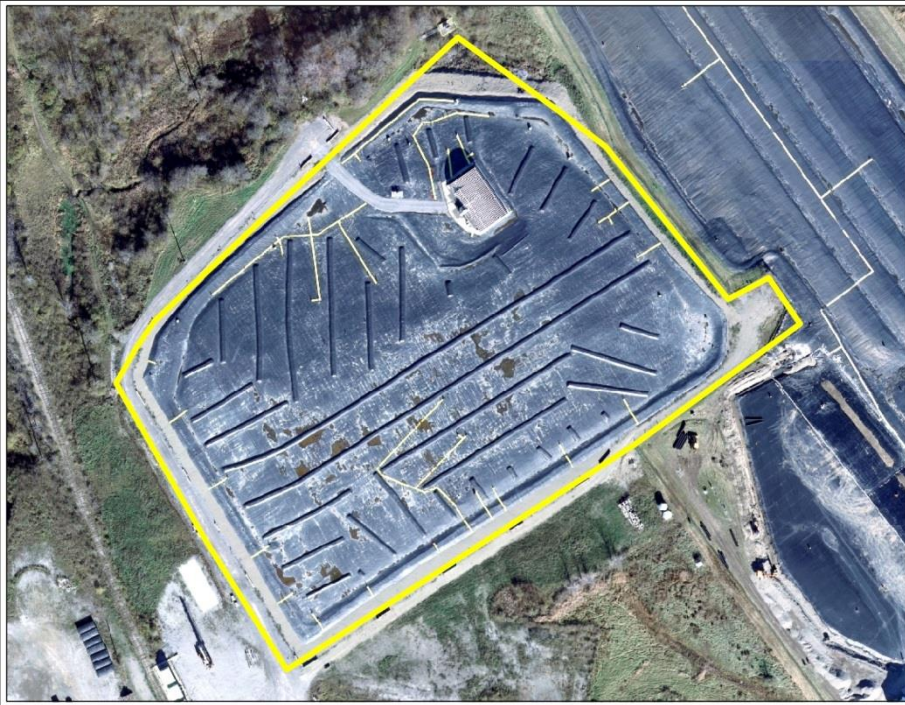
## Orthoimage of WMA 7 NRC-Licensed Disposal Area (NDA)

- A geomembrane cap and barrier wall were installed in 2008 to prevent water infiltration
- Liquid Pretreatment System is operable
- The NDA will remain in place during Phase 1 decommissioning

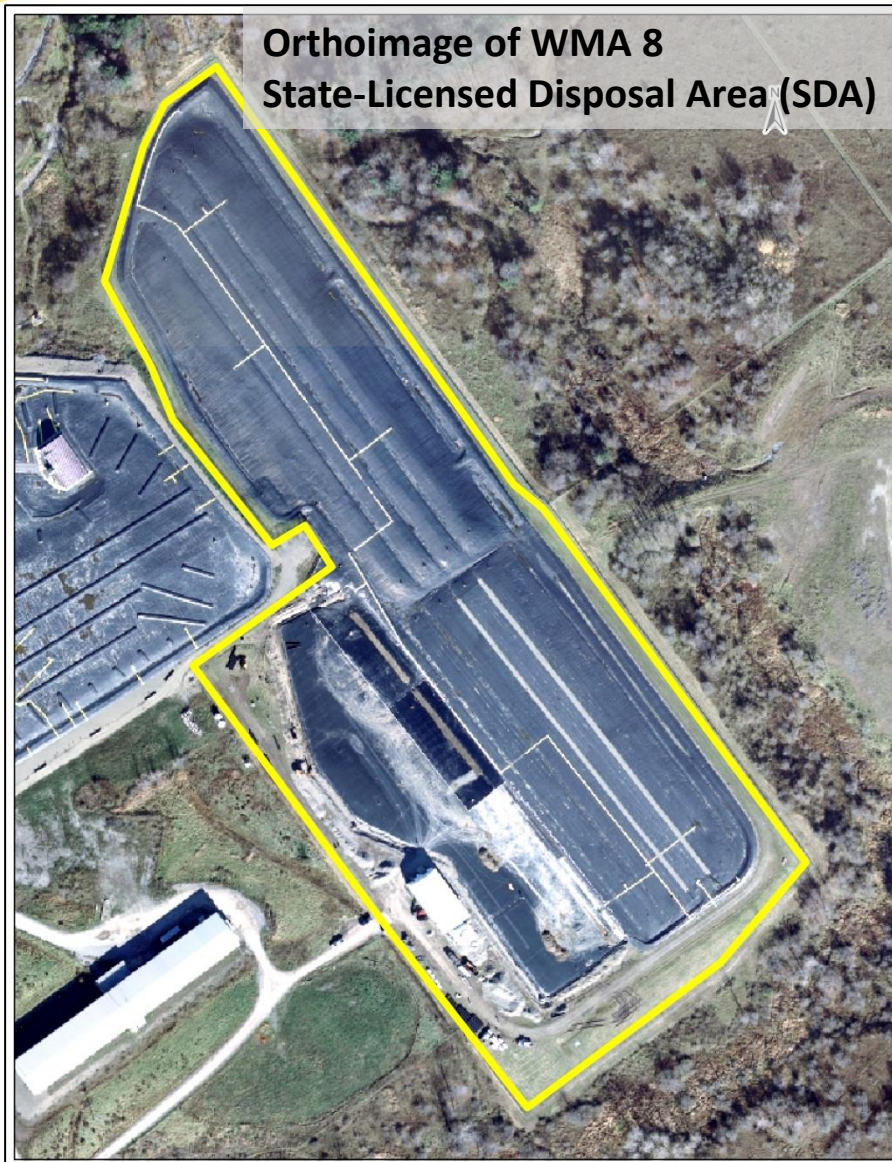
- The geomembrane cap and barrier wall prevent groundwater infiltration into the disposal area
- The leachate treatment facility was clean-closed and no longer stores mixed waste
- The SDA will remain in place during Phase 1 decommissioning

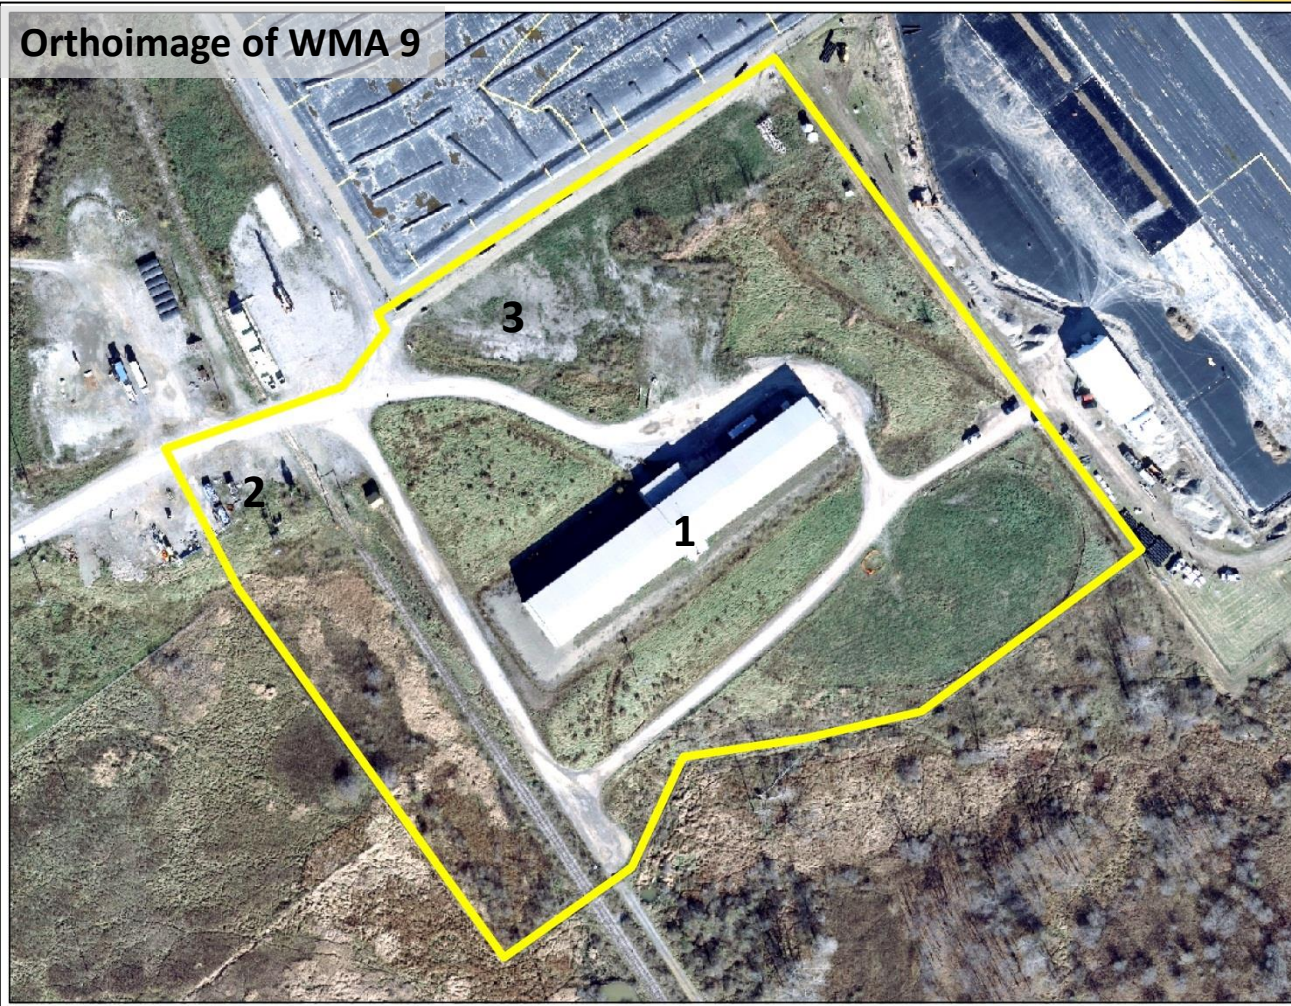
Orthoimage of WMA 9

1. Drum Cell
2. Subcontractor Maintenance Area
3. NDA Trench Container Area Pad

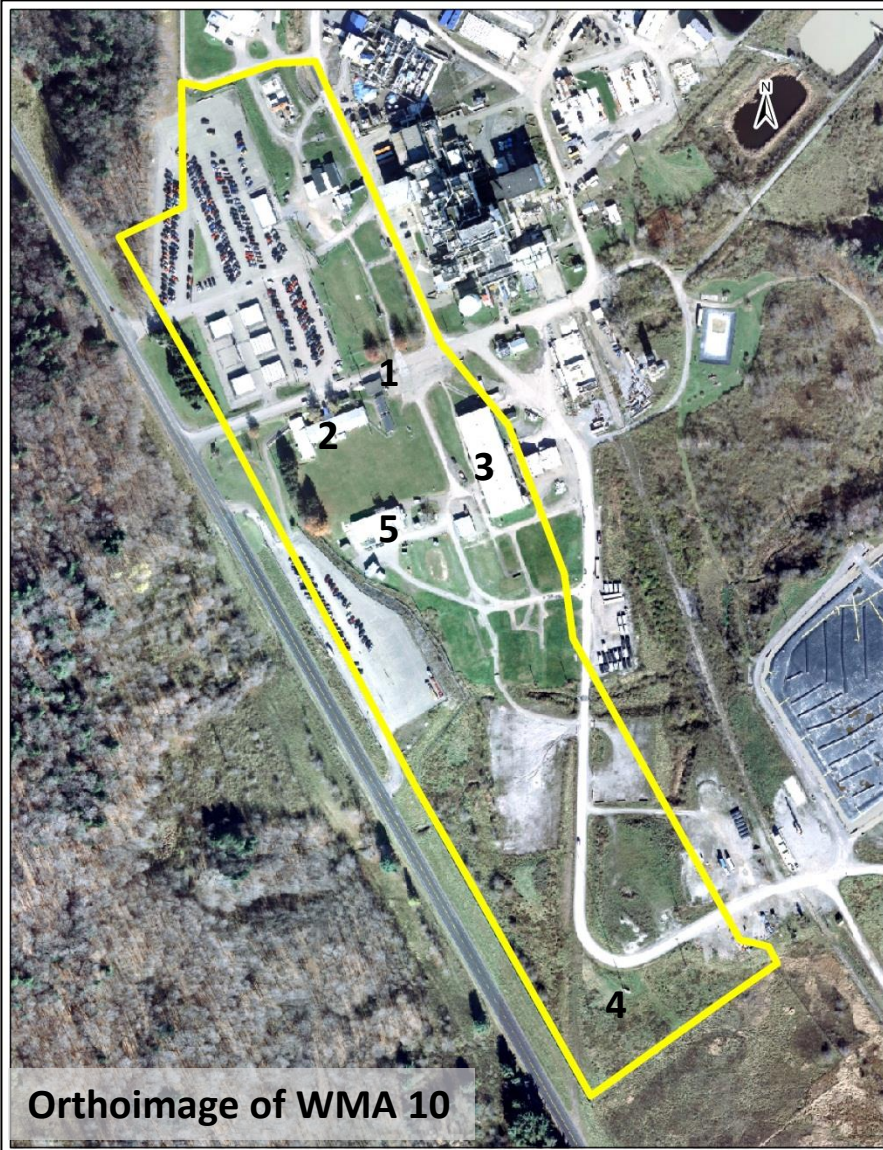
Orthoimage of WMA 10

1. Gatehouse
2. Administration Building
3. Warehouse
4. Meteorological Tower
5. Environmental Laboratory
