WEST VALLEY DEMONSTRATION PROJECT

CATTARAUGUS COUNTY, NEW YORK

GIS-Based Historical Photographic Analysis

October 2009 Final Report

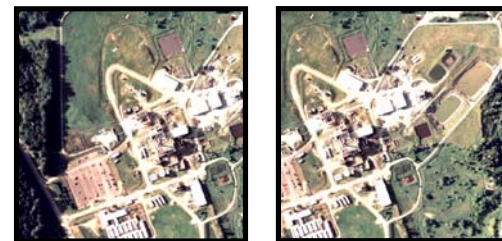
Sample of aerial photographs examined.

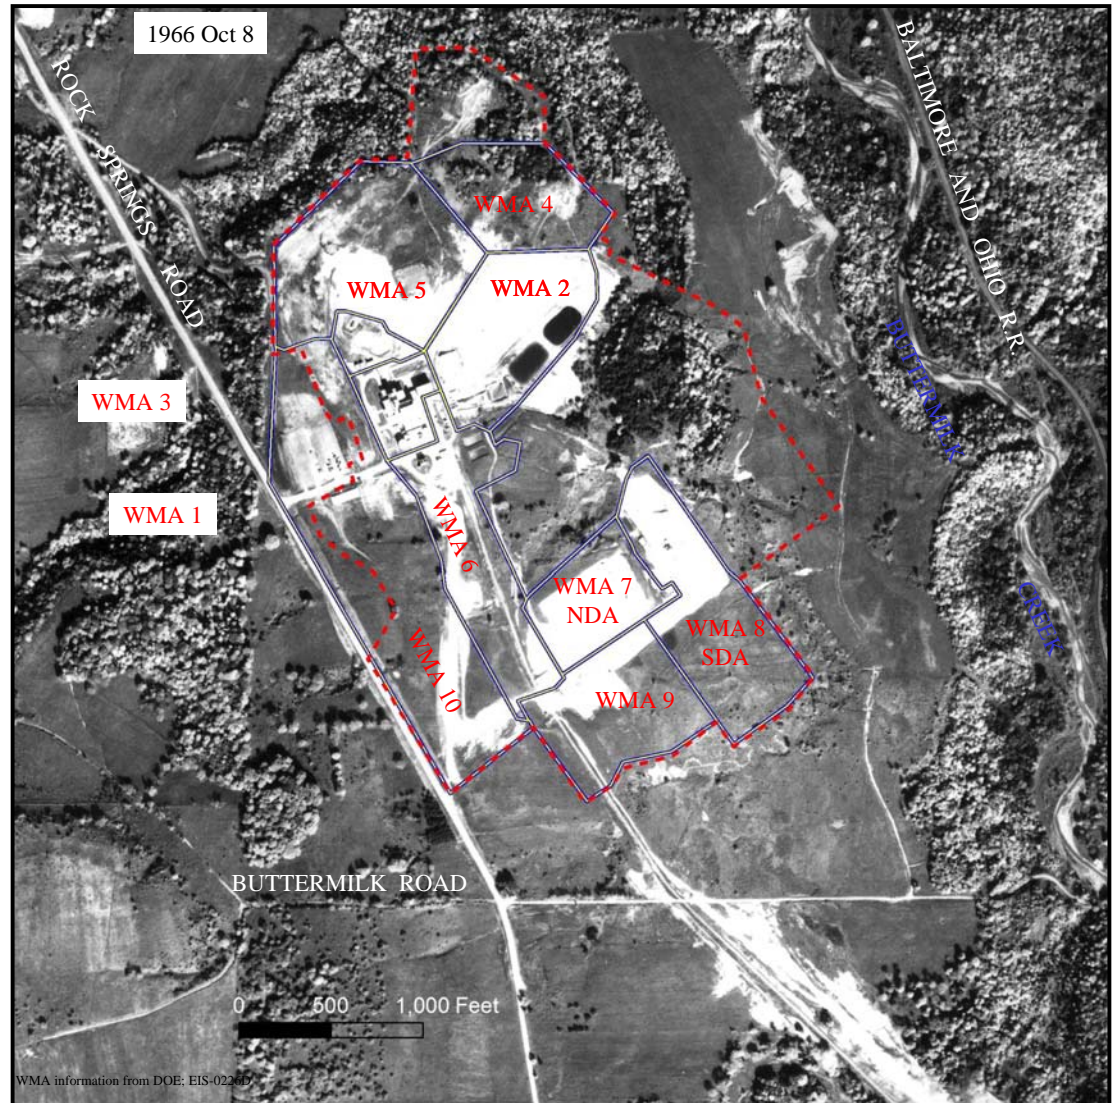
This graphic depicts an overview of findings derived from the 1966 aerial photography. Analysis of the 1966 imagery indicates a very active site. Although the site is still under construction, numerous pits, trenches, lagoons, ground scars, and other features are observed in the photo.

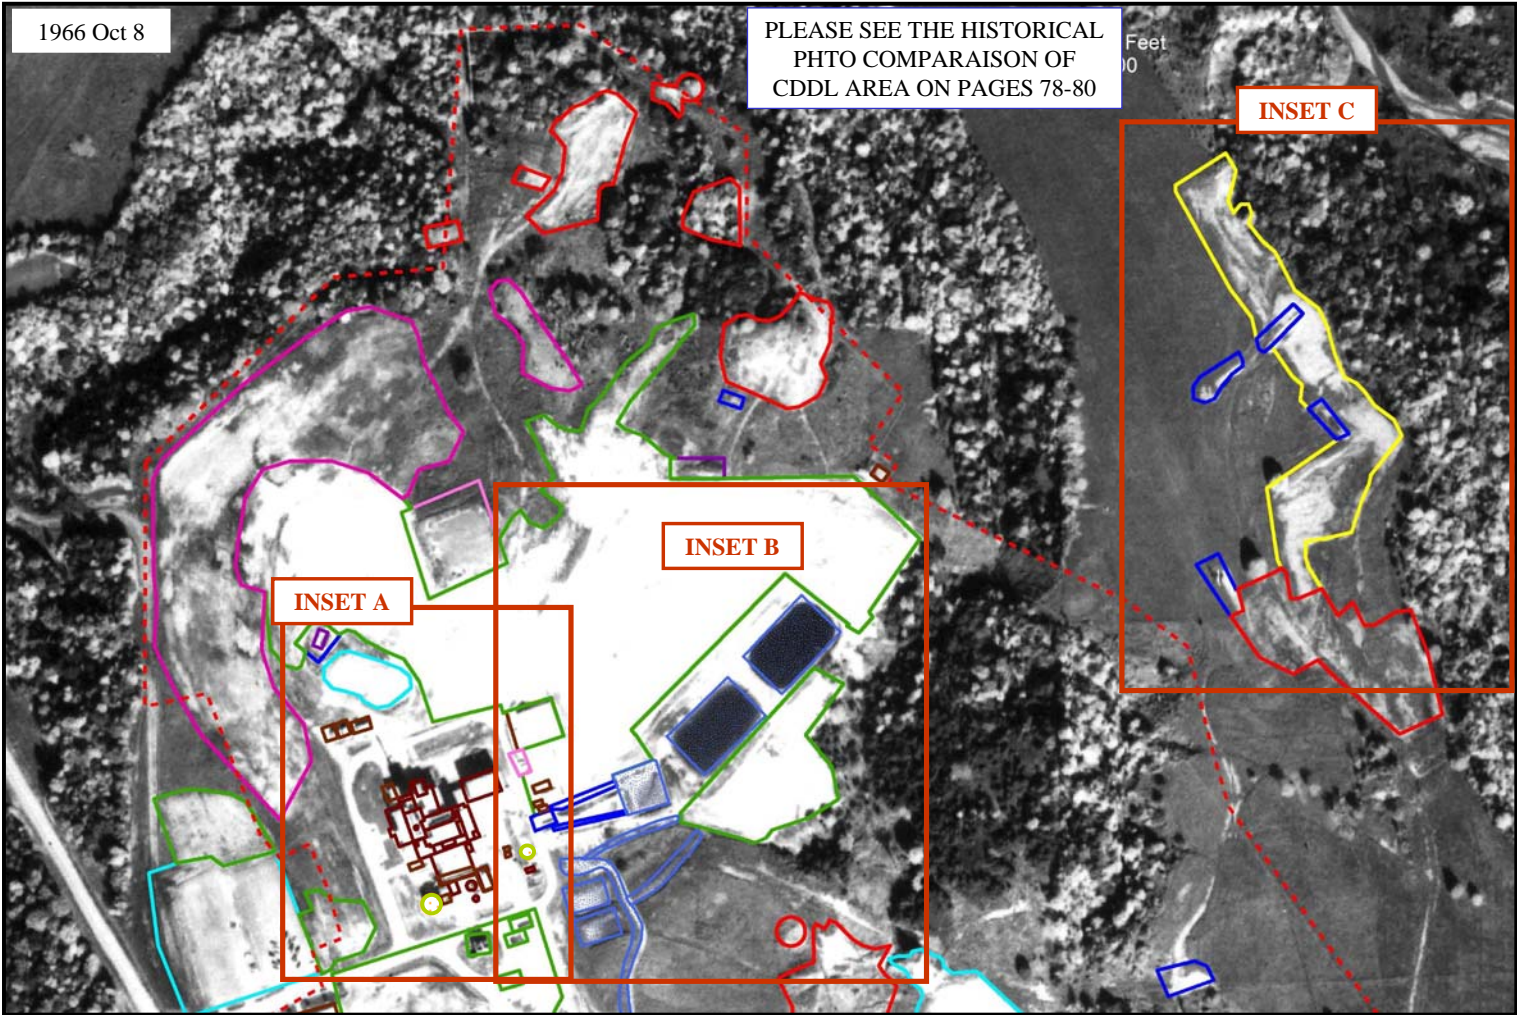
Activities are seen throughout the site. New structures, new buildings, lagoon, trenches, ground scars, excavation areas, and graded areas are more numerous than in earlier photos.

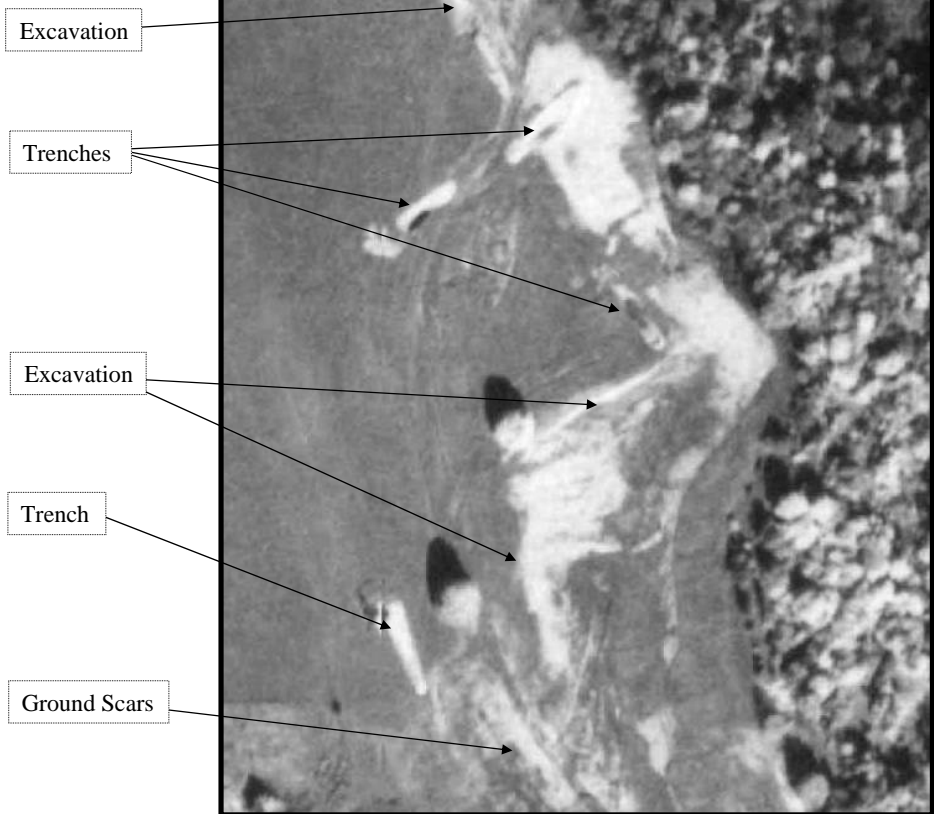
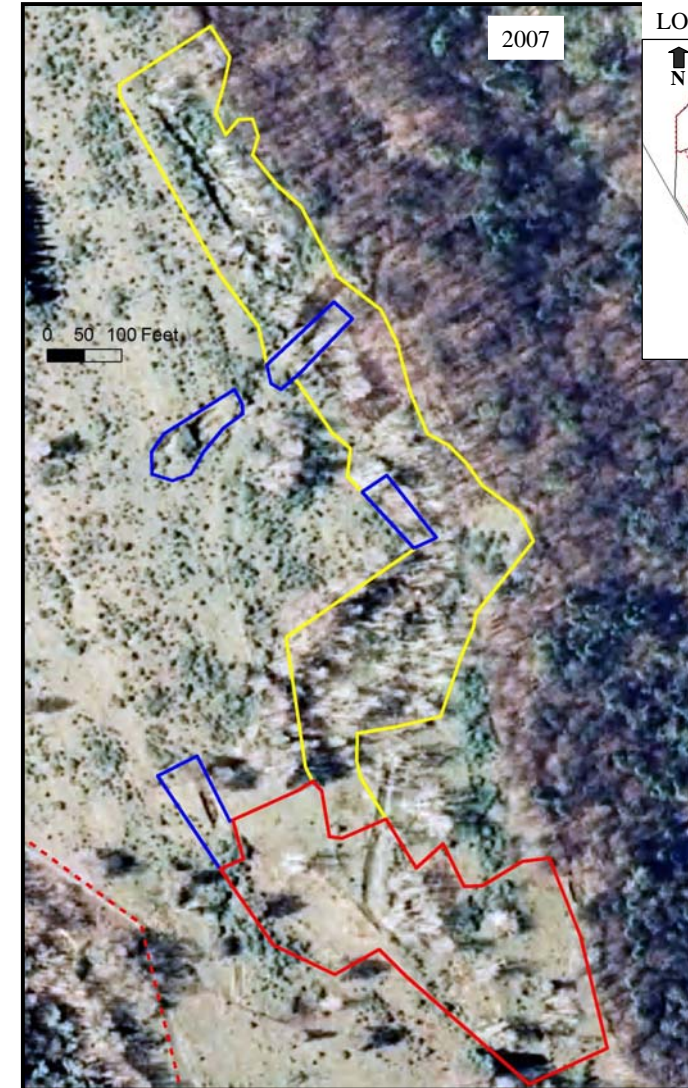
1966 Findings Draped Over a 2007 Aerial Photo

The 1966 image shows some activities on the eastern side, adjacent to the wooded area. Excavation, trenches, and ground scars are evident at the site.

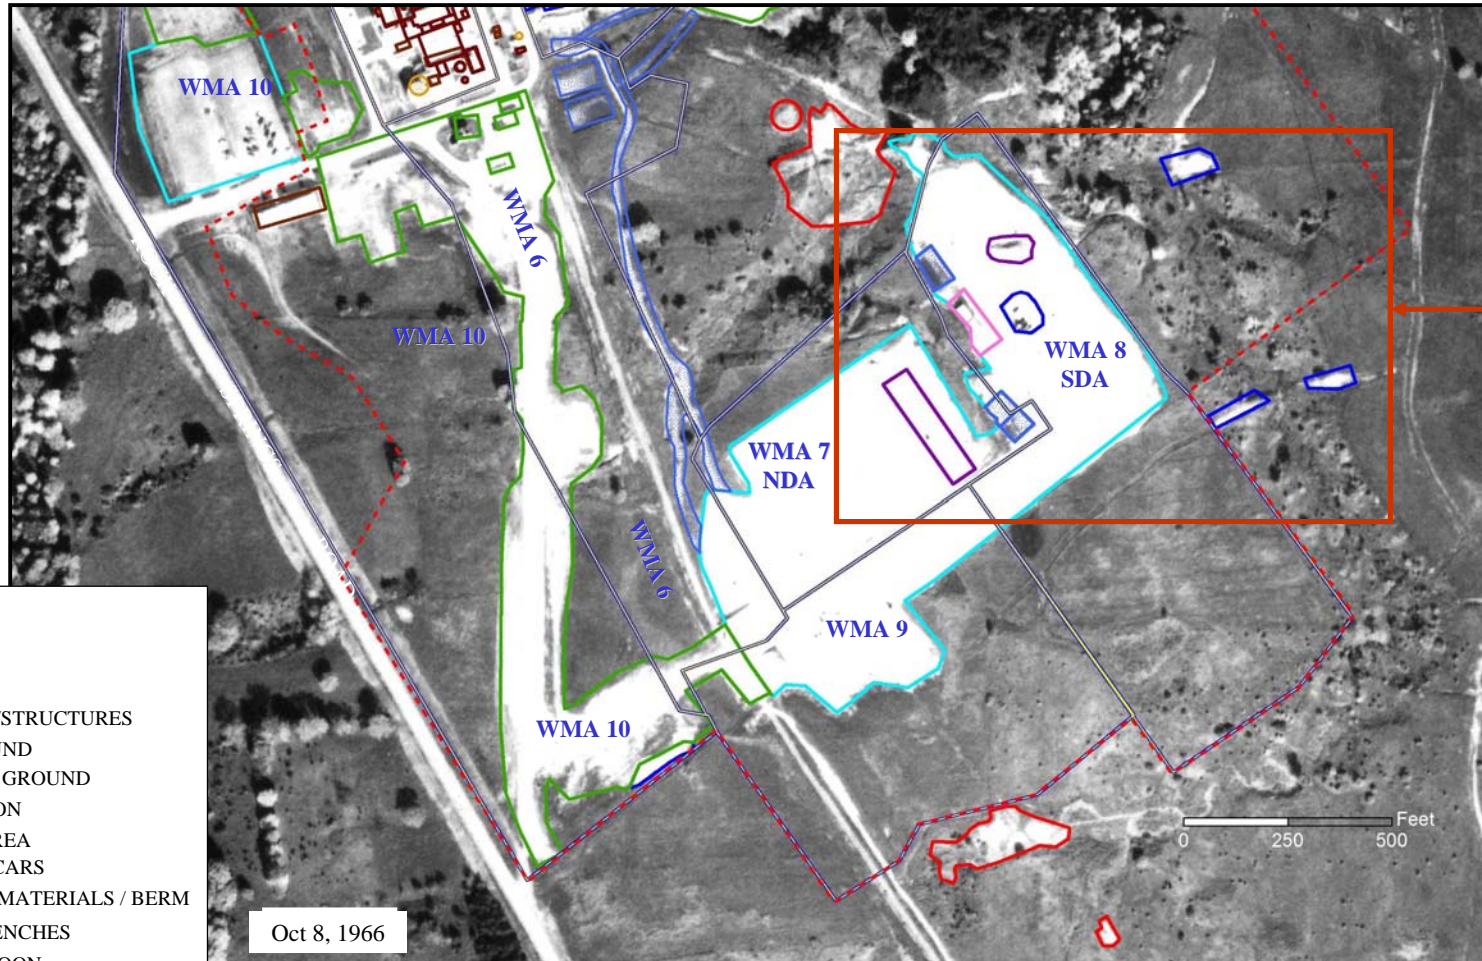
In this 1966 image, the southern part of the WVDP is still under construction. WMA 7, NRC-licensed Disposal Area (NDA), WMA 8 State-licensed Disposal Area (SDA), and WMA 9 are not completed. WMA 8 shows a lot of activity with structures like ponds / lagoons seen on the side, a big mounded materials and a huge pit in the middle. Some trenches and ground scars are observed around the area.

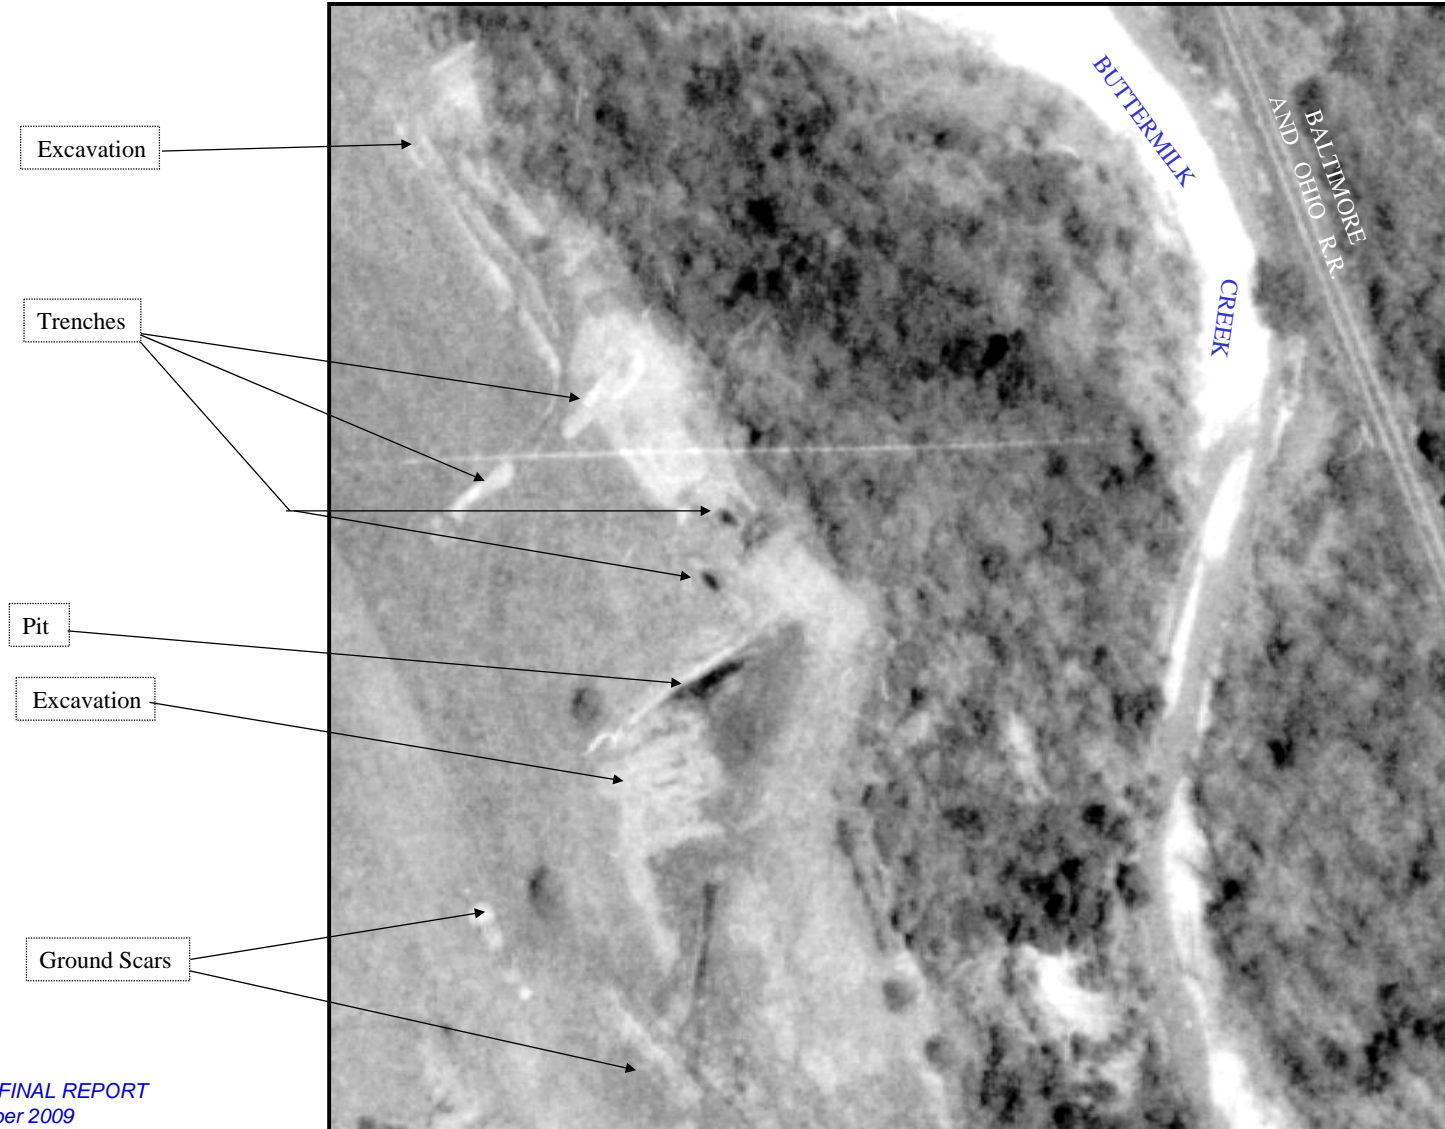
Activity area on the eastern side, adjacent to the woods, first evidenced in 1966.

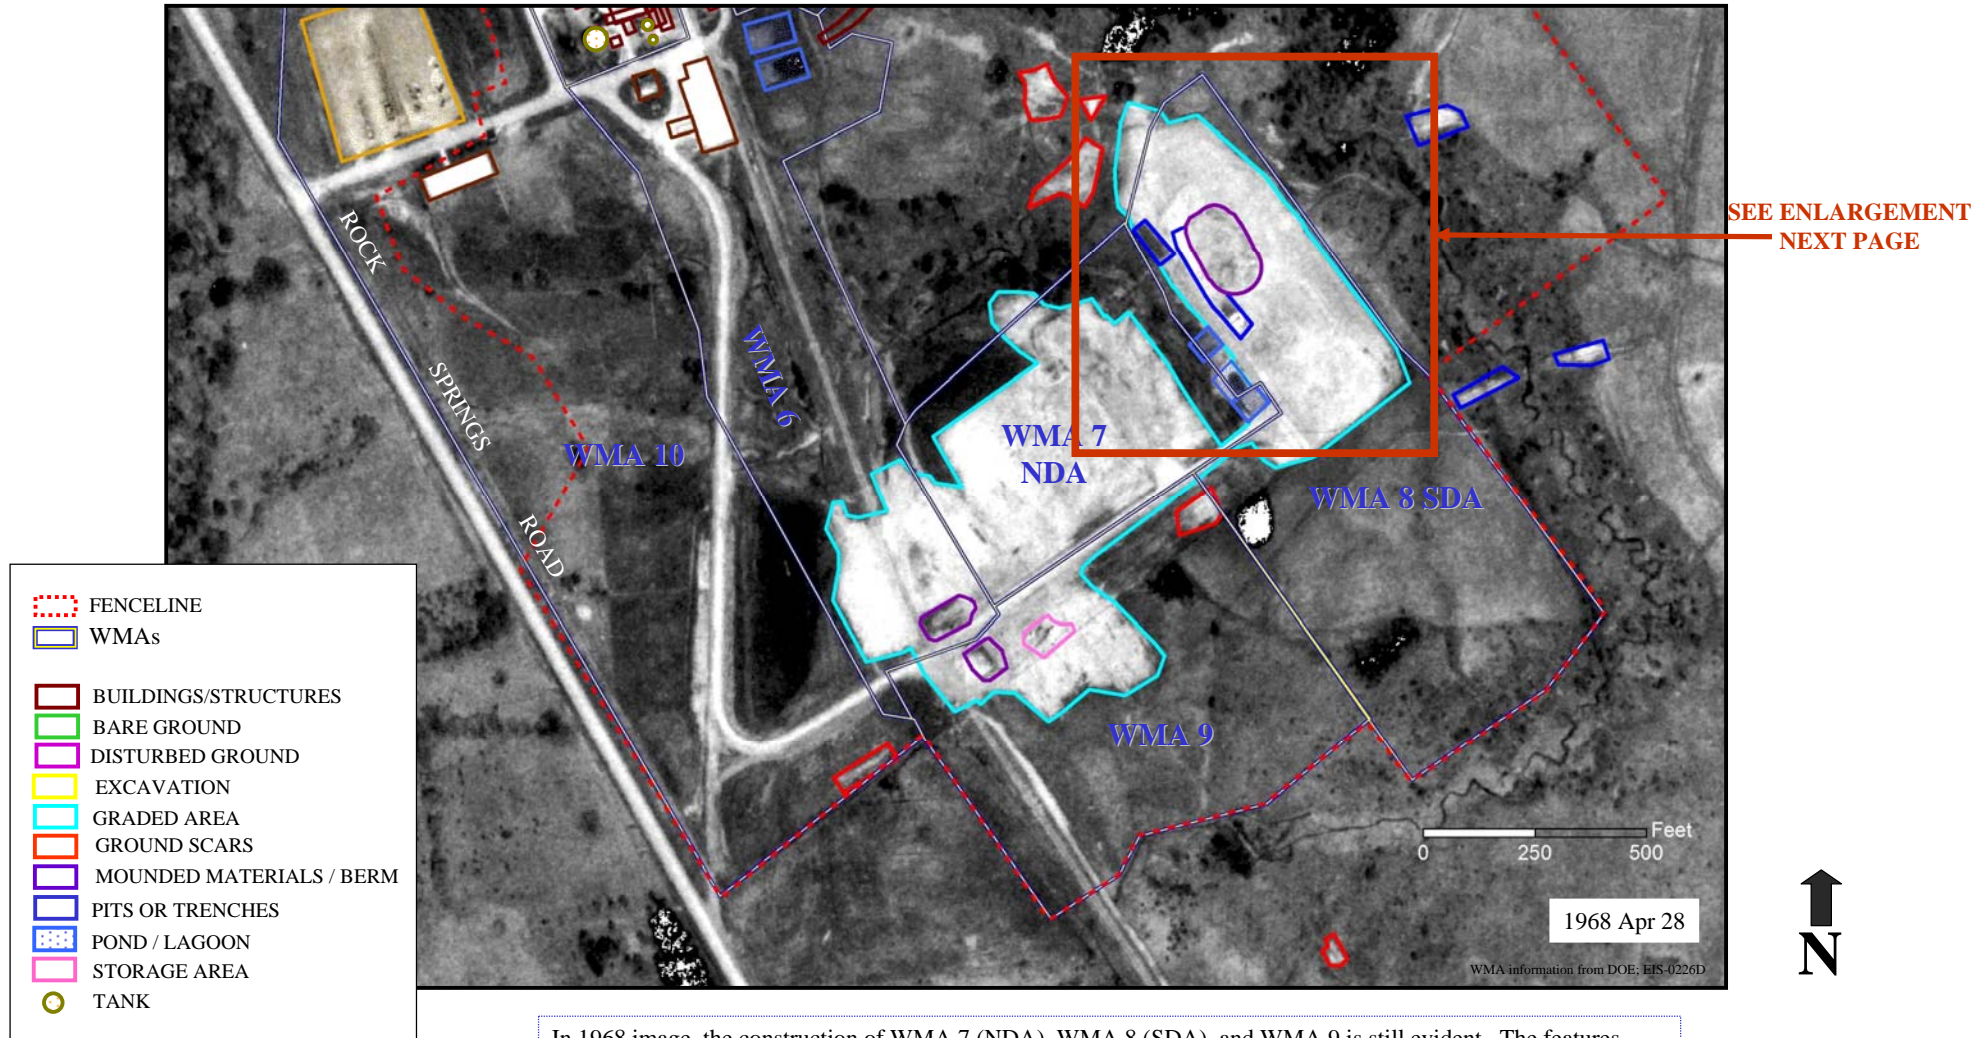
In 1968 image, the construction of WMA 7 (NDA), WMA 8 (SDA), and WMA 9 is still evident. The features found in 1966 photos (trenches, mounded materials, pit, lagoons) are still present.

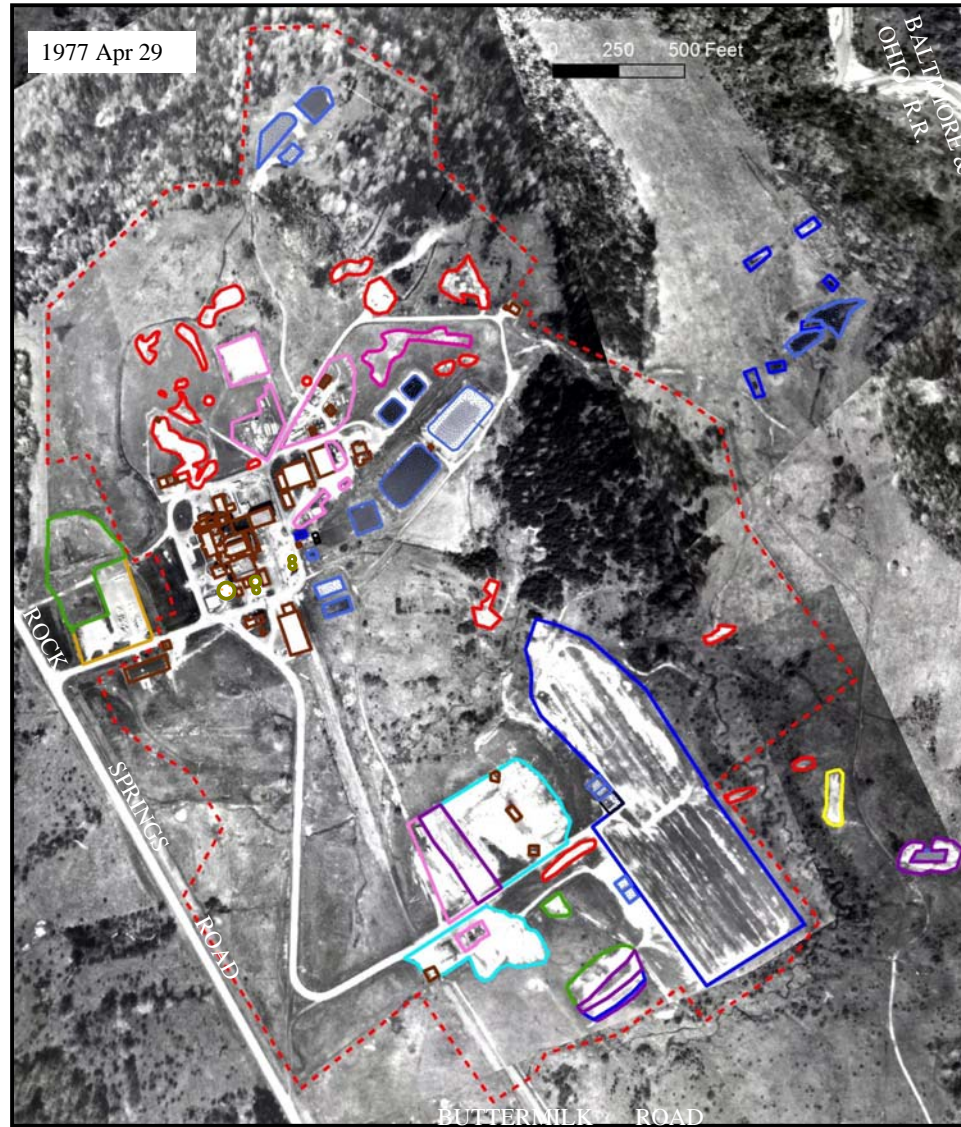
This graphic depicts an overview of findings derived from the 1977 aerial photography. Analysis of the 1977 imagery indicates a very active site with expanded parking lot, new storage areas, lagoons, structures, buildings, trenches & berms, etc.

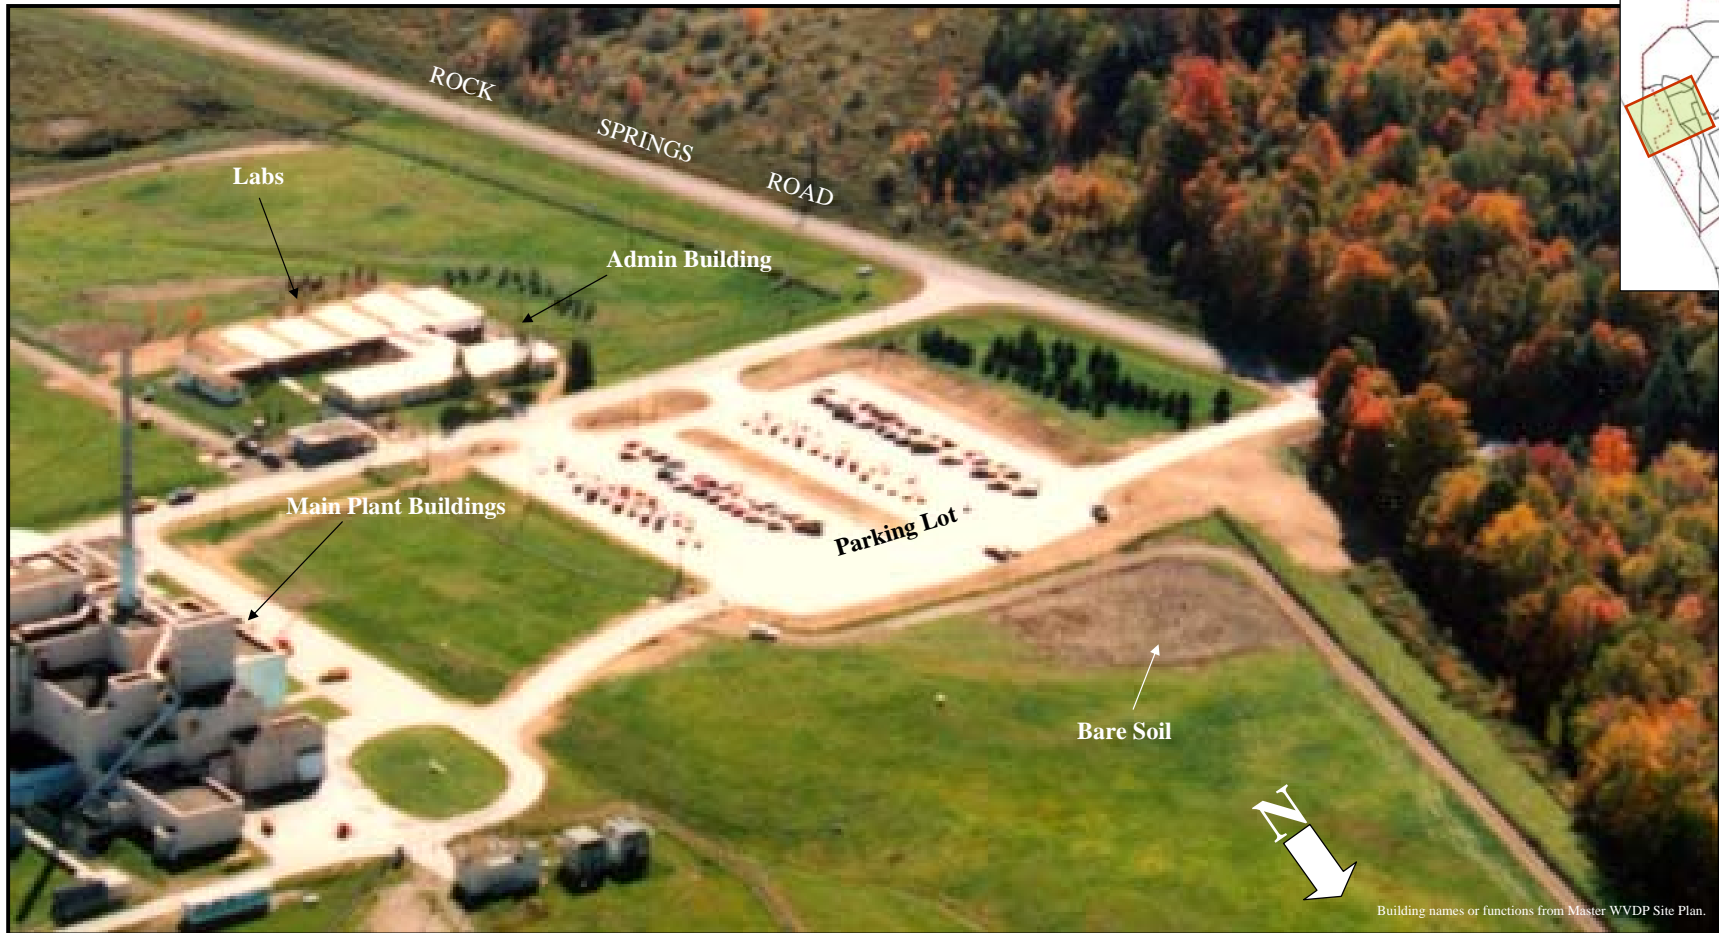
ADMIN & PARKING LOT AREA – 1982

In 1982, a series of new labs are seen behind the admin building. The parking lot is paved and is adjacent to a bare ground area.

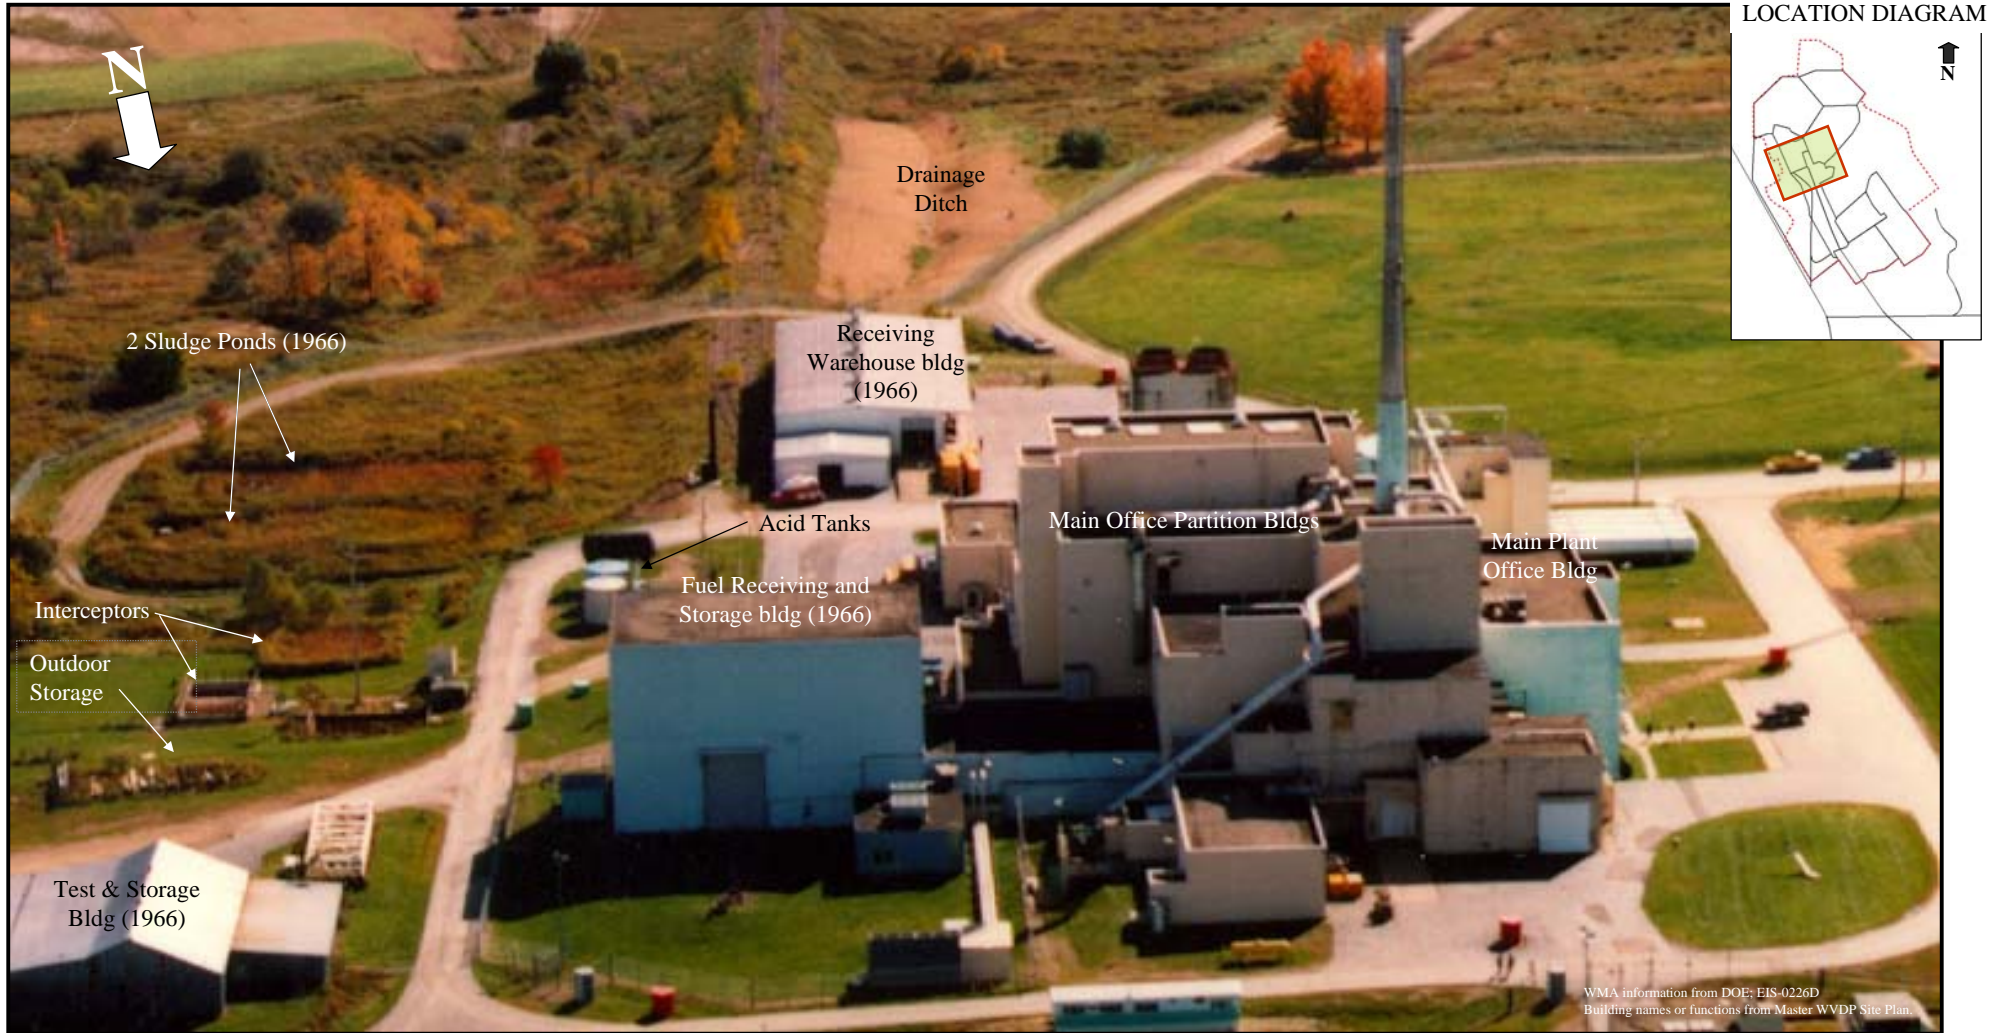
WMA 1 is the Admin Area. From this aerial view, the site is similar to the 1966 photos.

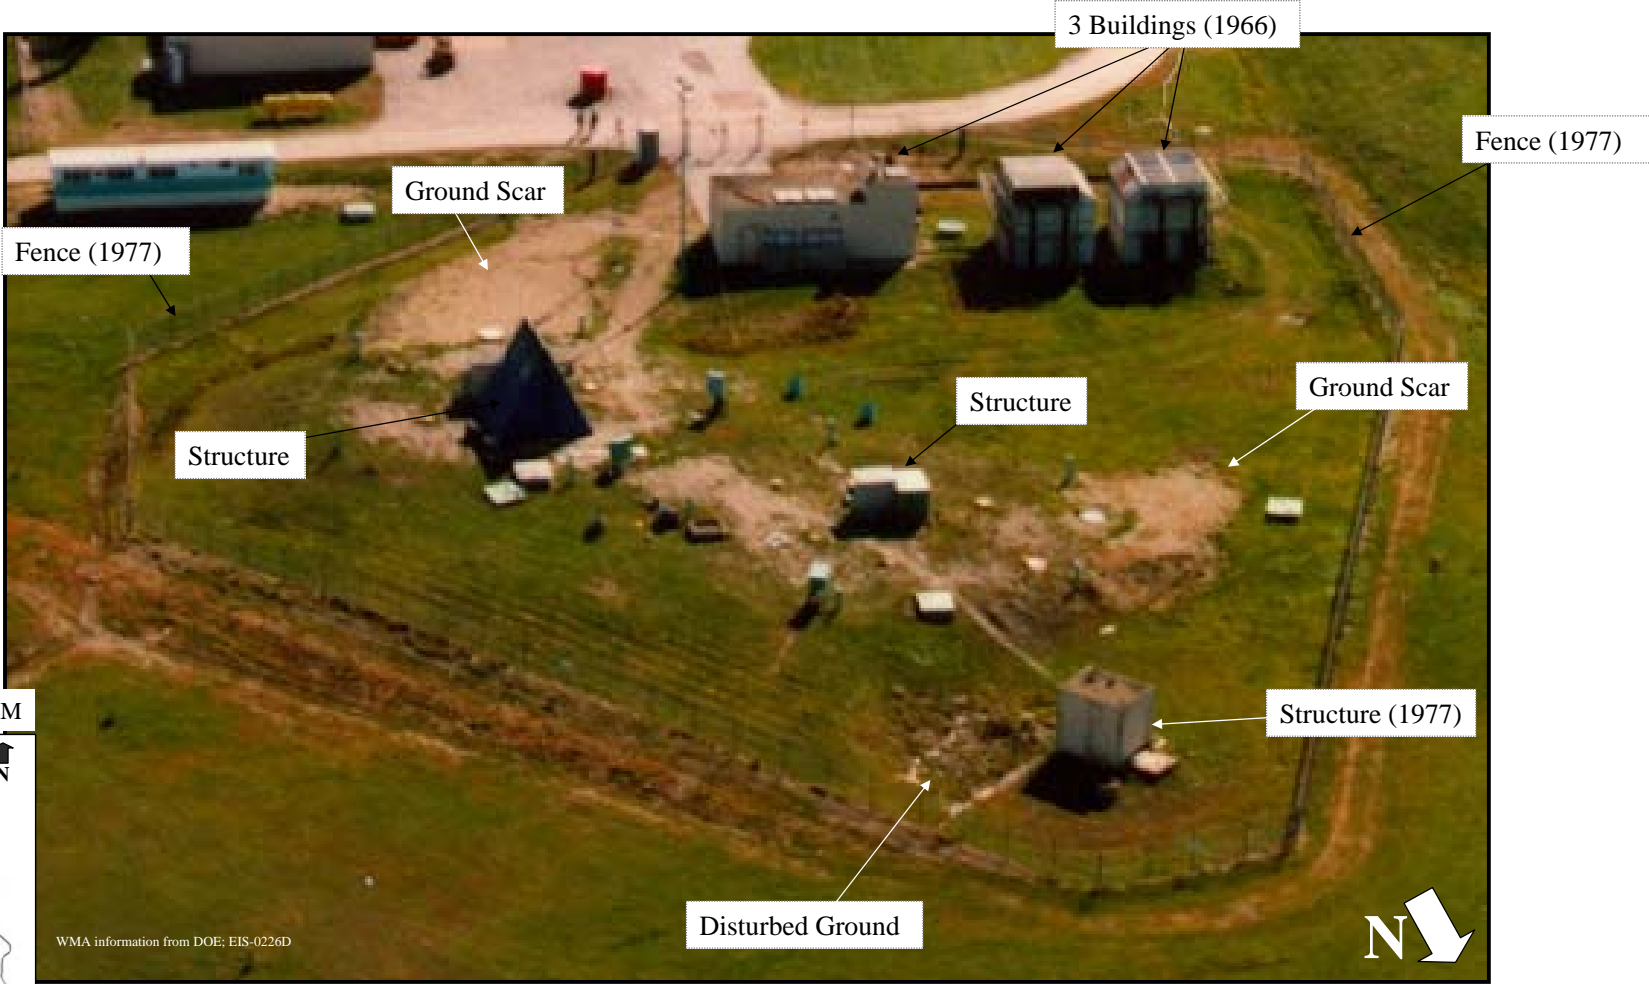
WMA 3 is fenced enclosed. The three buildings/structures found in 1966 photos are still present.

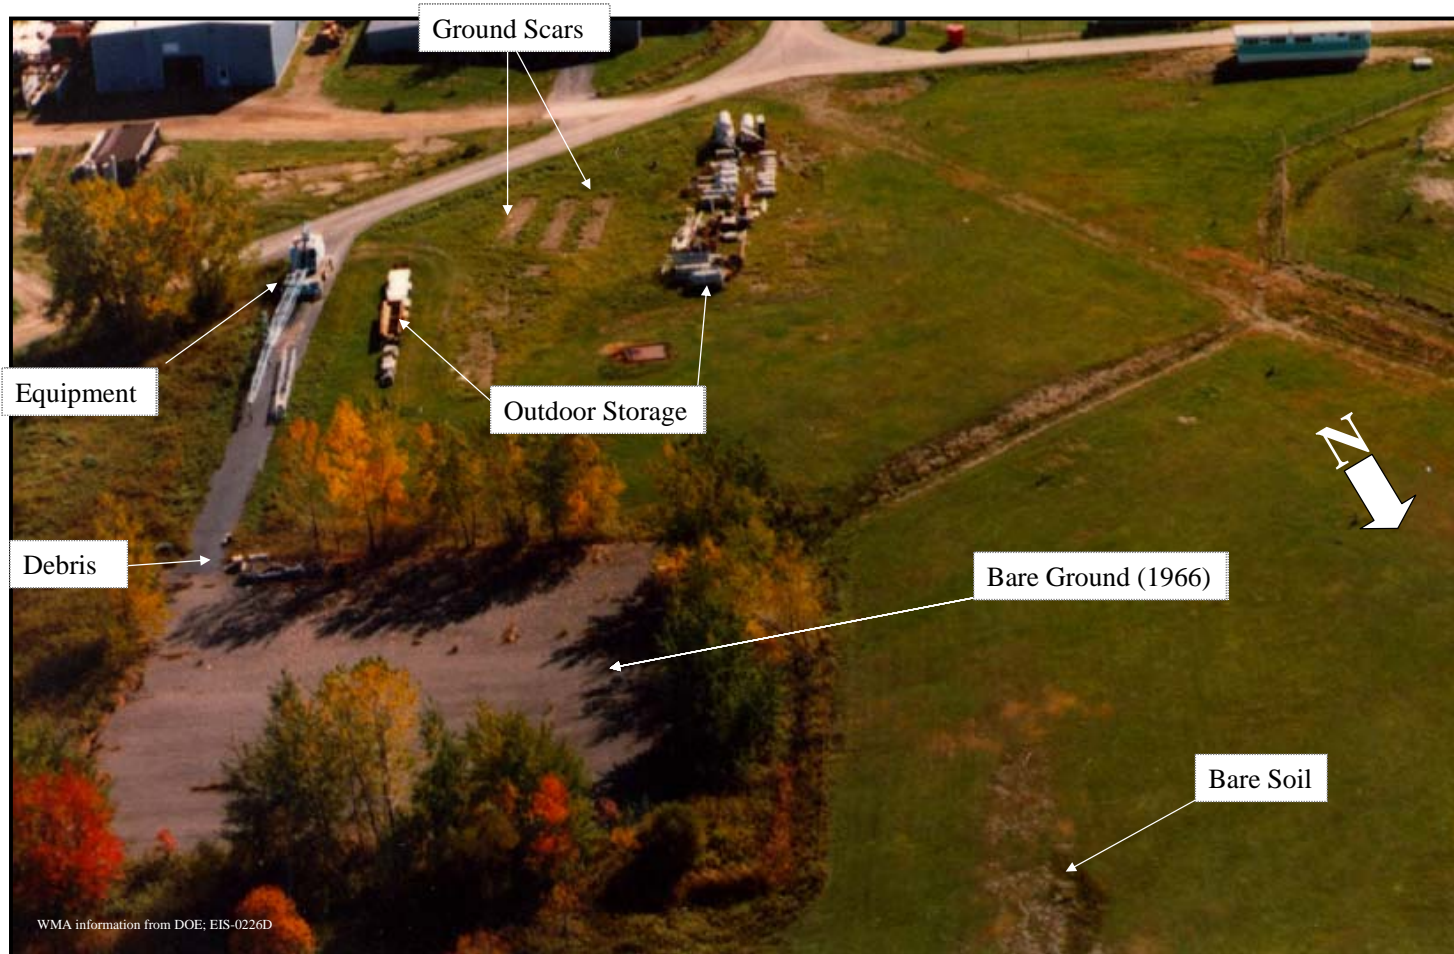
WMA 5 is the Waste Storage Area. From this aerial view, the site is similar to the view in 1966.

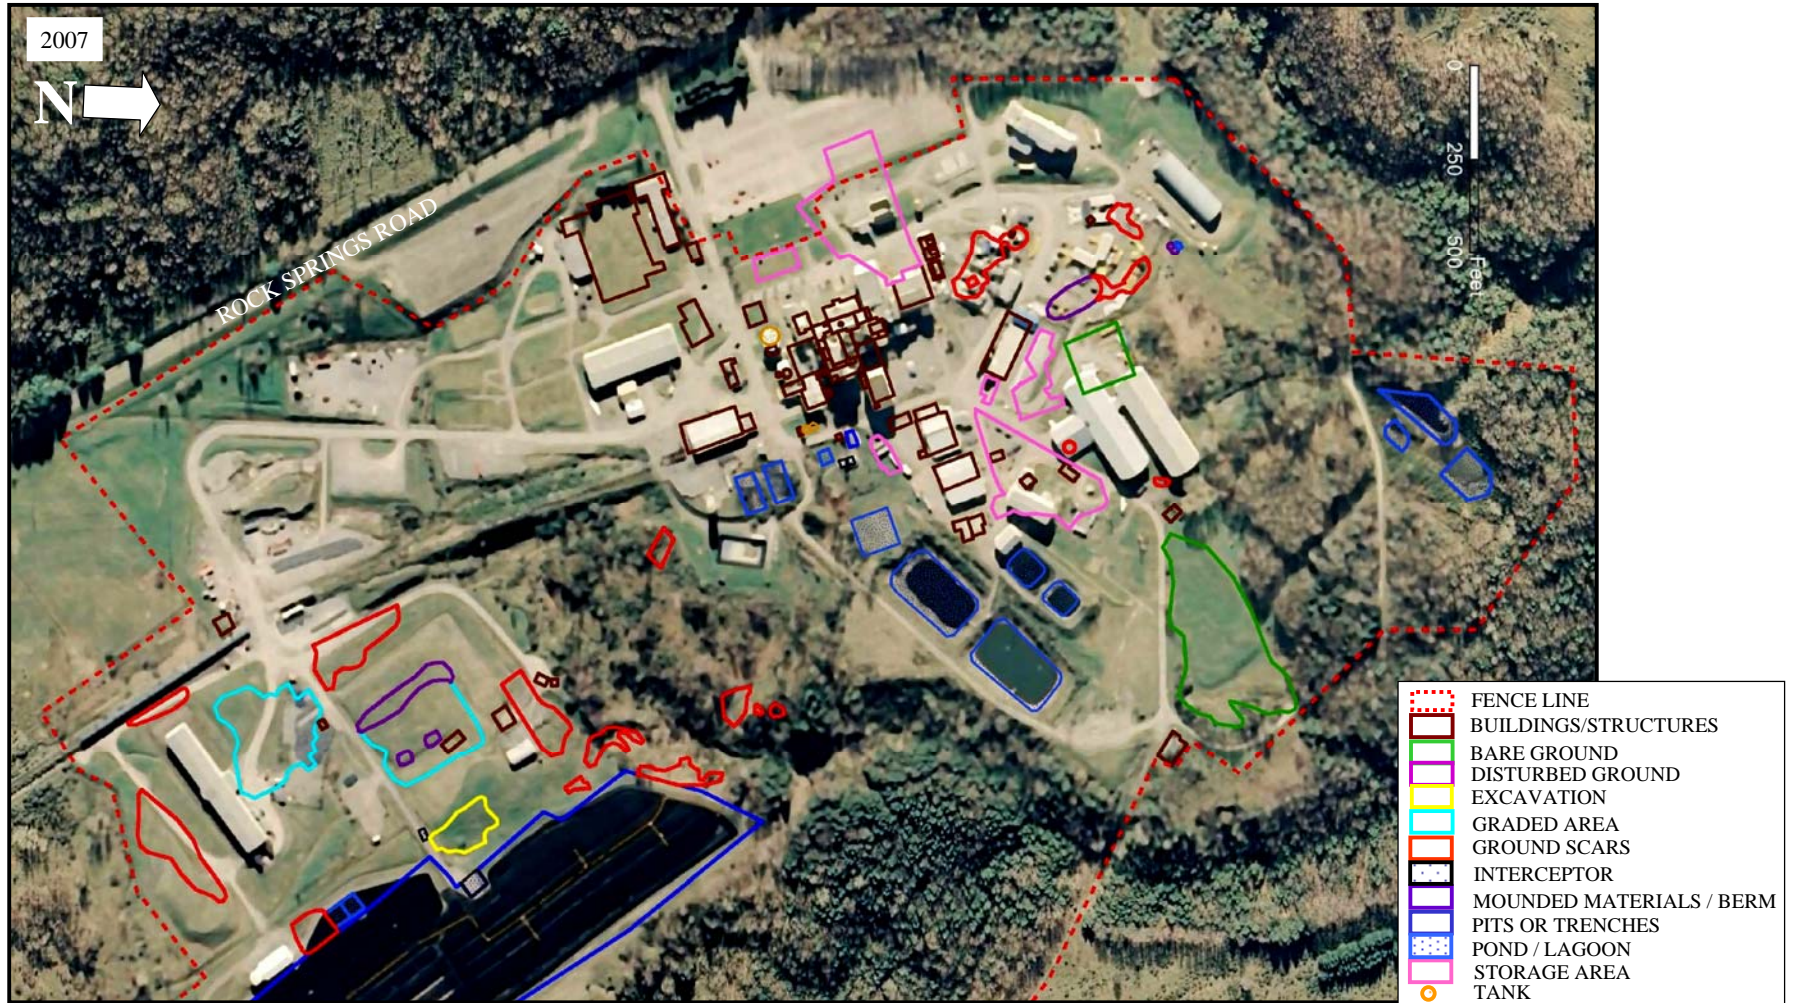
This graphic depicts an overview of findings from 1984 aerial photography superimposed on a 2007 base image.

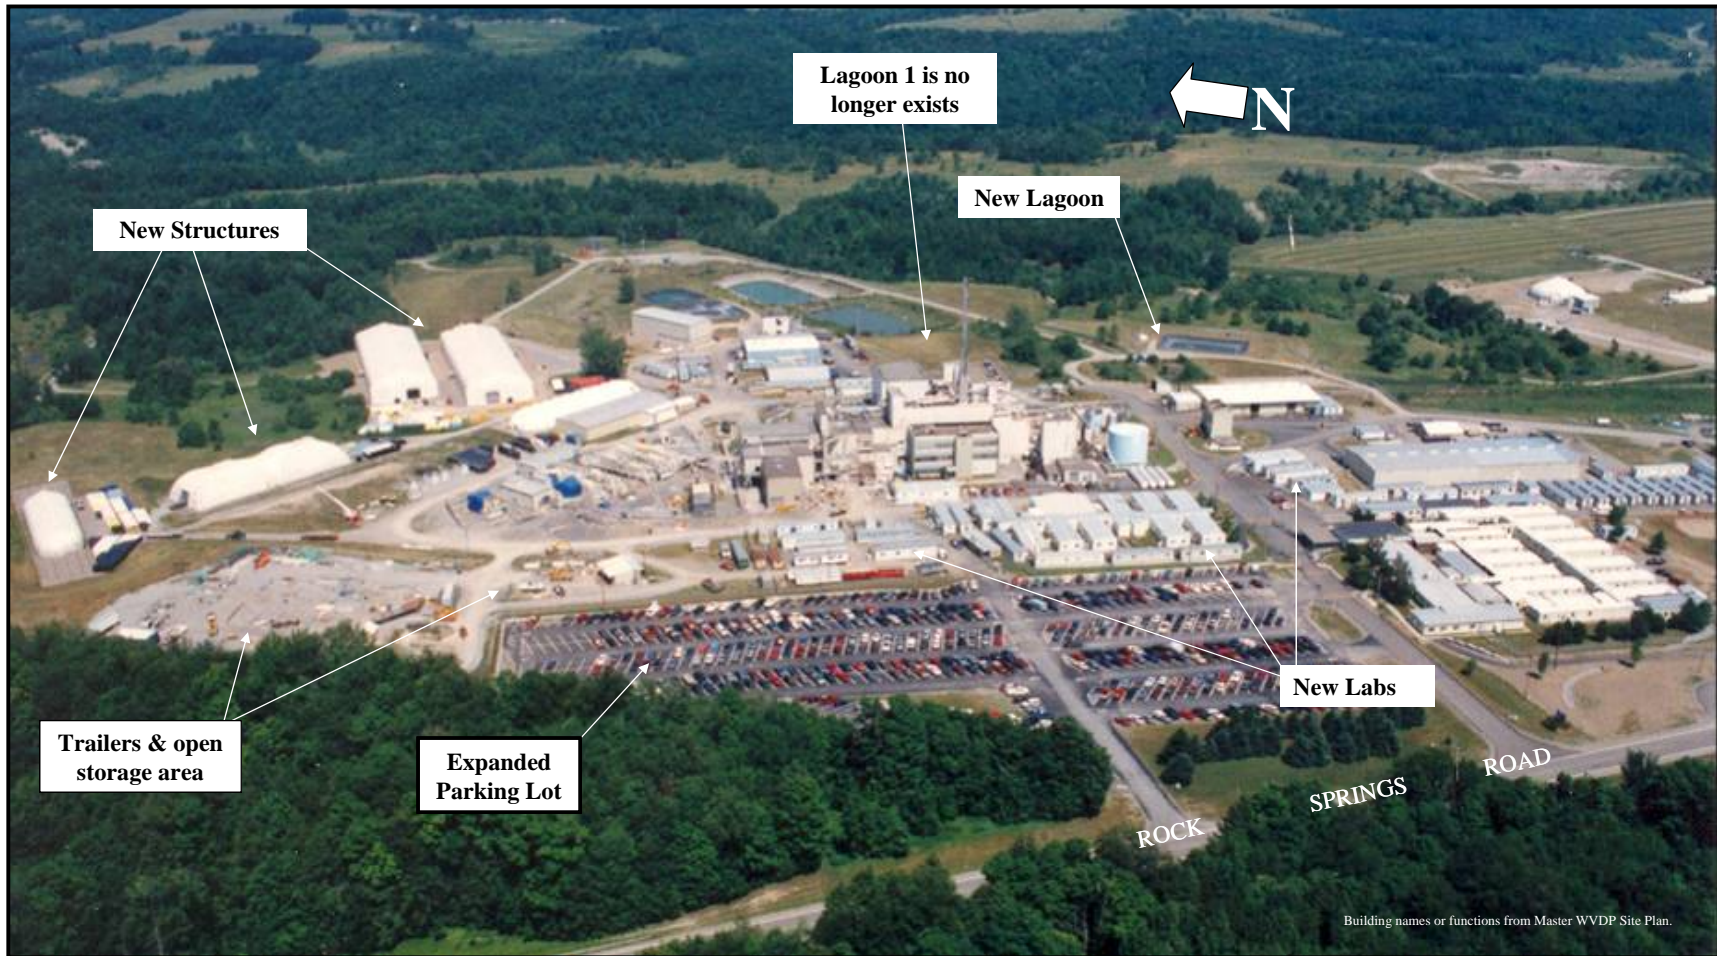
1991 Imagery is oblique aerial photograph and georeference is not available.
Numerous new (since 1984) lab/facilities are seen in this photo.

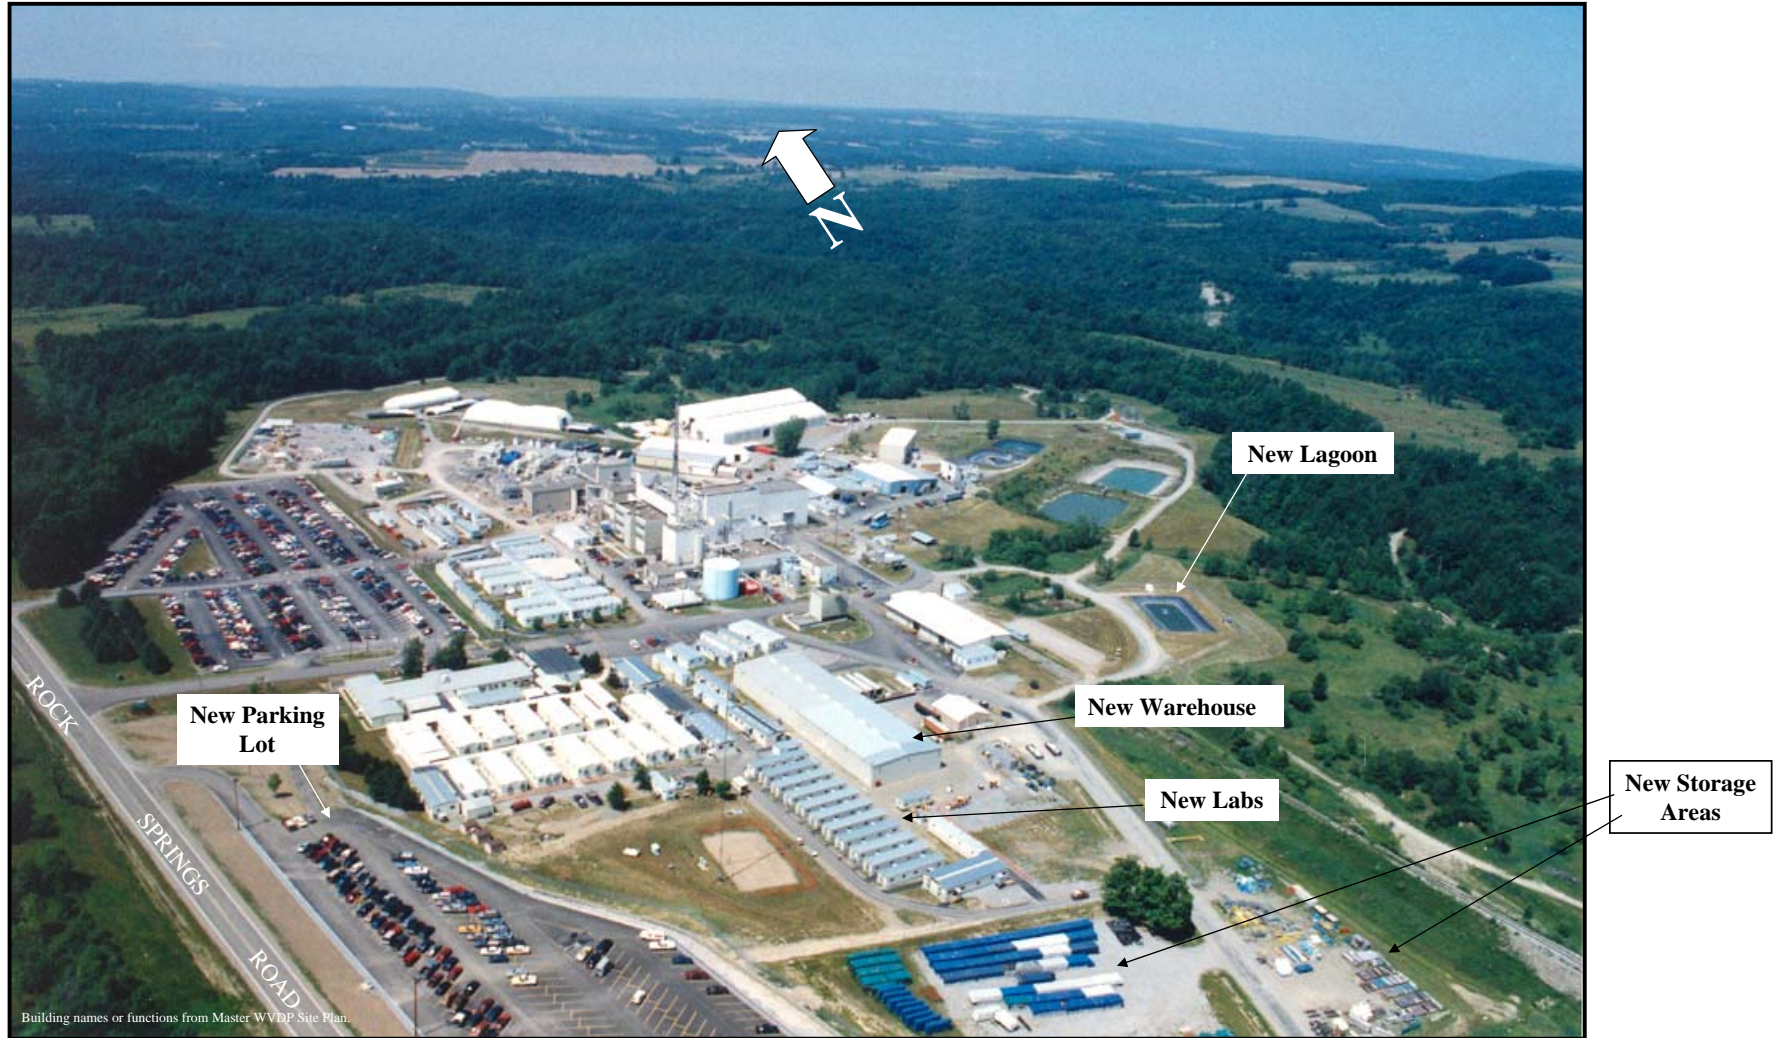
OBLIQUE PHOTO TAKEN FROM SOUTH SIDE LOOKING NORTHEAST

Numerous new (since 1984) lab/facilities are seen in this photo.
